Stream Biological Conditions EA Report

Project Name	H-600 Pipeline Spread F	AFE	124300135	Spread	H-600 Pipeline Spread F
Contractor	Price Gregory	Report #	351		
Environmental Auditor	Allyson Kincaid	Date/Time	11/10/2023 9:04 AM		
Stream ID	S-I20	Crossing Start Date	11/20/2023	Crossing Completion Date	12/7/2023
Milepost	163.20	Pre-Con Assessment Date	11/10/2023	Post-Con Assessment Date	12/7/2023
Station	8616+96	Bankfull Width (ft.)	11.5	Riffle:Pool Complexes Present?	No
State	WV	Stream Classification	Perennial		
County	Summers	303(d) Impairment Listing	No

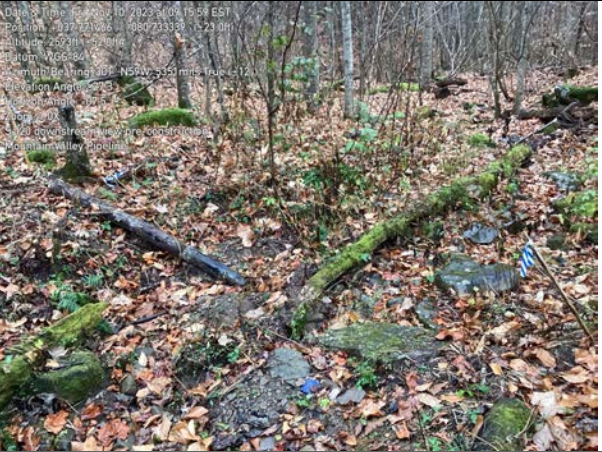
<p>GPS Location See Photo</p>	<p>GPS Location See Photo</p>
<p>Description Downstream view of permitted impact area during pre-construction assessment.</p>	<p>Description Downstream view of unimpacted area during pre-construction assessment.</p>

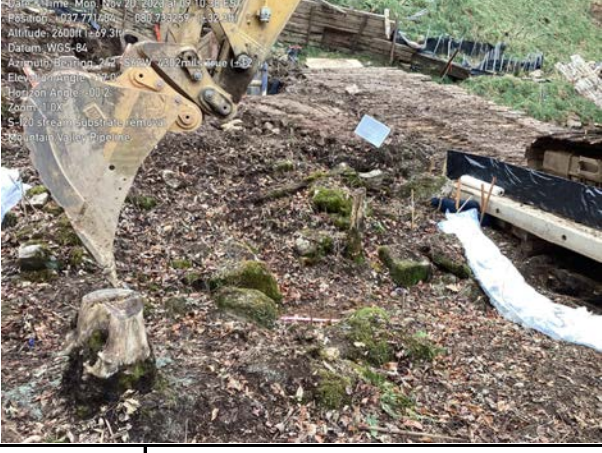
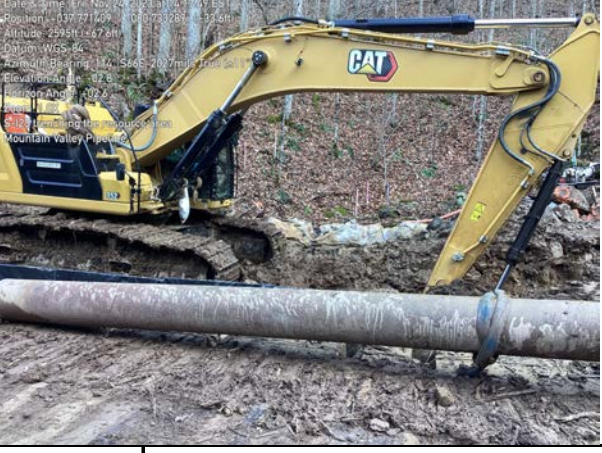
<p>GPS Location See Photo</p>	<p>GPS Location See Photo</p>
<p>Description Downstream view of permitted impact area during post-construction assessment.</p>	<p>Description Downstream view of unimpacted area during post-construction assessment.</p>

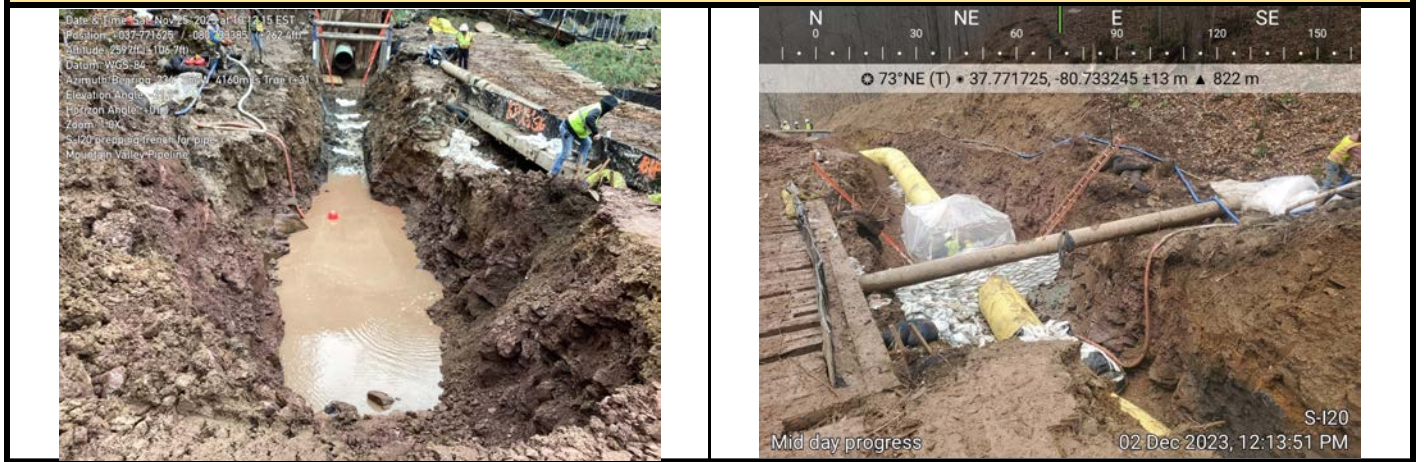
<p>GPS Location See Photo</p>	<p>GPS Location See Photo</p>
<p>Description Photo 1: Removing top 12 inches of substrate.</p>	<p>Description Photo 2: Excavating trench in aquatic resource.</p>

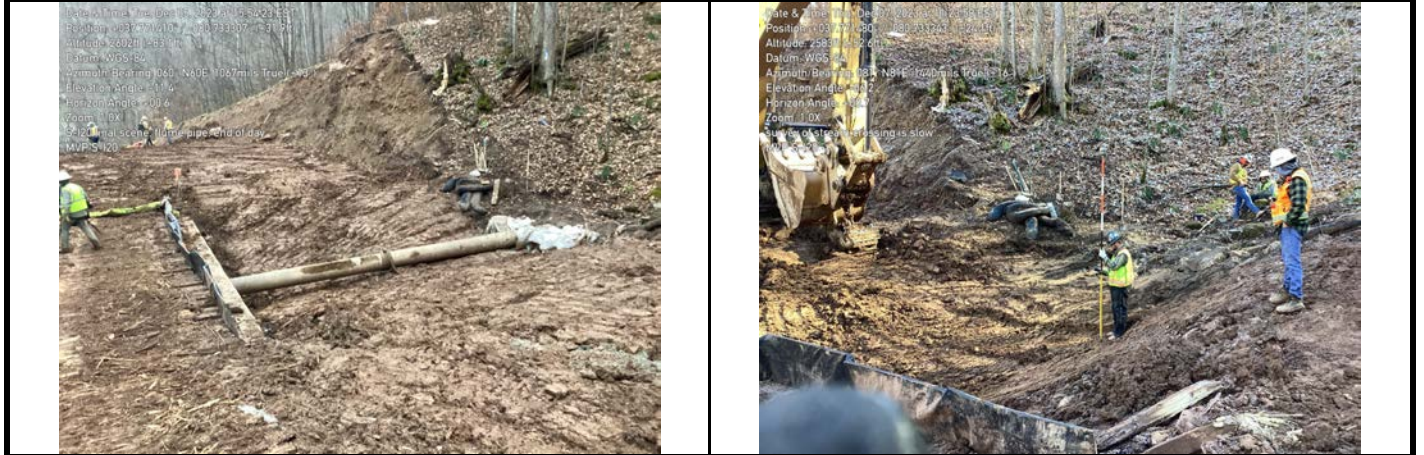
Description Photo 3: Sandbag pillows placed in trench.	Description Photo 4: Trench breaker on RDB. River weights.
---	---

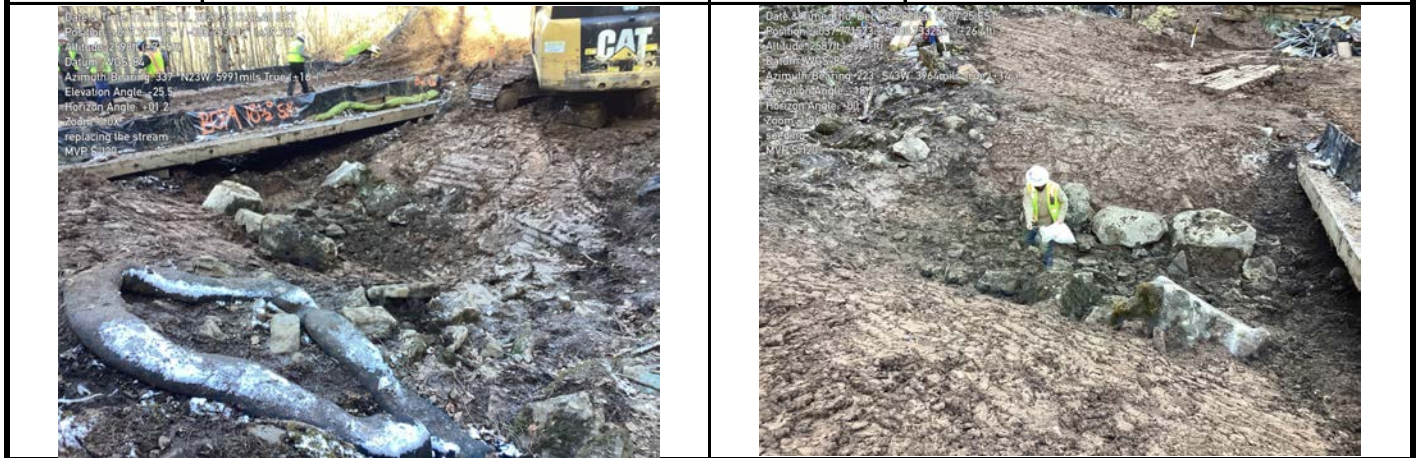
Description Photo 5: Backfilled subsoil and flumed replaced.	Description Photo 6: Survey present onsite.
---	--

Description Photo 7: Restoring substrate.	Description Photo 8: Seeding buffer.
--	---
