STREAM BIOLOGICAL CONDITIONS ENVIRONMENTAL AUDITOR REPORT

Stream ID: S-IJ1	Crossing Start Date: 10/28/2023	Crossing Completion Date: 11/30/2023
Milepost: 253.8	Pre-Con Assessment Date: 10/26/2023	Post-Con Assessment Date: 12/01/2023
Station: 13413+05	Stream Classification: Perennial (Perennial, Intermittent, Ephemeral)	Bankfull Width (ft.): 12
County: Franklin	303(d) Impairment Listing: Not Impaired	Riffle:Pool Complexes Present? No

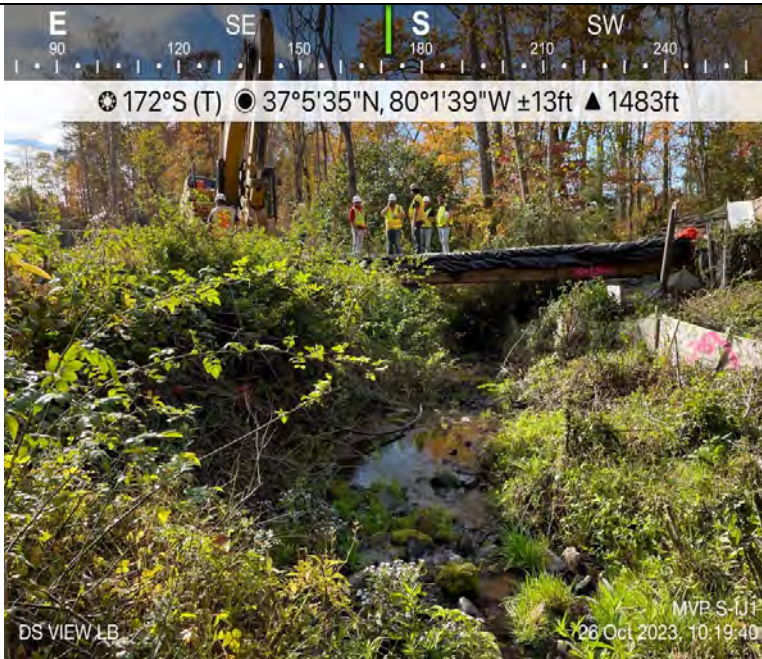
Photo Description: Downstream view of permitted impact area during pre-construction assessment.

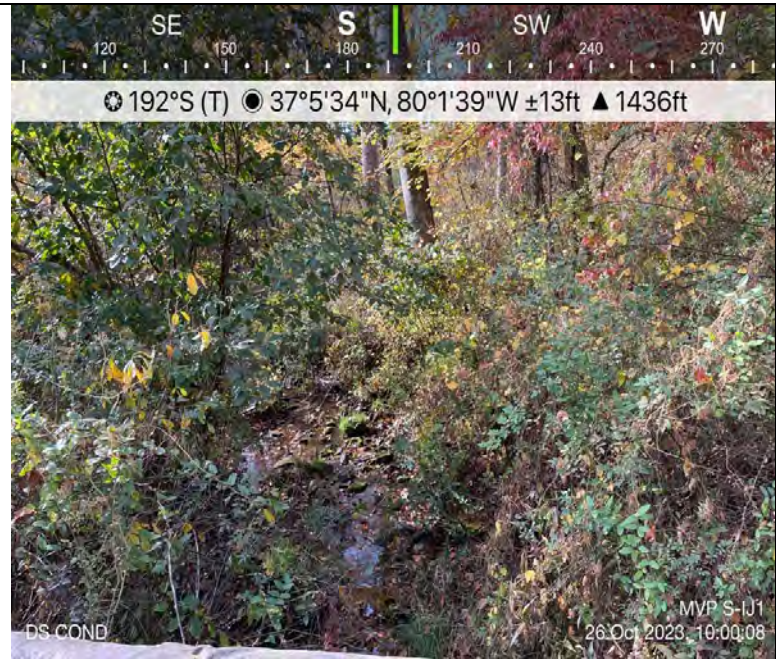
Photo Description: Conditions of the downstream area outside the ROW during pre-construction assessment.

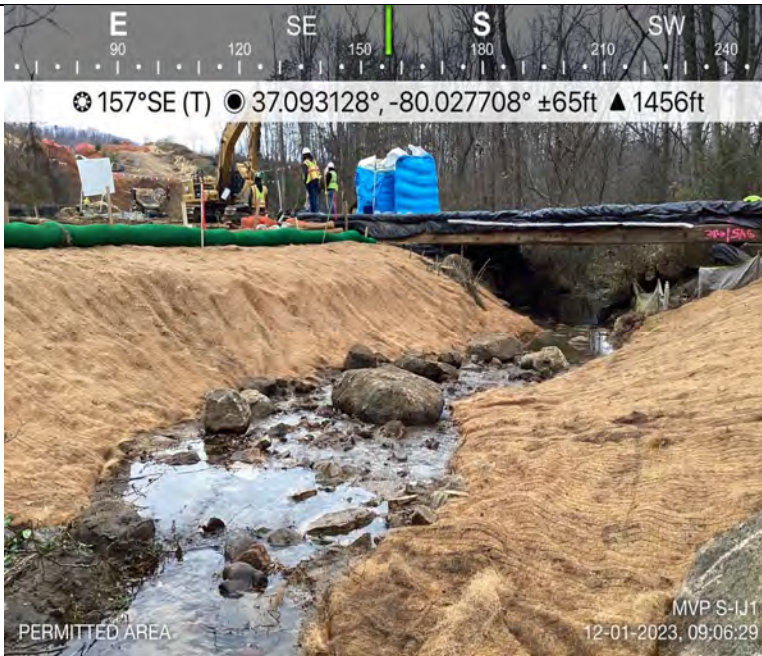
Photo Description: Downstream view of permitted impact area during post-construction assessment.

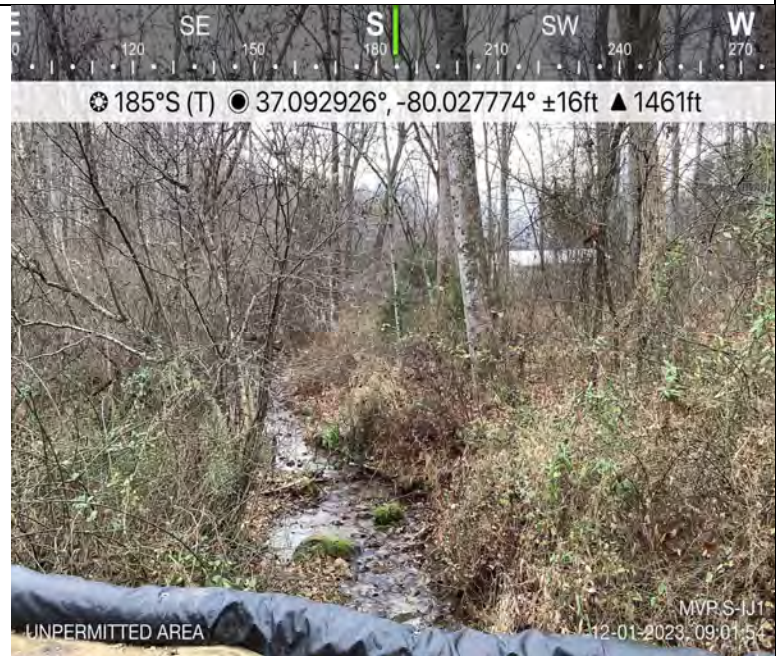
Photo Description: Conditions of the downstream area outside the ROW during post-construction assessment.

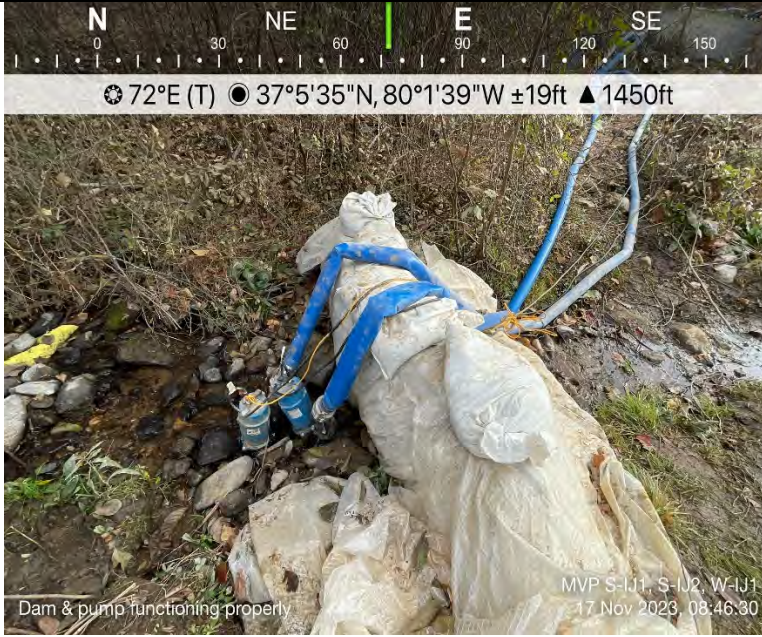
Photo Description: An overview of the dam and pump.

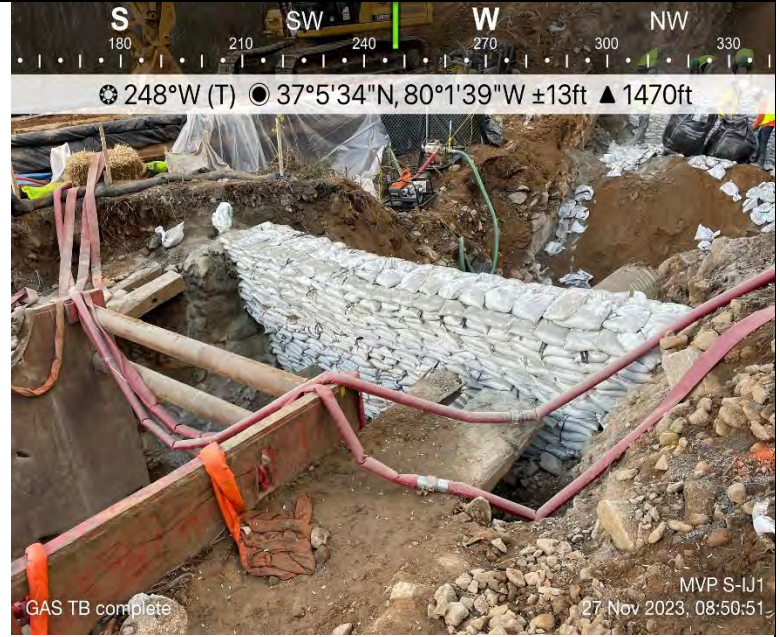
- 11/25/23: Began construction of the GAS impervious trench breaker with bentonite bags. -A. Thorpe
- 11/26/23: Construction of the trench breakers continued. Padding was installed along the trench. The installation of the GAS trench breaker was completed. It is anticipated that the installation of the CIS trench breaker will be completed tomorrow, 11/27/23. -A. Thorpe

Photo Description: The trench breaker installed on the GAS.

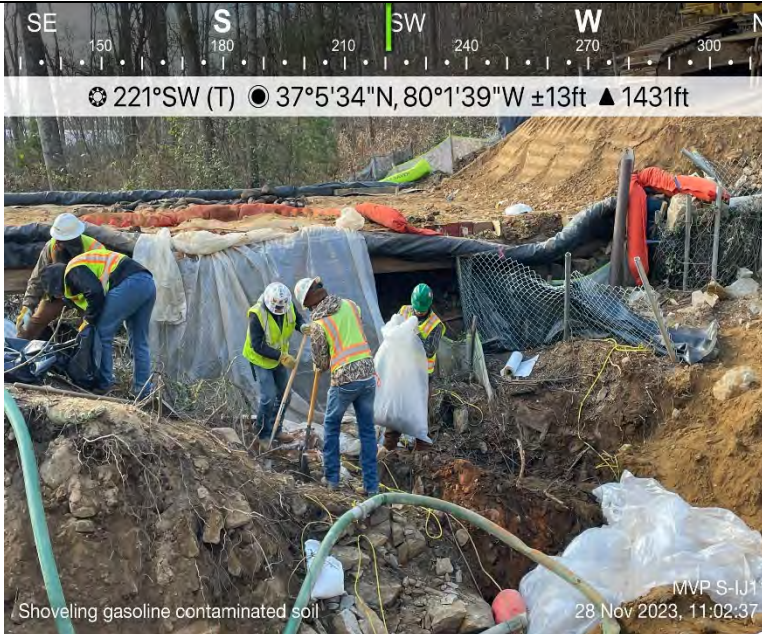
- 11/27/23: The installation of the CIS trench breaker was completed. Installation of padding in the trench continued, and the upland trench box was removed. Later in the afternoon, a Morooka fell off the timber mat bridge. The equipment fell into the downstream streambed of S-IJ1 on the working side, and all equipment remained within the ROW limits. No immediate negative downstream impacts were observed. Two pumps were damaged on impact and leaked approximately a gallon of gasoline into the open trench. Contaminated soil was excavated from the trench and properly disposed of. No gasoline was observed on the downstream side of the plastic liners and downstream dam, both of which remained intact after the fall. No unauthorized discharge or impacts to biological conditions were observed. MVP EI made applicable project notifications and spill reports for incident reporting requirements. -A. Thorpe

Photo Description: The crew removing the contaminated soil after the equipment malfunctioned.

- 11/28/23: After the area was cleared by safety, the Morooka was removed and the remaining debris and contaminated soil was excavated. The contaminated soil was disposed of appropriately. The downstream cofferdam was repaired as needed, and no unauthorized impacts to the resource were observed. -A. Thorpe

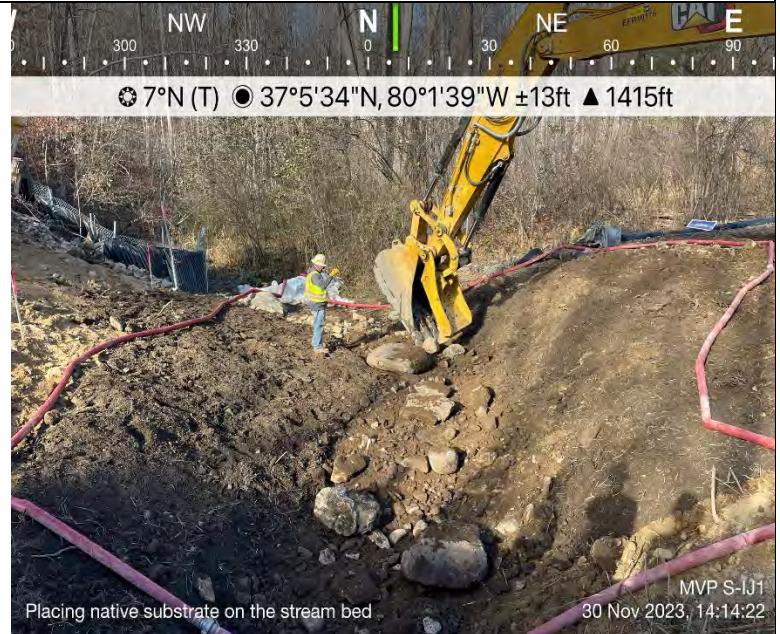
staked the area to be graded. The top 6-inches of native stream substrate was returned. The stream rocks that were bagged when the stream was initially stripped were not able to be located, so rocks were removed from the stripped stream substrate post-blasting to recreate the pre-construction contours. The survey crew verified the as-built conditions. The 10-foot buffer zones were seeded with a 50/50 riparian and rye seed mix and curlex was applied. A compost filter sock was placed along the top of the GAS 10-foot buffer and super silt fence was placed along the top of the CIS 10-foot buffer due to the steep upland slope behind the CIS. The upstream and downstream dams were removed, and flow was returned to the stream. -A. Thorpe

Photo Description: The crew replacing the native substrate into the stream bed.
