Stream Biological Conditions EA Report

Project Name	H-600 Pipeline Spread F	AFE	124300135	Spread	H-600 Pipeline Spread F
Contractor	Price Gregory	Report #	363		
Environmental Auditor	Luke Fultz	Date/Time	11/16/2023 11:12 AM		
Stream ID	S-K22	Crossing Start Date	11/28/2023	Crossing Completion Date	12/7/2023
Milepost	155.43	Pre-Con Assessment Date	11/16/2023	Post-Con Assessment Date	12/7/2023
Station	8206+70	Bankfull Width (ft.)	7.4	Riffle:Pool Complexes Present?	No
State	WV	Stream Classification	Perennial		
County	Greenbrier	303(d) Impairment Listing	No

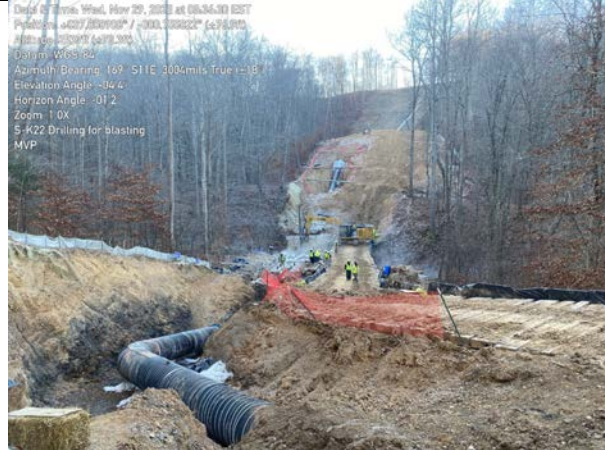
GPS Location See Photo	GPS Location See Photo
Description Photo 3: Excavated top 12 inches of substrate.	Description Photo 4: Drilling in aquatic resource area to prepare for blasting.
