Stream Biological Conditions EA Report

Project Name	H-600 Pipeline Spread F	AFE	124300135	Spread	H-600 Pipeline Spread F
Contractor	Price Gregory	Report #	345		
Environmental Auditor	LeMaster Kristen	Date/Time	11/9/2023 9:13 AM		
Stream ID	S-UV2	Crossing Start Date	11/13/2023	Crossing Completion Date	11/25/2023
Milepost	156.05	Pre-Con Assessment Date	11/9/2023	Post-Con Assessment Date	11/25/2023
Station	8239+60	Bankfull Width (ft.)	17.5	Riffle:Pool Complexes Present?	No
State	WV	Stream Classification	Perennial		
County	Greenbrier	303(d) Impairment Listing	No

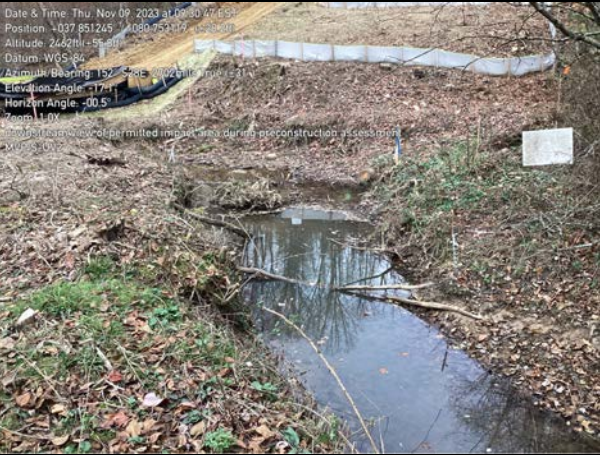
<p>Date & Time: Thu, Nov 09, 2023 at 06:30:47 EST Position: +037.851245 N / -080.753117 W (-15.5m) Altitude: 2462ft (-5.2m) Datum: WGS-84 Azimuth Bearing: 157.524E 273mils True (+12) Elevation Angle: -17.7 Horizon Angle: -00.5 Zoom: 1.0X S-UV2-DS View from US Edge ROW LDB for Construction Mountain Valley Pipeline</p>	See Photo	  <p>Date & Time: Thu, Nov 09, 2023 at 06:30:47 EST Position: +037.851245 N / -080.753117 W (-15.5m) Altitude: 2462ft (-5.2m) Datum: WGS-84 Azimuth Bearing: 157.524E 273mils True (+12) Elevation Angle: -17.7 Horizon Angle: -00.5 Zoom: 1.0X S-UV2-DS View from US Edge ROW LDB for Construction Mountain Valley Pipeline</p>	See Photo		
GPS Location	See Photo	GPS Location	See Photo		
Description	Downstream view of permitted impact area during pre-construction assessment.	Description	Downstream view of unimpacted area during pre-construction assessment.

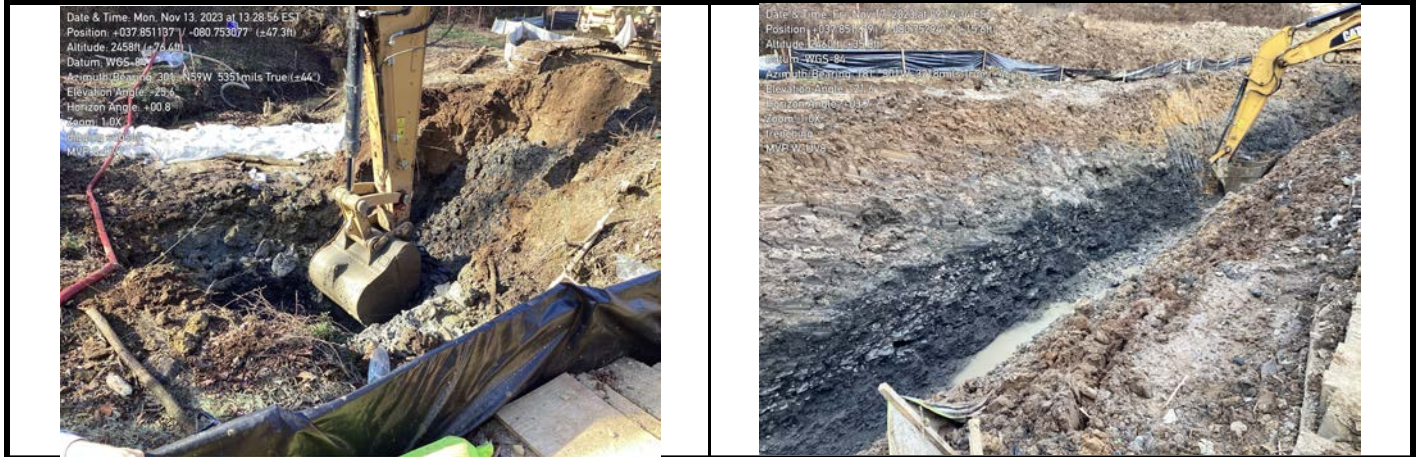
GPS Location See Photo	GPS Location See Photo
Description Photo 3: Excavating trench in aquatic resource area.	Description Photo 4: Excavating trench.

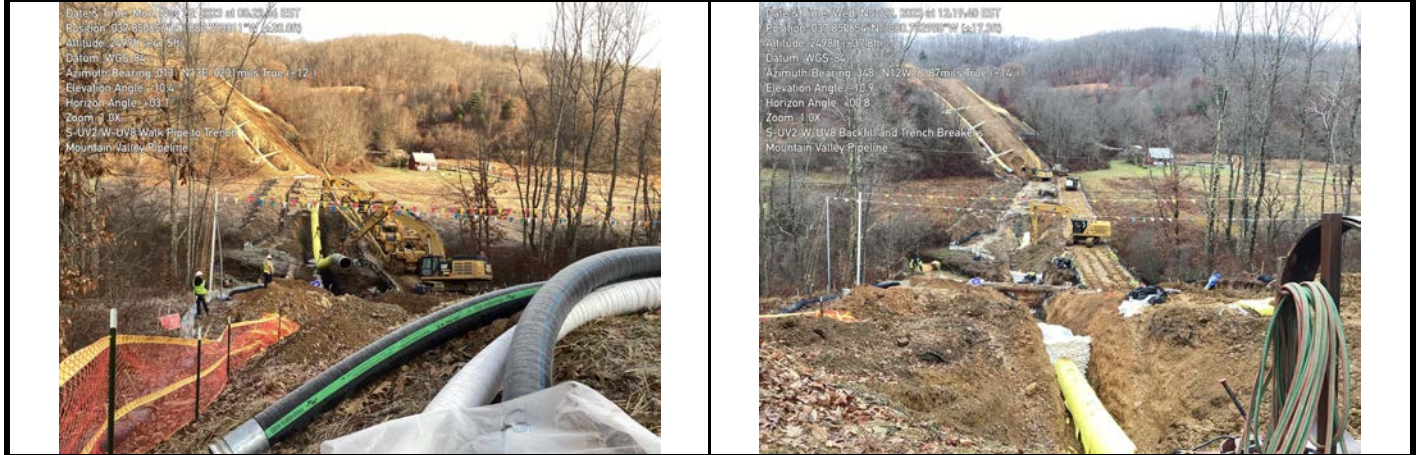
GPS Location See Photo	GPS Location See Photo
Description Photo 5: Lowering pipe into trench through aquatic resource area.	Description Photo 6: Backfilling and trench breaker construction.

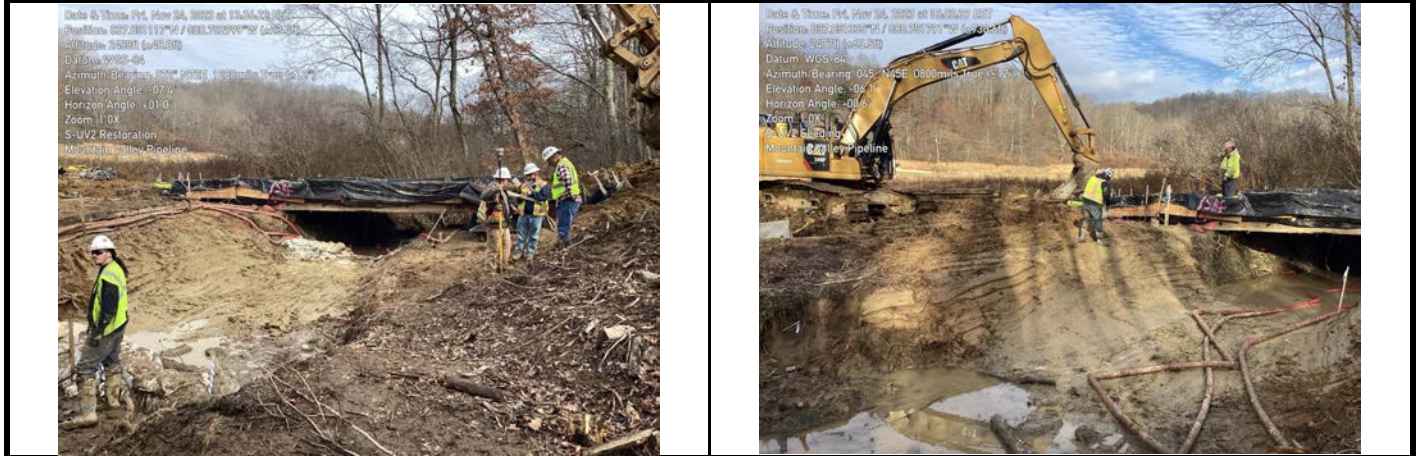
GPS Location See Photo	GPS Location See Photo
Description Photo 7: Restoration and survey.	Description Photo 8: Stream bank seeding.
