# Stream Biological Conditions EA Report

<b>Project Name</b>	H-600 Pipeline Spread F	<b>AFE</b>	124300135	<b>Spread</b>	H-600 Pipeline Spread F
<b>Contractor</b>	Price Gregory	<b>Report #</b>	346		
<b>Environmental Auditor</b>	Aaron Crank	<b>Date/Time</b>	11/9/2023 1:04 PM		
<b>Stream ID</b>	S-Z4	<b>Crossing Start Date</b>	11/17/2023	<b>Crossing Completion Date</b>	12/4/2023
<b>Milepost</b>	185.30	<b>Pre-Con Assessment Date</b>	11/9/2023	<b>Post-Con Assessment Date</b>	12/4/2023
<b>Station</b>	9783+84	<b>Bankfull Width (ft.)</b>	3.0	<b>Riffle:Pool Complexes Present?</b>	No
<b>State</b>	WV	<b>Stream Classification</b>	Ephemeral		
<b>County</b>	Monroe	<b>303(d) Impairment Listing</b>	No

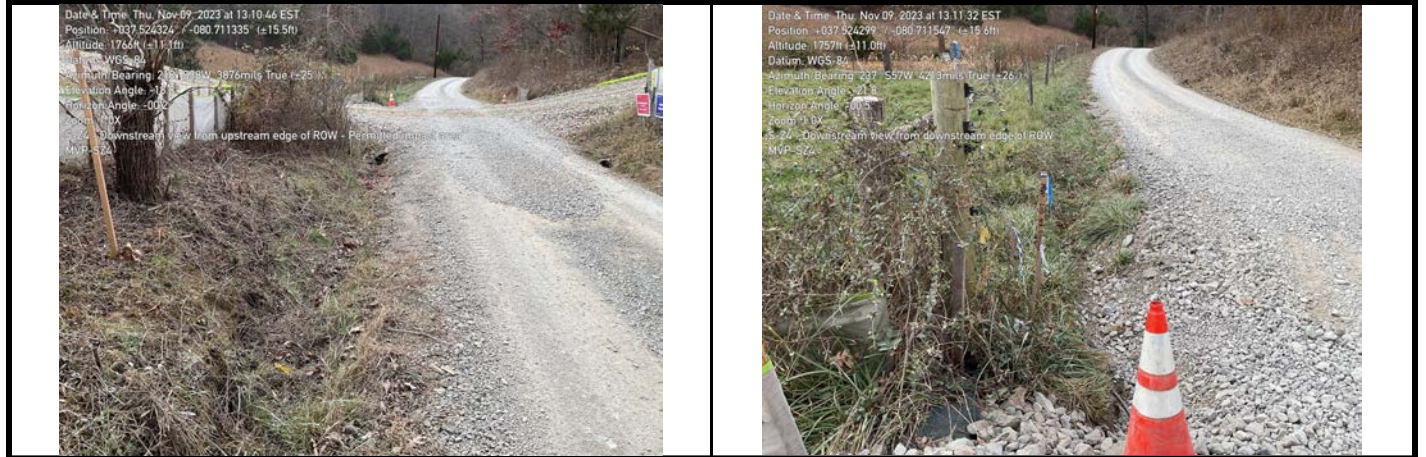
<b>GPS Location</b> See Photo	<b>GPS Location</b> See Photo
<b>Description</b> Downstream view of permitted impact area during pre-construction assessment.	<b>Description</b> Downstream view of unimpacted area during pre-construction assessment.

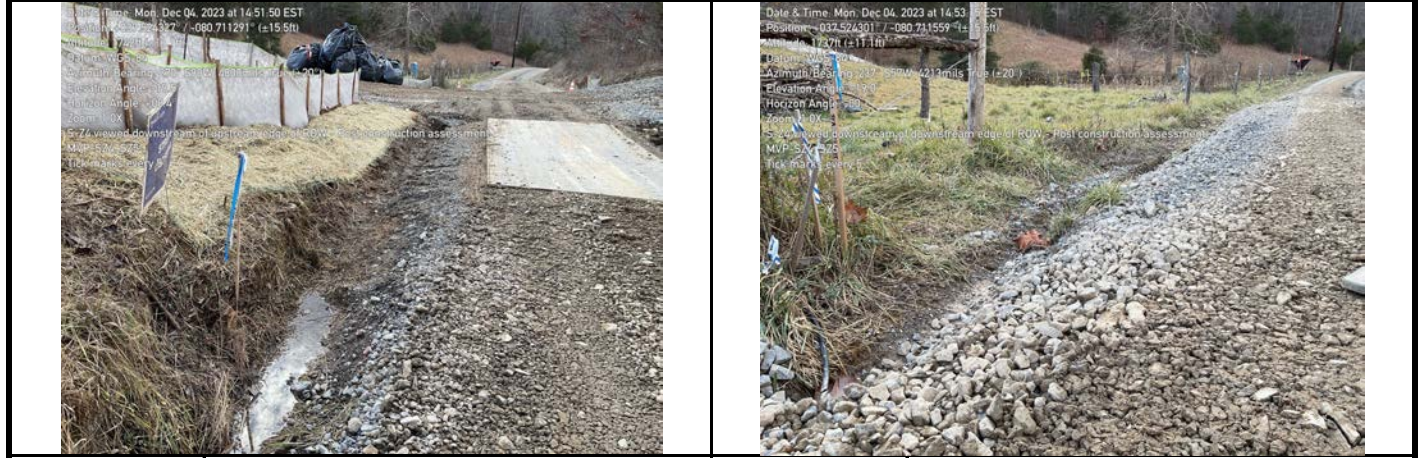
<b>GPS Location</b> See Photo	<b>GPS Location</b> See Photo
<b>Description</b> Downstream view of permitted impact area during post-construction assessment.	<b>Description</b> Downstream view of unimpacted area during post-construction assessment.

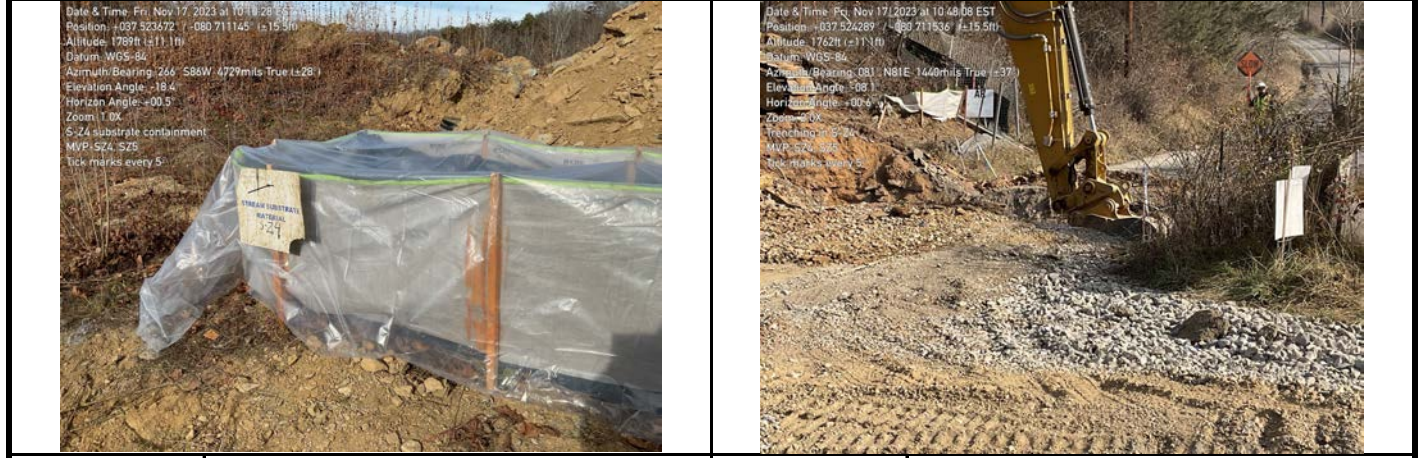
<b>GPS Location</b> See Photo	<b>GPS Location</b> See Photo
<b>Description</b> Photo 1: Stream substrate containment structure.	<b>Description</b> Photo 2: Trenching through resource.
