# WETLAND BIOLOGICAL CONDITIONS ENVIRONMENTAL AUDITOR REPORT

<b>Wetland ID:</b> W-AB6-PSS	<b>Crossing Start Date:</b> 11/20/2023	<b>Crossing Completion Date:</b> 12/02/2023
<b>Milepost:</b> 243.4	<b>Pre-Con Assessment Date:</b> 11/18/2023	<b>Post-Con Assessment Date:</b> 12/06/2023
<b>Station:</b> 12860+04	<b>Cowardin Classification:</b> PSS (PEM, PFO, PSS, POW)	<b>Wetland Impact Area (sq ft.):</b> 265.72
<b>County:</b> Roanoke

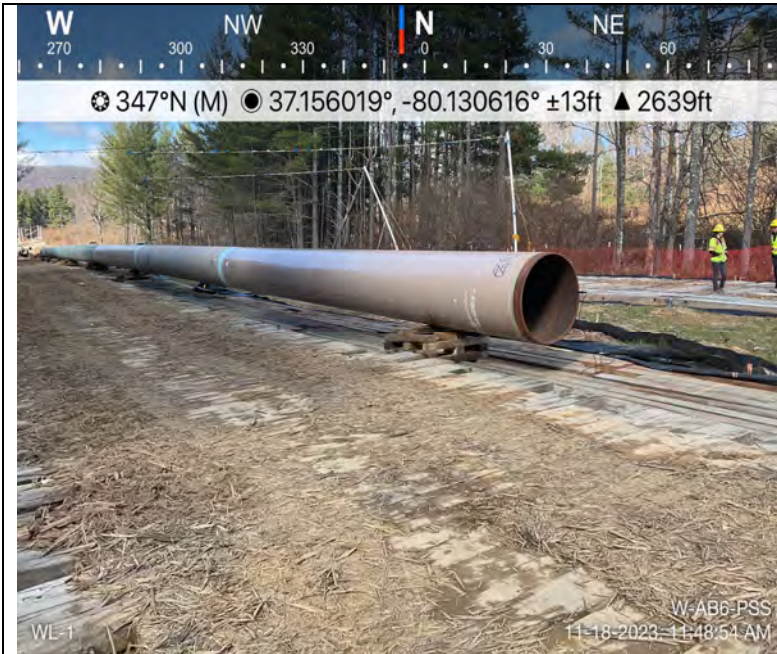
**Photo Description:** View of permitted resource impact area during pre-construction assessment.

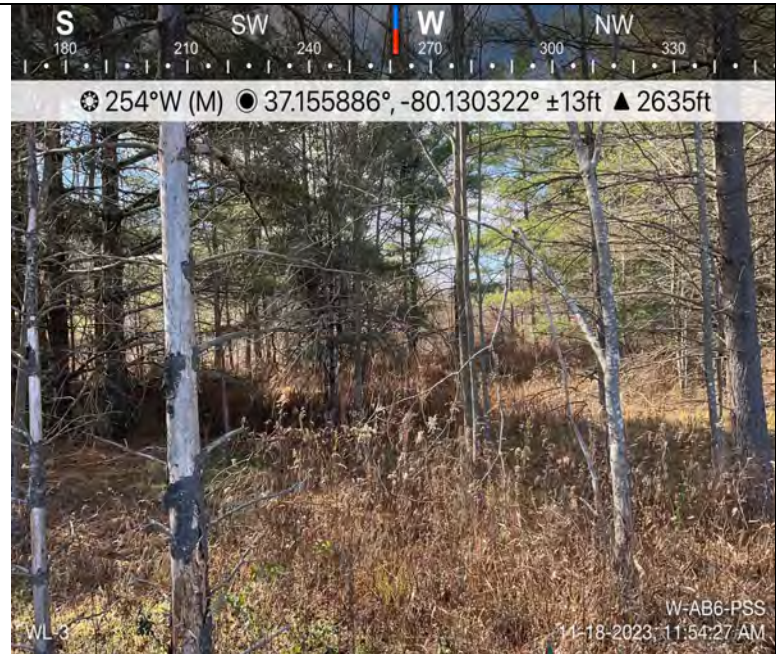
**Photo Description:** At edge of LOD, view of unpermitted resource area conditions during pre-construction assessment.

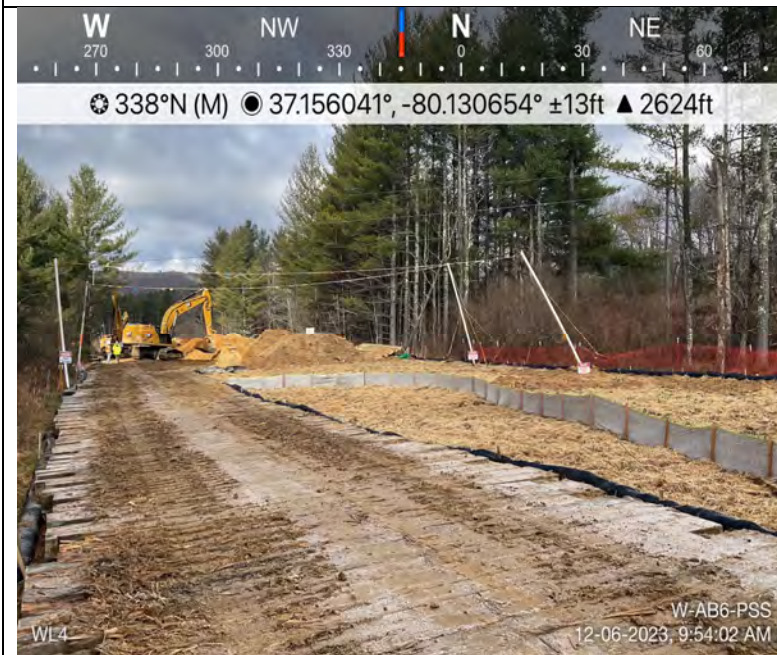
12/06/2023 – Post-construction auditor assessment completed. No impacts to biological conditions or unauthorized discharges were observed. – T. Brodbeck

**Photo Description:** View of permitted resource impact area during post-construction assessment.

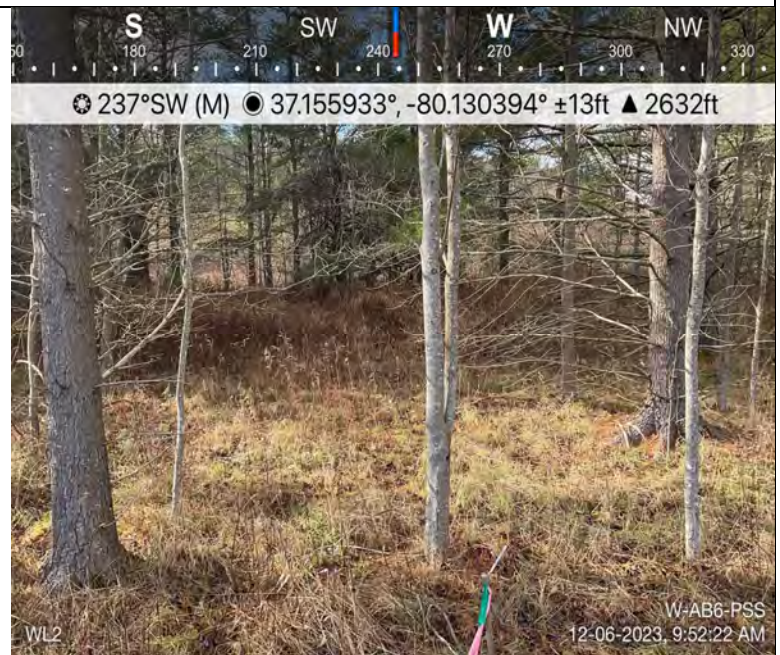
**Photo Description:** At edge of LOD, view of unpermitted resource area conditions during post-construction assessment.

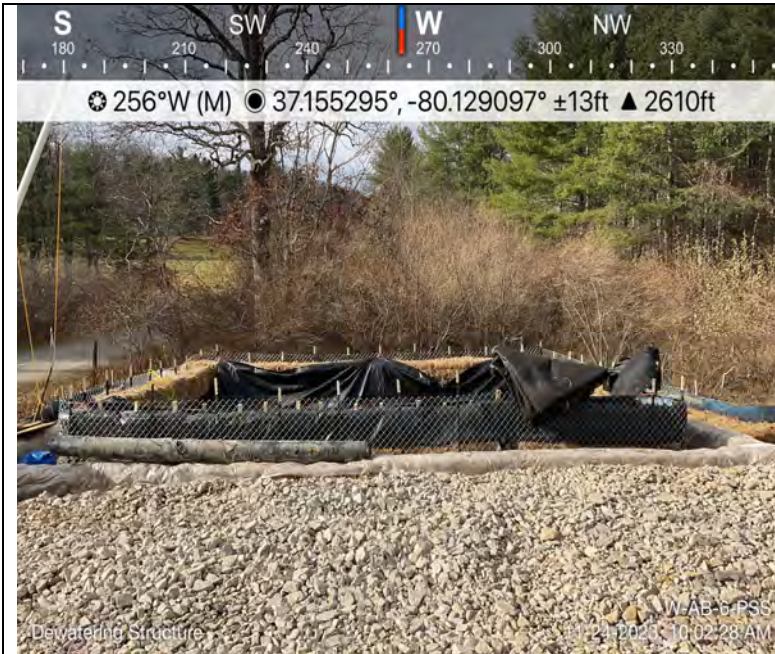
12/02/2023 - Resource restoration completed. Installed P1 fencing along border of wetland & upland buffer zone; Reseeded wetland & upland buffer zone. Cover wetlands & upland buffer zone with clean straw. Secondary dewatering structure constructed for additional work activities in the area. - T. Brodbeck.

**Photo Description:** Second dewatering structure installed on site.

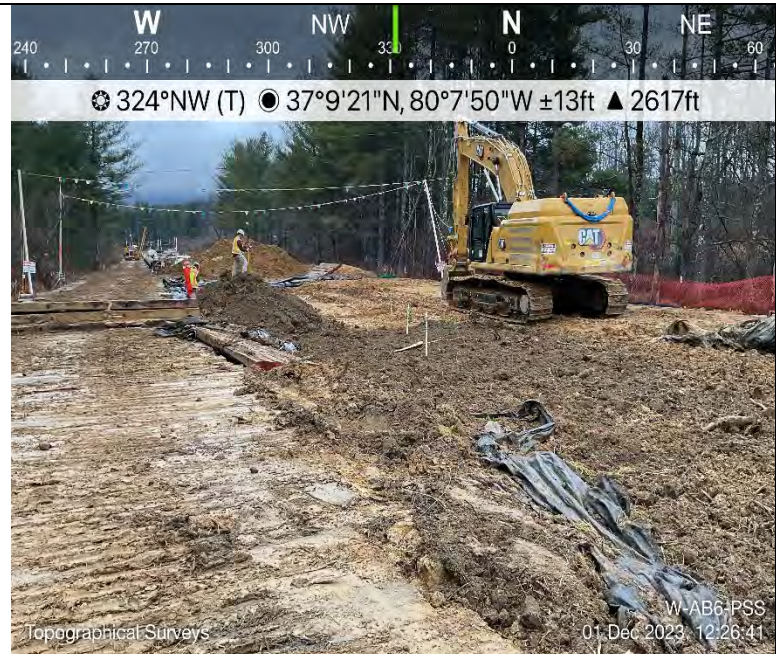
12/01/2023 - Topsoiled wetland area and applied seed and straw for stabilization. Topo survey was completed on-site to confirm pre-construction elevations. - T Brodbeck

**Photo Description:** Survey team on-site providing pre-construction data for restoration.

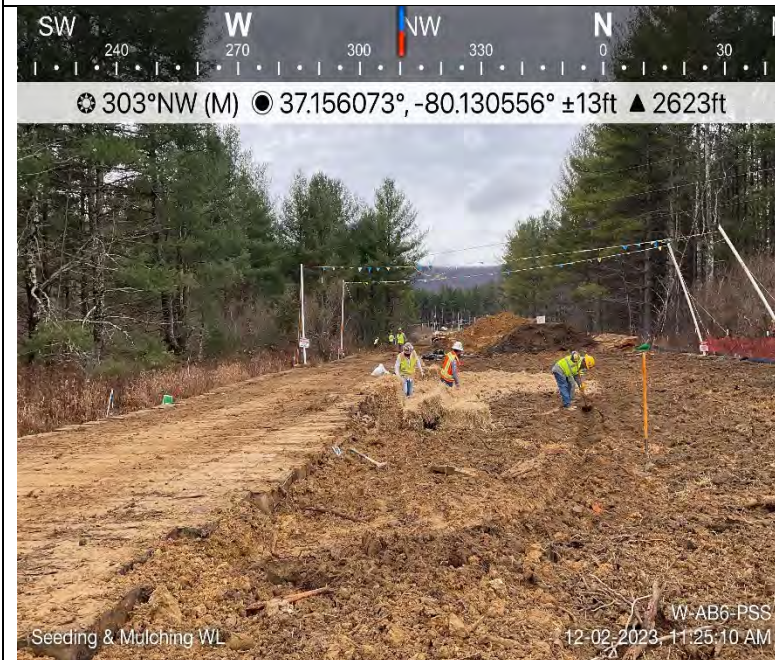
**Photo Description:** Seeding and stabilization of impact area during restoration.

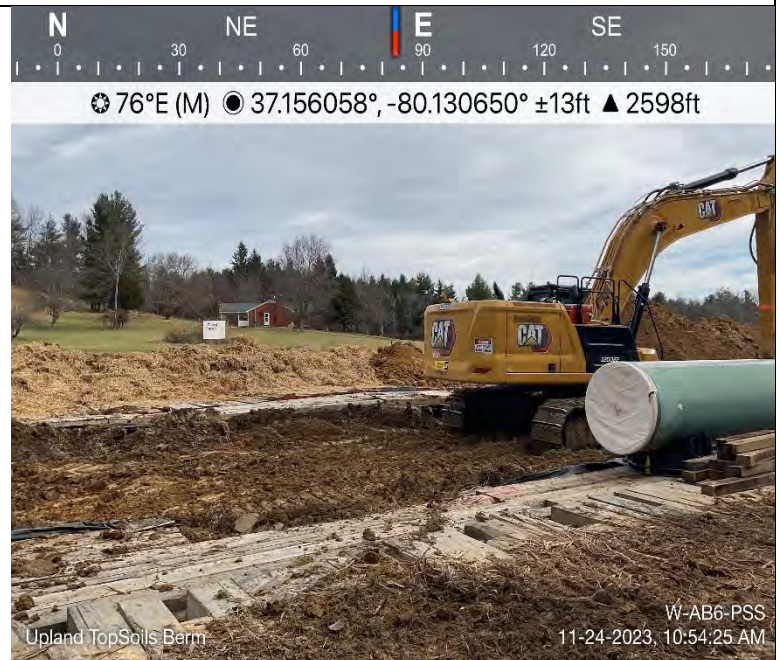
11/24/2023- Removing topsoil adjacent to wetland. Used topsoil and subsoil stockpiles as berms, separated with 6" of clean straw. -T. Brodbeck.

**Photo Description:** Topsoil and subsoil berms across from trenching area. Stockpiles stabilized.
