Wetland Biological Conditions EA Report

Project Name	H-600 Pipeline Spread C	AFE	124300131	Spread	H-600 Pipeline Spread C
Contractor	Precision	Report #	155		
Environmental Auditor	Jeffrey Arbogast			Date/Time	12/14/2023 10:51 AM
Wetland ID	W-B31	Crossing Start Date	12/14/2023	Crossing Completion Date	12/16/2023
Milepost	97.82	Pre-Con Assessment Date	12/14/2023	Post-Con Assessment Date	12/16/2023
Station	5164+82	Cowardin Classification	PEM	Wetland Impact Area(acres)	0.0515
State	WV				
County	Webster

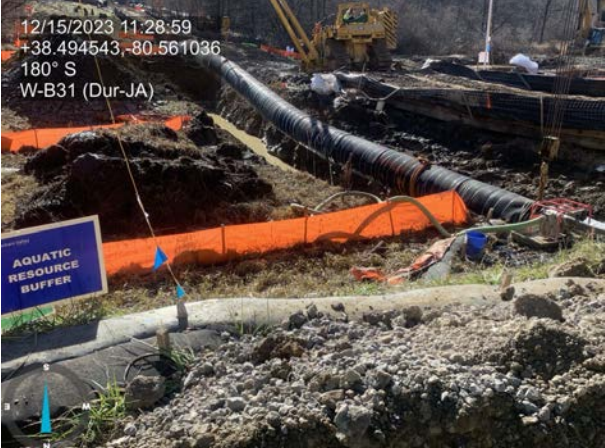
GPS Location	See Caption in Photo	GPS Location	See Caption in Photo
Description	The pipe section being lowered in.	Description	GAS bentonite breaker and river weight.

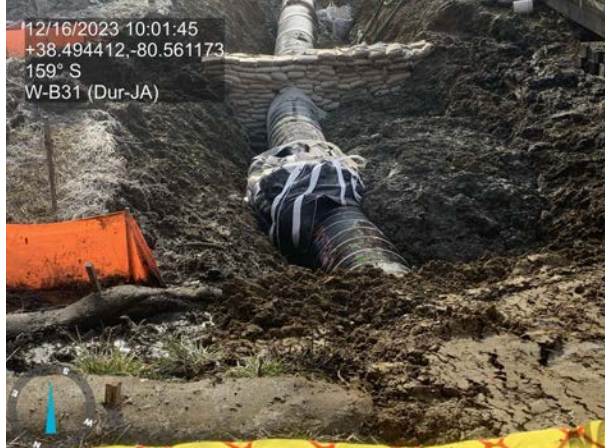
Expanded notes for question 10: Survey verified that the bentonite trench breakers were installed at 8' from coming in side (CIS) and 9' from going away side (GAS) of the wetland at station numbers 5164+74 and 5165+15, respectively.

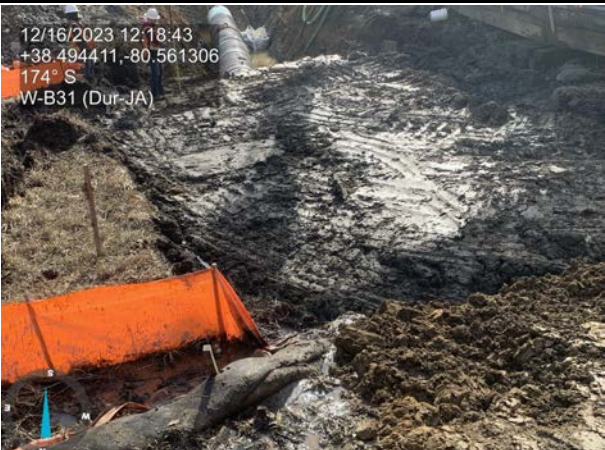
GPS Location	See Caption in Photo	GPS Location	See Caption in Photo
Description	Wetland subsoil has been replaced and readied for topsoil. Survey crew is in photo but obscured by the caption.	Description	Topsoil being returned.

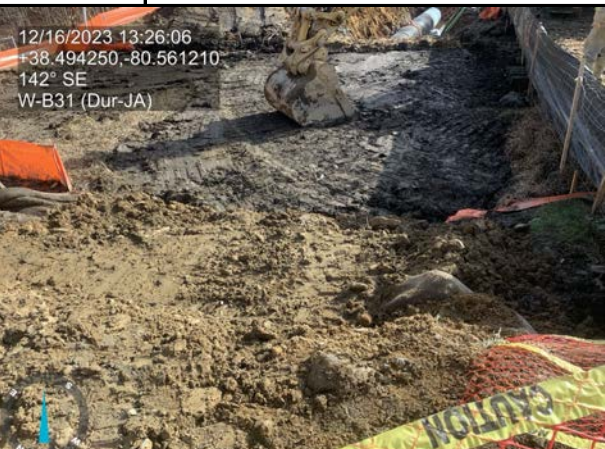
GPS Location	See Caption in Photo	GPS Location	See Caption in Photo
Description	Topsoil being graded back to pre-construction contours.	Description	Final erosion and sediment controls being installed.
