# WETLAND BIOLOGICAL CONDITIONS ENVIRONMENTAL AUDITOR REPORT

<b>Wetland ID:</b> W-C12	<b>Crossing Start Date:</b> 11/26/2023	<b>Crossing Completion Date:</b> 11/27/2023
<b>Milepost:</b> 229.4	<b>Pre-Con Assessment Date:</b> 11/25/2023	<b>Post-Con Assessment Date:</b> 11/28/2023
<b>Station:</b> 12120+33	<b>Cowardin Classification:</b> PFO (PEM, PFO, PSS, POW)	<b>Wetland Impact Area (sq ft.):</b> 2278.19
<b>County:</b> Montgomery

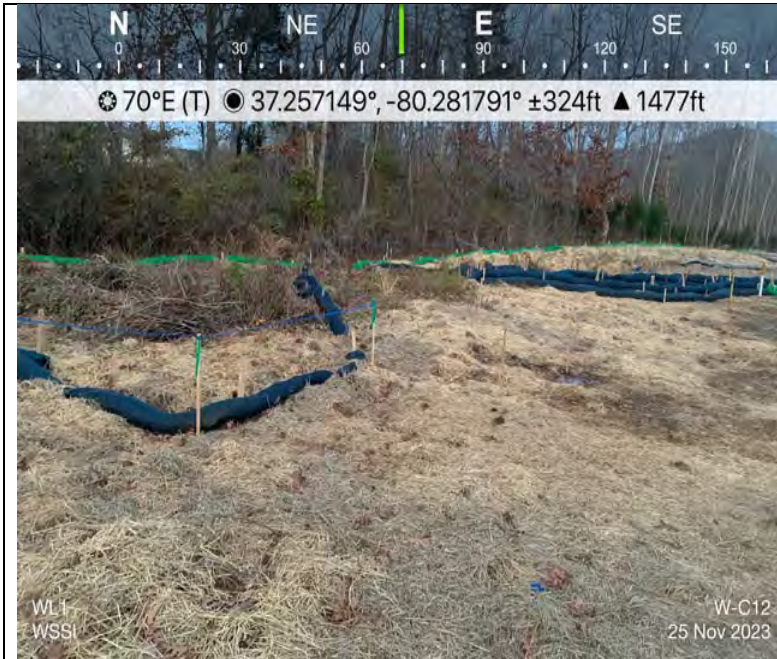
**Photo Description:** View of permitted resource impact area during pre-construction assessment.

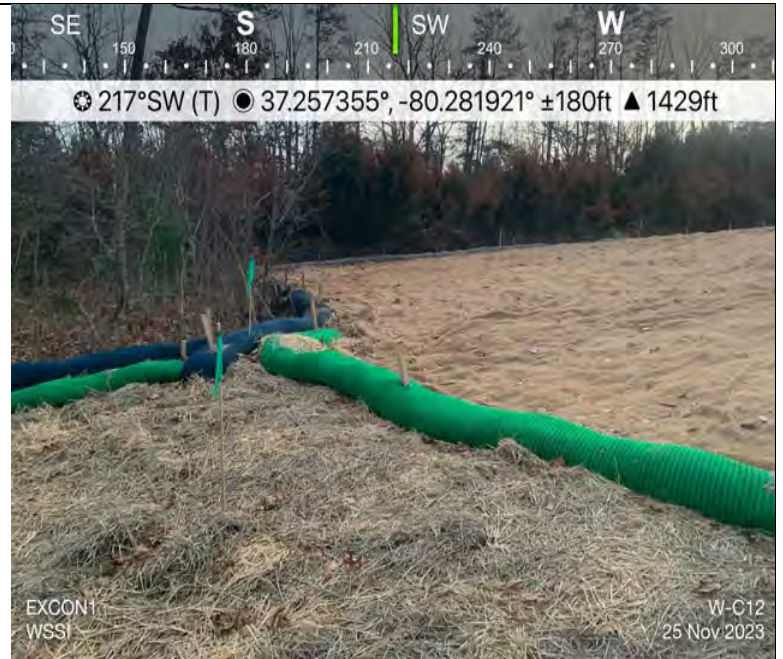
**Photo Description:** At edge of LOD, view of unpermitted resource area conditions during pre-construction assessment.

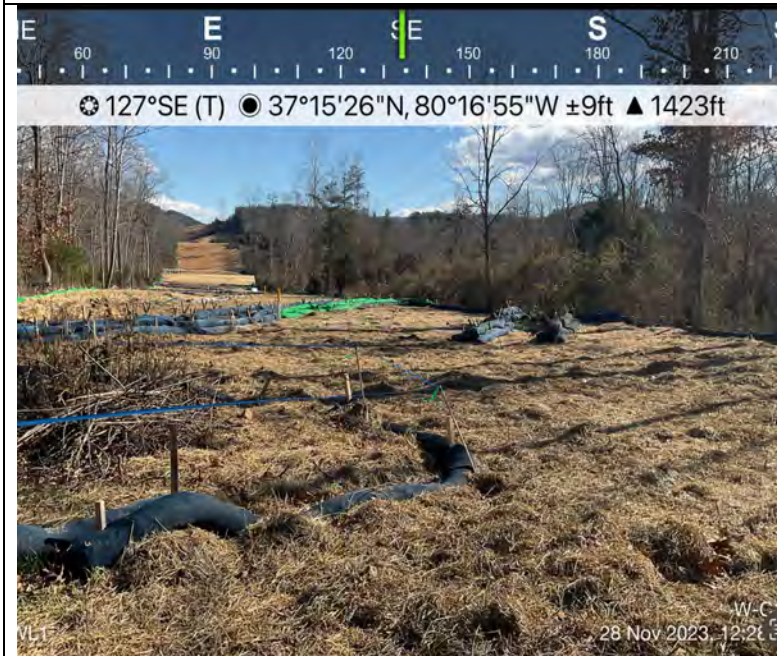
**Photo Description:** View of permitted resource impact area during post-construction assessment.

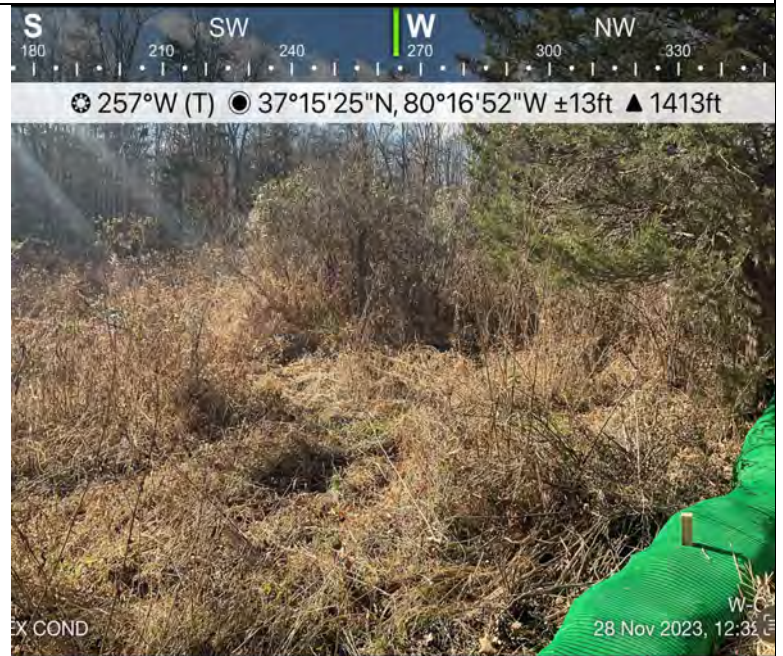
**Photo Description:** At edge of LOD, view of unpermitted resource area conditions during post-construction assessment.

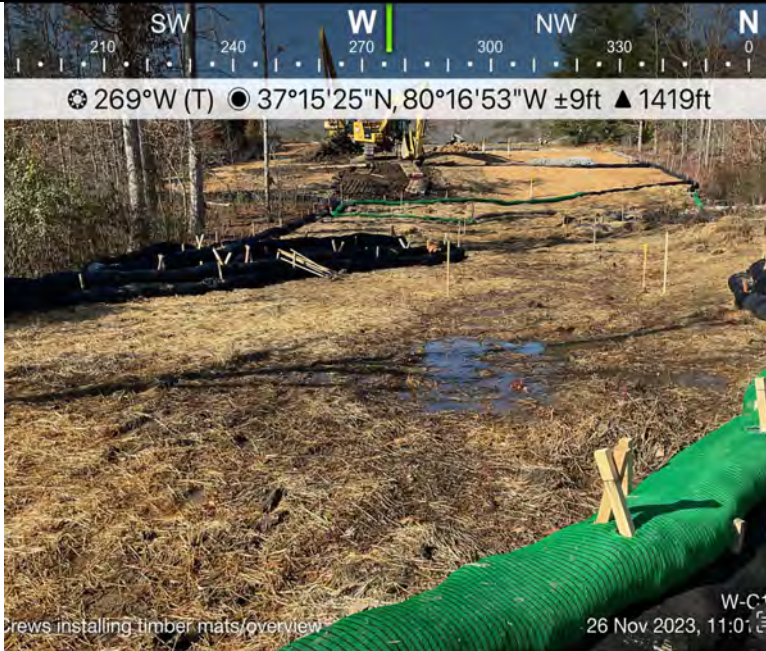
**Photo Description:** Crews laid timber mats to work in the wetland.

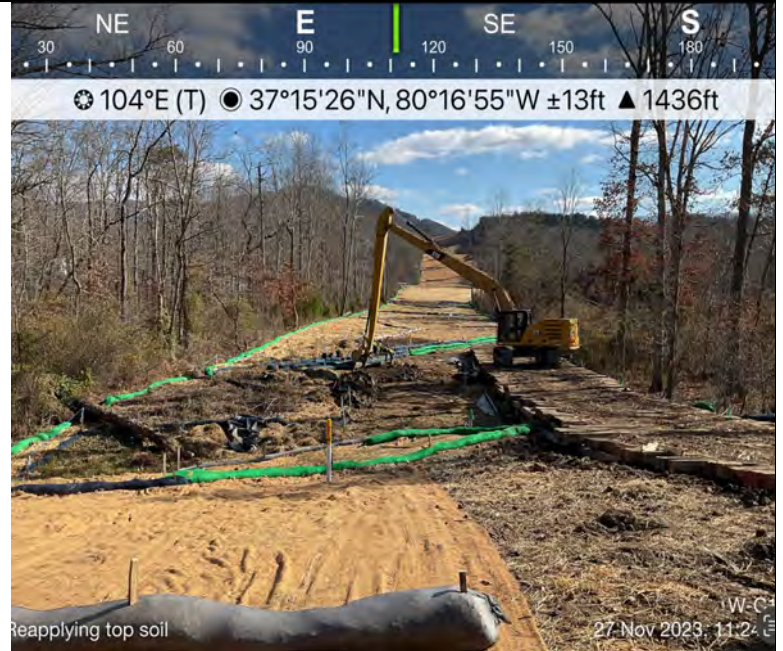
11/25/2023- This site has a previously completed report and this report is for resource maintenance. The wetland has experienced settling over time and low spots have emerged. This maintenance is to correct this issue and return the wetland to pre-construction conditions. -T. Cullop

**Photo Description:** Topsoil being replaced after fill material was used to fix the impacted section of the wetland.

11/27/2023- Crews placed timber mats inside the wetland to work and segregated topsoil. The top foot of topsoil was stripped and segregated on timber mats. Fill material was brought in to correct the low spots within the wetland. Topsoil was returned to the impacted area and survey took shots to confirm that the area was at pre-construction grade specs. Crews then re-seeded and stabilized the affected area. Timber mats were removed and the wetland was returned to final ROW stabilization. -T. Cullop

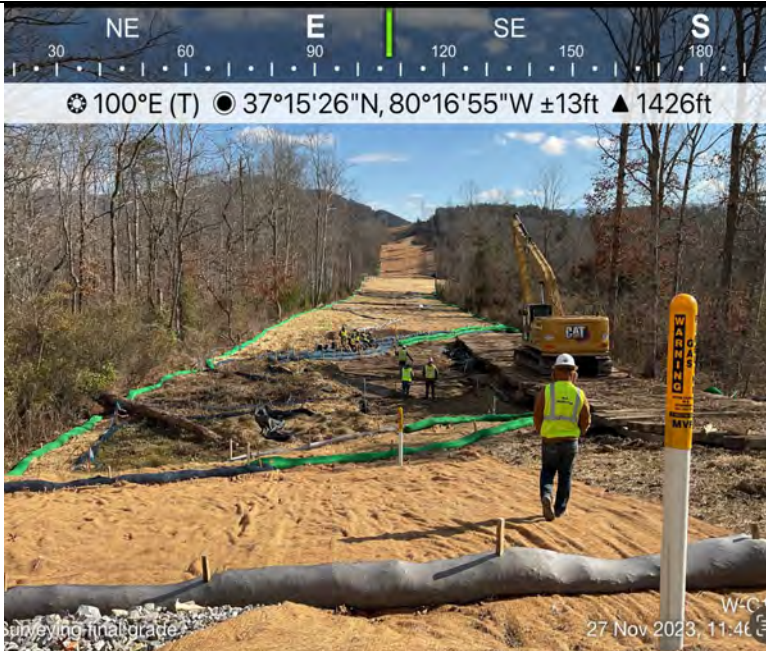
**Photo Description:** Survey conducting as-built shots to confirm that the wetland meets pre-construction conditions.

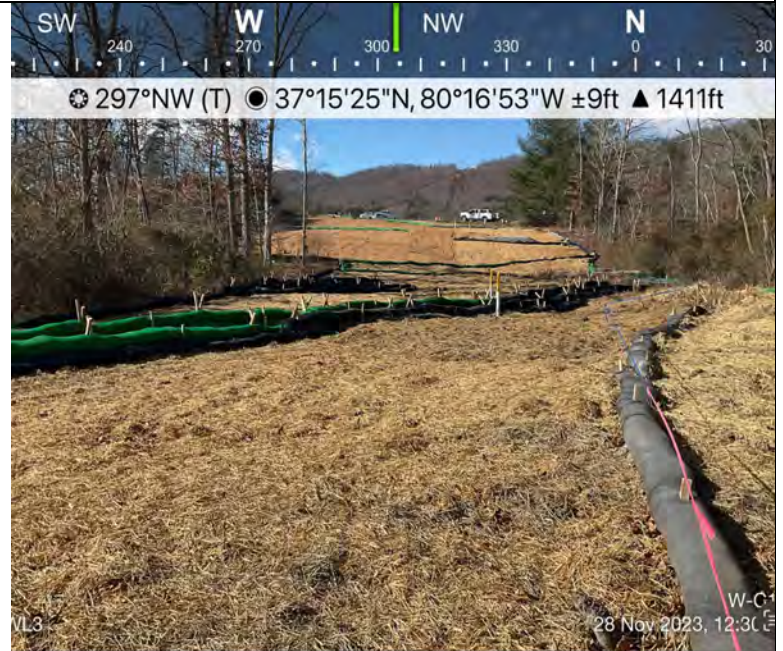
**Photo Description:** Final conditions and an overview of the wetland after construction was complete.
