Wetland Biological Conditions EA Report

Project Name	H-600 Pipeline Spread F	AFE	124300135	Spread	H-600 Pipeline Spread F
Contractor	Price Gregory	Report #	105		
Environmental Auditor	Luke Fultz	Date/Time	10/23/2023 11:15 AM		
Wetland ID	W-IJ30	Crossing Start Date	10/23/2023	Crossing Completion Date	11/28/2023
Milepost	155.08	Pre-Con Assessment Date	10/23/2023	Post-Con Assessment Date	11/28/2023
Station	8188+00	Cowardin Classification	PEM	Wetland Impact Area(acres)	0.3236
State	WV				
County	Greenbrier

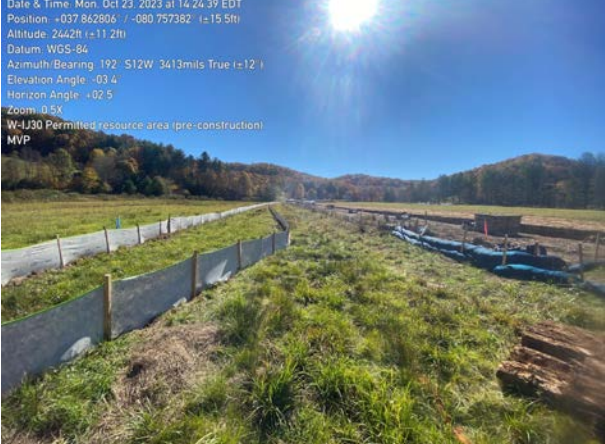
<p>Date & Time: Mon, Oct 23, 2023 at 14:24:39 EDT Position: +037.862806 / -080.757382 (+15.5ft) Altitude: 2422ft (+11.2ft) Datum: WGS-84 Azimuth/Bearing: 192 S12W 3413mils True (+12) Elevation Angle: +03.4 Horizon Angle: +02.9 Zoom: 0.5X W-130 Permitted resource area (pre-construction) MVP</p>

GPS Location	See Photo	GPS Location	See Photo
Description	View of permitted resource impact area during pre-construction assessment.	Description	At edge of LOD, view of unimpacted resource area conditions during pre-construction assessment.
	<p>Date & Time: Tue, Nov 28, 2023 at 15:04:08 EST Position: +037.862806 / -080.757382 (+15.5ft) Altitude: 2447ft (+39.2ft) Datum: WGS-84 Azimuth/Bearing: 198 S18W 3520mils True (+12) Elevation Angle: +11.2 Horizon Angle: +00.4 Zoom: 1.0X View of permitted resource area during post-construction assessment MVP: W-130</p>

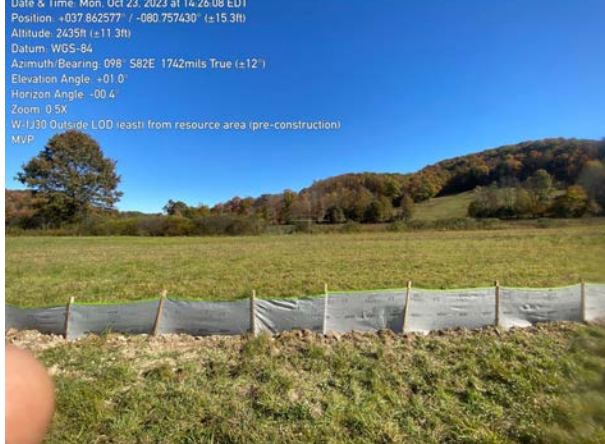
<p>Date & Time: Mon, Oct 23, 2023 at 14:26:08 EDT Position: +037.862577 / -080.757430 (+15.3ft) Altitude: 2435ft (+11.3ft) Datum: WGS-84 Azimuth/Bearing: 098 S82E 1742mils True (+12) Elevation Angle: +01.0 Horizon Angle: -00.4 Zoom: 0.5X W-130 Outside LOD (east from resource area (pre-construction)) MVP</p>

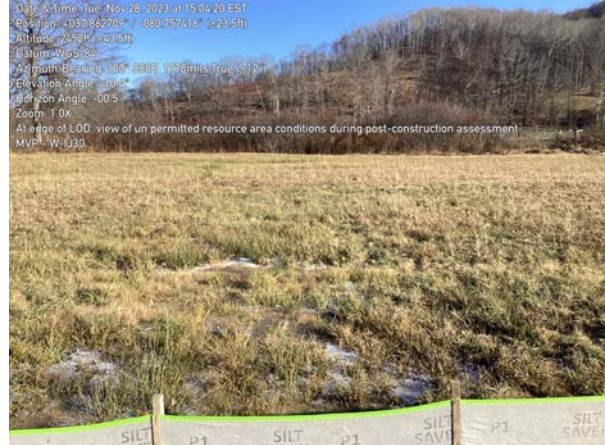
<p>Date & Time: Tue, Nov 28, 2023 at 15:04:20 EST Position: +037.862767 / -080.757430 (+15.3ft) Altitude: 2450ft (+11.3ft) Datum: WGS-84 Azimuth/Bearing: 097 S88E 1779mils True (+12) Elevation Angle: +01.4 Horizon Angle: -00.5 Zoom: 1.0X At edge of LOD, view of unimpacted resource area conditions during post-construction assessment MVP: W-130</p>

GPS Location	See Photo	GPS Location	See Photo
Description	View of permitted resource impact area during post-construction assessment.	Description	At edge of LOD, view of unimpacted resource area conditions during post-construction assessment.
	<p>Date & Time: Mon, Oct 23, 2023 at 13:59:41 EDT Position: +037.863049 / -080.757474 (+15.4ft) Altitude: 2451ft (+11.3ft) Datum: WGS-84 Azimuth/Bearing: 144 S34E 2560mils True (+13) Elevation Angle: -1.1 Horizon Angle: +00.5 Zoom: 0.5X W-130 Removal of topsoil in resource area, moved to containment MVP</p>

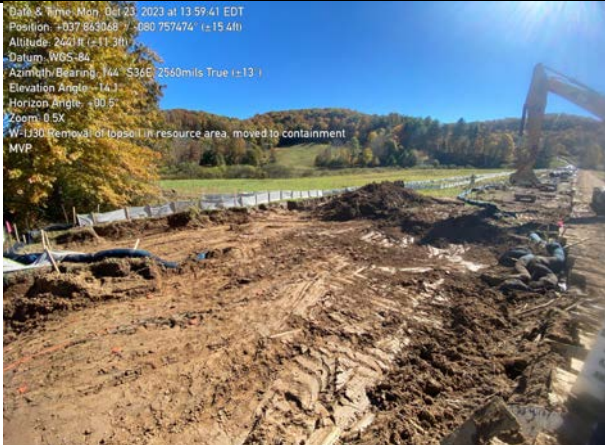
10/23/2023 - Excavation of the first 12 inches topsoil from Northern (N) end of aquatic resource area (ARA) (Photo 1), separated and moved to containment. Labeled with signage. Halt removal of topsoil for blasting.
 10/24/2023 - Excavation of adjacent aquatic resource (AR) from timber mats (TM). Excavation of bell hole in ARA (Photo 2). Subsoil separated to containment. Staging pipe in ARA.
 10/25/2023 - Water pumped from trench in ARA. Sandbags "pillows" added to the trench for padding. Pipe placed N end of ARA.
 10/26/2023 - Water pumped from trench in ARA. Constructed northern most trench breaker.
 10/27/2023-10/28/2023 - Continue to pump on edge of ARA. No work in resource. Work ongoing in other areas of the site.
 10/30/2023 - Water pumped from trench in ARA. Backfilling of portion of ARA adjacent to S-K17.
 10/31/2023 - Water pumped from trench in ARA. Excavation of additional topsoil from AR, separated to containment and labeled with signage. Excavation of subsoil. Work ongoing in other areas of the site.

GPS Location	See Photo	GPS Location	See Photo
Description	Photo 1: First 12 inches of topsoil removal in the northern most section of the aquatic resource.	Description	Photo 2: Excavation of bell hole in aquatic resource area.

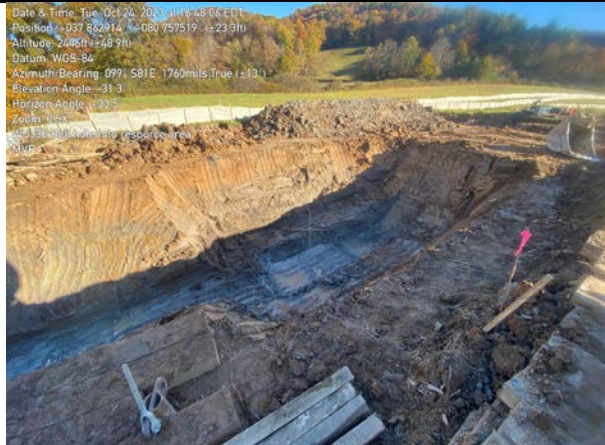
<p>Date & Time: Tue, Oct 24, 2023 at 16:48:06 EDT Position: +037.862914 / -080.757519 (+15.3ft) Altitude: 2459ft (+11.3ft) Datum: WGS-84 Azimuth/Bearing: 097 S81E 1760mils True (+13) Elevation Angle: -31.3 Horizon Angle: +00.5 Zoom: 1.0X W-130 Excavation into resource area MVP</p>
