# Wetland Biological Conditions EA Report

<b>Project Name</b>	H-600 Pipeline Spread F	<b>A/E</b>	124300135	<b>Spread</b>	H-600 Pipeline Spread F
<b>Contractor</b>	Price Gregory	<b>Report #</b>	126		
<b>Environmental Auditor</b>	Eric Schicker			<b>Date/Time</b>	11/7/2023 11:22 AM
<b>Wetland ID</b>	W-M2	<b>Crossing Start Date</b>	11/7/2023	<b>Crossing Completion Date</b>	11/20/2023
<b>Milepost</b>	159.55	<b>Pre-Con Assessment Date</b>	11/7/2023	<b>Post-Con Assessment Date</b>	11/20/2023
<b>Station</b>	8424+40	<b>Cowardin Classification</b>	PEM	<b>Wetland Impact Area(acres)</b>	0.1064
<b>State</b>	WV				
<b>County</b>	Summers

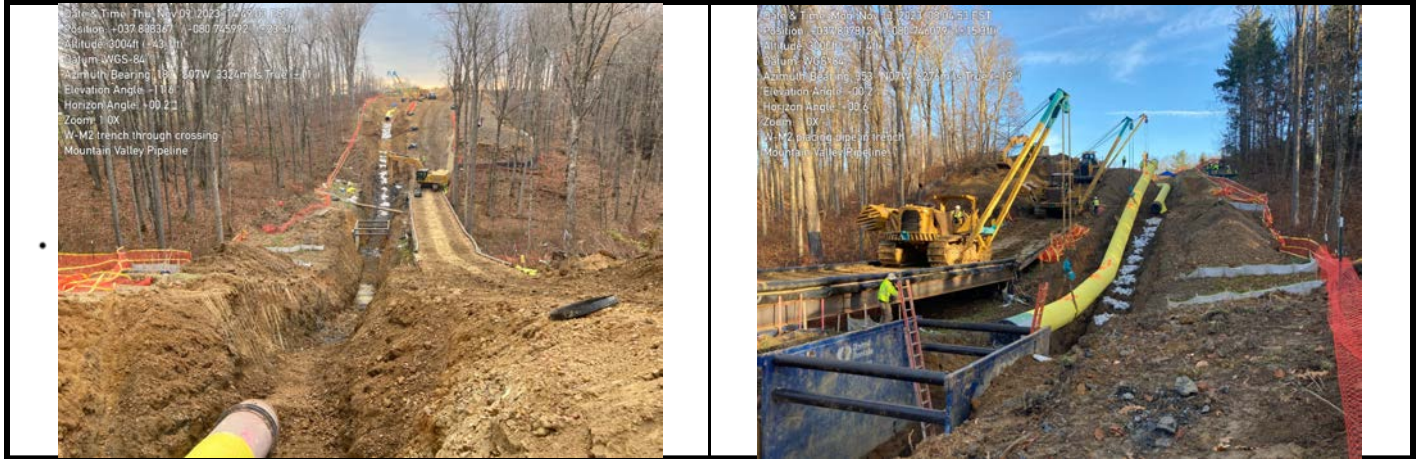
11/9/2023 - Excavation of trench continued through both southern and northern portions of aquatic resource (Photo 3). Trench box installed. Excavation of trench continued outside aquatic resource area. Sandbags placed in trench for pipe support. Welding and X-ray outside aquatic resource area.

11/13/2023 - Pipe transported and lowered into the northern portion of the aquatic resource area (Photo 4). Welded pipe section to existing pipeline. Sandblasting and coating welds outside resource area. Checked topsoil storage stockpile, properly separated and labeled.

<b>Description</b> Photo 3: Completed excavation of trench through aquatic resource area.	<b>Description</b> Photo 4: Lowering pipe into aquatic resource area.
---	---

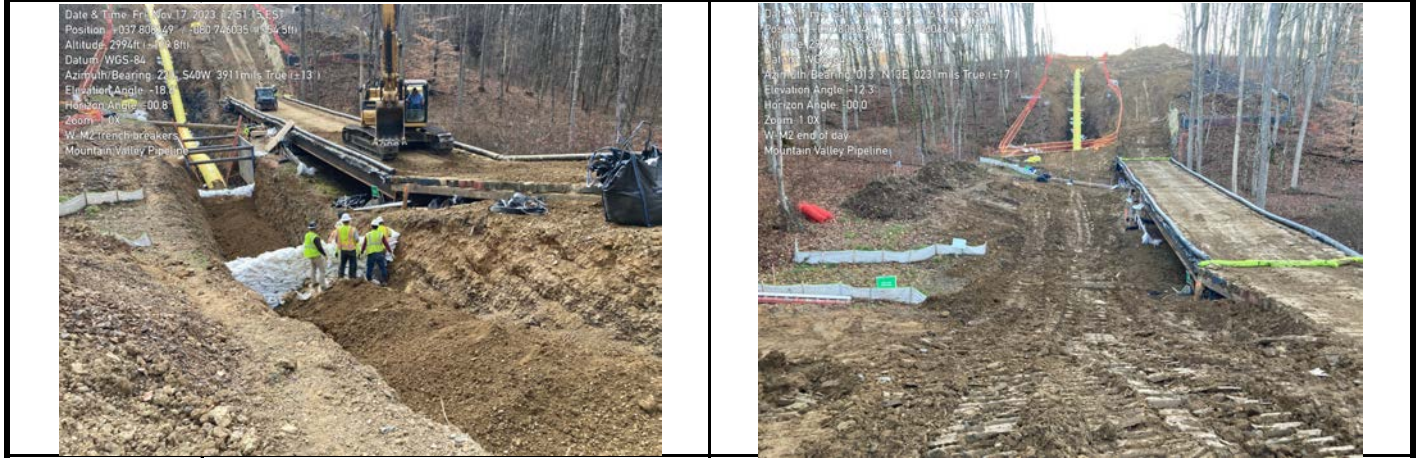
11/17/2023 - Prepared more pad dirt and backfilling. Previous days weld completed. Coated weld in trench box. Survey on site to shoot trench breakers and other features. Trench breakers constructed adjacent to northern aquatic resource area (Photo 5) and the northern portion of the southern aquatic resource area. X-ray of final weld. Coating previous days weld. Remove trench box. Backfilling trench.

11/18/2023 - Finished final trench breaker. Survey on site to shoot wetland boundary and elevation but couldn't compete that due to lack of elevation data. Coating final weld. Continued to backfill trench (Photo 6).

<b>Description</b> Photo 5: Trench breakers being constructed adjacent to northern portion of the aquatic resource area.	<b>Description</b> Photo 6: Backfilling trench.
--	---

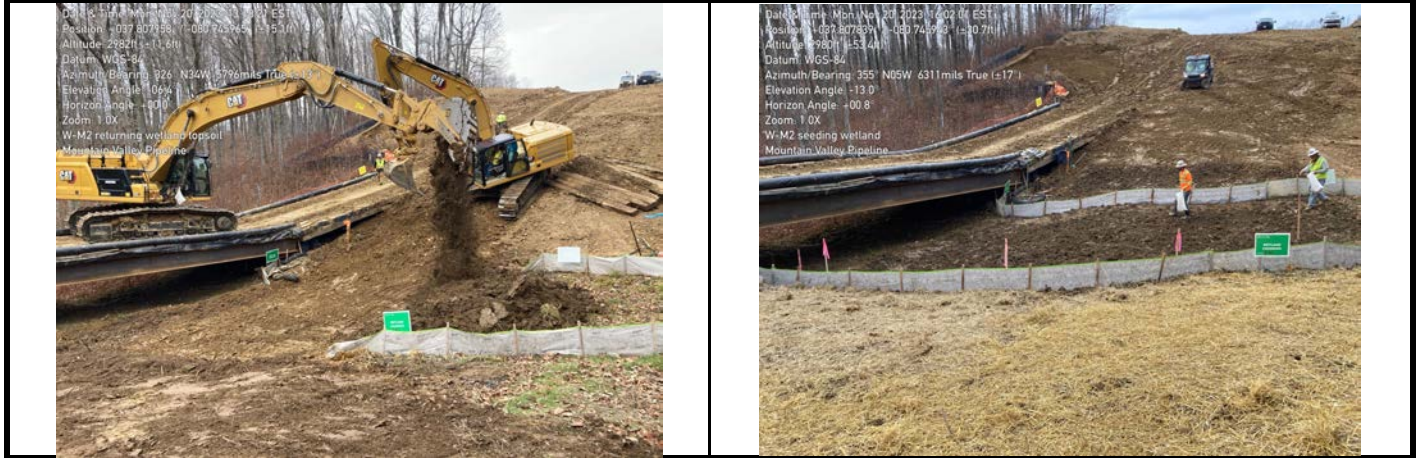
11/20/2023 Survey onsite for boundary and elevation and working with equipment operator to contour subsoil in southern section of aquatic resource. Topsoil restored in aquatic resource and contoured according to pre-construction survey data. P1 installed around aquatic resource boundary. Southern aquatic resource area seeded and covered with jute. Wetland topsoil returned to northern section of aquatic resource (Photo 7) and contoured using pre-construction survey data. P1 installed around boundary. Wetland seeded (Photo 8).

<b>Description</b> Photo 7: Restoring topsoil in northern portion of aquatic resource crossing.	<b>Description</b> Photo 8: Seeding northern portion of aquatic resource post construction.
---	---
