Wetland Biological Conditions EA Report

Project Name	H-600 Pipeline Spread F	AFE	124300135	Spread	H-600 Pipeline Spread F
Contractor	Price Gregory	Report #	106		
Environmental Auditor	Luke Fultz	Date/Time	10/26/2023 3:21 PM		
Wetland ID	W-UV11	Crossing Start Date	11/8/2023	Crossing Completion Date	11/25/2023
Milepost	155.17	Pre-Con Assessment Date	10/26/2023	Post-Con Assessment Date	11/25/2023
Station	8192+98	Cowardin Classification	PEM	Wetland Impact Area(acres)	0.0285
State	WV				
County	Greenbrier

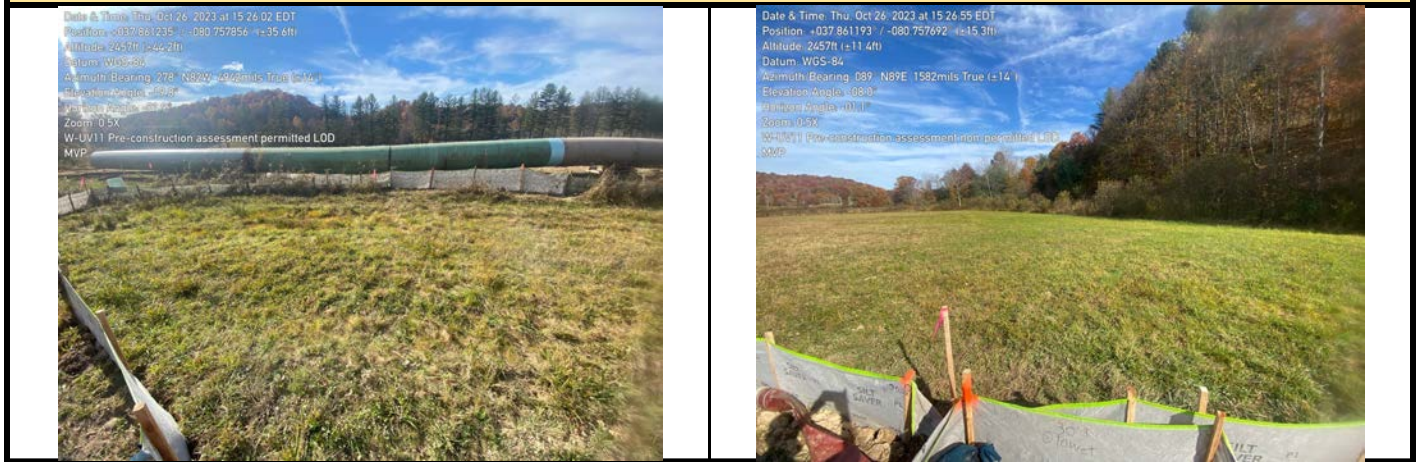
GPS Location See Photo	GPS Location See Photo
Description View of permitted resource impact area during pre-construction assessment.	Description At edge of LOD, view of unimpacted resource area conditions during pre-construction assessment.

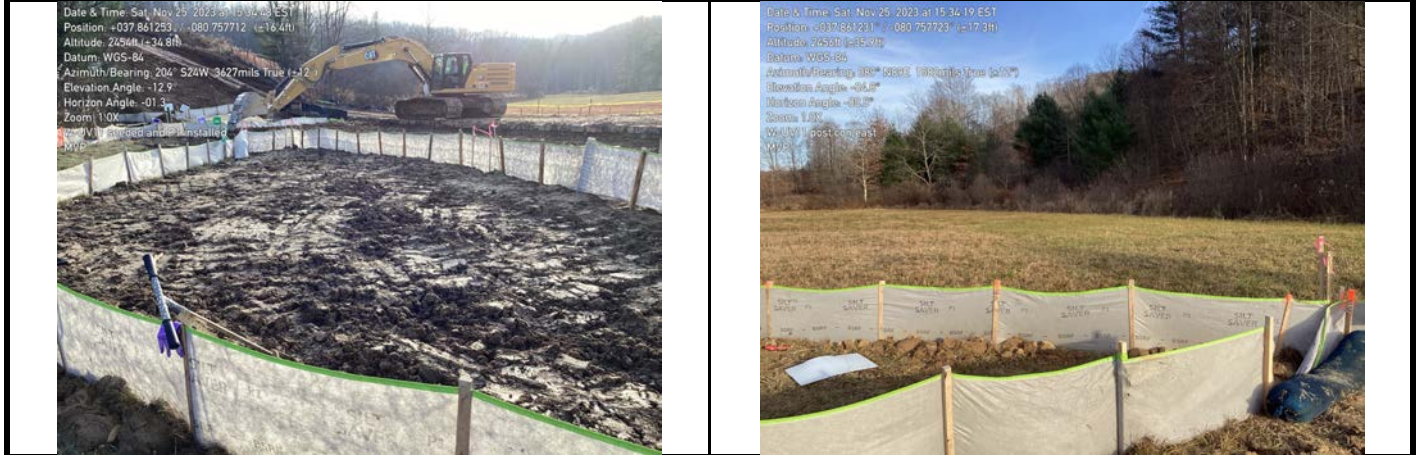
Post Construction Notes
 19. Crossing has recently been restored. These areas will be monitored until 80% vegetative cover is achieved. Areas that do not have 80% vegetative cover within 30 days will be reseeded.

GPS Location See Photo	GPS Location See Photo
Description View of permitted resource impact area during post-construction assessment.	Description At edge of LOD, view of unimpacted resource area conditions during post-construction assessment.

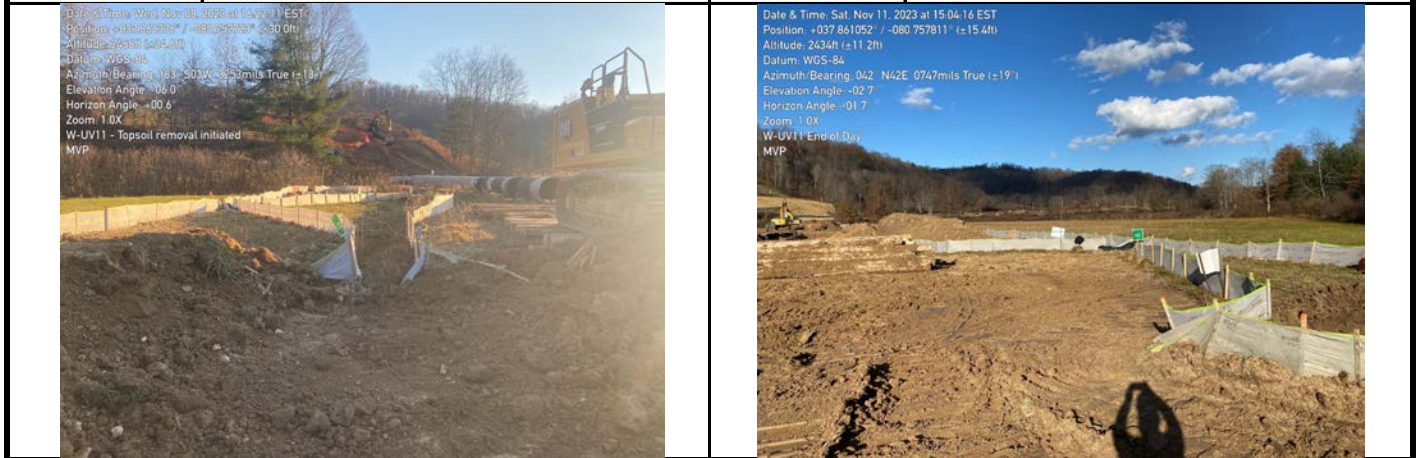
11/08/2023 - Pre-Construction Assessment review and was found to be consistent with current conditions. First 12 inches of topsoil on the northwestern edge of the aquatic resource was removed and segregated (Photo 1).

11/11/2023 - First 12 inches of topsoil was removed from the remainder of the aquatic resource (Photo 2). Material was segregated.

GPS Location See Photo	GPS Location See Photo
Description Photo 1: Removal of first 12 inches of topsoil in the northwestern corner of the aquatic resource.	Description Photo 2: Remainder of the first 12 inches of topsoil in the aquatic resource removed.
