Stream Biological Conditions EA Report

Project Name	H-600 Pipeline Spread C	AFE	124300131	Spread	H-600 Pipeline Spread C
Contractor	Precision	Report #	469		
Environmental Auditor	Jeffrey Arbogast	Date/Time	12/19/2023 7:49 AM		
Stream ID	S-B34	Crossing Start Date	12/19/2023	Crossing Completion Date	12/22/2023
Milepost	97.84	Pre-Con Assessment Date	12/18/2023	Post-Con Assessment Date	12/22/2023
Station	5166+20	Bankfull Width (ft.)	30.0	Riffle:Pool Complexes Present?	No
State	WV	Stream Classification	Perennial		
County	Webster	303(d) Impairment Listing	No

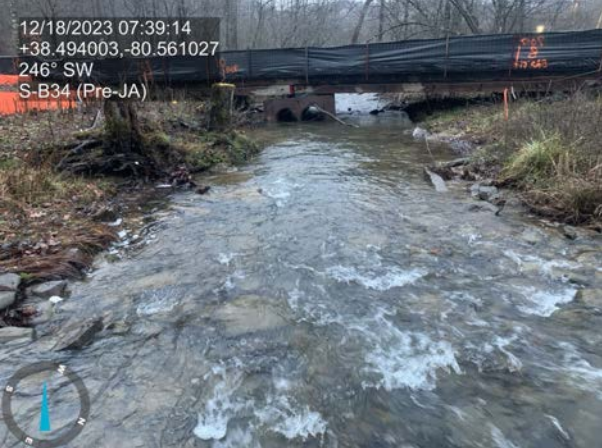
GPS Location	See Caption in Photo	GPS Location	See Caption in Photo
Description	Downstream view of permitted impact area during pre-construction assessment.	Description	Downstream view of unimpacted area during pre-construction assessment. Standing on timber mat bridge.

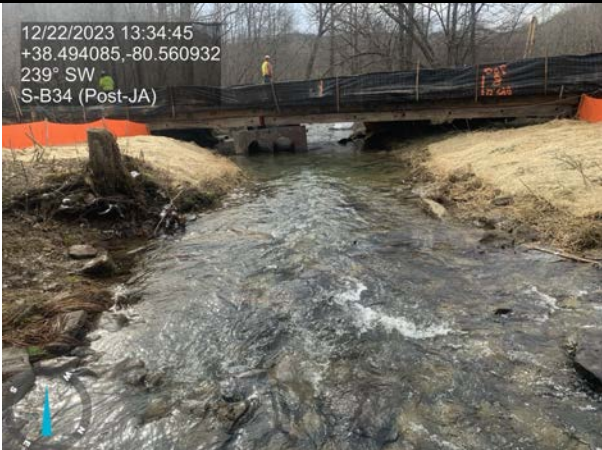
GPS Location	See Caption in Photo	GPS Location	See Caption in Photo
Description	Downstream view of permitted impact area during post-construction assessment.	Description	Downstream view of unimpacted area during post-construction assessment. Standing on timber mat bridge.

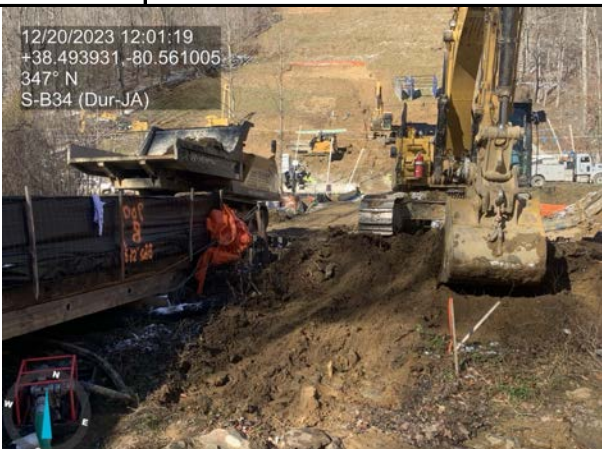
GPS Location	See Caption in Photo	GPS Location	See Caption in Photo
Description	10' buffer material being removed.	Description	Stream subsoil being placed in super sacks.

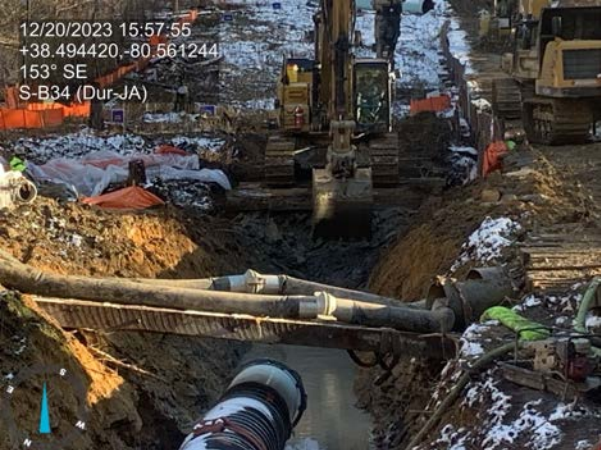
<p>12/20/2023 15:57:55 +38.494420,-80.561244 153° SE S-B34 (Dur-JA)</p>

<p>12/21/2023 13:38:53 +38.494376,-80.561218 153° SE S-B34 (Dur-JA)</p>	
GPS Location	See Caption in Photo	GPS Location	See Caption in Photo
Description	Stream subsoil being removed.	Description	Stream section of pipe lowered in.

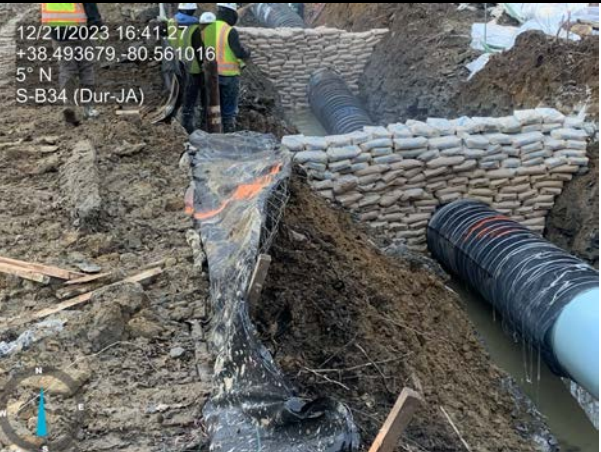
<p>12/21/2023 16:41:27 +38.493679,-80.561016 5° N S-B34 (Dur-JA)</p>

<p>12/21/2023 20:10:04 +38.494172,-80.561082 172° S S-B34 (Dur-JA)</p>	
GPS Location	See Caption in Photo	GPS Location	See Caption in Photo
Description	Bentonite trench breakers	Description	Backfilling with native subsoil

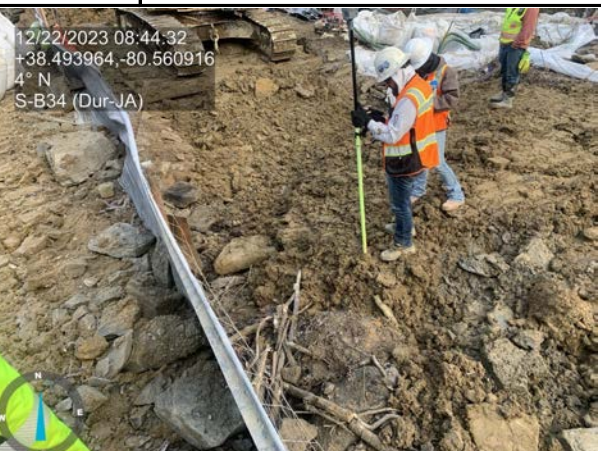
<p>12/22/2023 08:44:32 +38.493964,-80.560916 4° N S-B34 (Dur-JA)</p>

<p>12/22/2023 09:33:38 +38.494054,-80.560872 322° NW S-B34 (Dur-JA)</p>	
GPS Location	See Caption in Photo	GPS Location	See Caption in Photo
Description	Survey verifying stream subsoil elevation.	Description	Stream substrate being returned to the channel.
