# Stream Biological Conditions EA Report

| <b>Project Name</b> | H-600 Pipeline Spread F | <b>AFE</b> | 124300135 | <b>Spread</b> | H-600 Pipeline Spread F |
| <b>Stream ID</b> | S-C38 | <b>Crossing Start Date</b> | 12/11/2023 | <b>Crossing Completion Date</b> | 12/22/2023 |

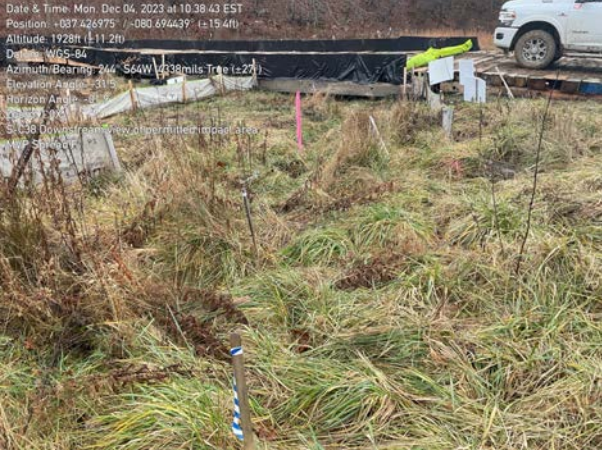
| <b>Description</b> Downstream view of permitted impact area during pre-construction assessment. | <b>Description</b> Downstream view of unimpacted area during pre-construction assessment. |

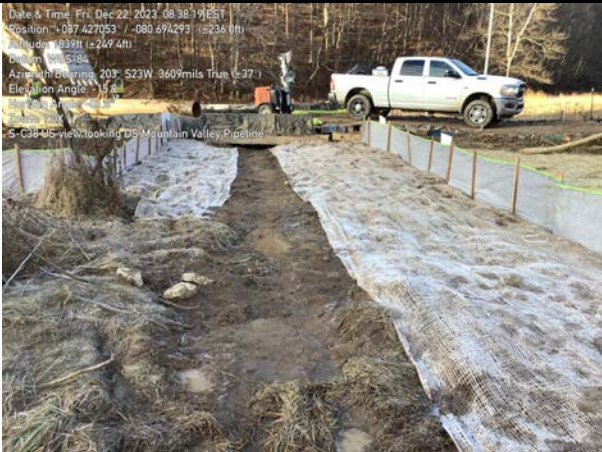
| <b>Description</b> Downstream view of permitted impact area during post-construction assessment. | <b>Description</b> Downstream view of unimpacted area during post-construction assessment. |

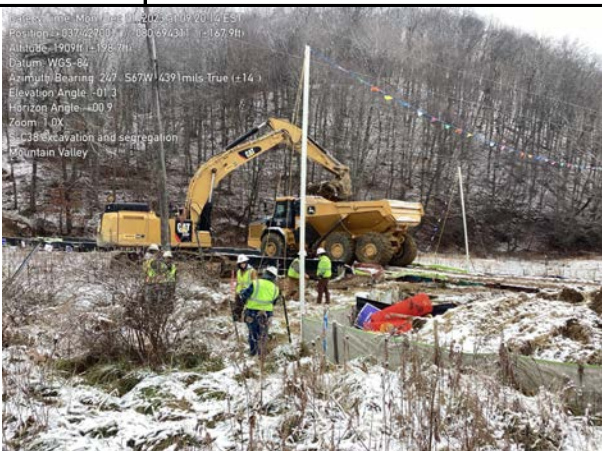
| <b>Description</b> Photo 1: Excavating top 12 inches of substrate from aquatic resource. | <b>Description</b> Photo 2: Excavating through aquatic resource and adjacent resource area. |
