Stream Biological Conditions EA Report

Project Name	H-600 Pipeline Spread F	AFE	124300135	Spread	H-600 Pipeline Spread F
Contractor	Price Gregory	Report #	419		
Environmental Auditor	Mathew Huber	Date/Time	12/3/2023 8:29 PM		
Stream ID	S-C39	Crossing Start Date	12/12/2023	Crossing Completion Date	12/21/2023
Milepost	194.73	Pre-Con Assessment Date	12/4/2023	Post-Con Assessment Date	12/22/2023
Station	10281+97	Bankfull Width (ft.)	5.0	Riffle:Pool Complexes Present?	No
State	WV	Stream Classification	Perennial		
County	Monroe	303(d) Impairment Listing	No

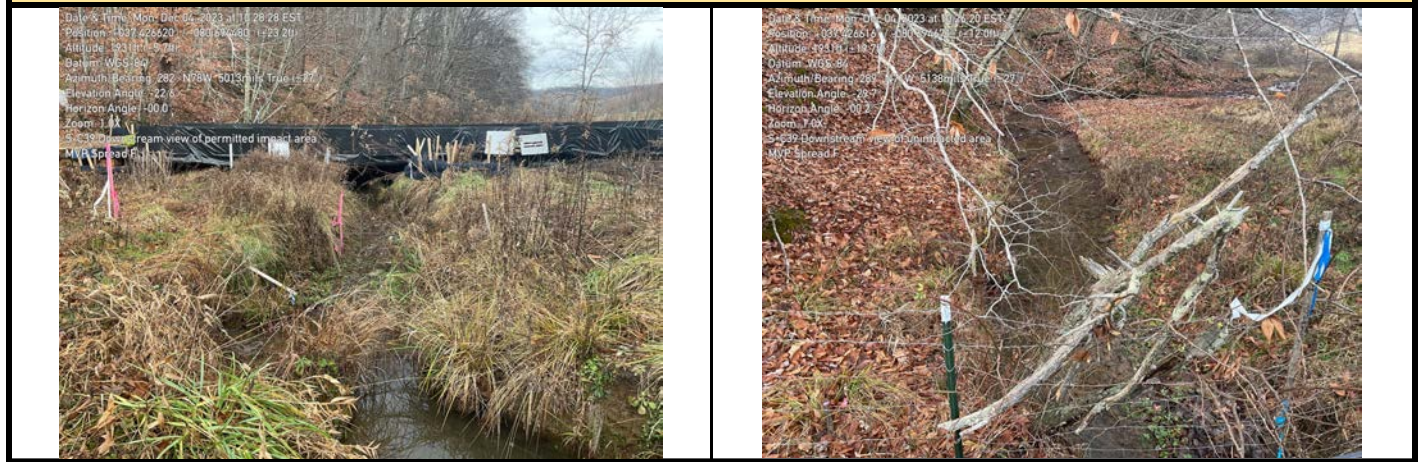
GPS Location	See photo	GPS Location	See photo
Description	Downstream view of permitted impact area during pre-construction assessment.	Description	Downstream view of unimpacted area during pre-construction assessment.

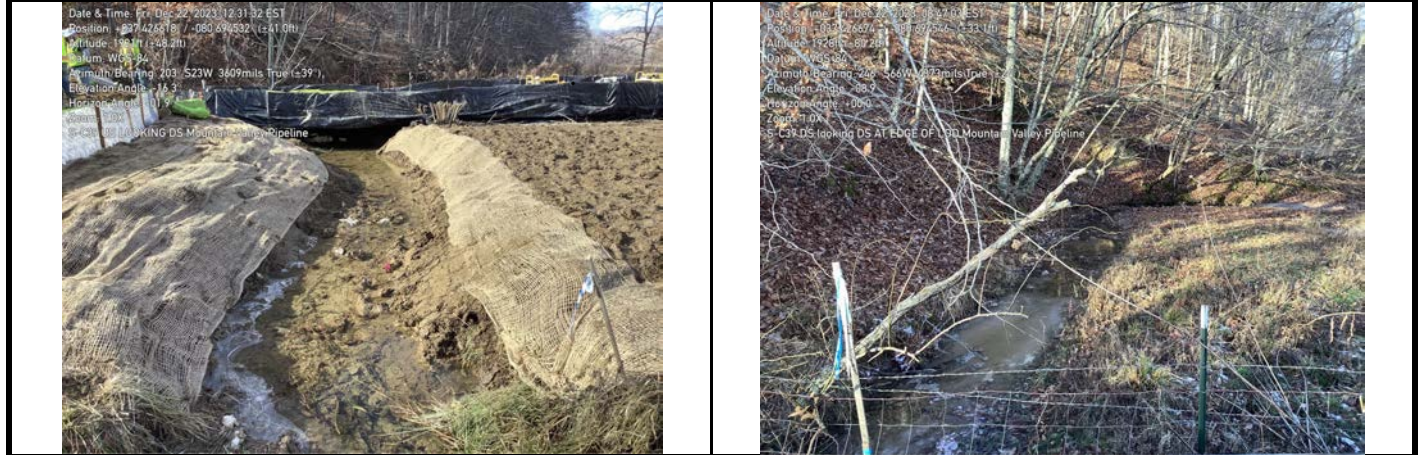
GPS Location	See photo	GPS Location	See photo
Description	Downstream view of permitted impact area during post-construction assessment.	Description	Downstream view of unimpacted area during post-construction assessment.

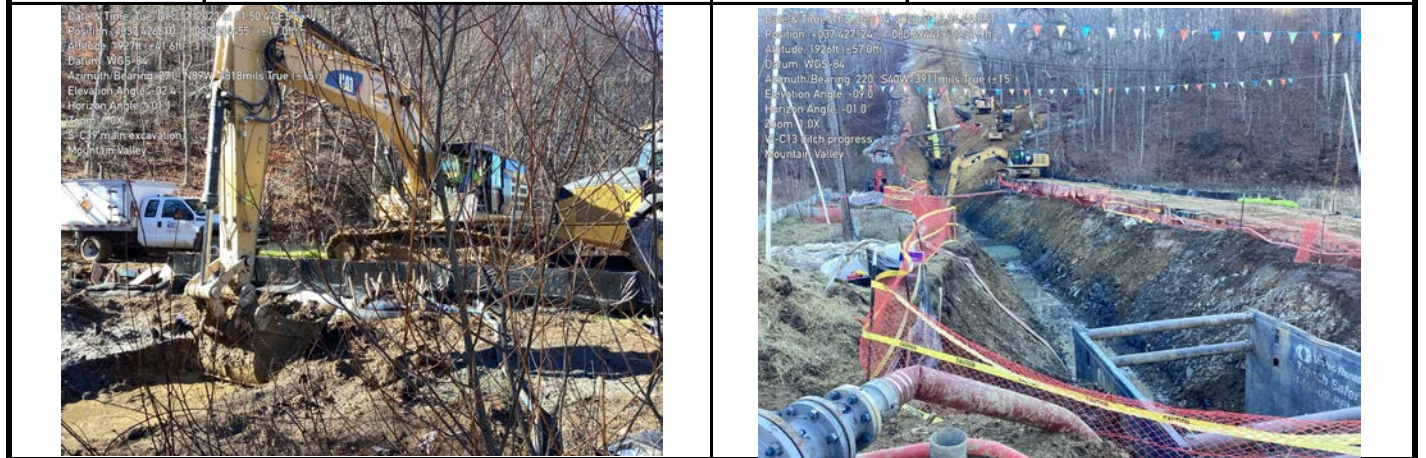
GPS Location	See photo	GPS Location	See photo
Description	Photo 1: Excavating of first 12 inches of substrate.	Description	Photo 2: Excavated through aquatic resource.
