Stream Biological Conditions EA Report

Project Name	H-600 Pipeline Spread F	AFE	124300135	Spread	H-600 Pipeline Spread F
Contractor	Price Gregory	Report #	416		
Environmental Auditor	Charles Haden	Date/Time	11/27/2023 12:49 PM		
Stream ID	S-CV17	Crossing Start Date	12/2/2023	Crossing Completion Date	1/8/2024
Milepost	171.48	Pre-Con Assessment Date	11/27/2023	Post-Con Assessment Date	1/8/2024
Station	9054+16	Bankfull Width (ft.)	3.7	Riffle:Pool Complexes Present?	No
State	WV	Stream Classification	Ephemeral		
County	Summers	303(d) Impairment Listing	N/A

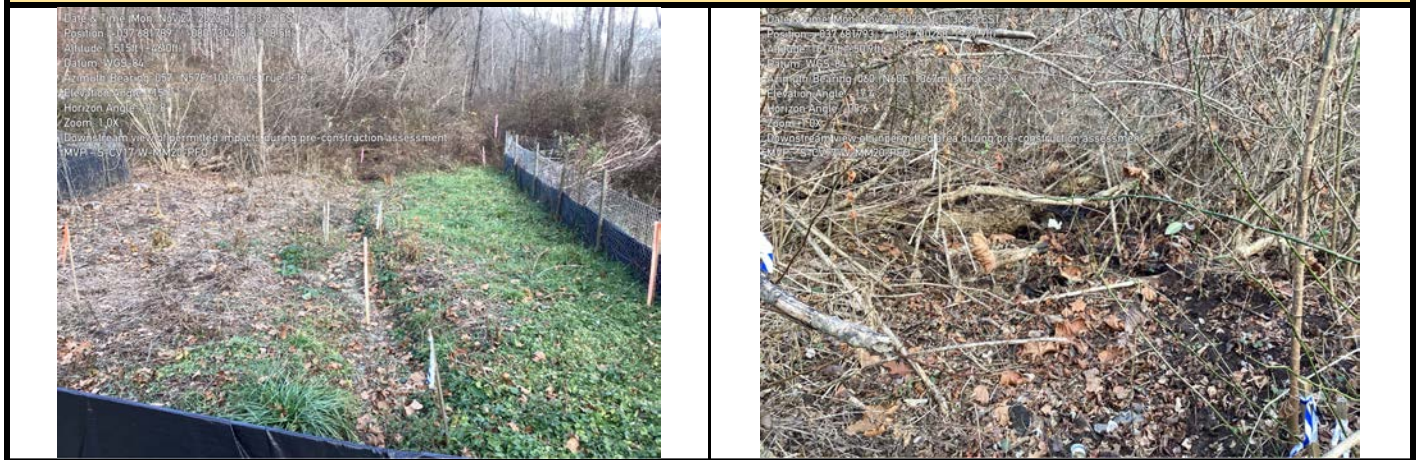
GPS Location See Photo	GPS Location See Photo
Description Downstream view of permitted impact area during pre-construction assessment.	Description Downstream view of unimpacted area during pre-construction assessment.

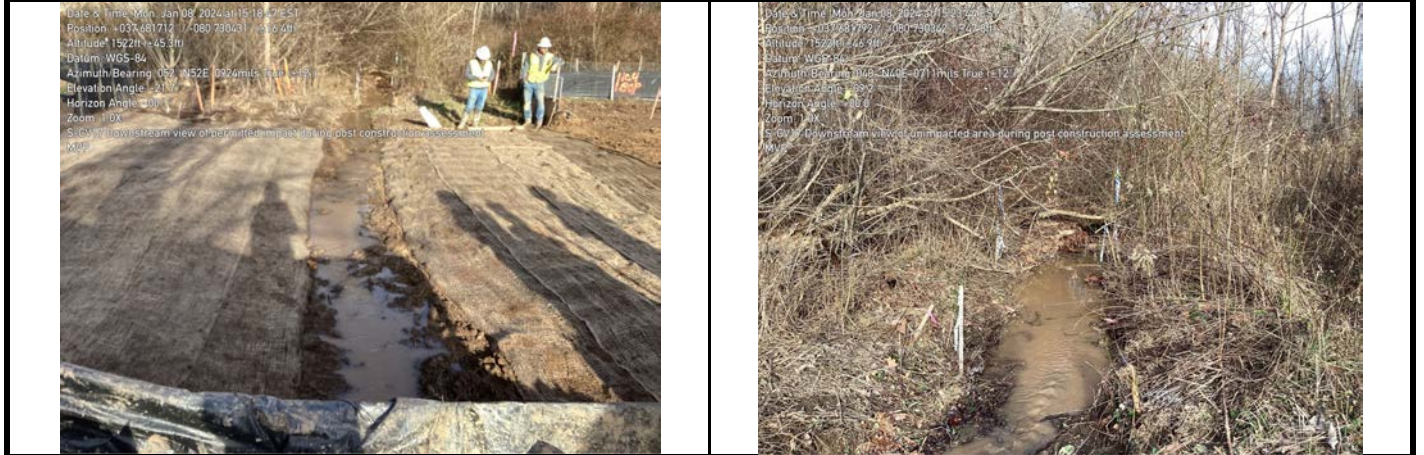
GPS Location See Photo	GPS Location See Photo
Description Downstream view of permitted impact area during post-construction assessment.	Description Downstream view of unimpacted area during post-construction assessment.

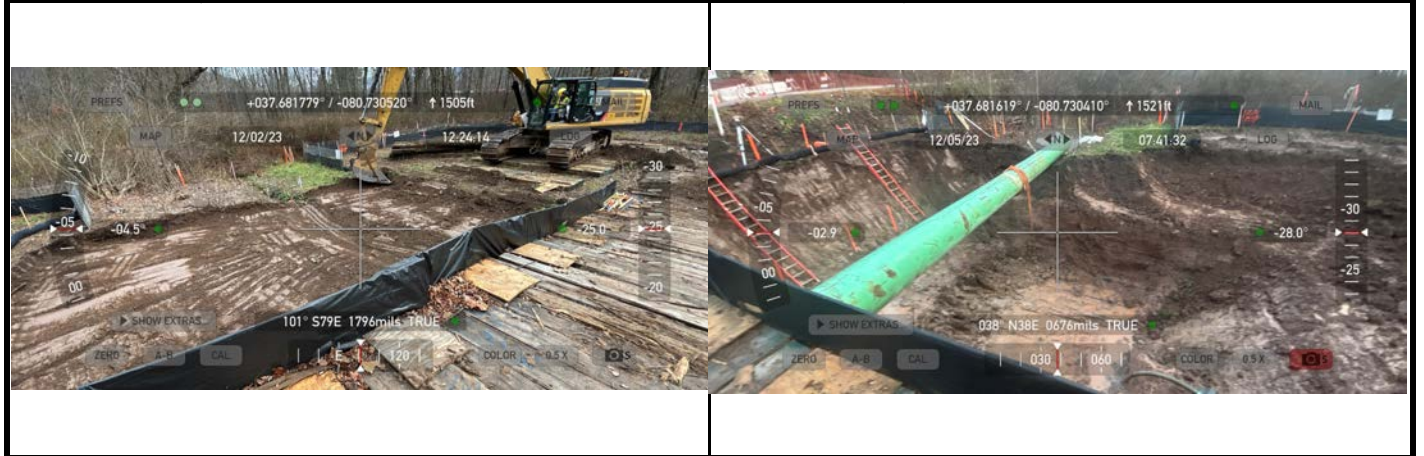
GPS Location See Photo	GPS Location See Photo
Description Photo 1: Excavating top 12 inches of substrate and buffer topsoil.	Description Photo 2: Excavating through aquatic resource.

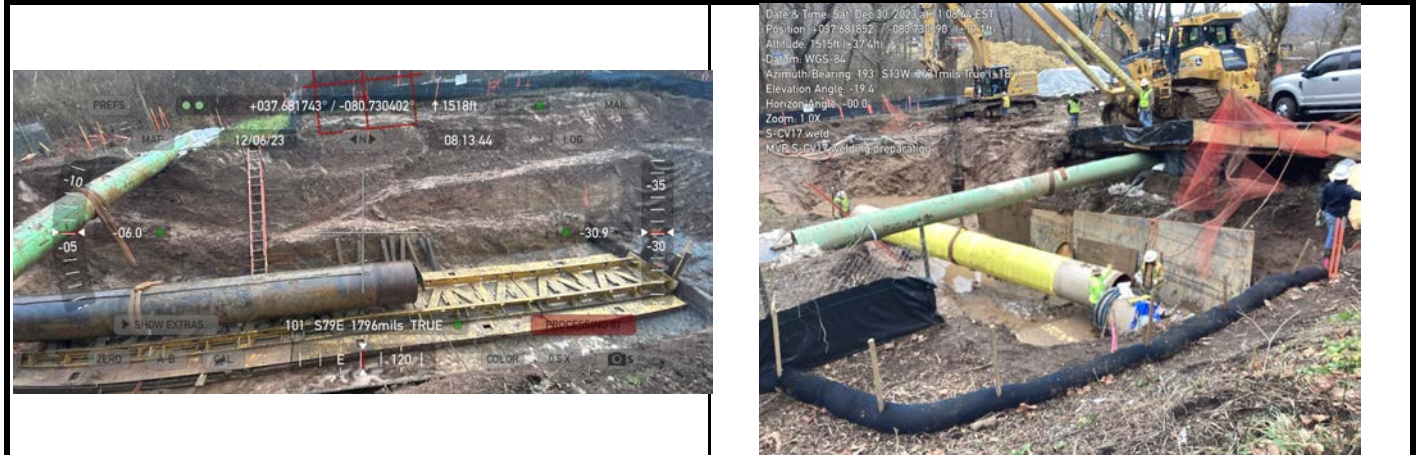
GPS Location See Photo	GPS Location See Photo
Description Photo 3: Bore track installed through aquatic resource.	Description Photo 4: Pipe in trench through aquatic resource. Preparing to weld to road bore.

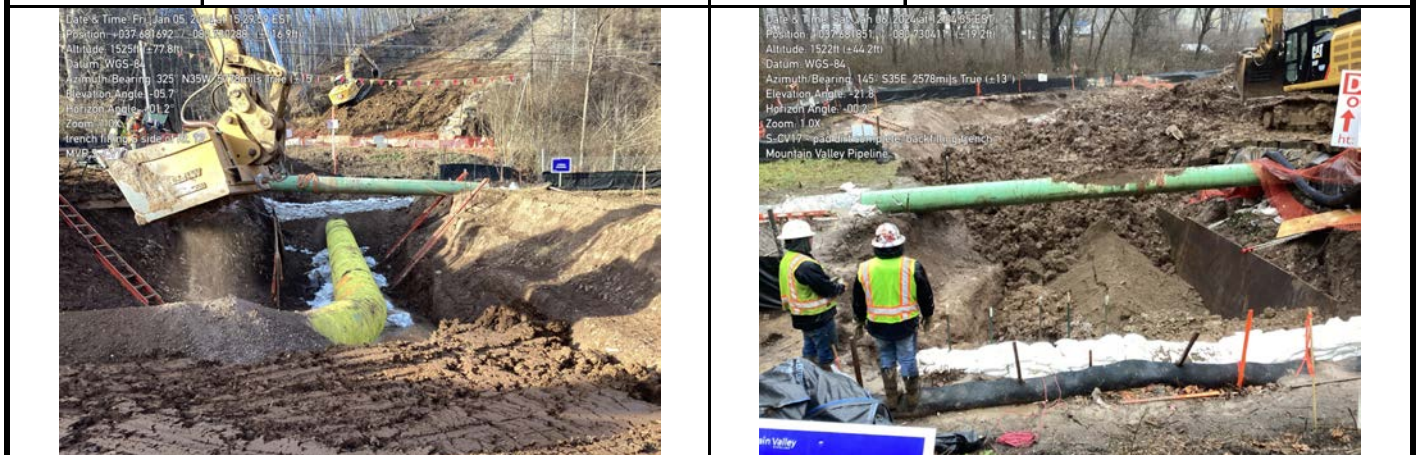
GPS Location See Photo	GPS Location See Photo
Description Photo 5: Northern trench breaker constructed and padding dirt added to trench.	Description Photo 6: Padding dirt and subsoil added to trench in aquatic resource area.

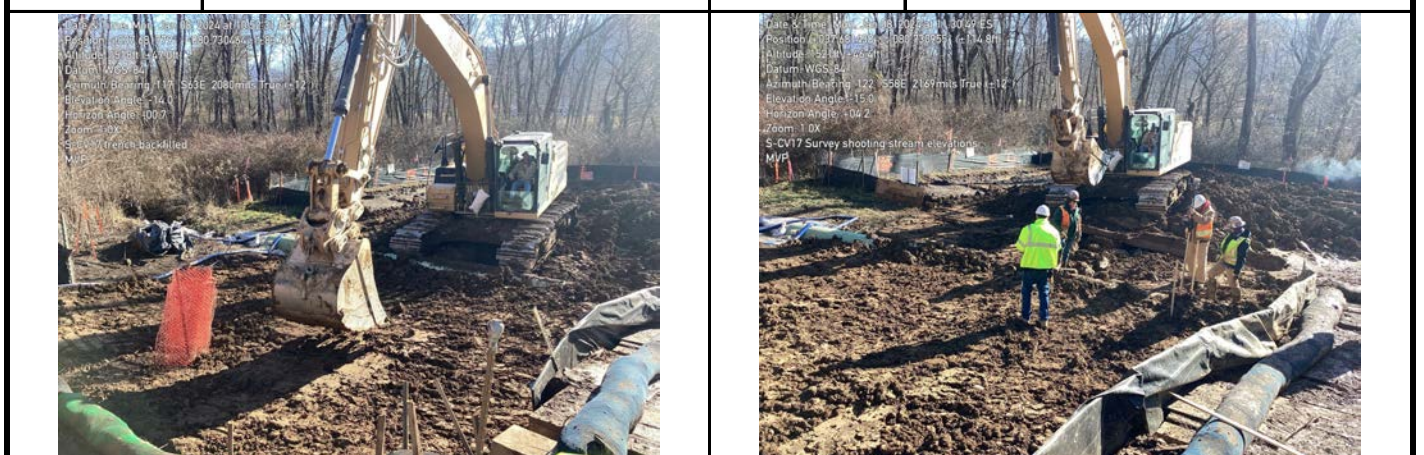
GPS Location See Photo	GPS Location See Photo
Description Photo 7: Backfilled complete and contouring ongoing.	Description Photo 8: Survey shooting elevations.
