Stream Biological Conditions EA Report

Project Name	H-600 Pipeline Spread D	AFE	124300132	Spread	H-600 Pipeline Spread D
Contractor	Precision	Report #	483		
Environmental Auditor	Gary Cruz	Date/Time	1/22/2024 10:23 AM		
Stream ID	S-IJ62	Crossing Start Date	1/3/2024	Crossing Completion Date	1/21/2024
Milepost	112.92	Pre-Con Assessment Date	1/3/2024	Post-Con Assessment Date	1/23/2024
Station	5962+09	Bankfull Width (ft.)	1.3	Riffle:Pool Complexes Present?	No
State	WV	Stream Classification	Intermittent		
County	Nicholas	303(d) Impairment Listing	No

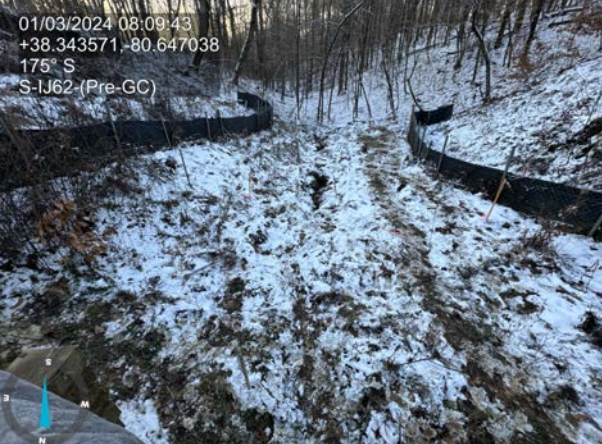
GPS Location See photo above	GPS Location See photo above
Description Downstream view of permitted impact area during pre-construction assessment.	Description Downstream view of unimpacted area during pre-construction assessment.

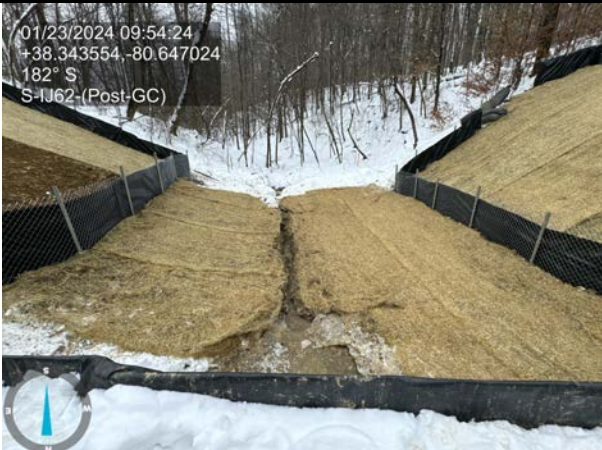
GPS Location See photo above	GPS Location See photo above
Description Downstream view of permitted impact area during post-construction assessment.	Description Downstream view of unimpacted area during post-construction assessment.

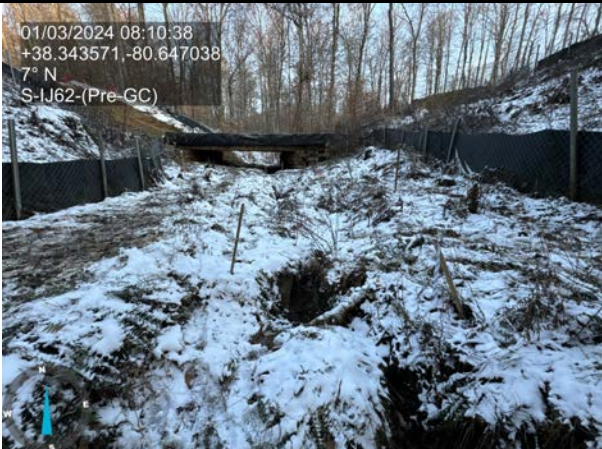
GPS Location See photo above	GPS Location See photo above
Description Upstream view of permitted impact area during pre-construction assessment.	Description Removing top 12" of stream topsoil.
