Stream Biological Conditions EA Report

Project Name	H-600 Pipeline Spread F	AFE	124300135	Spread	H-600 Pipeline Spread F
Contractor	Price Gregory	Report #	422		
Environmental Auditor	Aaron Crank	Date/Time	12/4/2023 9:27 AM		
Stream ID	S-MN2	Crossing Start Date	12/4/2023	Crossing Completion Date	12/23/2023
Milepost	185.88	Pre-Con Assessment Date	12/4/2023	Post-Con Assessment Date	12/23/2023
Station	9814+22	Bankfull Width (ft.)	5.0	Riffle:Pool Complexes Present?	No
State	WV	Stream Classification	Perennial		
County	Monroe	303(d) Impairment Listing	No

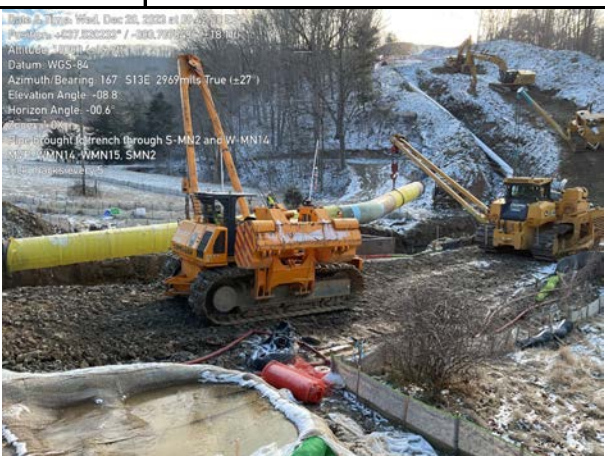
<p><small>Date & Time: Mon, Dec 04, 2023 at 12:48:25 EST Position: +037.520007 / -080.707600 (+28.0ft) Altitude: 1795ft (+39.4ft) Datum: WGS-84 Azimuth/Bearing: 177.563E 309mils True (+28) Elevation Angle: -15.3 Horizon Angle: -00.8 Zoom: 1.0x Stream Susceptibility: MNP MVP: WMN14, WMN15, SMN2 Tick marks every 5'</small></p>	  <p><small>Date & Time: Mon, Dec 04, 2023 at 08:48:29 EST Position: +037.520007 / -080.707565 (+15.6ft) Altitude: 1795ft (+39.4ft) Datum: WGS-84 Azimuth/Bearing: 222.542W 394mils True (+28) Elevation Angle: -18.3 Horizon Angle: -01.1 Zoom: 1.0x Trench Breaker: SMN2 MVP: WMN14, WMN15, SMN2 Tick marks every 5'</small></p>
GPS Location See Photo	GPS Location See Photo
Description Photo 3: Drilling for blasting in aquatic resource.	Description Photo 4: Excavating trench through aquatic resource.

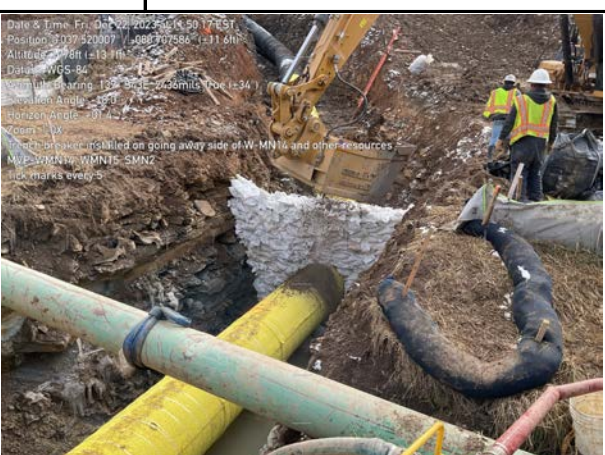
<p><small>Date & Time: Wed, Dec 06, 2023 at 09:51:18 EST Position: +037.520007 / -080.707586 (+31.8ft) Altitude: 1794ft (+39.1ft) Datum: WGS-84 Azimuth/Bearing: 167.513E 296mils True (+27) Elevation Angle: -09.8 Horizon Angle: -00.6 Zoom: 1.0x Trench Breaker installed over pipe in S-MN2 MVP: WMN14, WMN15, SMN2 Tick marks every 5'</small></p>	  <p><small>Date & Time: Fri, Dec 08, 2023 at 11:28:39 EST Position: +037.519987 / -080.707560 (+42.8ft) Altitude: 1779ft (+37.1ft) Datum: WGS-84 Azimuth/Bearing: 331.87N 79W 499mils True (+35) Elevation Angle: -28.6 Horizon Angle: -00.3 Zoom: 1.0x River weights installed over pipe in S-MN2 MVP: WMN14, WMN15, SMN2 Tick marks every 5'</small></p>

GPS Location See Photo	GPS Location See Photo
Description Photo 5: Lowered pipe into trench in aquatic resource.	Description Photo 6: Adding river weights.

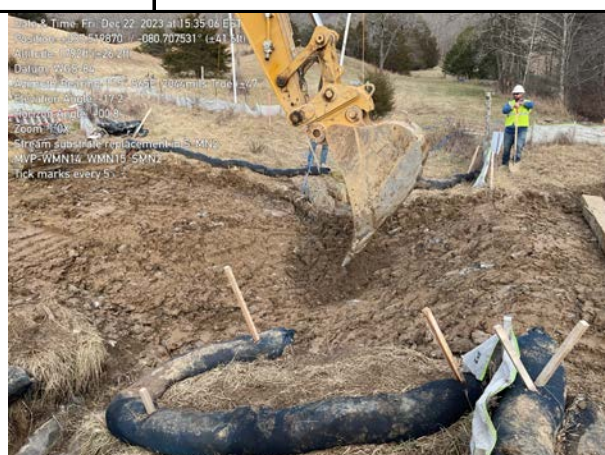
<p><small>Date & Time: Fri, Dec 08, 2023 at 14:50:17 EST Position: +037.520007 / -080.707586 (+31.8ft) Altitude: 1798ft (+31.1ft) Datum: WGS-84 Azimuth/Bearing: 139.563E 263mils True (+34) Elevation Angle: -29.0 Horizon Angle: -00.1 Zoom: 1.0x Trench Breaker installed on going away side of W-MN14 and other resources MVP: WMN14, WMN15, SMN2 Tick marks every 5'</small></p>

<p><small>Date & Time: Fri, Dec 22, 2023 at 15:35:08 EST Position: +037.519870 / -080.707531 (+41.8ft) Altitude: 1820ft (+28.0ft) Datum: WGS-84 Azimuth/Bearing: 150.164E 180mils True (+28) Elevation Angle: -27.3 Horizon Angle: 00.0 Zoom: 1.0x Stream substrate replacement: MNP MVP: WMN14, WMN15, SMN2 Tick marks every 5'</small></p>
GPS Location See Photo	GPS Location See Photo

Description Photo 7: Trench Breaker installed.	Description Photo 8: Substrate restored.
