# Wetland Biological Conditions EA Report

<b>Project Name</b>	H-600 Pipeline Spread D	<b>AFE</b>	124300132	<b>Spread</b>	H-600 Pipeline Spread D
<b>Contractor</b>	Precision	<b>Report #</b>	149		
<b>Environmental Auditor</b>	Scott Wessel			<b>Date/Time</b>	11/25/2023 8:12 PM
<b>Wetland ID</b>	W-FF3	<b>Crossing Start Date</b>	11/25/2023	<b>Crossing Completion Date</b>	12/21/2023
<b>Milepost</b>	114.43	<b>Pre-Con Assessment Date</b>	11/15/2023	<b>Post-Con Assessment Date</b>	12/21/2023
<b>Station</b>	6041+82	<b>Cowardin Classification</b>	PEM	<b>Wetland Impact Area(acres)</b>	0.0444
<b>State</b>	WV				
<b>County</b>	Nicholas

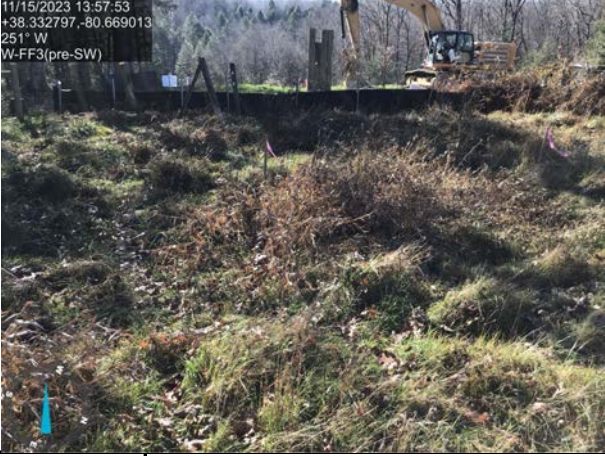
<p>11/15/2023 13:57:53 +38.332797,-80.669013 251° W W-FF3(pre-SW)</p>

<p>11/15/2023 13:59:10 +38.332747,-80.669037 111° E W-FF3(pre-SW)</p>
<b>GPS Location</b> See coordinates in above photo.	<b>GPS Location</b> See coordinates in above photo.
<b>Description</b> View of permitted resource impact area during pre-construction assessment.	<b>Description</b> At edge of LOD, view of unimpacted resource area conditions during pre-construction assessment.

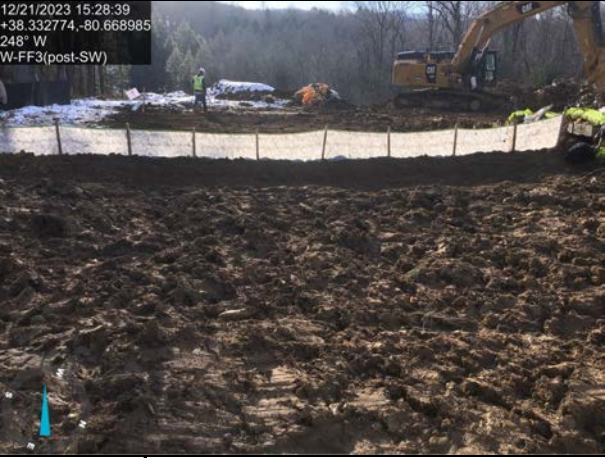
<p>12/21/2023 15:28:39 +38.332774,-80.668985 248° W W-FF3(post-SW)</p>

Conditions 18 and 19 were given a rating of 4 due to the lack of vegetation in the disturbed permitted impact area following completion of the crossing and restoration efforts. The W-FF3 PEM topsoil was properly stabilized and the disturbed area was seeded with the appropriate permanent seed mix in accordance with Appendix B: Restoration Work Plan of the Mountain Valley Pipeline Comprehensive Stream and Wetland Monitoring, Restoration and Mitigation Framework.

<p>12/21/2023 15:25:06 +38.332746,-80.669076 120° SE W-FF3(post-SW)</p>
<b>GPS Location</b> See coordinated in above photo.	<b>GPS Location</b> See coordinates in above photo.
<b>Description</b> View of permitted resource impact area during post-construction assessment.	<b>Description</b> At edge of LOD, view of unimpacted resource area conditions during post-construction assessment.

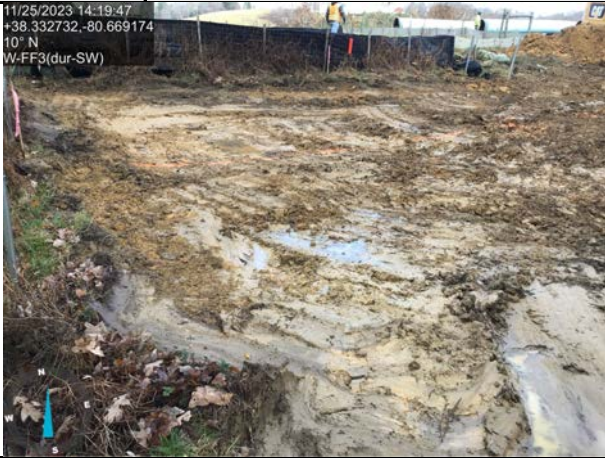
<p>11/25/2023 14:19:47 +38.332732,-80.669174 10° N W-FF3(dur-SW)</p>

11/25/23 – At the commencement of wetland crossing W-FF3, the top 12" of wetland soil was segregated and stockpiled on plastic that was surrounded by silt fence on the coming in side (CIS) of the resource. The loose ends on the CIS and going away side (GAS) of crossing were excavated.

<p>11/28/2023 15:49:50 +38.332858,-80.669143 194° S W-FF3(dur-SW)</p>
<b>GPS Location</b> See coordinates in above photo.	<b>GPS Location</b> See coordinates in above photo.
<b>Description</b> Removing topsoil from resource area.	<b>Description</b> Contractor removing ditch spoils after hammering rock.

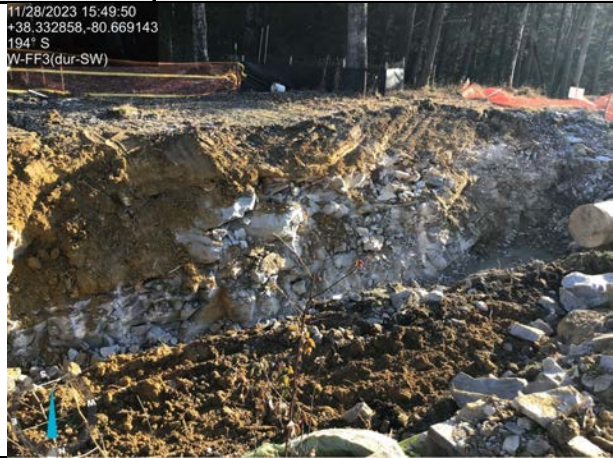
11/26/23 to 11/28/23- In the process of excavating the ditch line, a solid rock layer was hit that required the use of a rock hammer for the remainder of the trenching operations. Once the proper depth was achieved, the ditch was lined with interval spaced sandbags.
