Wetland Biological Conditions EA Report

Project Name	H-600 Pipeline Spread F	A/E	124300135	Spread	H-600 Pipeline Spread F
Contractor	Price Gregory	Report #	147		
Environmental Auditor	Aaron Crank			Date/Time	12/4/2023 9:23 AM
Wetland ID	W-MN14	Crossing Start Date	12/4/2023	Crossing Completion Date	12/23/2023
Milepost	185.87	Pre-Con Assessment Date	12/4/2023	Post-Con Assessment Date	12/23/2023
Station	9813+69	Cowardin Classification	PEM	Wetland Impact Area(acs)	0.0390
State	WV				
County	Monroe

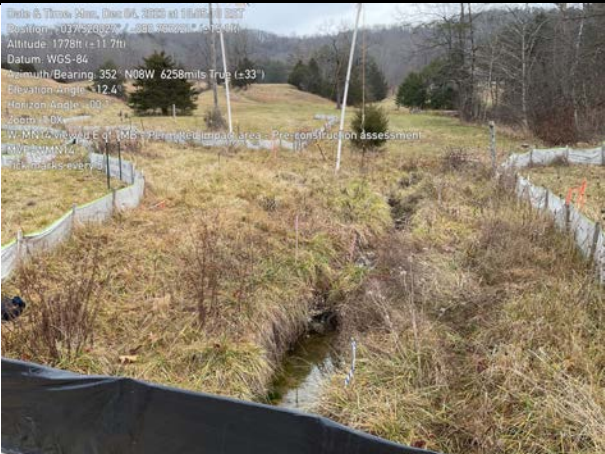
<p><small>Date & Time: Sun, Dec 04, 2023 at 10:55:42 EST Position: +037.520134 / -080.707416 (±50.3ft) Altitude: 1772ft (±11.7ft) Datum: WGS-84 Azimuth/Bearing: 352° N08W 6258mils True (±33°) Elevation Angle: -12.4° Horizon Angle: -00.5° Zoom: 1.0X W-MN16 topsoil removal MVP-WMN16, WMN15, SMN2 Tickmark's every 5'</small></p>

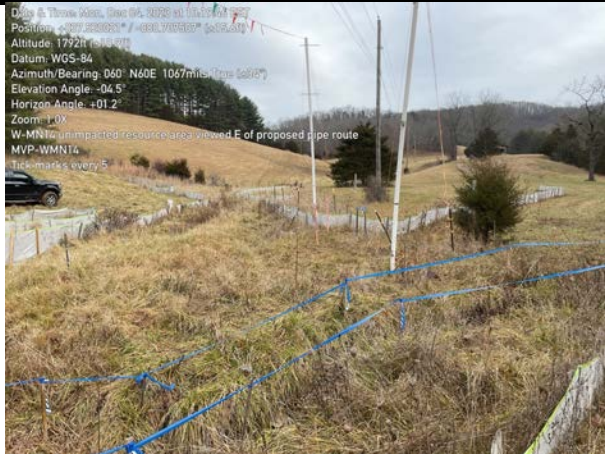
<p><small>Date & Time: Sun, Dec 04, 2023 at 10:55:42 EST Position: +037.520134 / -080.707416 (±50.3ft) Altitude: 1772ft (±11.7ft) Datum: WGS-84 Azimuth/Bearing: 060° N60E 1087mils True (±16°) Elevation Angle: -04.5° Horizon Angle: -01.2° Zoom: 1.0X W-MN16 unimpacted resource area viewed E of proposed pipe route MVP-WMN16 Tickmark's every 5'</small></p>
GPS Location See Photo	GPS Location See Photo
Description View of permitted resource impact area during pre-construction assessment.	Description At edge of LOD, view of unimpacted resource area conditions during pre-construction assessment.

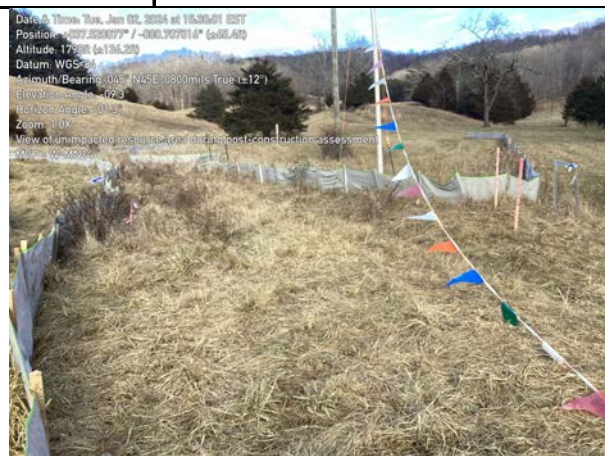
<p><small>Date & Time: Tue, Jan 02, 2024 at 15:30:01 EST Position: +037.520077 / -080.707814 (±48.4ft) Altitude: 1766ft (±13.3ft) Datum: WGS-84 Azimuth/Bearing: 005° N45E 0800mils True (±12°) Elevation Angle: -02.3° Horizon Angle: -02.3° Zoom: 1.0X View of unimpacted resource area during post-construction assessment MVP-W-MN16</small></p>
GPS Location See Photo	GPS Location See Photo
Description View of permitted resource impact area during post-construction assessment.	Description At edge of LOD, view of unimpacted resource area conditions during post-construction assessment.

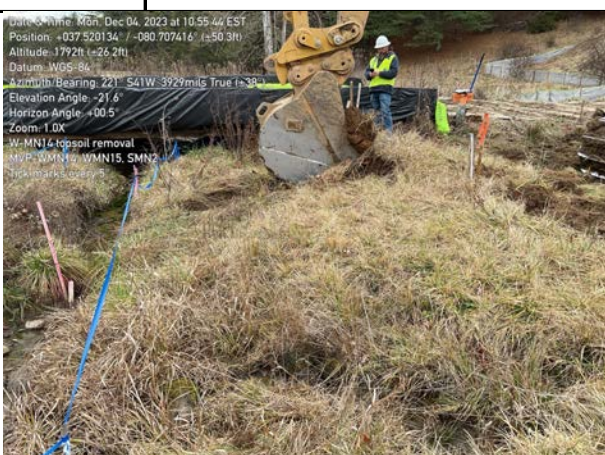
<p><small>Date & Time: Mon, Dec 04, 2023 at 10:55:42 EST Position: +037.520134 / -080.707416 (±50.3ft) Altitude: 1772ft (±11.7ft) Datum: WGS-84 Azimuth/Bearing: 221° S41W 3929mils True (±38°) Elevation Angle: -21.6° Horizon Angle: -00.5° Zoom: 1.0X W-MN16 topsoil removal MVP-WMN16, WMN15, SMN2 Tickmark's every 5'</small></p>

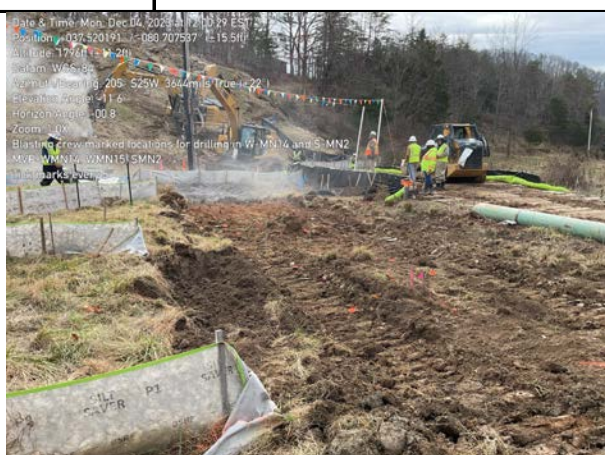
<p><small>Date & Time: Mon, Dec 04, 2023 at 11:21:09 EST Position: +037.520193 / -080.707537 (±15.5ft) Altitude: 1774ft (±11.7ft) Datum: WGS-84 Azimuth/Bearing: 208° S25W 3844mils True (±22°) Elevation Angle: -11.6° Horizon Angle: -00.8° Zoom: 1.0X Blasting crew marked locations for drilling in W-MN16 and S-MN2 MVP-WMN16, WMN15, SMN2 Tickmark's every 5'</small></p>
GPS Location See Photo	GPS Location See Photo
Description Photo 1: Excavated top 12 inches of topsoil.	Description Photo 2: Blasting crew marking aquatic resource for drilling.

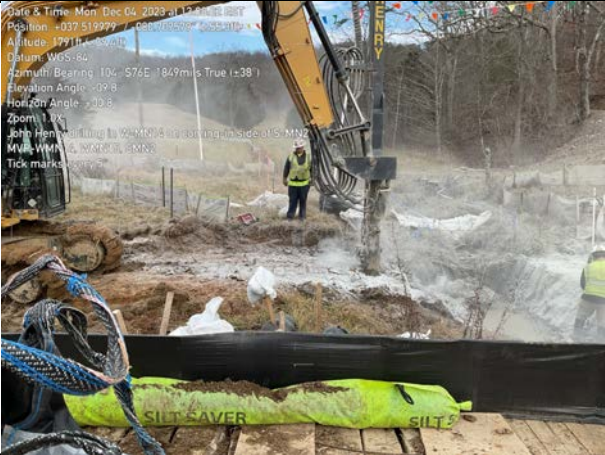
<p>Date & Time: Mon, Dec 04, 2023 at 12:44:01 EST Position: +037 519279 / -080 707536 (-19.21m) Altitude: 1771ft (-540ft) Datum: WGS-84 Azimuth/Bearing: 10c, S76E, 1849mils True (-38) Elevation Angle: -09.8 Horizon Angle: -03.3 Zoom: 1.0X Trench breaker installed on side of W-MN14 and other resources MVP: WMN14, WMN15, SMN2 Tick marks every 5'</p>	See Photo

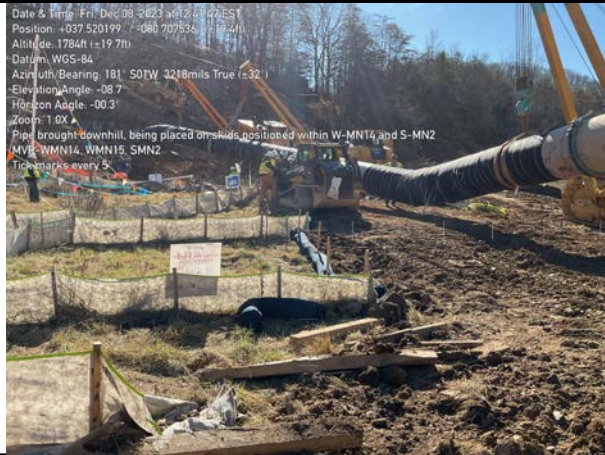
<p>Date & Time: Fri, Dec 08, 2023 at 12:40:07 EST Position: +037 520199 / -080 707536 (-19.21m) Altitude: 1784ft (-19.7ft) Datum: WGS-84 Azimuth/Bearing: 181 S01W, 3218mils True (-32) Elevation Angle: -08.7 Horizon Angle: -00.3 Zoom: 1.0X Pipe brought downhill, being placed on skids, positioned within W-MN14 and S-MN2 MVP: WMN14, WMN15, SMN2 Tick marks every 5'</p>	See Photo		
GPS Location Description	See Photo Photo 3: Drilling for blasting in aquatic resource.	GPS Location Description	See Photo Photo 4: Pipe placed on skids in aquatic resource area.

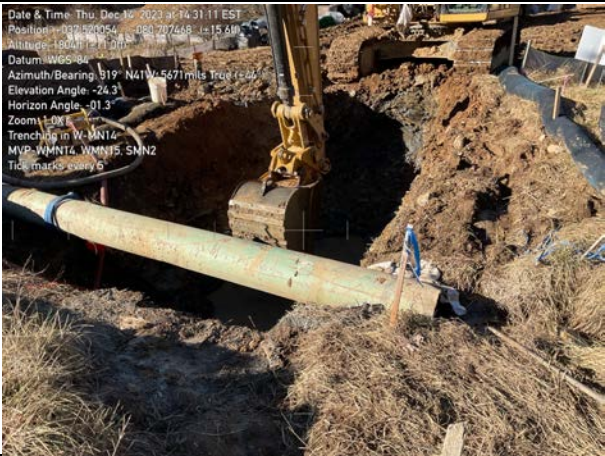
<p>Date & Time: Thu, Dec 07, 2023 at 14:31:11 EST Position: +037 520054 / -080 707469 (-15.61m) Altitude: 1904ft (-17.1ft) Datum: WGS-84 Azimuth/Bearing: 919 N41W, 5671mils True (-2) Elevation Angle: -24.3 Horizon Angle: -01.3 Zoom: 1.0X Trenching in W-MN14 MVP: WMN14, WMN15, SMN2 Tick marks every 5'</p>	See Photo

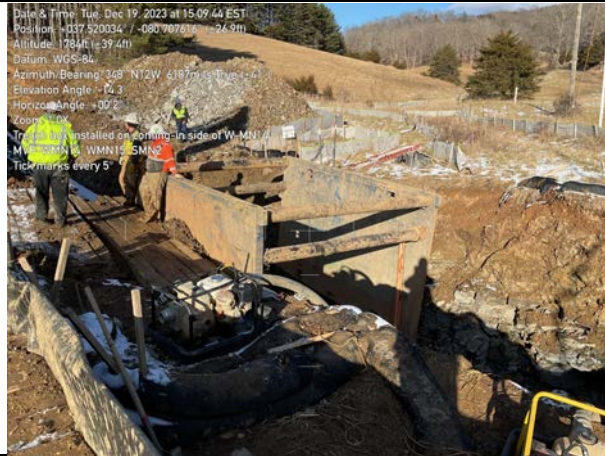
<p>Date & Time: Tue, Dec 19, 2023 at 15:09:44 EST Position: +037 520034 / -080 707616 (-24.9ft) Altitude: 1784ft (-19.7ft) Datum: WGS-84 Azimuth/Bearing: 309 N12W, 6187mils True (-4) Elevation Angle: -14.3 Horizon Angle: -00.2 Zoom: 1.0X Trench box installed on skids on side of W-MN14 MVP: WMN14, WMN15, SMN2 Tick marks every 5'</p>	See Photo		
GPS Location Description	See Photo Photo 5: Excavating trench through aquatic resource.	GPS Location Description	See Photo Photo 6: Trench box in aquatic resource.

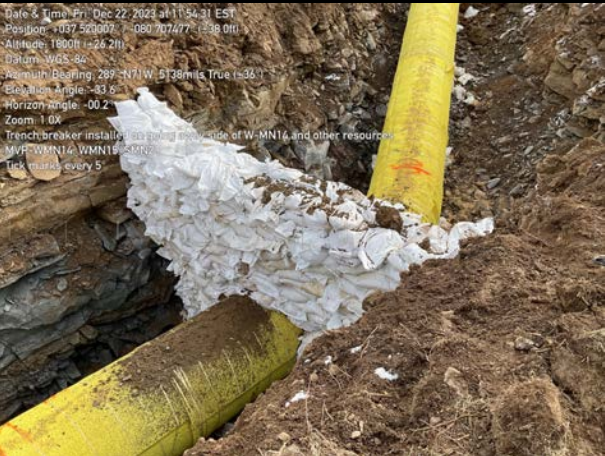
<p>Date & Time: Fri, Dec 22, 2023 at 11:54:31 EST Position: +037 520007 / -080 707477 (-19.38ft) Altitude: 1800ft (-19.2ft) Datum: WGS-84 Azimuth/Bearing: 289 N17W, 5138mils True (-36) Elevation Angle: -33.6 Horizon Angle: -00.2 Zoom: 1.0X Trench breaker installed on side of W-MN14 and other resources MVP: WMN14, WMN15, SMN2 Tick marks every 5'</p>	See Photo

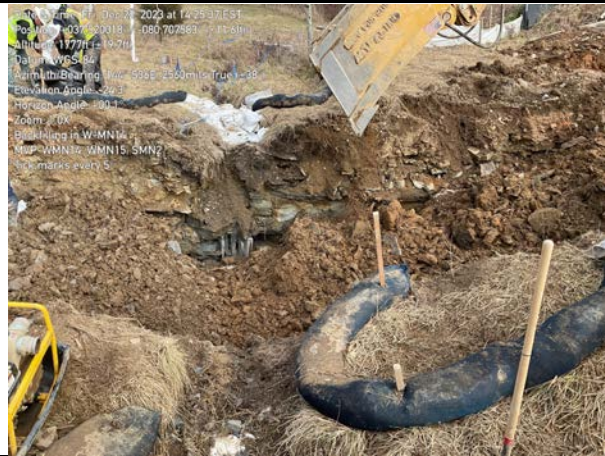
<p>Date & Time: Fri, Dec 22, 2023 at 12:25:37 EST Position: +037 520318 / -080 707881 (-17.8ft) Altitude: 1777ft (-19.7ft) Datum: WGS-84 Azimuth/Bearing: 100c S98E, 2560mils True (-38) Elevation Angle: -09.2 Horizon Angle: -00.1 Zoom: 2.0X Backfilling in W-MN14 MVP: WMN14, WMN15, SMN2 Tick marks every 5'</p>	See Photo
