# Wetland Biological Conditions EA Report

<b>Project Name</b>	H-600 Pipeline Spread F	<b>A/E</b>	124300135	<b>Spread</b>	H-600 Pipeline Spread F
<b>Contractor</b>	Price Gregory	<b>Report #</b>	152		
<b>Environmental Auditor</b>	Eric Schicker			<b>Date/Time</b>	12/12/2023 7:22 AM
<b>Wetland ID</b>	W-MN18-PFO	<b>Crossing Start Date</b>	12/12/2023	<b>Crossing Completion Date</b>	12/21/2023
<b>Milepost</b>	188.80	<b>Pre-Con Assessment Date</b>	12/11/2023	<b>Post-Con Assessment Date</b>	12/22/2023
<b>Station</b>	9968+64	<b>Cowardin Classification</b>	PFO	<b>Wetland Impact Area(acres)</b>	0.1750
<b>State</b>	WV				
<b>County</b>	Monroe

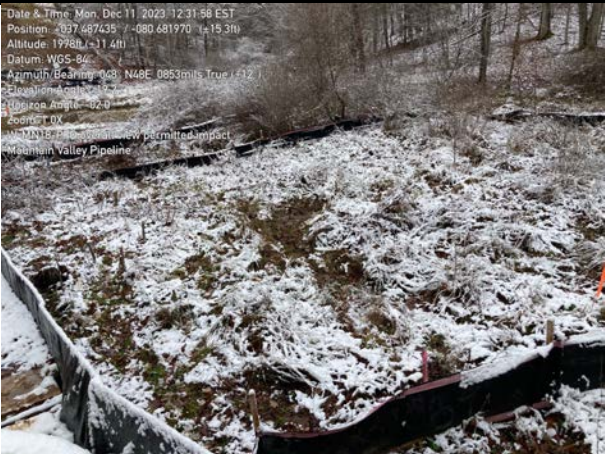
<p style="font-size: small; margin-top: 5px;">Date &amp; Time: Mon, Dec 11, 2023 12:31:58 EST Position: +037.487435, -080.681970 (+15.3ft) Altitude: 1798ft (+11.4ft) Datum: WGS-84 Azimuth Bearing: 093. N49E 0853mils True (+12) Elevation Angle: -02.9 Horizon Angle: -02.9 Zoom: 1.0X W-MN18-PFO overall view permitted impact Mountain Valley Pipeline</p>

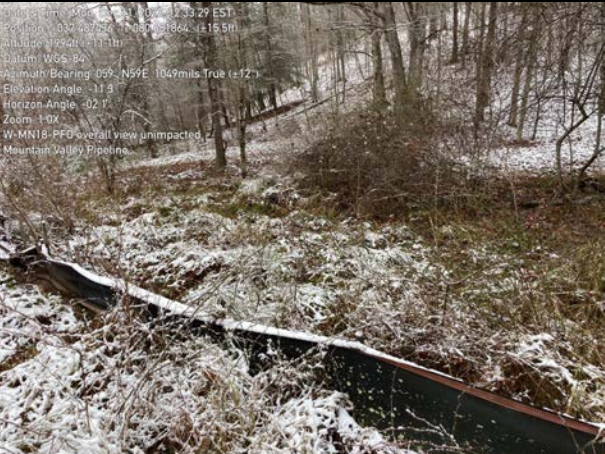
<p style="font-size: small; margin-top: 5px;">Date &amp; Time: Mon, Dec 11, 2023 12:33:27 EST Position: +037.487424, -080.681864 (+15.5ft) Altitude: 1992ft (+11.1ft) Datum: WGS-84 Azimuth Bearing: 099. N59E 1049mils True (+12) Elevation Angle: -11.3 Horizon Angle: -02.1 Zoom: 1.0X W-MN18-PFO overall view unimpacted Mountain Valley Pipeline</p>
<b>GPS Location</b> See Photo	<b>GPS Location</b> See Photo
<b>Description</b> View of permitted resource impact area during pre-construction assessment.	<b>Description</b> At edge of LOD, view of unimpacted resource area conditions during pre-construction assessment.

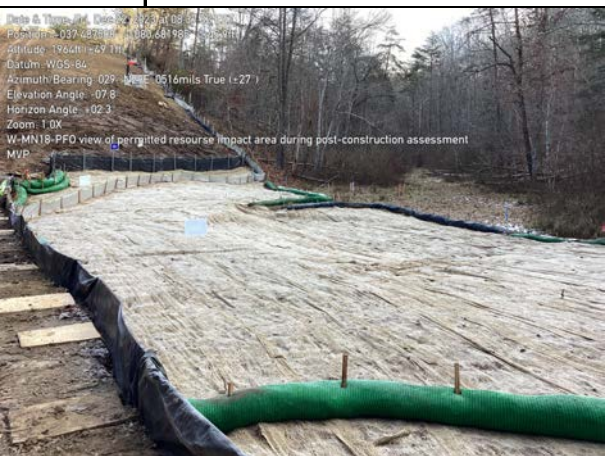
<p style="font-size: small; margin-top: 5px;">Date &amp; Time: Tue, Dec 12, 2023 11:08:52 AM EST Position: +037.487436, -080.682209 (+15.3ft) Altitude: 1924ft (+9.7ft) Datum: WGS-84 Azimuth Bearing: 029. N45E 0516mils True (+27) Elevation Angle: -07.8 Horizon Angle: -02.3 Zoom: 1.0X W-MN18-PFO view of permitted resource impact area during post-construction assessment MVP</p>

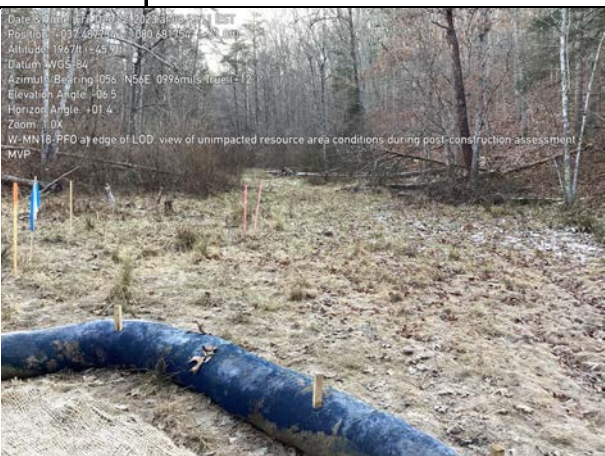
<p style="font-size: small; margin-top: 5px;">Date &amp; Time: Tue, Dec 12, 2023 11:09:31 AM EST Position: +037.487436, -080.681954 (+15.3ft) Altitude: 1927ft (+9.9ft) Datum: WGS-84 Azimuth Bearing: 025. N45E 0499mils True (+27) Elevation Angle: -08.5 Horizon Angle: -01.4 Zoom: 1.0X W-MN18-PFO at edge of LOD view of unimpacted resource area conditions during post-construction assessment MVP</p>
<b>GPS Location</b> See Photo	<b>GPS Location</b> See Photo
<b>Description</b> View of permitted resource impact area during post-construction assessment.	<b>Description</b> At edge of LOD, view of unimpacted resource area conditions during post-construction assessment.

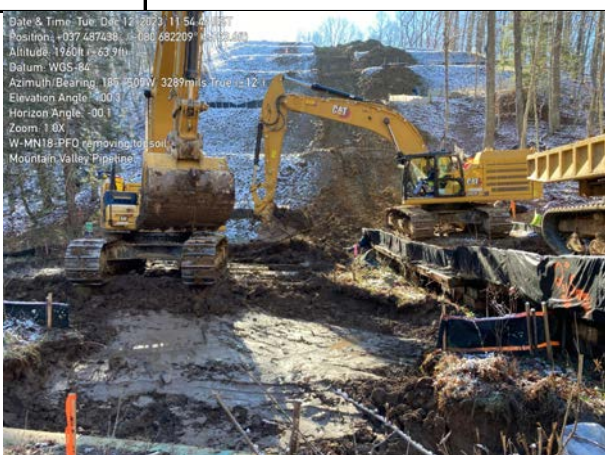
12/12/2023 - Timber mats put in place for excavating. Removed top 12 inches of topsoil (Photo 1) and used Morooka to transport to separate upland containment area. Drilled for blasting. Drilling suspended due to dust.

<p style="font-size: small; margin-top: 5px;">Date &amp; Time: Tue, Dec 12, 2023 11:54:40 AM EST Position: +037.487436, -080.682209 (+15.3ft) Altitude: 1948ft (+9.9ft) Datum: WGS-84 Azimuth Bearing: 189. S07W 3289mils True (+12) Elevation Angle: -00.1 Horizon Angle: -00.1 Zoom: 1.0X W-MN18-PFO removing topsoil Mountain Valley Pipeline</p>

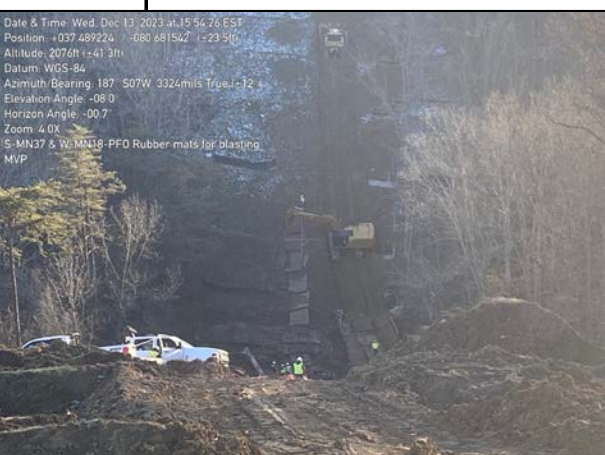
12/13/2023 - Prepped for blasting through aquatic resource area. Drilled for blasting. Mats put in place for blasting (Photo 2). Blasted.

<p style="font-size: small; margin-top: 5px;">Date &amp; Time: Wed, Dec 13, 2023 at 15:54:26 EST Position: +037.489224, -080.681542 (+23.5ft) Altitude: 2071ft (+0.13ft) Datum: WGS-84 Azimuth Bearing: 187. S07W 3324mils True (+12) Elevation Angle: -08.0 Horizon Angle: -00.7 Zoom: 4.0X S-MN37 &amp; W-MN18-PFO Rubber mats for blasting MVP</p>
<b>GPS Location</b> See Photo	<b>GPS Location</b> See Photo
<b>Description</b> Photo 1: Excavating top 12 inches of topsoil.	<b>Description</b> Photo 2: Rubber mats in place in aquatic resource for blasting.
