# Stream Biological Conditions EA Report

<b>Project Name</b>	H-600 Pipeline Spread D	<b>AFE</b>	124300132	<b>Spread</b>	H-600 Pipeline Spread D
<b>Contractor</b>	Precision	<b>Report #</b>	500		
<b>Environmental Auditor</b>	Jeffrey Arbogast	<b>Date/Time</b>	2/6/2024 2:45 PM		
<b>Stream ID</b>	S-A65	<b>Crossing Start Date</b>	2/6/2024	<b>Crossing Completion Date</b>	2/12/2024
<b>Milepost</b>	116.35	<b>Pre-Con Assessment Date</b>	2/6/2024	<b>Post-Con Assessment Date</b>	2/13/2024
<b>Station</b>	6143+24	<b>Bankfull Width (ft.)</b>	70.0	<b>Riffle:Pool Complexes Present?</b>	No
<b>State</b>	WV	<b>Stream Classification</b>	Perennial		
<b>County</b>	Nicholas	<b>303(d) Impairment Listing</b>	No

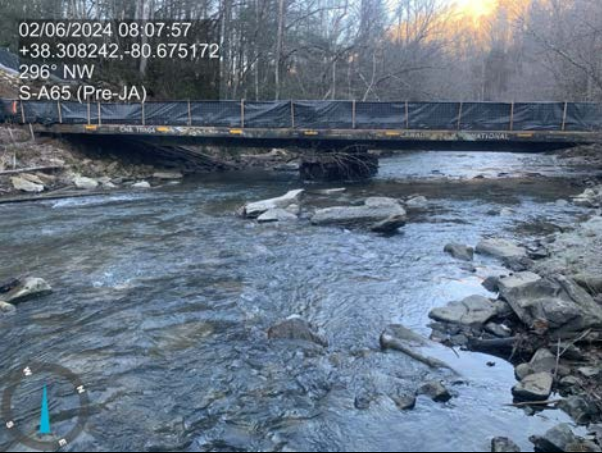
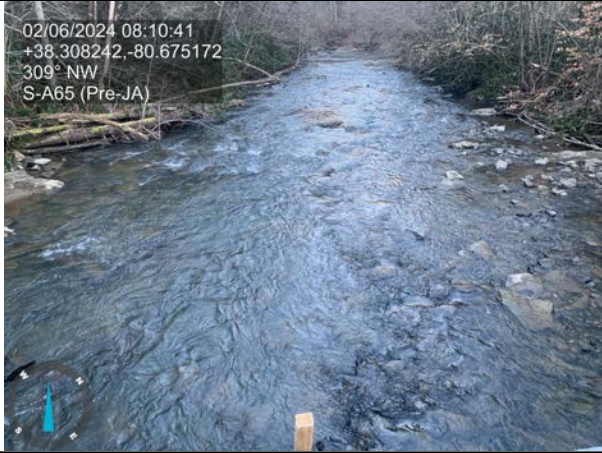
<b>GPS Location</b>	See Caption in Photo.		<b>GPS Location</b>	See Caption in Photo.	
<b>Description</b>	Downstream view of permitted impact area during pre-construction assessment.		<b>Description</b>	Downstream view of unimpacted area during pre-construction assessment.

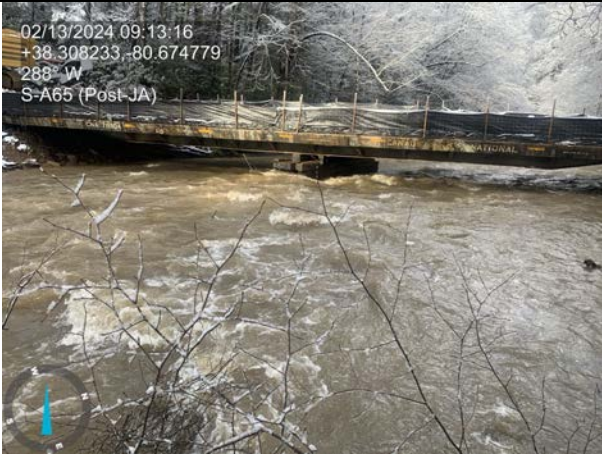
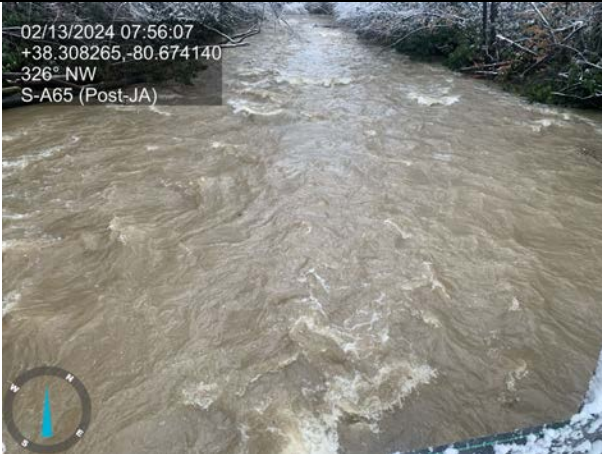
<b>GPS Location</b>	See Caption in Photo.		<b>GPS Location</b>	See Caption in Photo.	
<b>Description</b>	Downstream view of permitted impact area during post-construction assessment.		<b>Description</b>	Downstream view of unimpacted area during post-construction assessment.

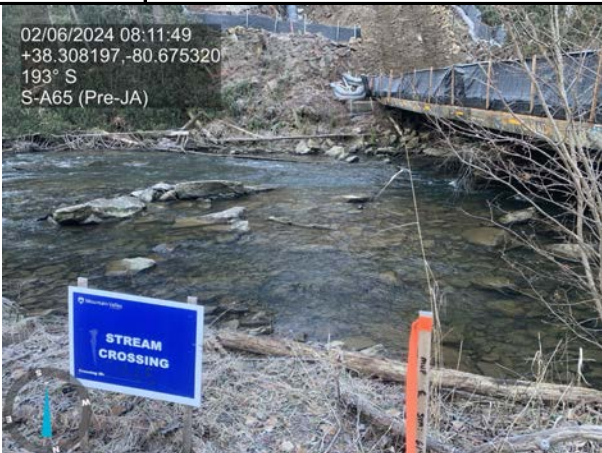
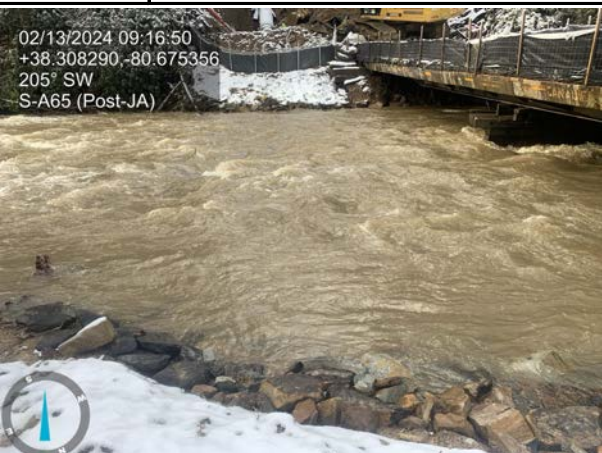
<b>GPS Location</b>	See Caption in Photo.		<b>GPS Location</b>	See Caption in Photo.	
<b>Description</b>	View from CIS standing on centerline, pre-construction.		<b>Description</b>	View from CIS standing near centerline, post-construction.

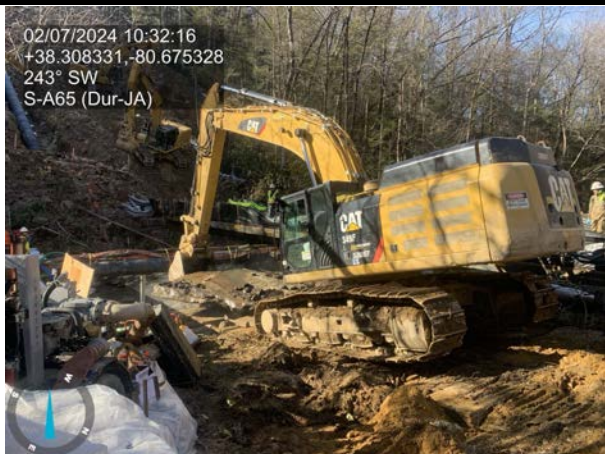
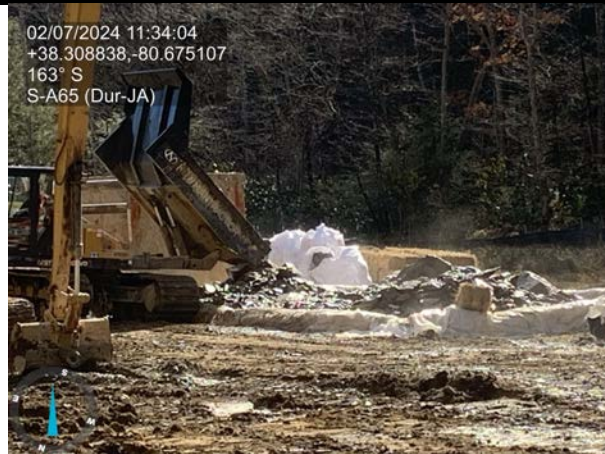
<p>02/07/2024 10:32:16 +38.308331,-80.675328 243° SW S-A65 (Dur-JA)</p>

<b>GPS Location</b>	See Caption in Photo.	<b>GPS Location</b>	See Caption in Photo.
<b>Description</b>	Large rocks being removed from stream individually.	<b>Description</b>	Stream substrate being stored in a plastic lined containment.
<p>02/08/2024 18:15:02 +38.308690,-80.675193 216° SW S-A65 (Dur-JA)</p>

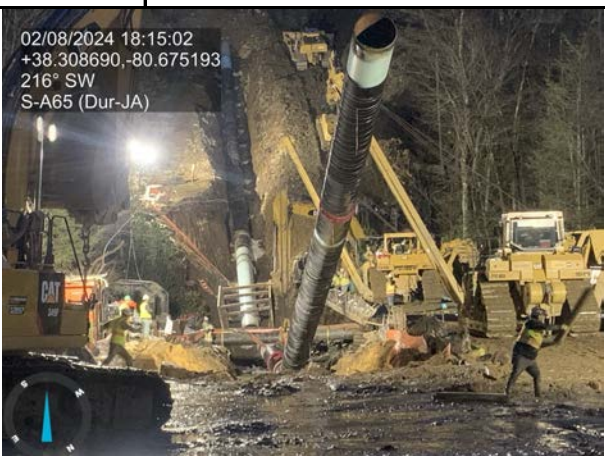
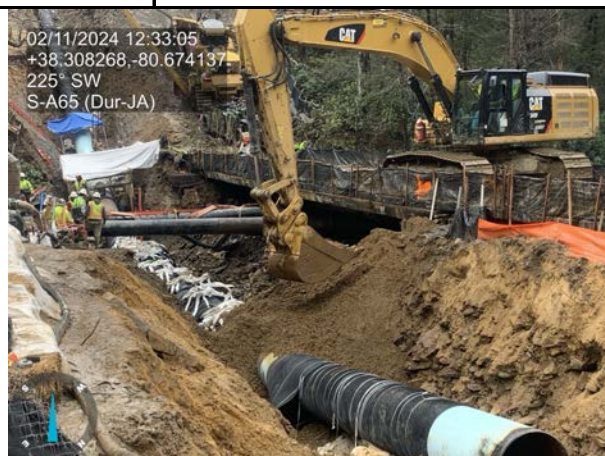
<p>02/11/2024 12:33:05 +38.308268,-80.674137 225° SW S-A65 (Dur-JA)</p>

<b>GPS Location</b>	See Caption in Photo.	<b>GPS Location</b>	See Caption in Photo.
<b>Description</b>	Lowering in the stream section.	<b>Description</b>	Backfilling
<p>02/12/2024 13:08:42 +38.308180,-80.675119 63° NE S-A65 (Dur-JA)</p>

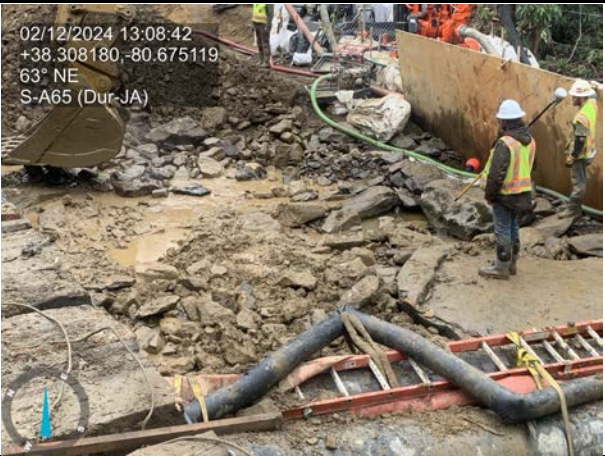
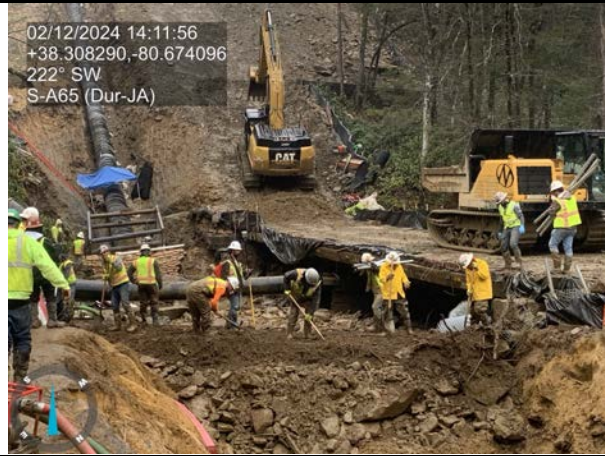
<p>02/12/2024 14:11:56 +38.308290,-80.674096 222° SW S-A65 (Dur-JA)</p>

<b>Description</b>	Survey overseeing large rock placement and substrate installation.	<b>Description</b>	ECDs being installed on CIS 10' buffer area.
