Stream Biological Conditions EA Report

Project Name	H-600 Pipeline Spread D	AFE	124300132	Spread	H-600 Pipeline Spread D
Contractor	Precision	Report #	497		
Environmental Auditor	Scott Wessel	Date/Time	2/5/2024 8:26 AM		
Stream ID	S-A67	Crossing Start Date	2/5/2024	Crossing Completion Date	2/17/2024
Milepost	115.63	Pre-Con Assessment Date	2/2/2024	Post-Con Assessment Date	2/18/2024
Station	6105+01	Bankfull Width (ft.)	7.0	Riffle:Pool Complexes Present?	No
State	WV	Stream Classification	Perennial		
County	Nicholas	303(d) Impairment Listing	No

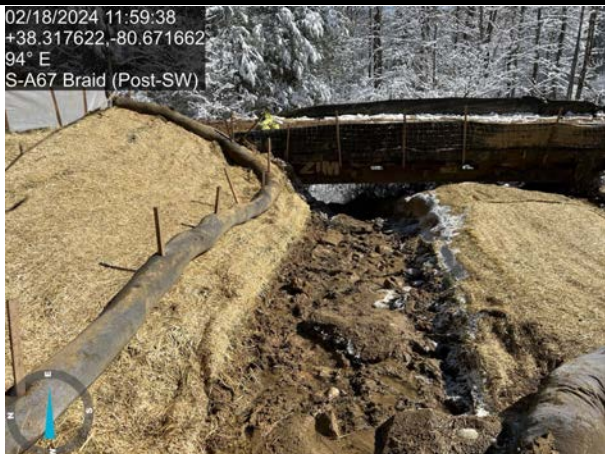
<p>02/18/2024 11:59:38 +38.317622,-80.671662 94° E S-A67 Braid (Post-SW)</p>

GPS Location See coordinates in above photo.	GPS Location See coordinates in above photo.
Description Downstream view of permitted impact area (S-A67 Braid) during post-construction assessment.	Description Downstream view of unimpacted area (S-A67 Braid) during post-construction assessment.
<p>02/15/2024 14:09:27 +38.317300,-80.671644 29° NE S-A67 (Dur-SW)</p>

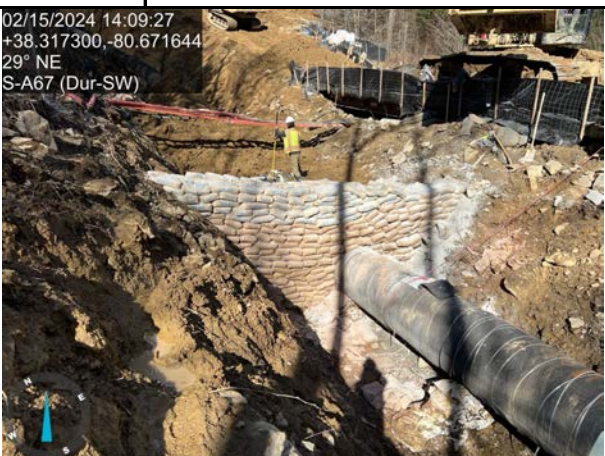
GPS Location See coordinates in above photo.	GPS Location See coordinates in above photo.
Description Trench breakers being constructed on the GAS of feature.	Description Welding activities occurring once pipe section was lowered into ditch.
<p>02/18/2024 12:01:22 +38.317523,-80.671530 251° W S-A67 (Post-SW)</p>

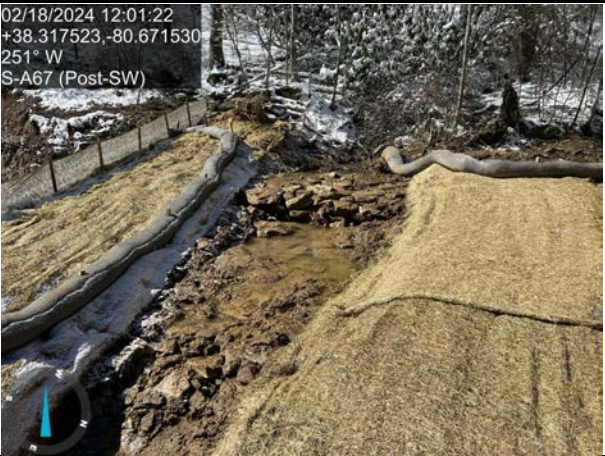
GPS Location See coordinates in above photo.	GPS Location See coordinates in above photo.
Description Upstream view of restored area with erosion blanket, filter sock, and silt fence for S-A67.	Description Upstream view of restored area with erosion blanket, filter sock, and silt fence for S-A67 Braid.
