Stream Biological Conditions EA Report

Project Name	H-600 Pipeline Spread D	AFE	124300132	Spread	H-600 Pipeline Spread D
Contractor	Precision	Report #	489		
Environmental Auditor	Todd Grant	Date/Time	1/30/2024 6:19 PM		
Stream ID	S-I37	Crossing Start Date	1/30/2024	Crossing Completion Date	2/2/2024
Milepost	125.67	Pre-Con Assessment Date	1/25/2024	Post-Con Assessment Date	2/7/2024
Station	6635+55	Bankfull Width (ft.)	6.0	Riffle:Pool Complexes Present?	No
State	WV	Stream Classification	Ephemeral		
County	Nicholas	303(d) Impairment Listing	No

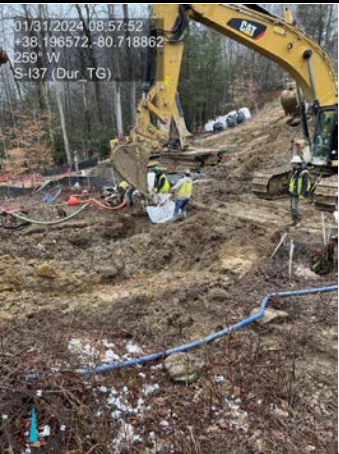
GPS Location See top left corner for GPS location	GPS Location See top left corner for GPS location
Description View of stream substrate being segregated in super sacks.	Description View of pipe being lowered in at stream S-I37.

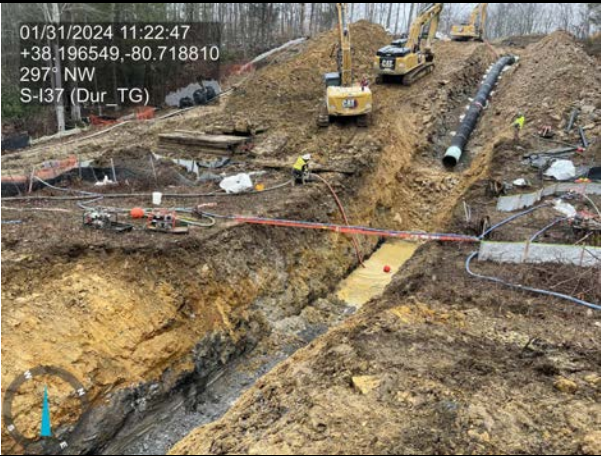
GPS Location See top left corner for GPS location	GPS Location See top left corner for GPS location
Description View of ditch dewatering pumps being maintained.	Description View of trench breaker construction at stream S-I37 GAS.

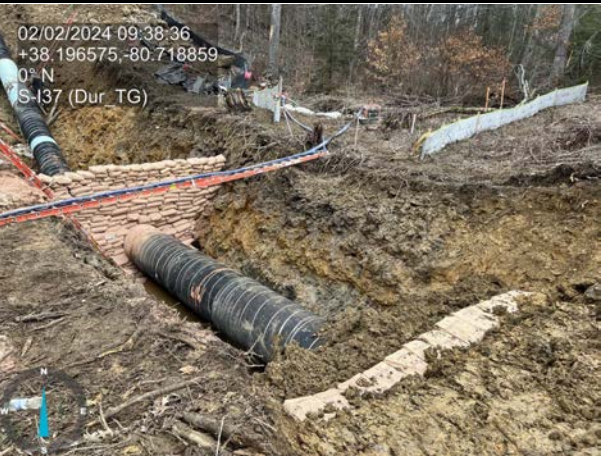
GPS Location See top left corner for GPS location	GPS Location See top left corner for GPS location
Description View of trench breakers on either side of the stream.	Description View of the contractor contouring stream banks to the surveyed elevations.
