Stream Biological Conditions EA Report

Project Name	H-600 Pipeline Spread F	AFE	124300135	Spread	H-600 Pipeline Spread F
Contractor	Price Gregory	Report #	432		
Environmental Auditor	Jessica Yeager	Date/Time	12/11/2023 11:43 AM		
Stream ID	S-KL29	Crossing Start Date	12/29/2023	Crossing Completion Date	1/24/2024
Milepost	170.00	Pre-Con Assessment Date	12/11/2023	Post-Con Assessment Date	1/24/2024
Station	8976+00	Bankfull Width (ft.)	44.0	Riffle:Pool Complexes Present?	No
State	WV	Stream Classification	Perennial		
County	Summers	303(d) Impairment Listing	No

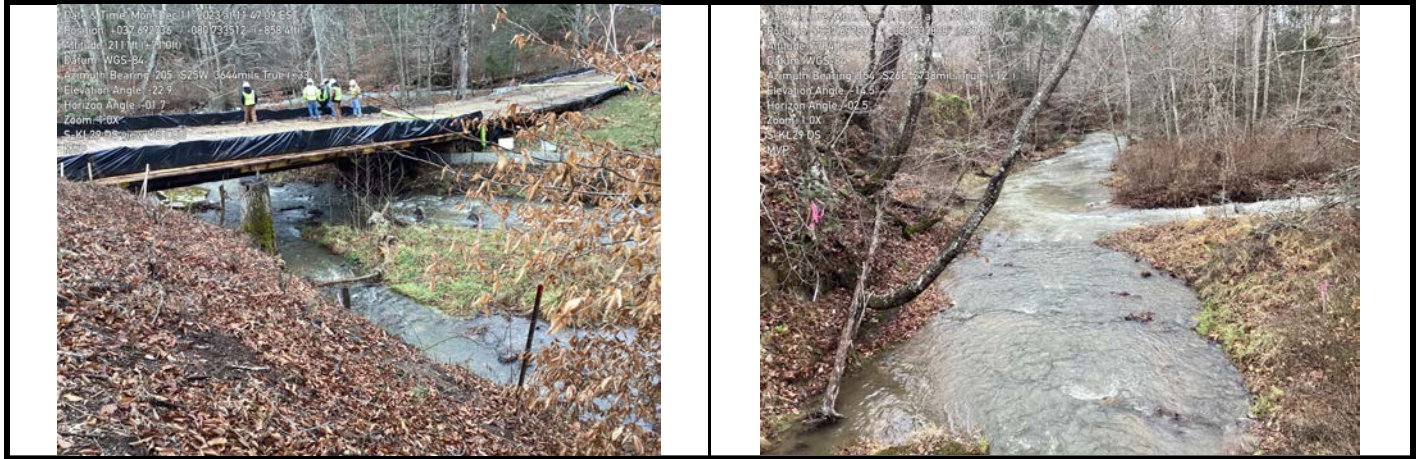
GPS Location	See Photo	GPS Location	See Photo
Description	Downstream view of permitted impact area during pre-construction assessment.	Description	Downstream view of unimpacted area during pre-construction assessment.

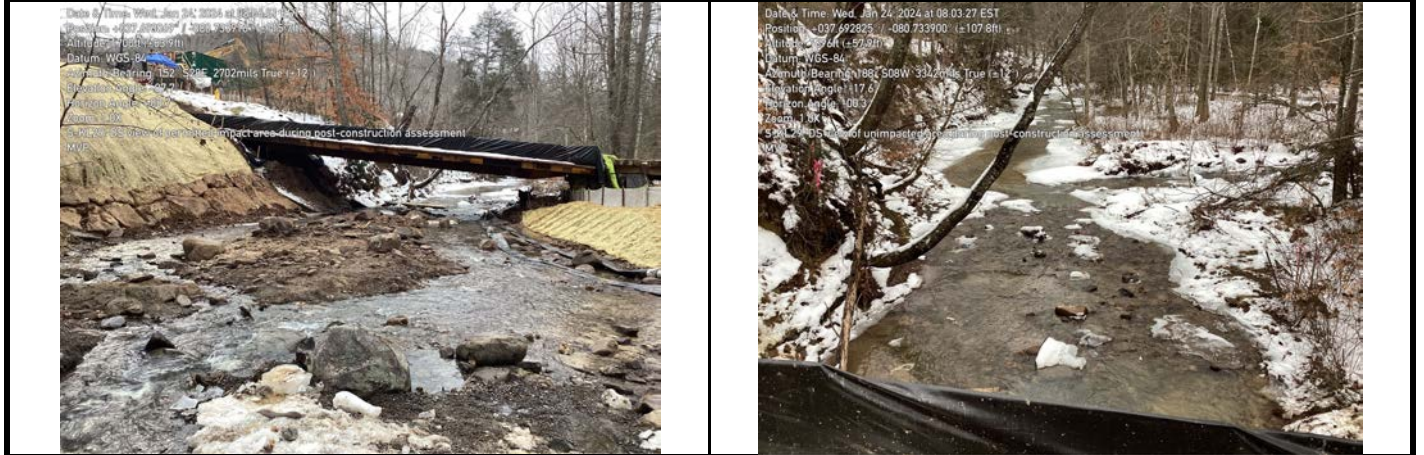
GPS Location	See Photo	GPS Location	See Photo
Description	Downstream view of permitted impact area during post-construction assessment.	Description	Downstream view of unimpacted area during post-construction assessment.

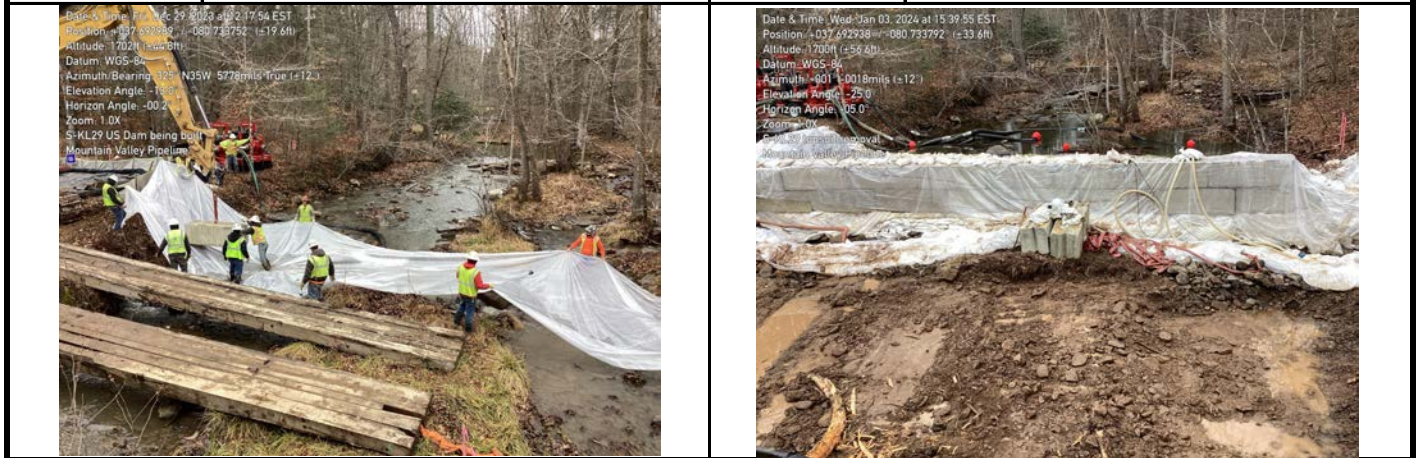
GPS Location	See Photo	GPS Location	See Photo
Description	Photo 1: Constructing upstream dam.	Description	Photo 2: Top 12 inches of substrate removed from aquatic resource.
