August 28, 2024

Mr. Robert Burrough  
Director, Eastern Region  
Pipeline and Hazardous Materials Safety Administration  
840 Bear Tavern Road  
Suite 300  
West Trenton, New Jersey, 08628

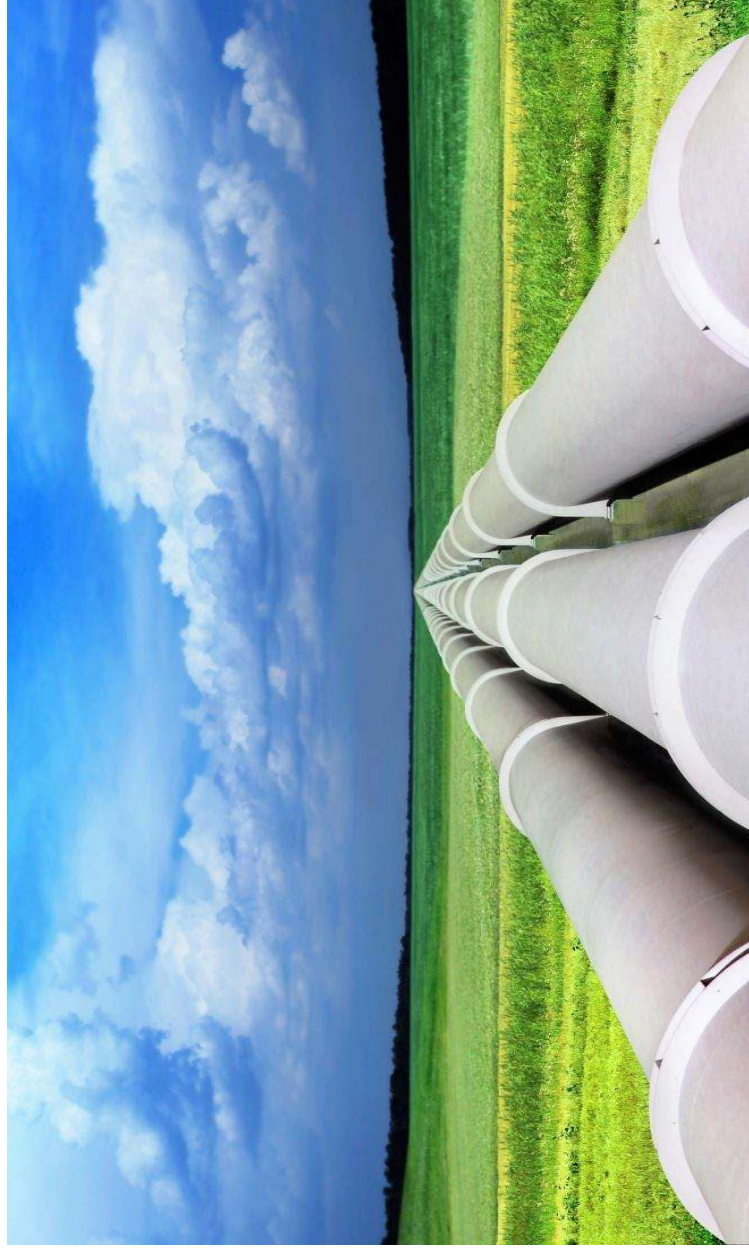
Report No: E-AD-LI / GTQU (10513119)  
August 1, 2024

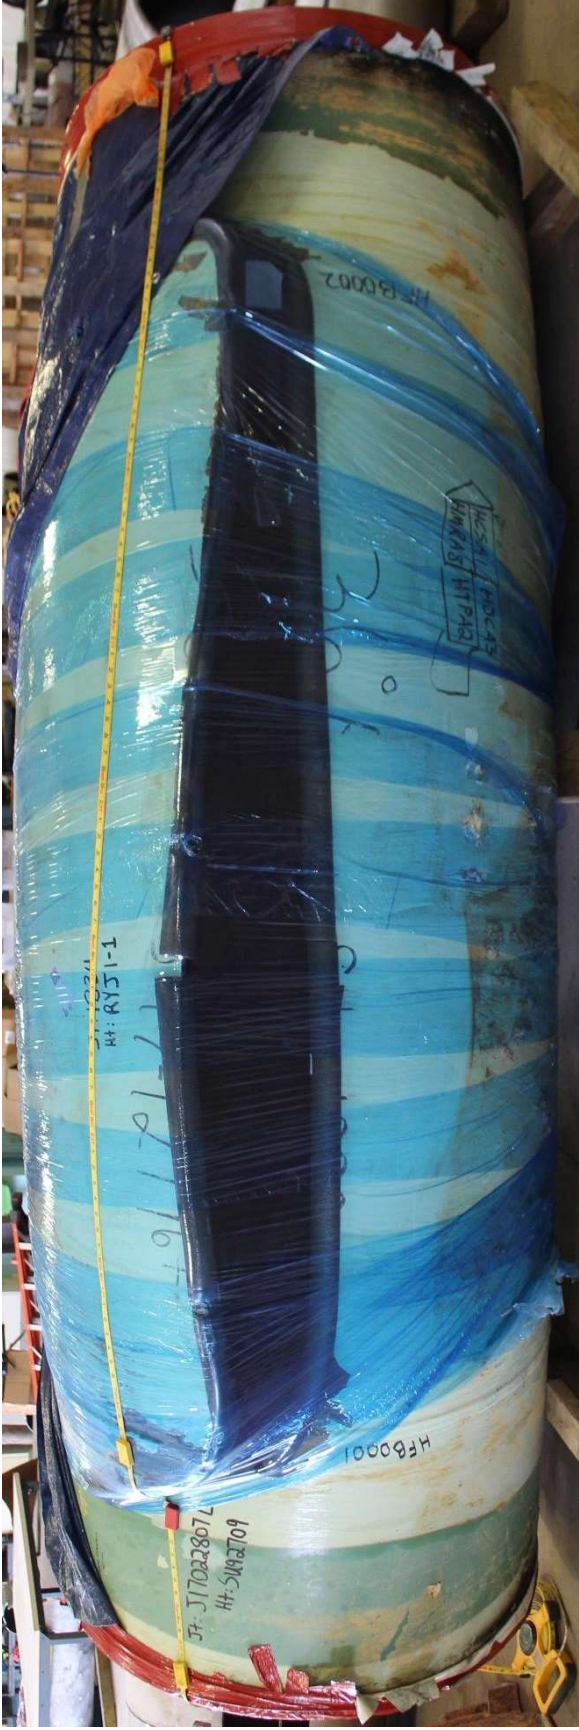
Figure 1. Photograph of the pipe section as received at DNV, after unloading. The pipe section was wrapped with plastic and tarps, with the ends sealed. The fracture surfaces were protected with foam tubing construction, various labels were written on the external pipe surface, such as "Jt: J17022807H HT: SU92709, upstream, HFB0002, HCSA1, HJCA3, HMRA8, HTPA2, 36°, Jt: 1834 Ht: RYJ1-1, HFB0001, Jt: J17022807L Ht: SU92709, downstream, TDC, Jeeped 7-17-18, 2 of 3 JT sec, .740 36°".

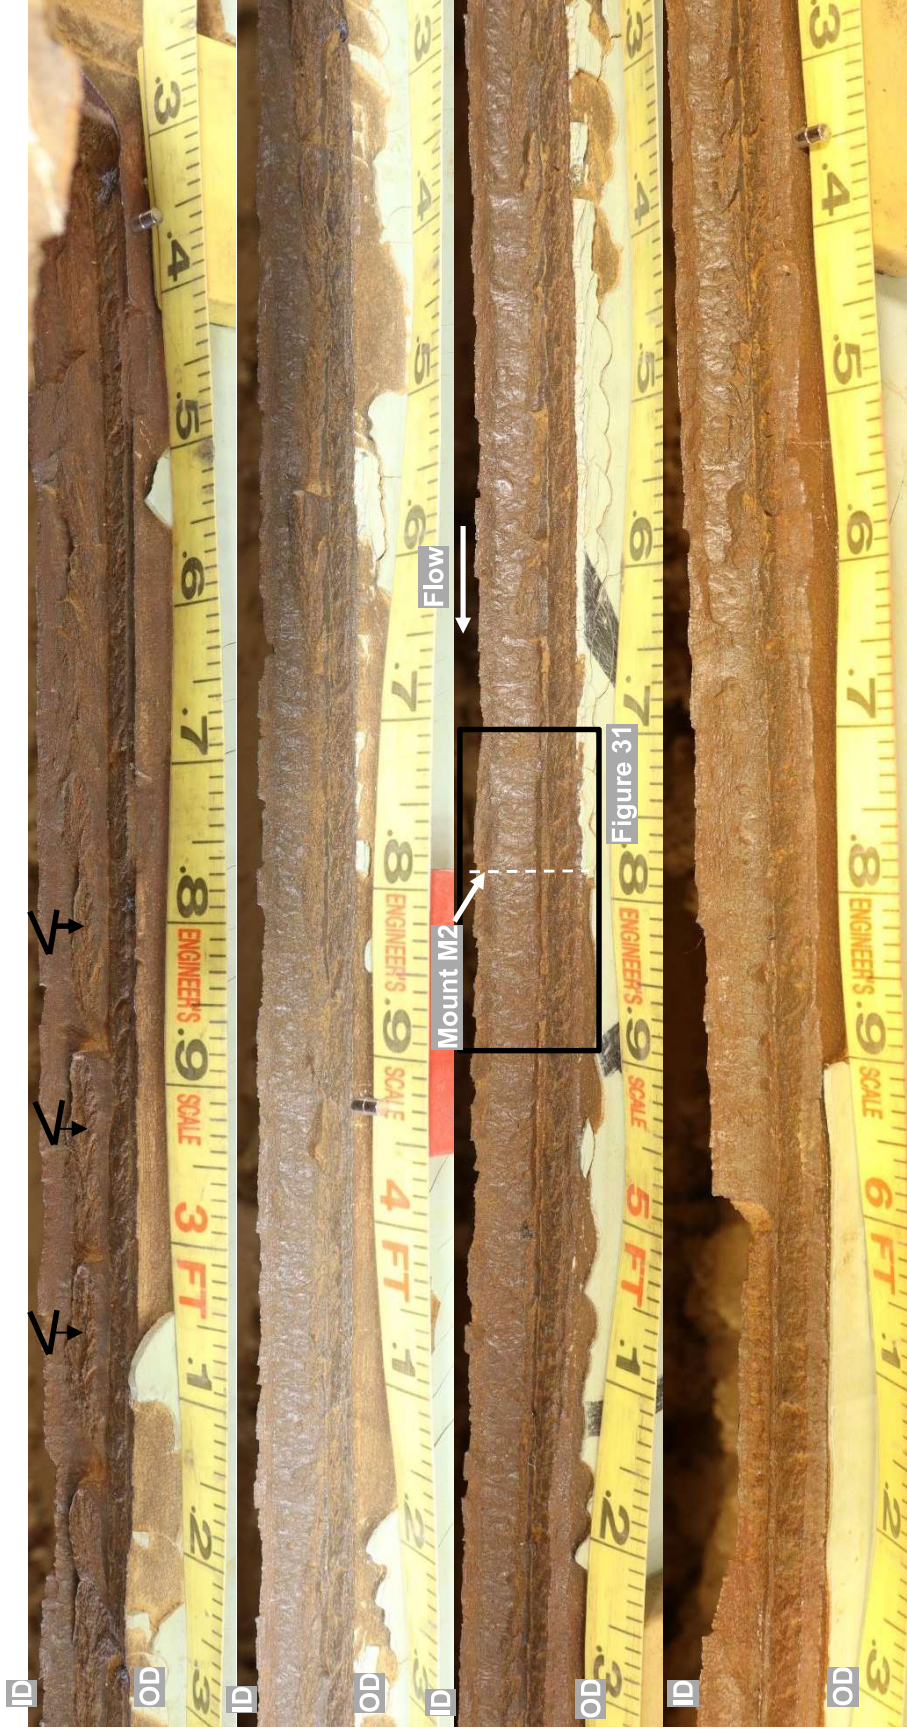
Figure 5. Photographs (4) of the fracture surface counter clockwise (CCW) of the rupture opening from 2.3 to 6.3 feet from the U/S end of the pipe section; area indicated in Figure 2. The tape measure indicates the distance from the U/S end of the pipe section. Chevrons are located on the top photograph indicating that the origin was D/S of that location (3.1 feet D/S from the U/S end of the pipe section). No obvious pre-existing flaws were observed on the fracture surface.

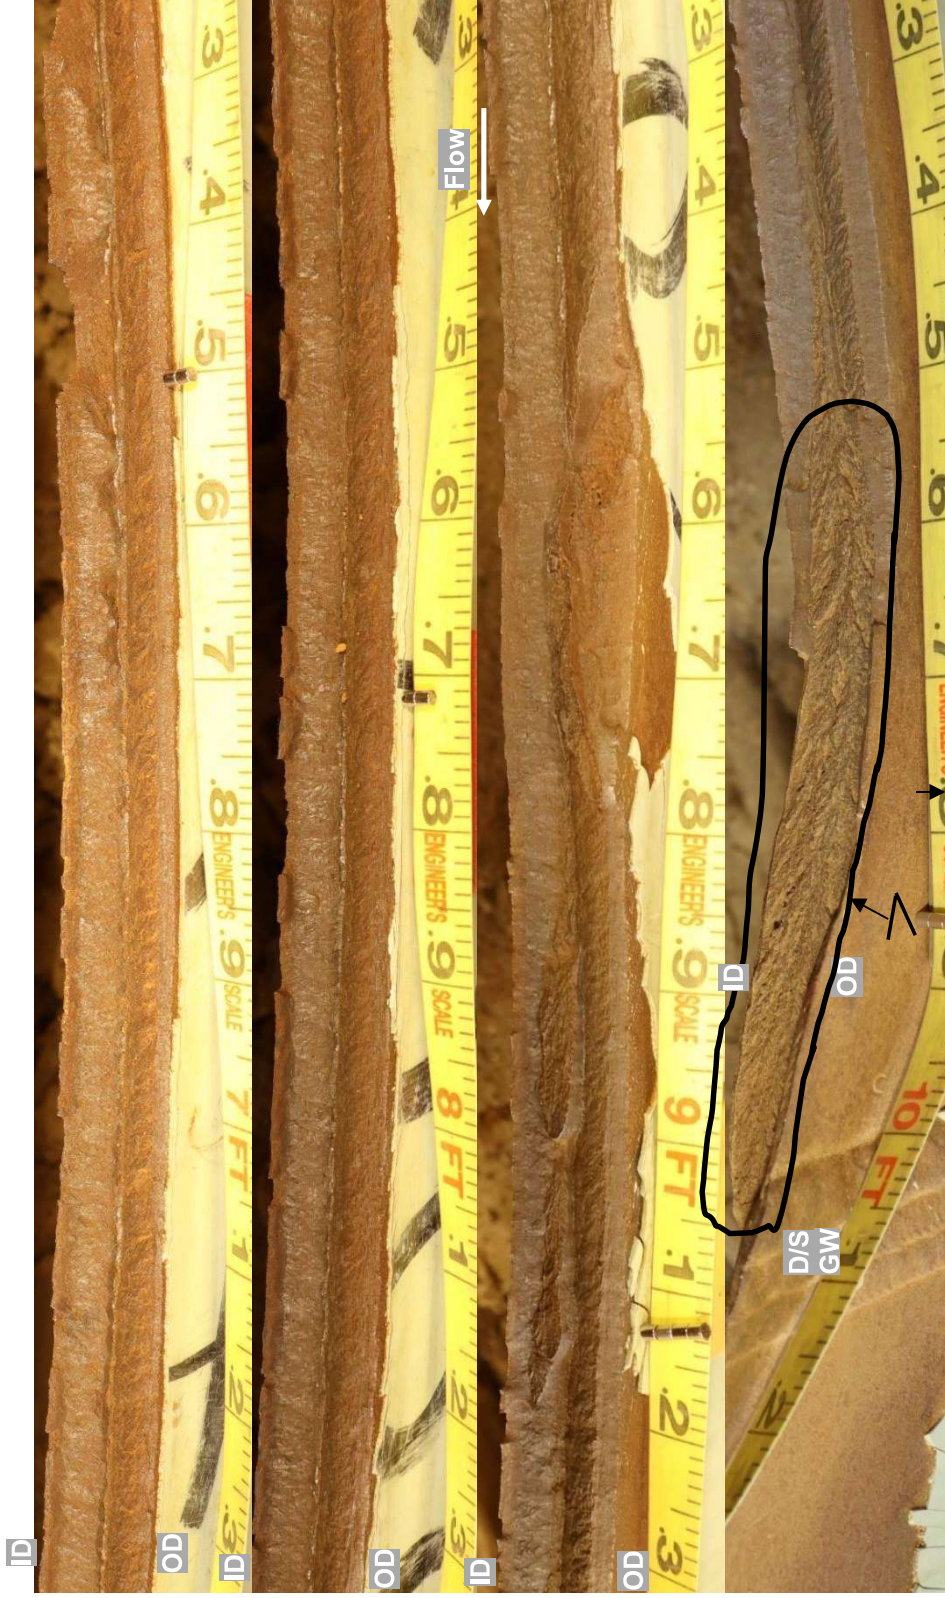
Figure 6. Photographs of the fracture surface CCW of the rupture opening from 6.3 to 10.1 feet from the U/S end of the pipe section; area indicated in Figure 2. The tape measure indicates the distance from the U/S end of the pipe section. Chevrons are located in the bottom two photographs indicating that the origin was U/S of 8.9 feet from the U/S end of the pipe section, indicating the origin is between 3.1 and 8.9 feet from the U/S end of the pipe section, near the middle of the elbow fitting. No obvious pre-existing flaws were observed on the fracture surface. Overall, the fracture surfaces had a similar profile for the entire length where midwall was further away from the camera compared to the OD and ID surfaces. Additionally, the fracture surfaces are slightly rough to macroscopically smooth, except for a few places near the ends of the fracture surfaces.

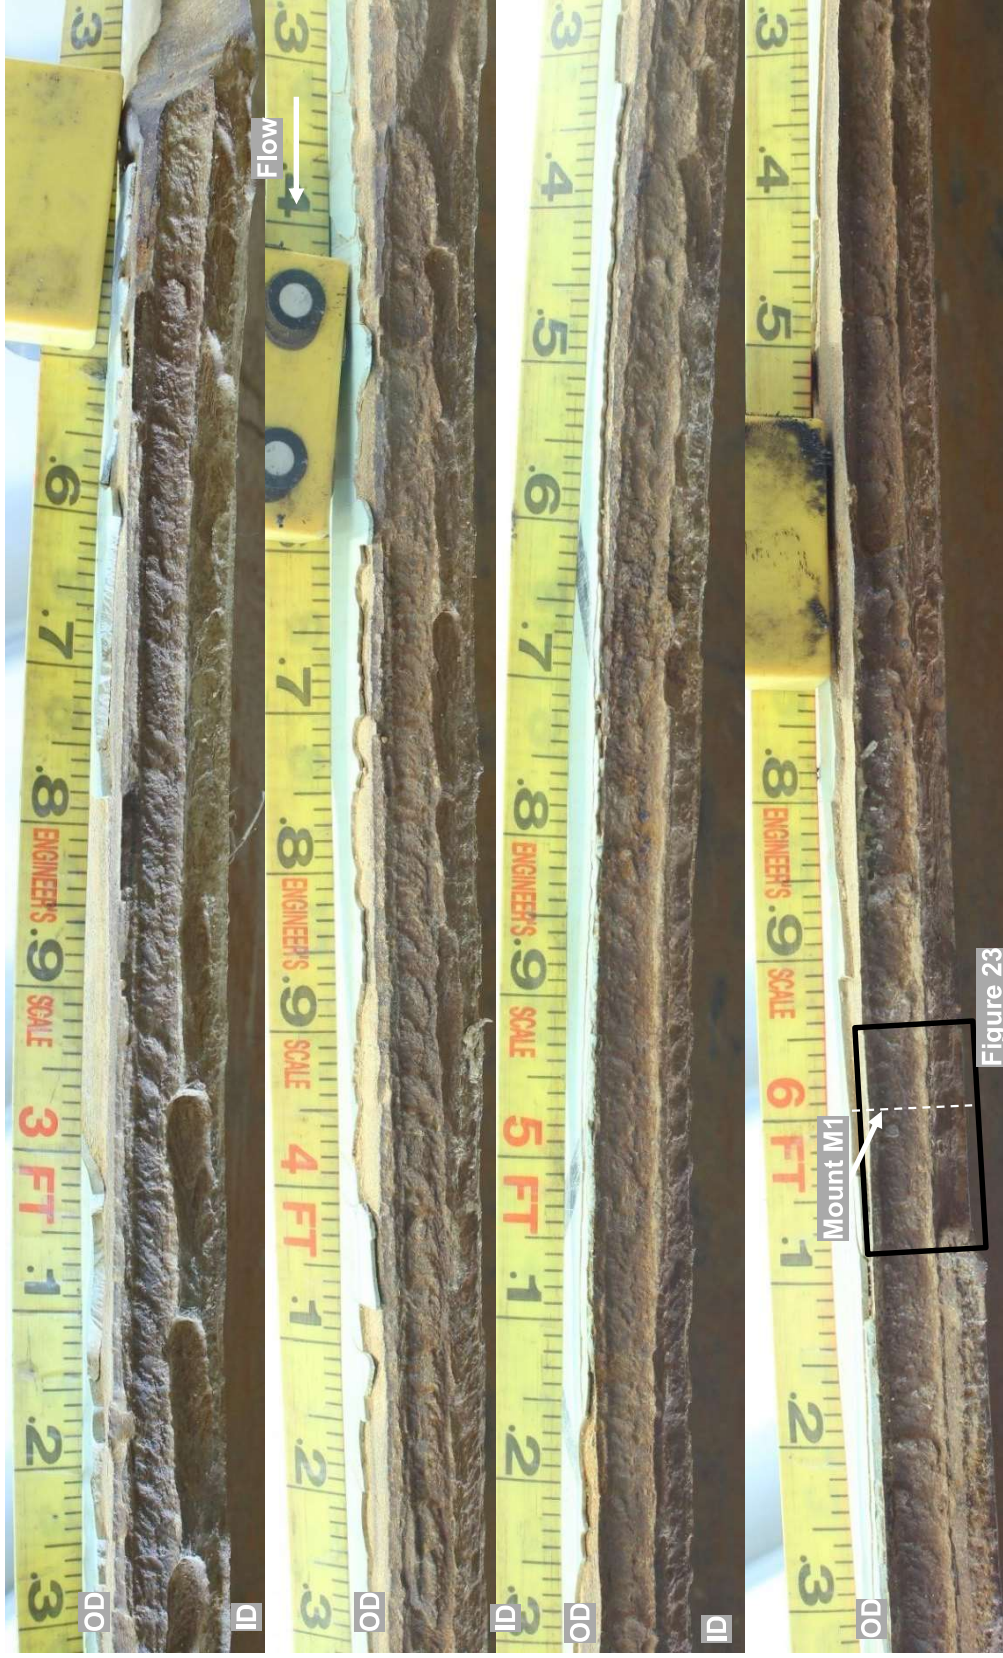
Figure 7. Photographs of the fracture surface clockwise (CW) of the rupture opening from 2.3 to 6.3 feet from the U/S end of the pipe section. The tape measure indicates the distance from the U/S end of the pipe section. The fracture morphology is similar to the CCW fracture surface expect more topography is visible due to the lighting.

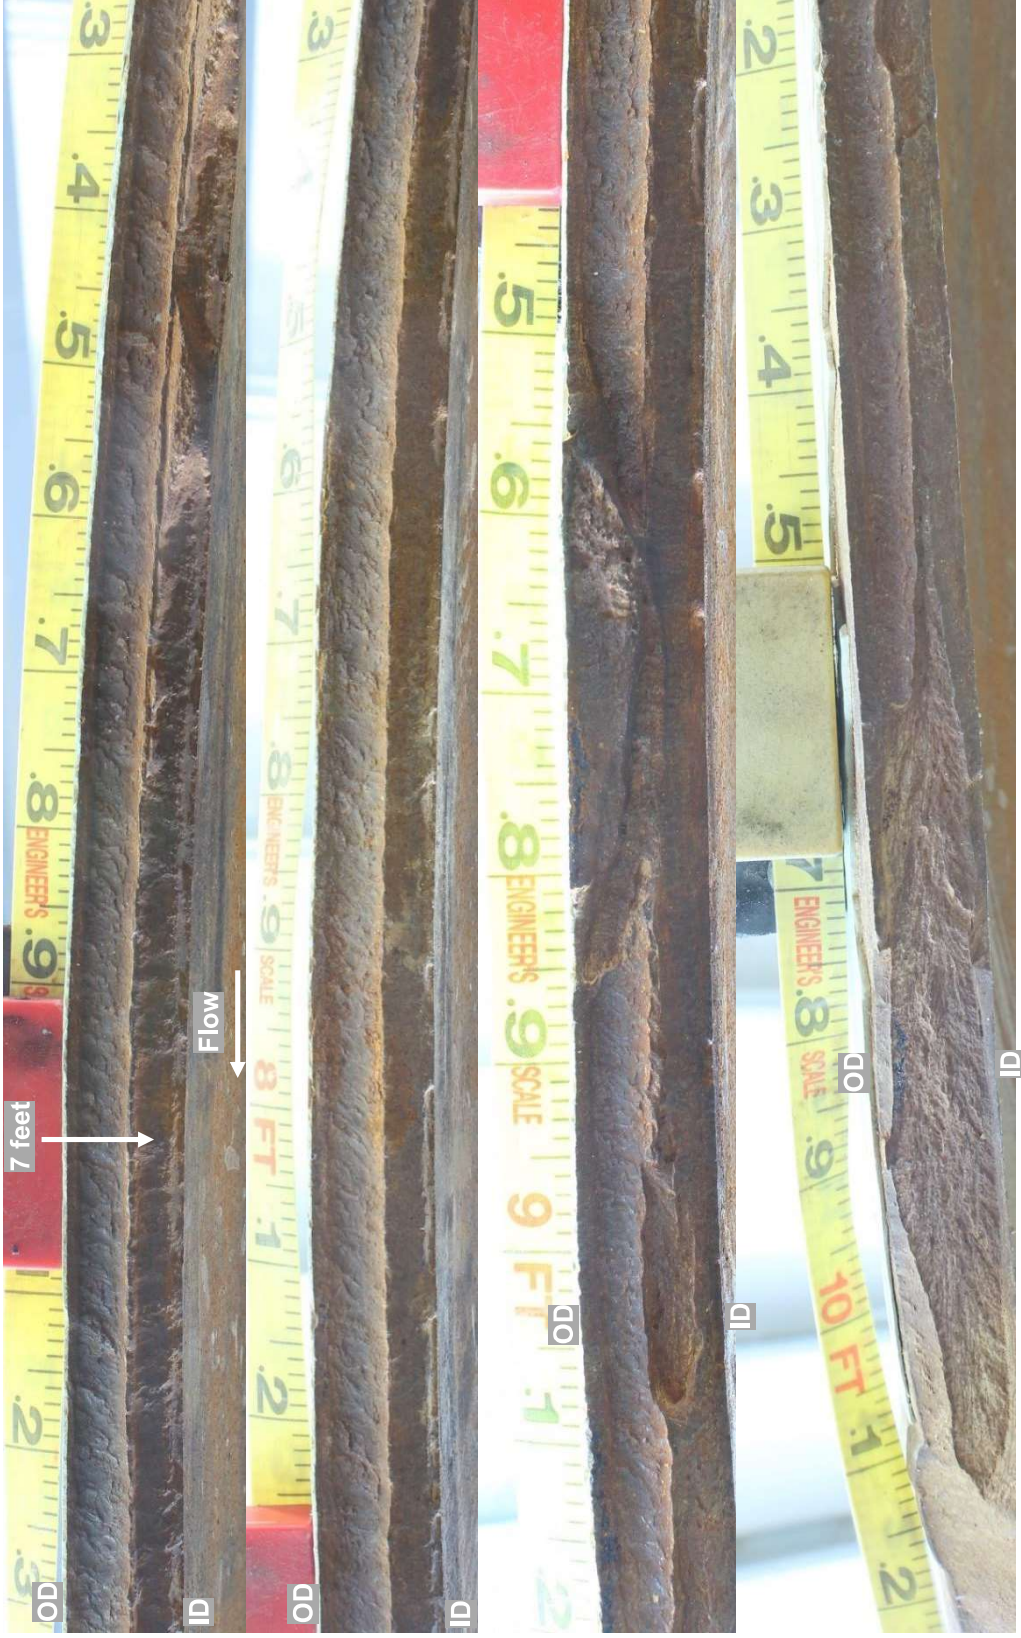
Figure 8. Photographs of the fracture surface CW of the rupture opening from 6.3 to 10.2 feet from the U/S end of the pipe section. The tape measure indicates the distance from the U/S end of the pipe section. The fracture morphology is similar to the CW fracture surface expect more topography is visible due to the lighting.

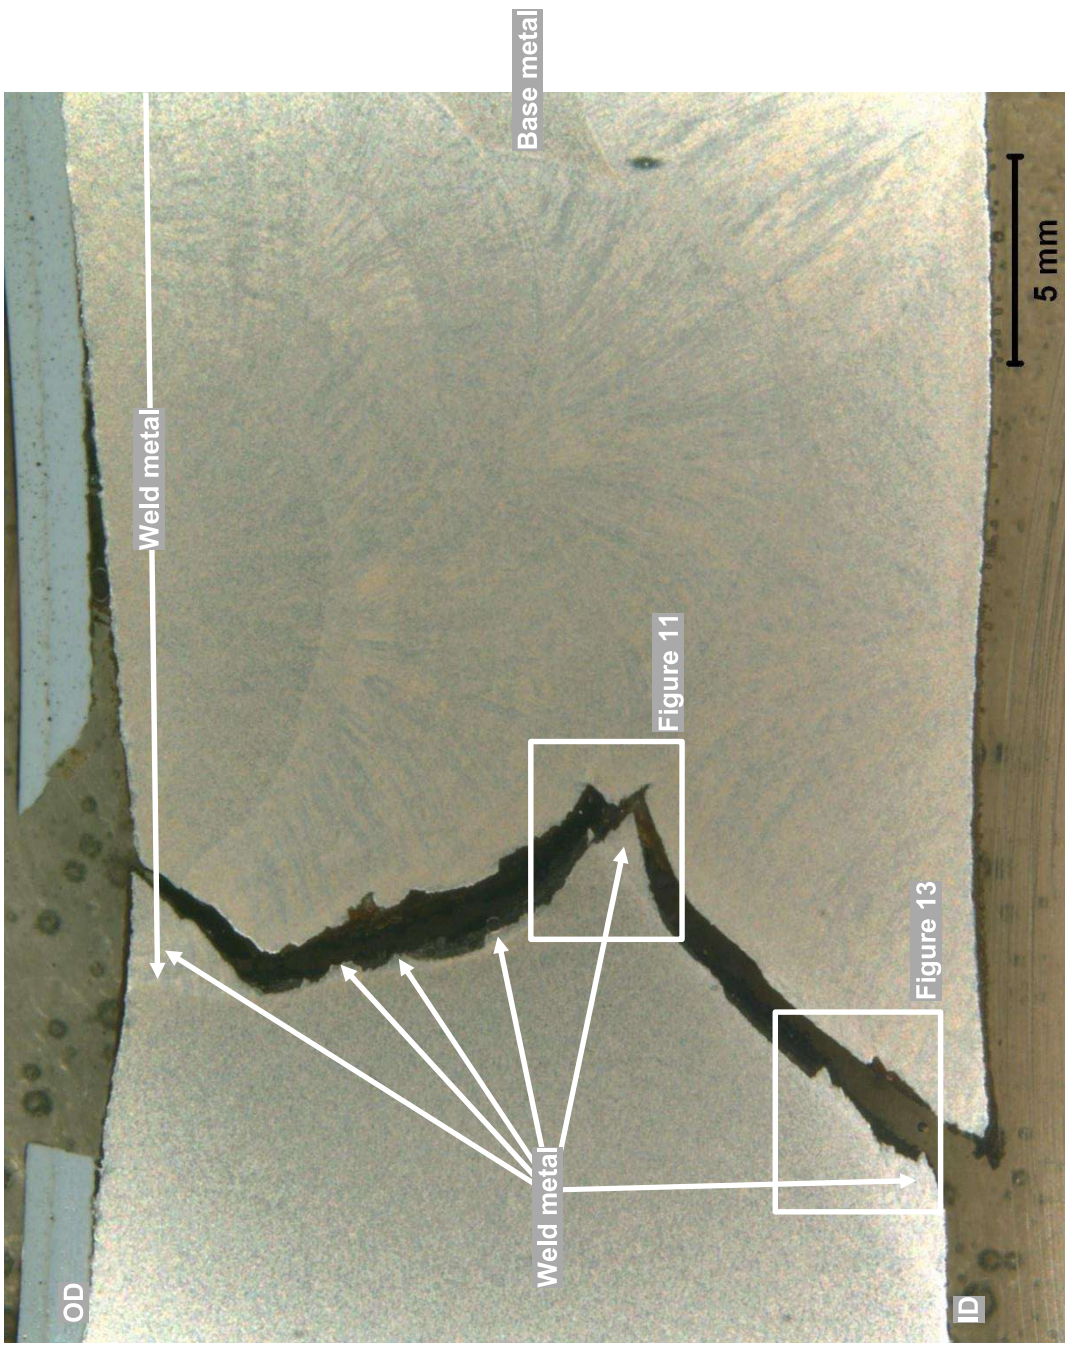
Figure 10. Light photomicrograph of transverse Mount M1 showing the fracture surfaces in cross-section (2% Nital Etchant); area indicated in Figure 9. There appears to be 5 (or 6) weld passes made from the OD surface and 2 from the ID surface with the ID passes being deposited first. The figure shows that the crack path is through the weld metal at the OD surface, ID surface, and midwall, and located at or near the fusion boundary elsewhere. Most of the material is base metal left of the fracture path and weld metal right of the fracture path.

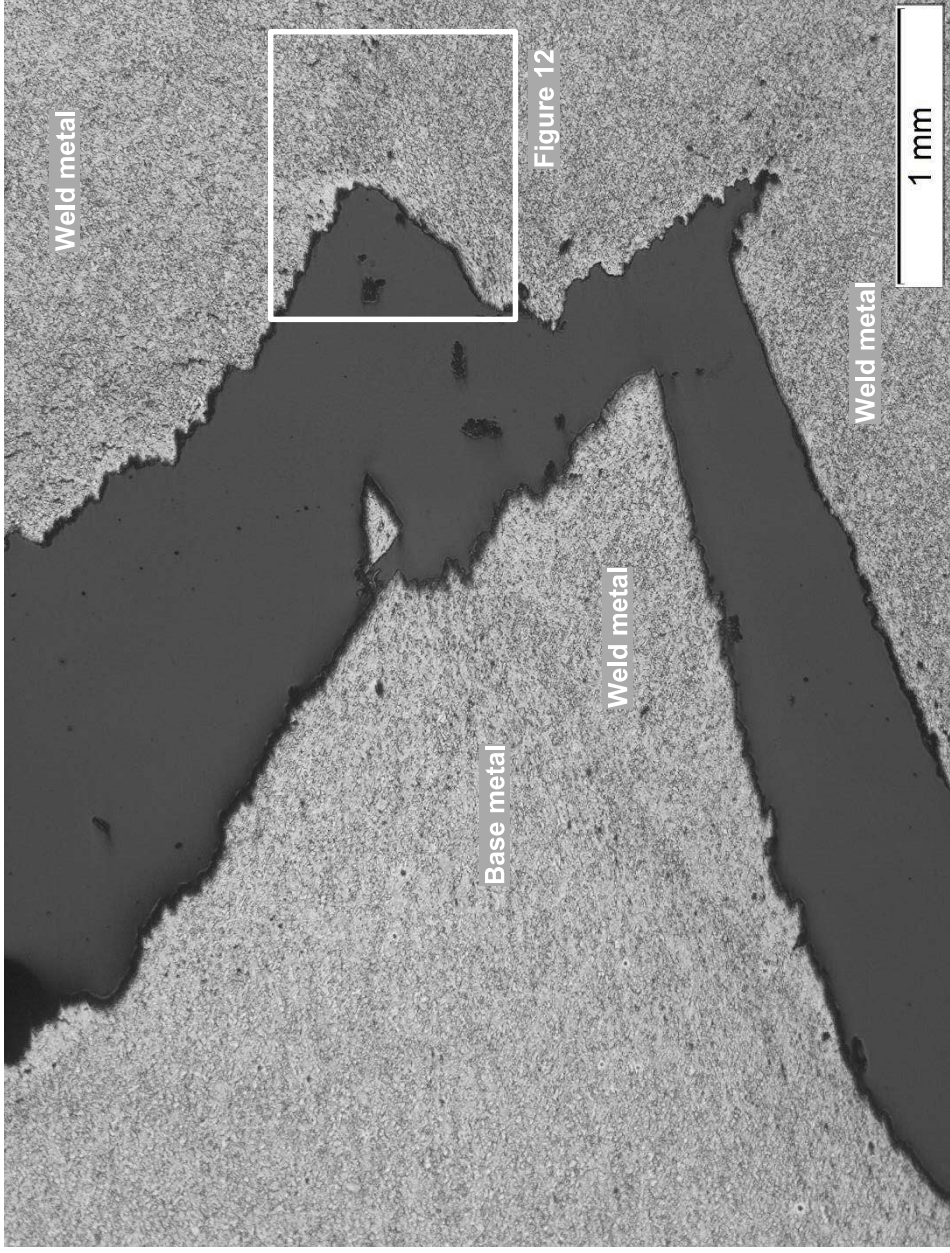
Figure 11. Light photomicrograph of Mount M1 midwall (2% Nital Etchant); area indicated in Figure 10. The figure shows where a portion of the path is through the weld metal and the remainder is at or near the fusion boundary.

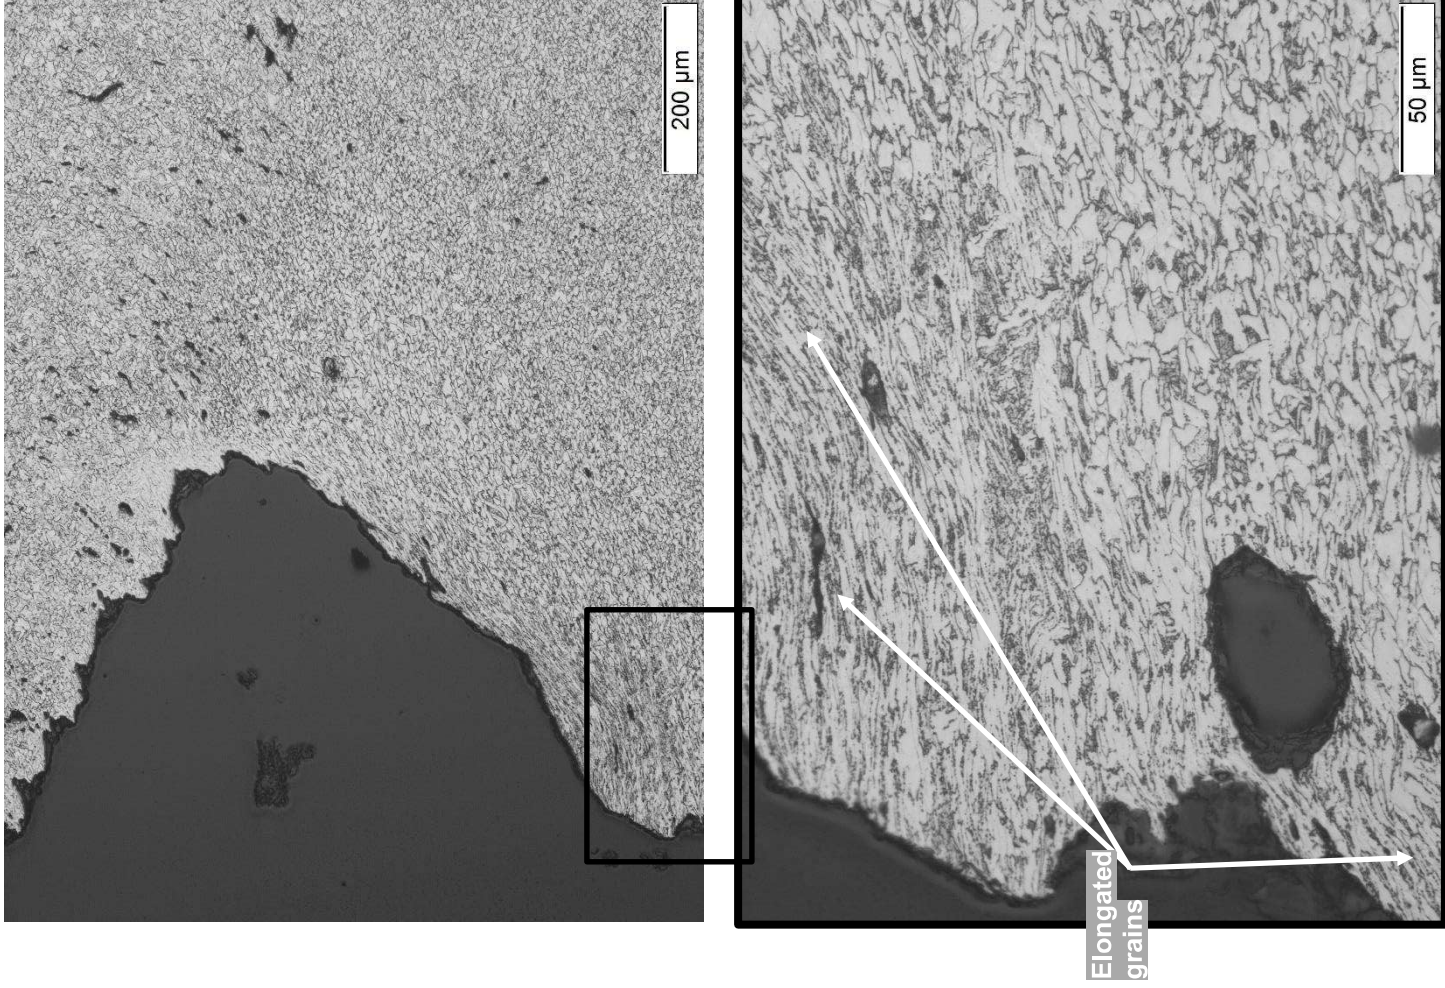
Figure 12. Low and high magnification light photomicrographs of Mount M1 midwall (2% Nital Etchant); area indicated in Figure 11. The figures shows elongated grains adjacent to the fracture surface, which is consistent with ductile overload.

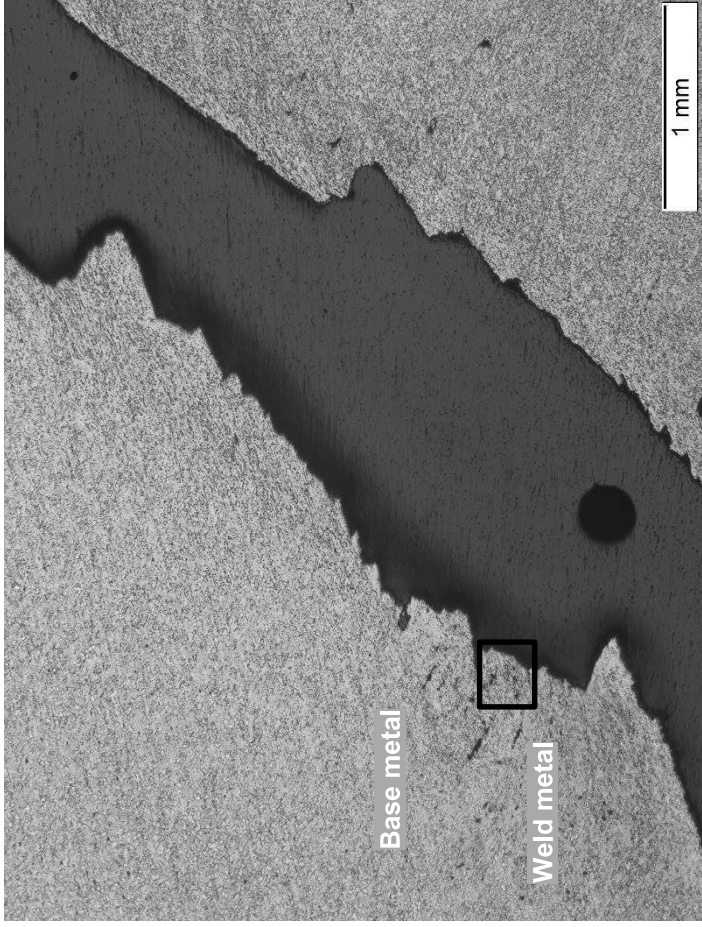
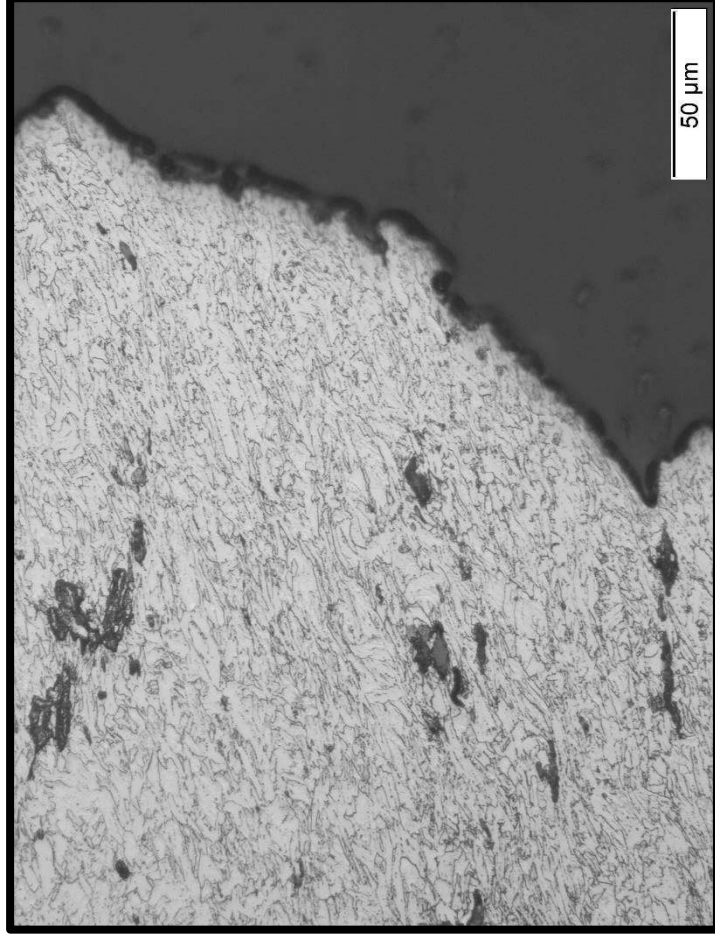
Figure 13. Low and high magnification light photomicrograph of Mount M1 near the ID surface (2% Nital Etchant); area indicated in Figure 10. The bottom photomicrograph shows elongated grains in the weld metal.

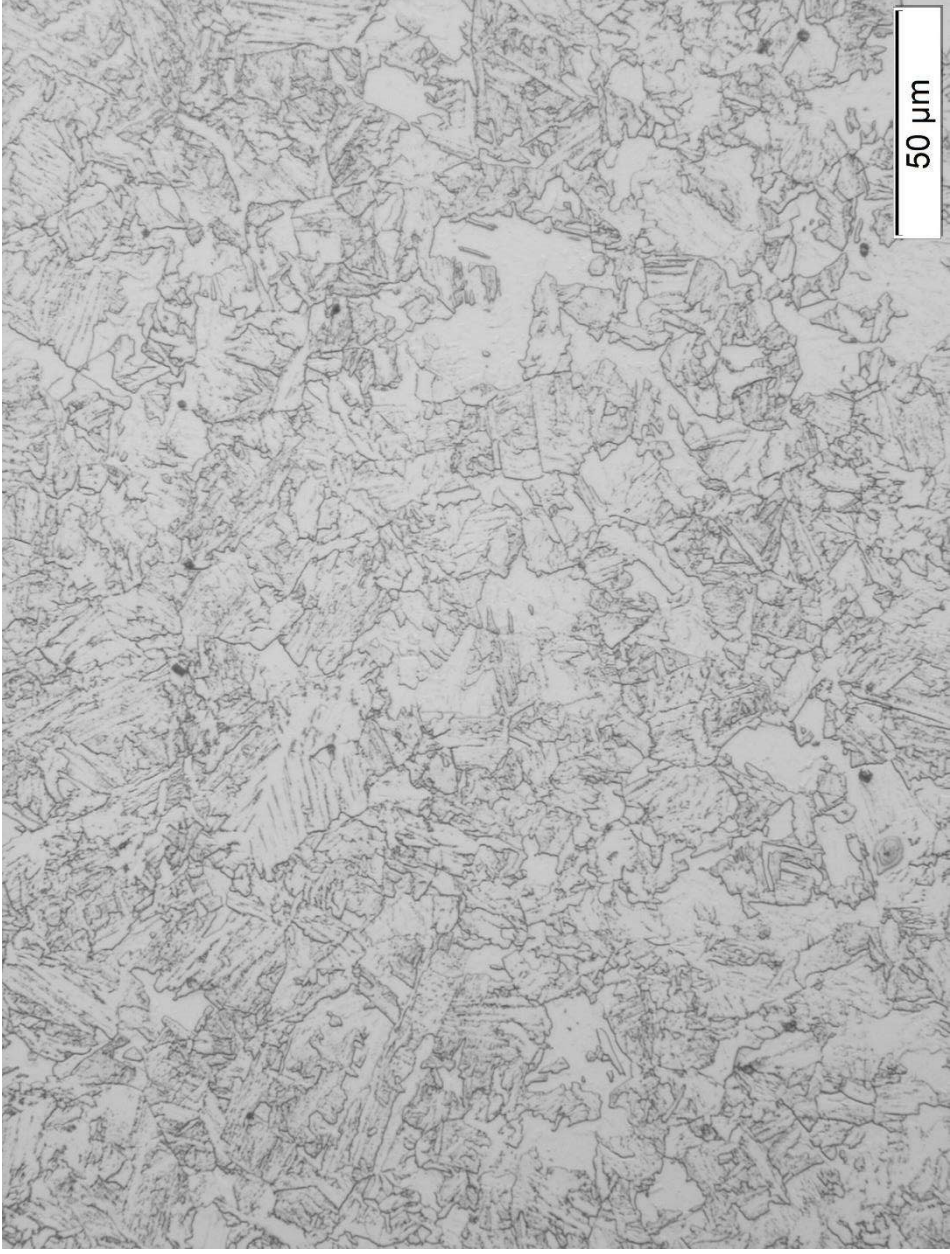
Figure 14. Light photomicrographs of Mount M1 showing the typical base metal microstructure of the fitting (2% Nital Etchant). The microstructure is consistent with a quench & temper (Q&T) microstructure and consistent with that reported in the MTR.

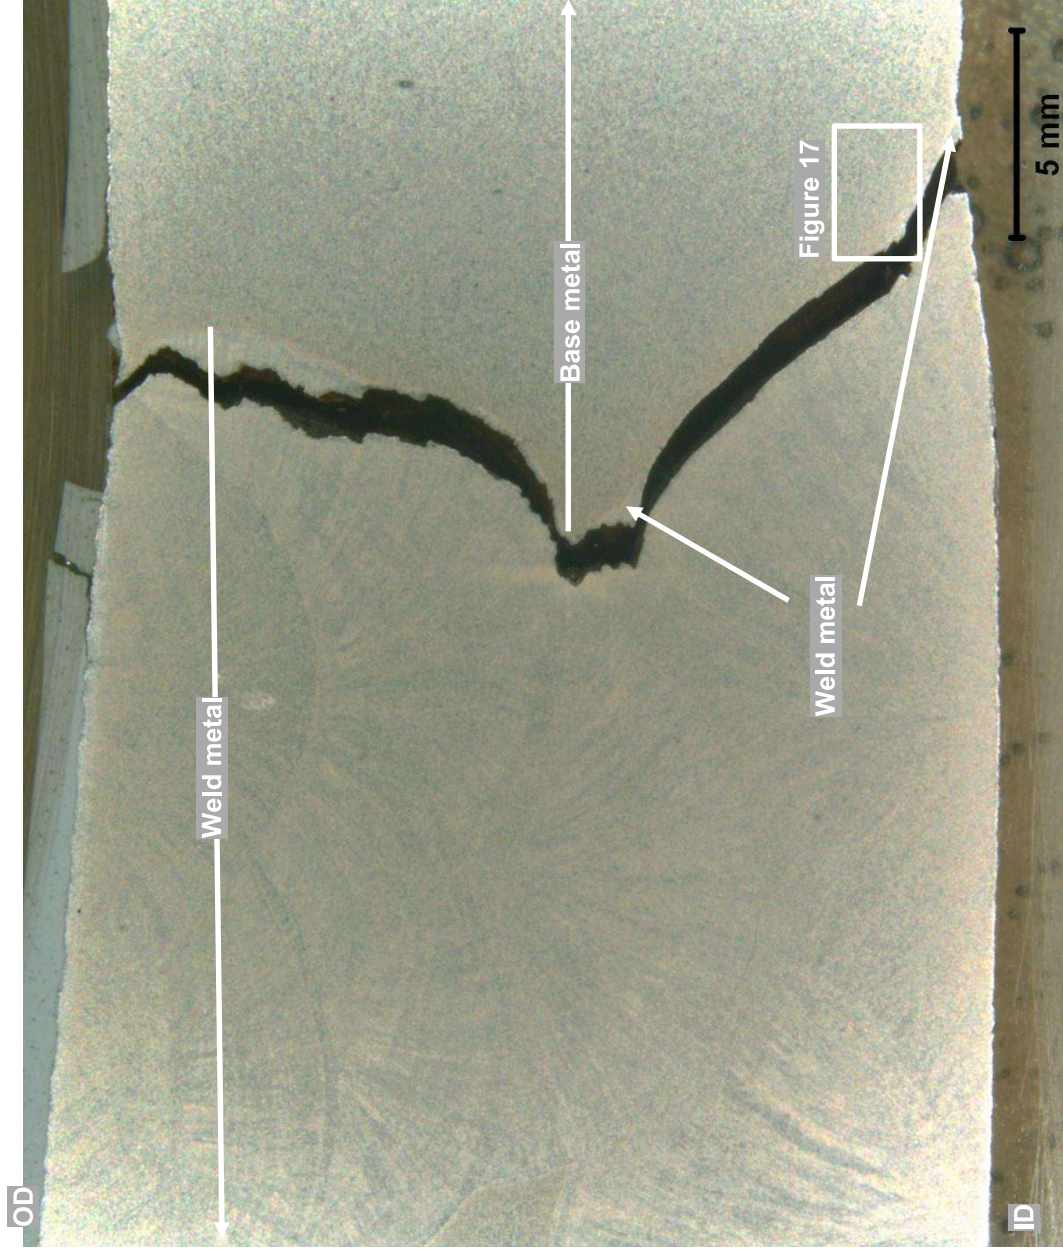
Figure 16. Light photomicrograph of transverse Mount M2 showing the fractures surfaces in cross-section (2% Nital Etchant); area indicated in Figure 15. There appears to be 5 weld passes made from the OD surface and 2 from the ID surface with the ID passes being deposited first. The figure shows that the crack path is through the weld metal at the OD surface, ID surface, and midwall, and located at or near the fusion boundary elsewhere. Most of the material is weld metal left of the fracture path and base metal right of the fracture path.

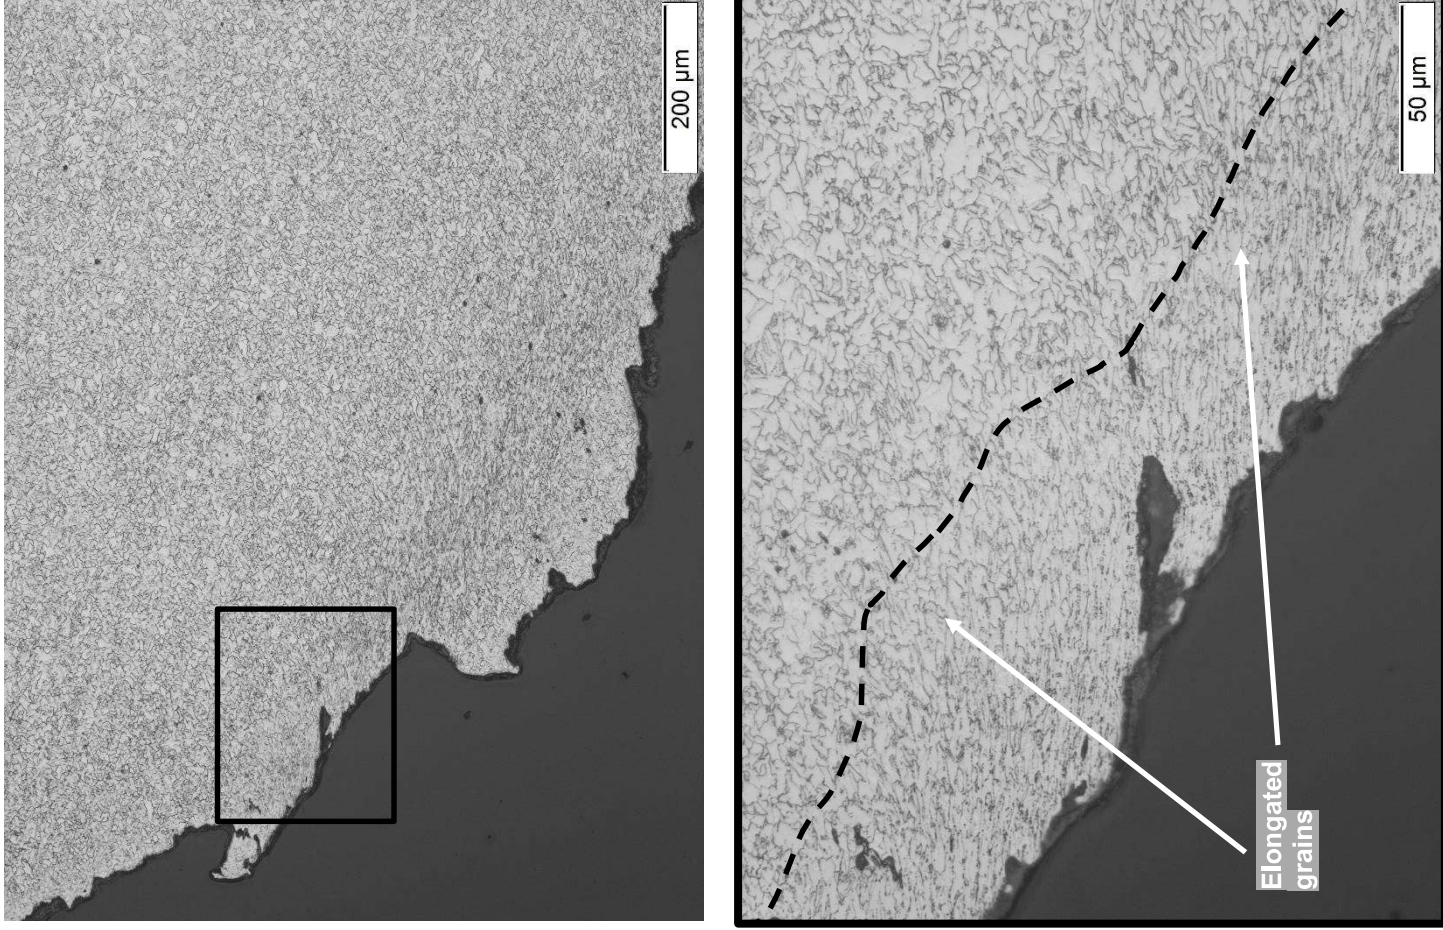
Figure 17. Low and high magnification light photomicrographs of Mount M2 near the ID surface (2% Nital Etchant); area indicated in Figure 16. The figure shows elongated grains at the fracture surface and unaffected grains away. The elongated grains are consistent with ductile overload.

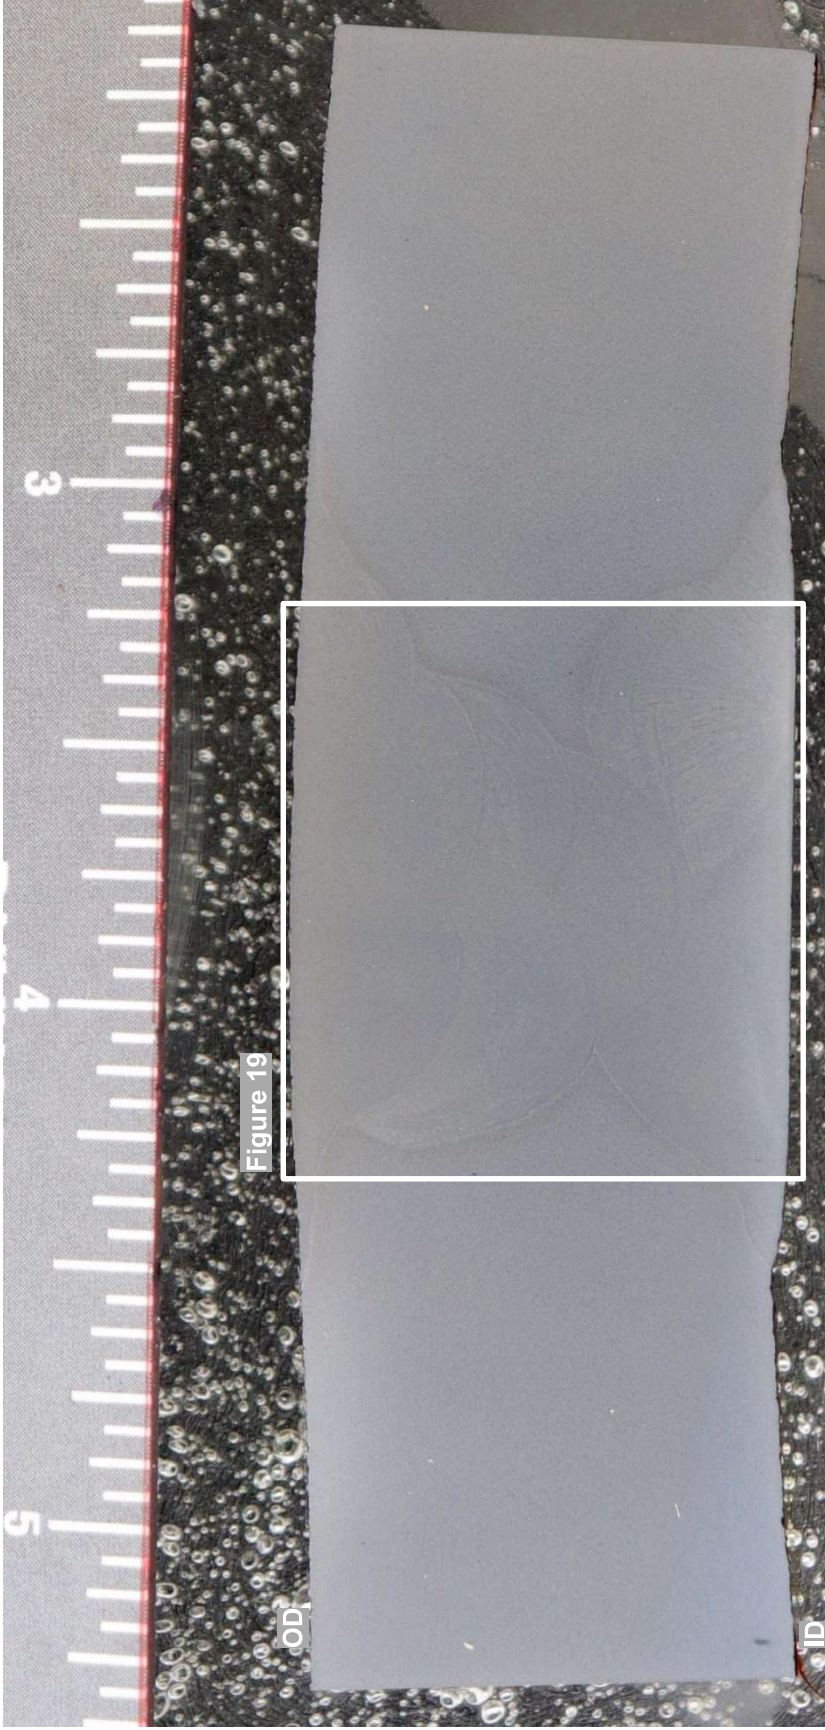
Figure 18. Photograph of the transverse metallographic section (Mount M3) that was removed across the seam weld of the sister elbow fitting. The scale is in inches. The morphology of the weld is similar to that in Mounts M1 and M2. The wall thickness at the far left of the cross-section, at the middle of the weld, and far right of the cross-section are approximately 0.925 inches, 0.959 inches, and 0.921 inches, respectively. Compared to Mounts M1 and M2, the fitting at this location does not show any evidence of wall reduction. The weld metal on the ID surface is approximately 1.5 inches wide (in the circumferential direction), similar to the failed elbow fitting.

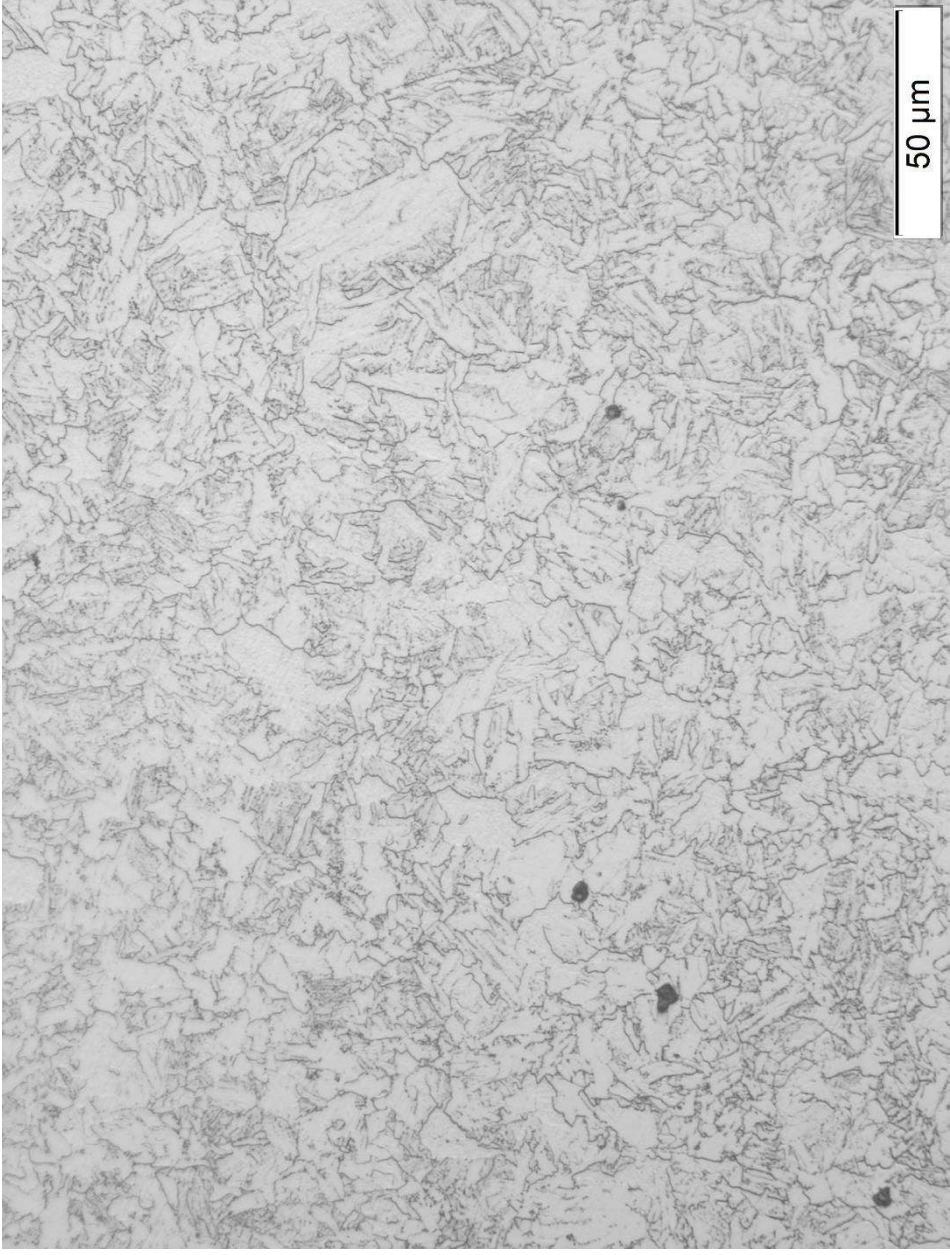
Figure 20. Light photomicrographs of Mount M3 showing the typical base metal microstructure of the sister elbow fitting (2% Nital Etchant). The microstructure is similar to that in the failed elbow fitting, consistent with a Q&T microstructure, and consistent with that reported in the MTR.

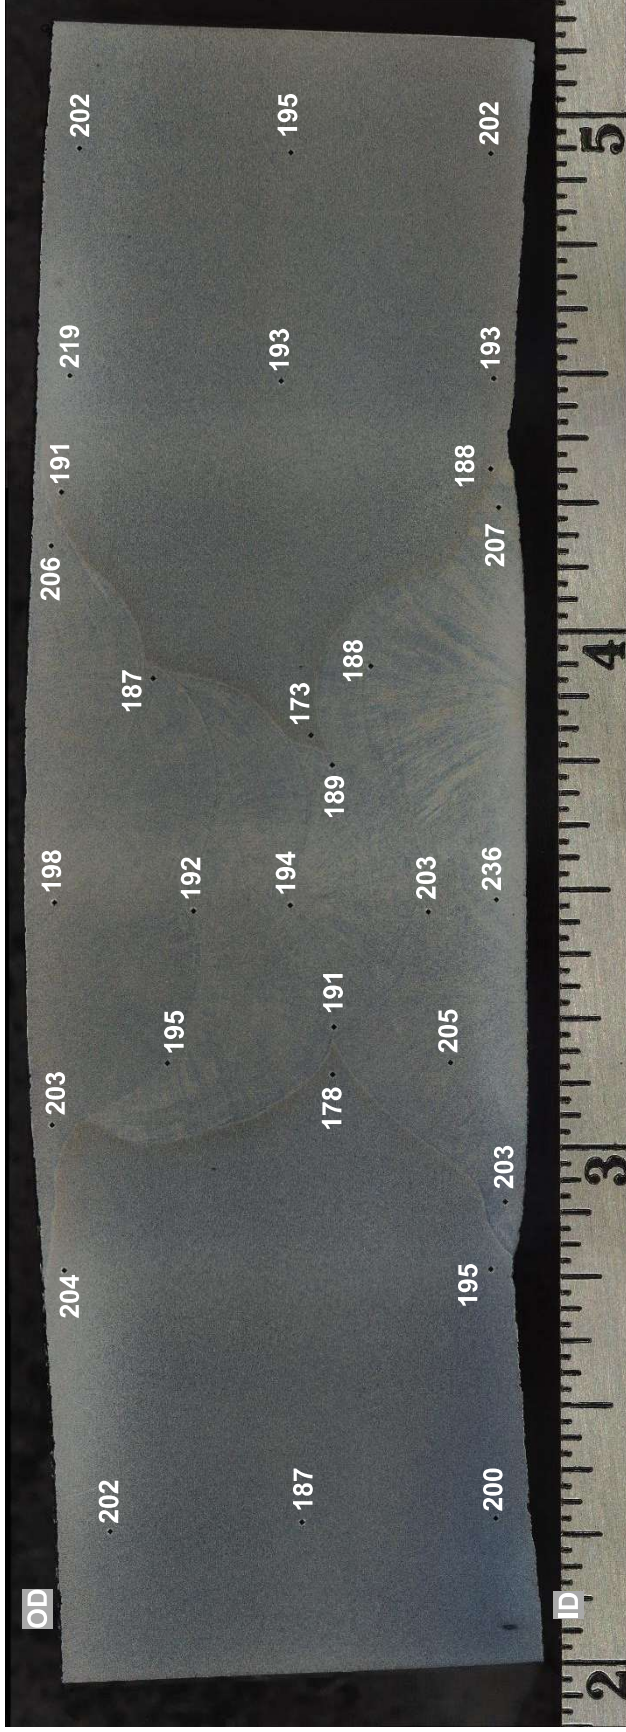
Figure 22. Light photomicrograph of Mount M3 from the sister elbow fitting following hardness testing (Vickers 10 kg load) showing the indents and corresponding hardness values (2% Nital Etchant). The hardness values are between 173 HV and 236 HV, with an average value of 197HV. A similar trend is present at this cross-section when comparing to Mount M2. The mid-thickness of the sample is slightly softer than the outer edges. The softest portion of the base metal is mid thickness near the weld metal (173 and 178 HV), near the intersection of OD and ID weld passes, compared to the next highest base metal value of 187 HV. Overall, there appears to be a softening of the base metal mid-thickness adjacent to the weld metal, where the weld metal is also somewhat softer compared to the outer edges of the weld metal.
