August 28, 2024

Mr. Robert Burrough  
Director, Eastern Region  
Pipeline and Hazardous Materials Safety Administration  
840 Bear Tavern Road  
Suite 300  
West Trenton, New Jersey, 08628

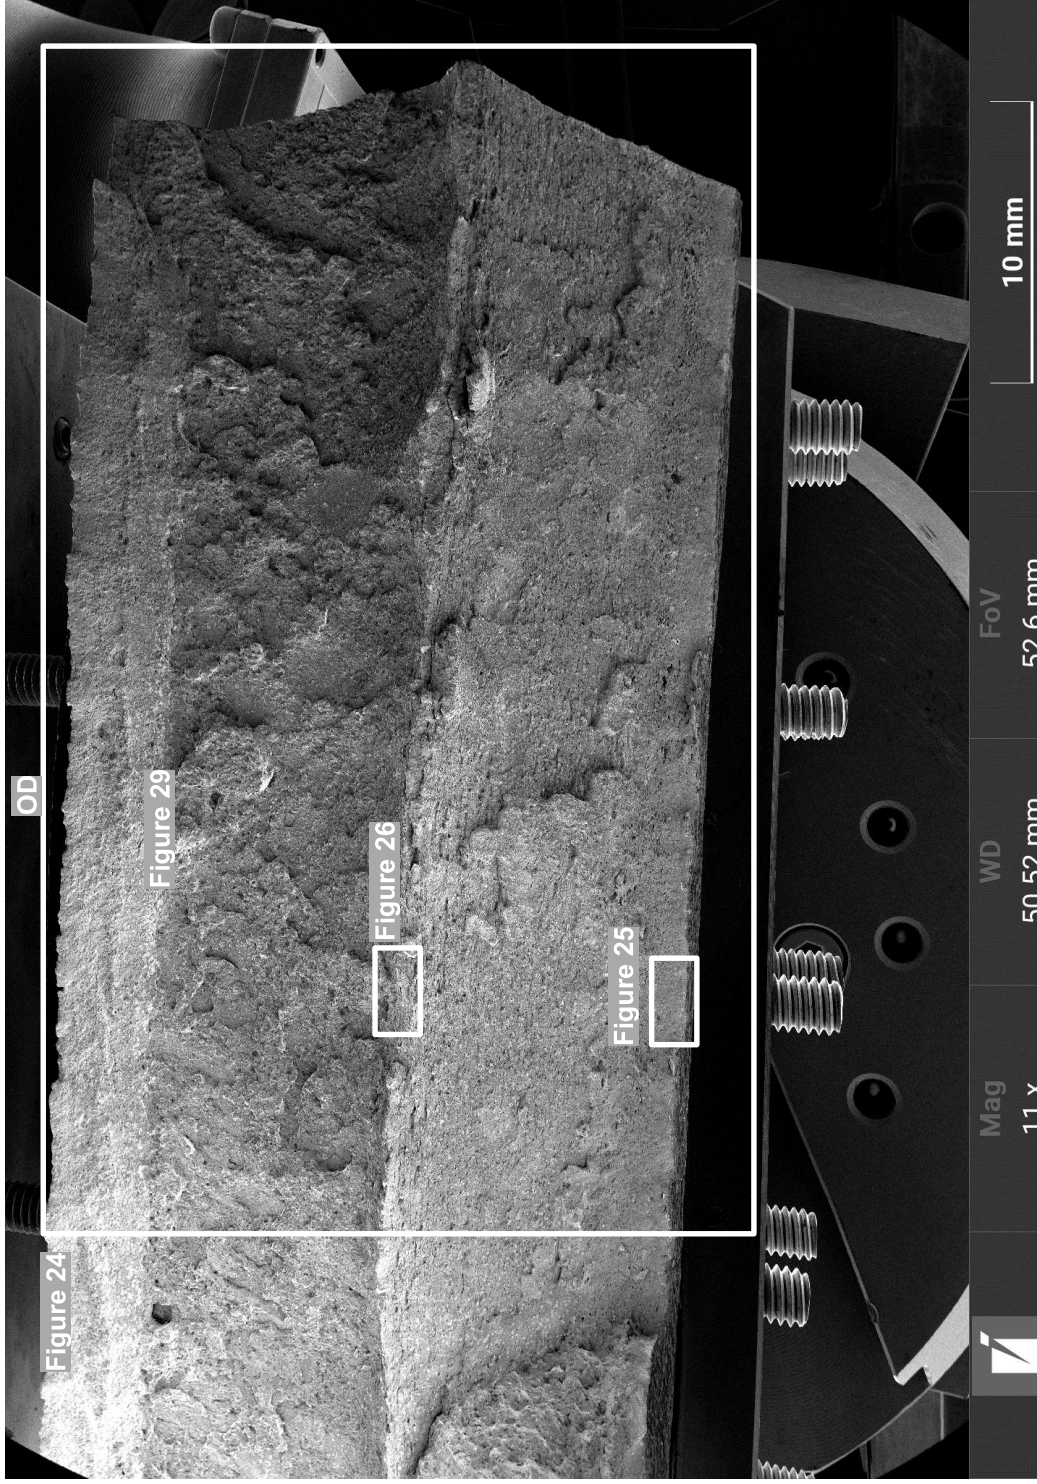
Figure 23. SEM image of Sample S1 showing the fracture surface, following cleaning in ENPREP®214; area indicated in Figure 7. The figure shows where higher magnification SEM images were taken. As mentioned above, the sample was removed at this location since it appeared to be the thinnest region of the fracture surface.

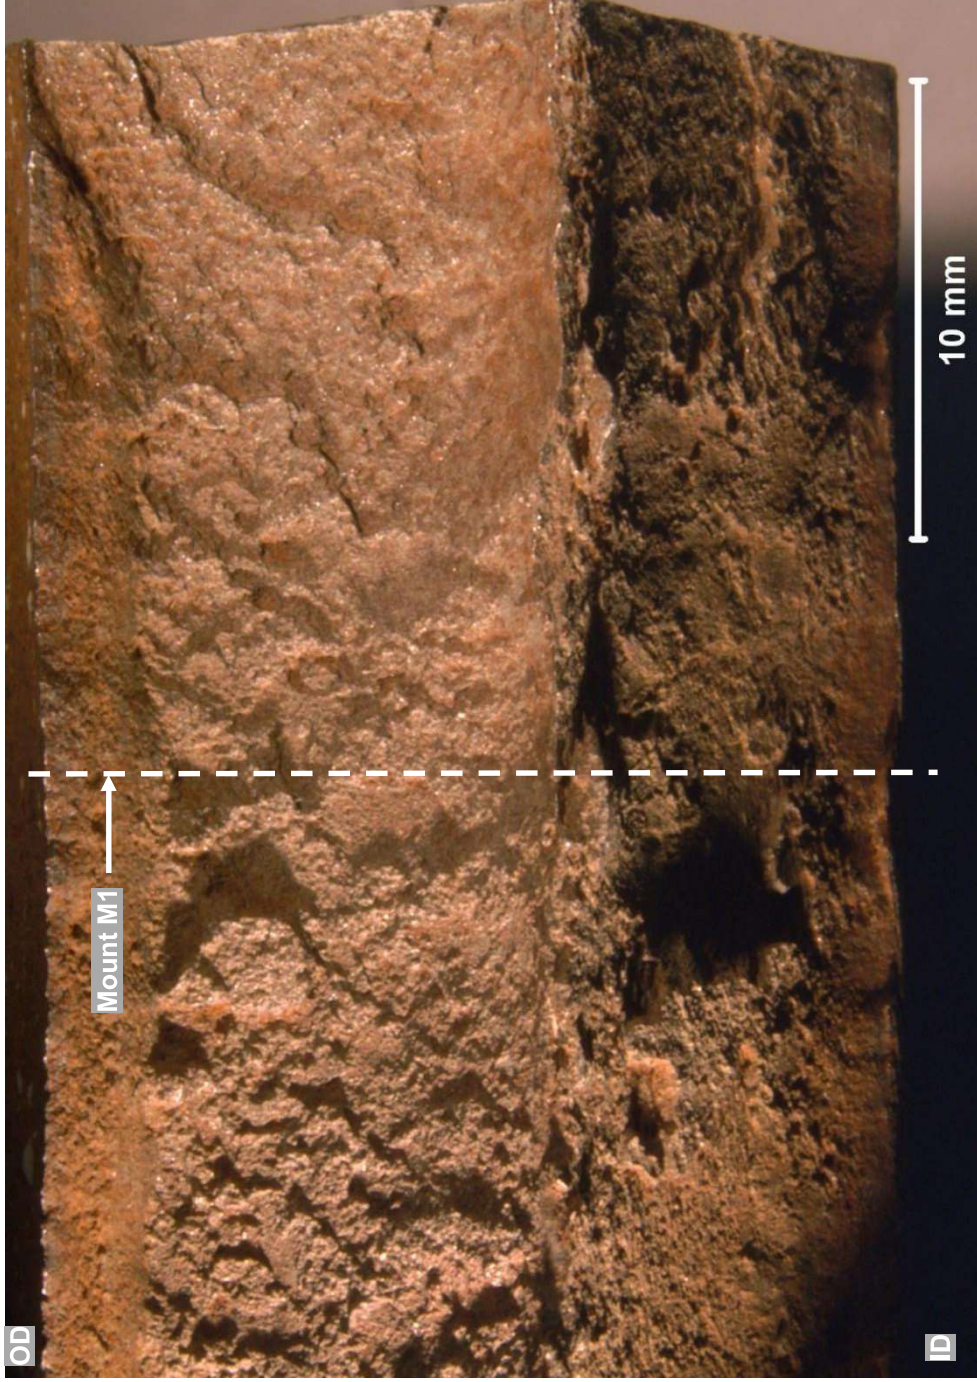
Figure 24. Light photomicrograph of Sample S1 showing the fracture surface; area indicated in Figure 23. The figure shows where Mount M1 was removed. The fracture surface is somewhat smooth from the ID surface to midwall, transitions to a rougher portion from midwall to just below the OD surface, and then the remaining portion adjacent to the OD surface is similar to the portion adjacent to the ID surface.

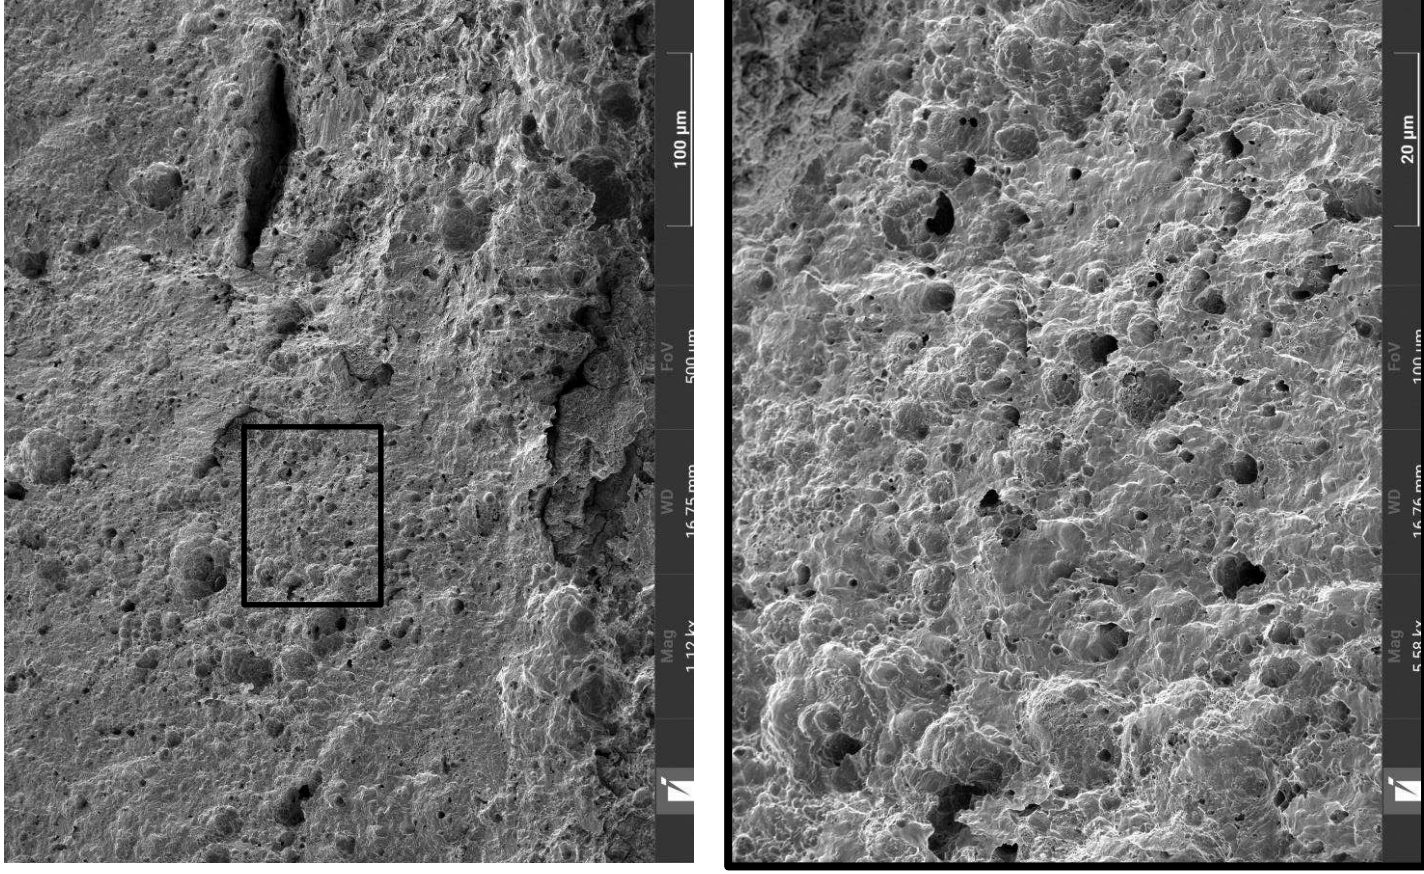
Figure 25. Low and high magnification SEM images of Sample S1 near the ID surface showing the fracture surface in Region 1; area indicated in Figure 23. The fracture surface consists of dimples, consistent with ductile fracture overload. This morphology is consistent with the metallographic cross-section.

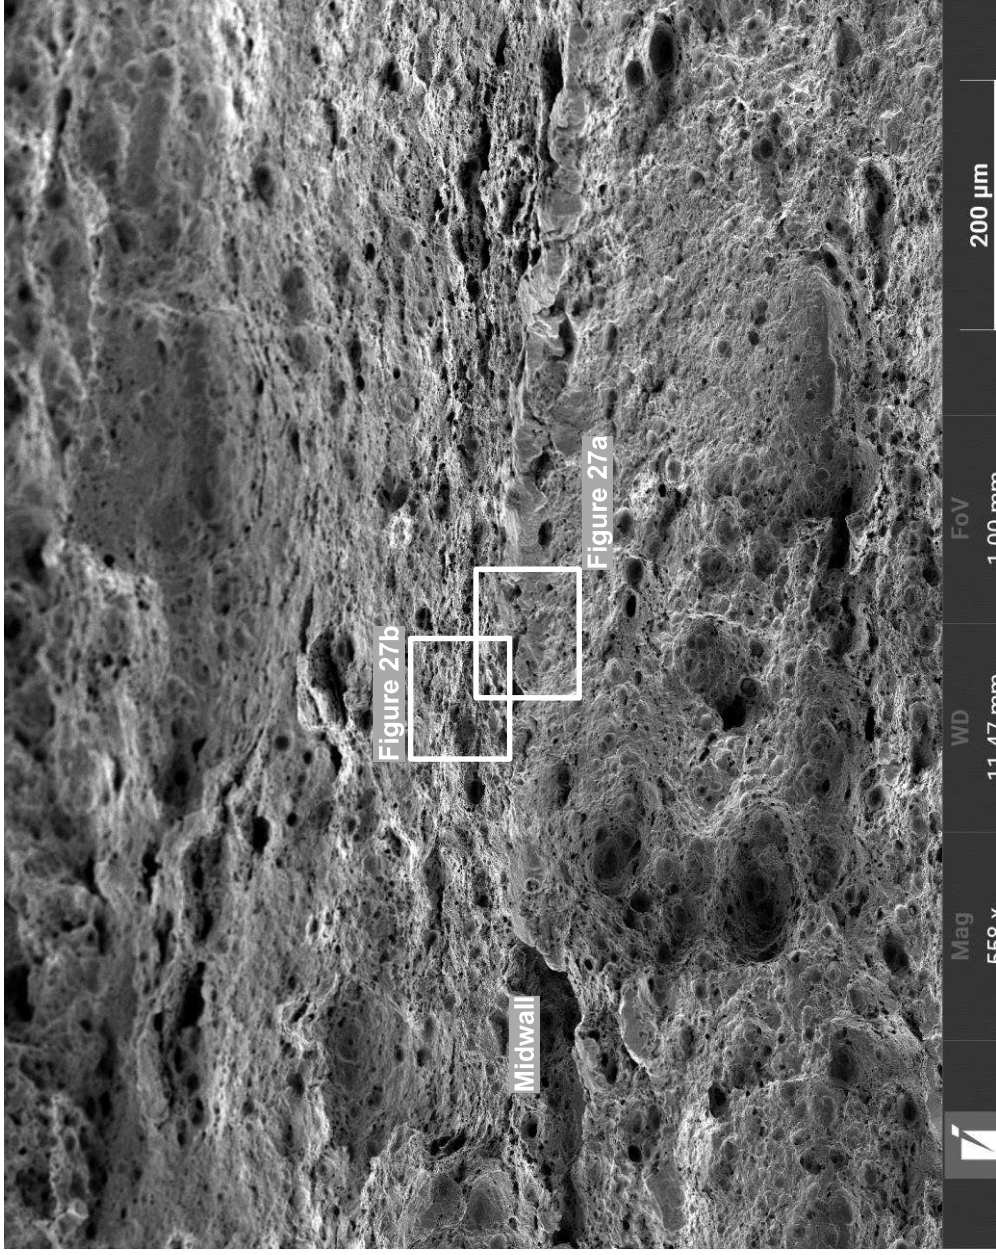
Figure 26. SEM image of Sample S1 midwall showing the fracture surface near midwall; area indicated in Figure 23. The fracture surface at this location also contains dimples, consistent with ductile overload.

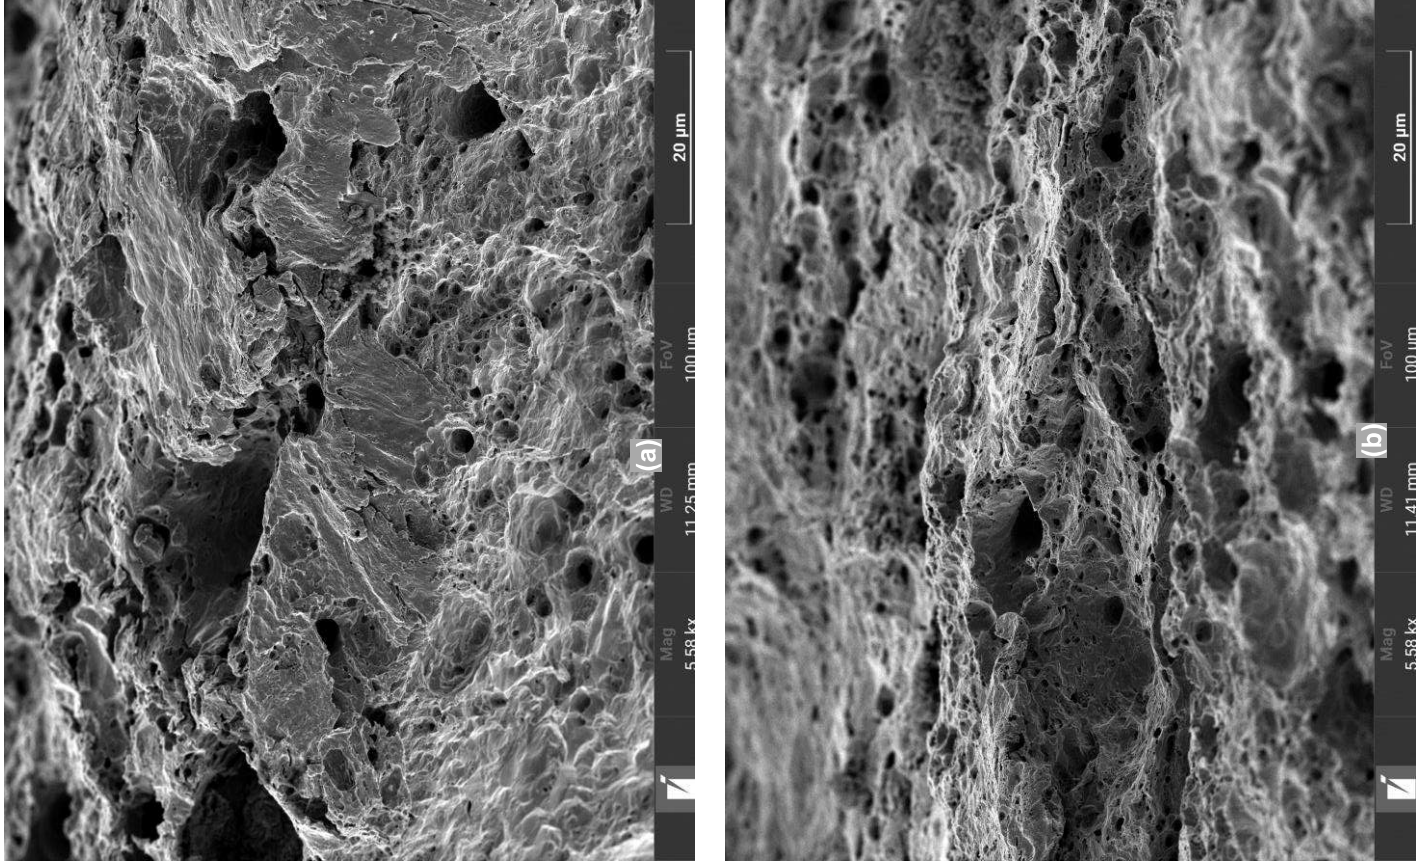
Figure 27. SEM images of Sample S1 at/below midwall (a) and above (b) showing the fracture surface; area indicated in Figure 26. The fracture surface appears smooth and smeared midwall as shown in (a) above and dimples are located above and below it.

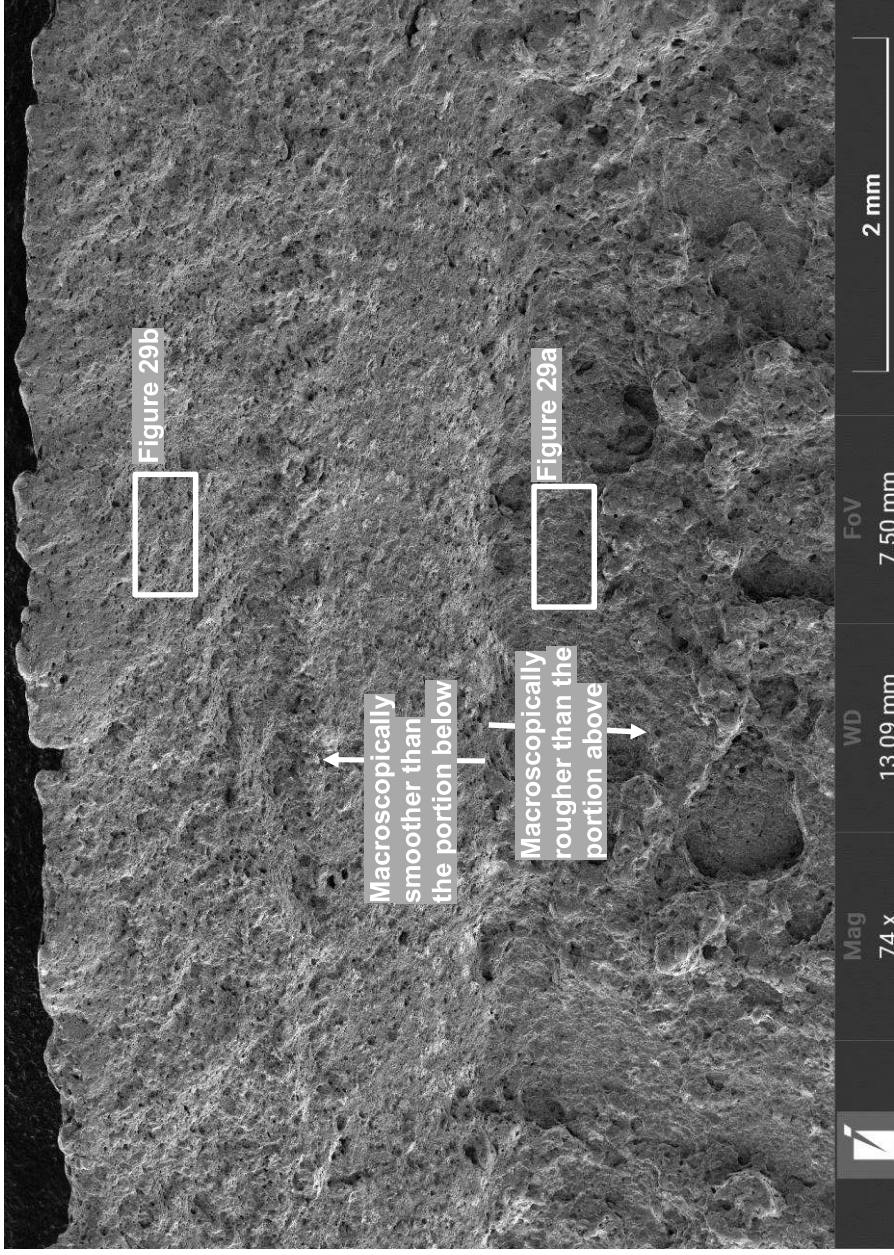
Figure 28. SEM image of Sample S1 showing the fracture surfaces near the OD surface; area indicated in Figure 23. The figure shows the difference in the topography of the fracture surface and where higher magnification SEM images were taken.

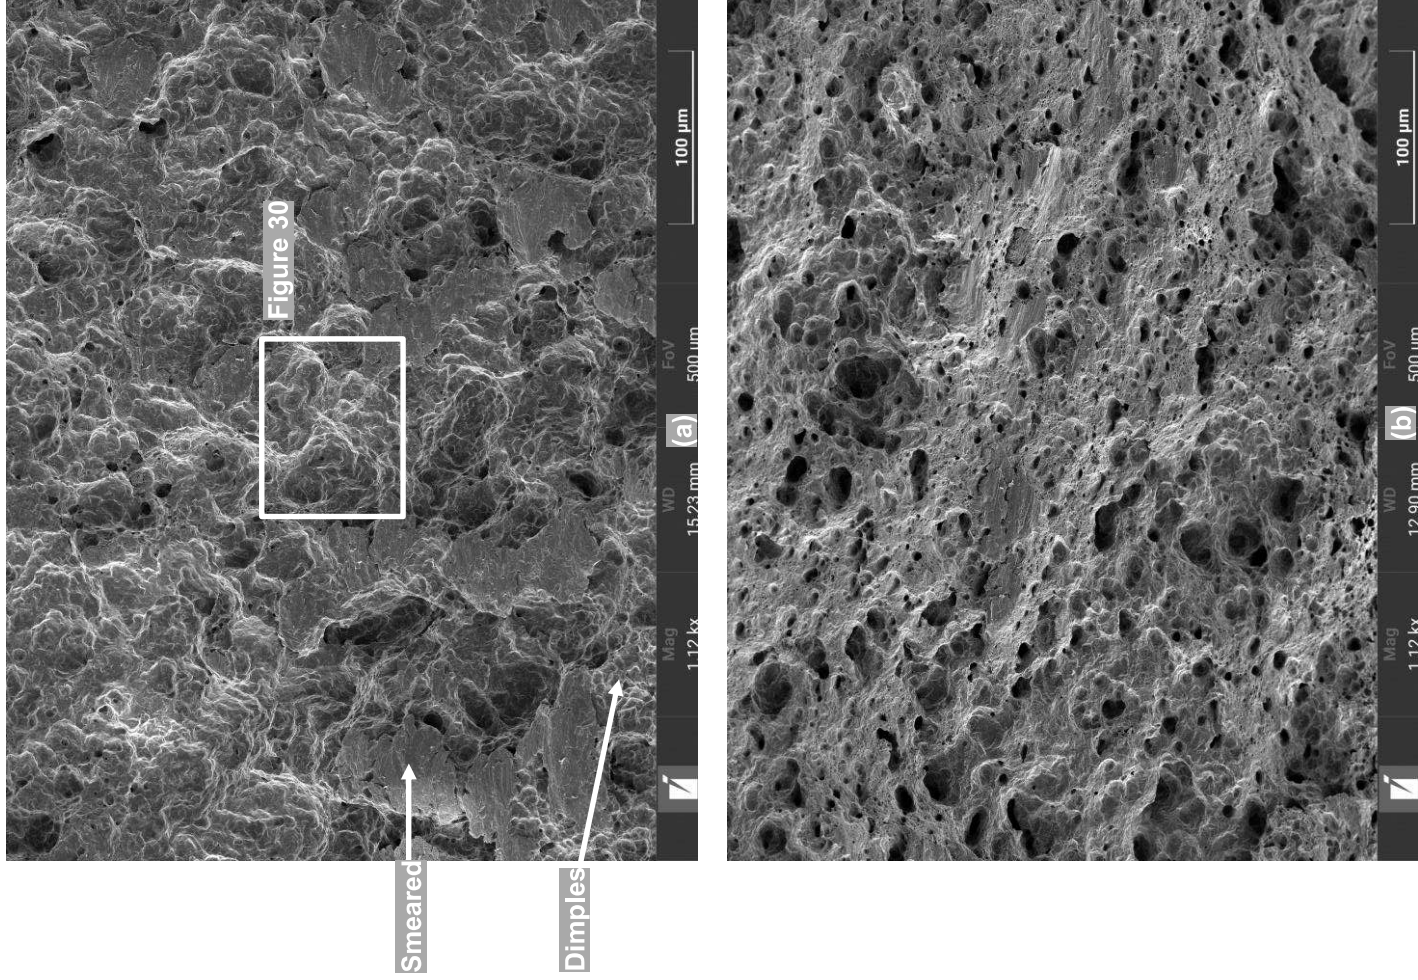
Figure 29. High magnification SEM images of Sample S1 showing the fracture surfaces at the areas described in Figure 28; areas indicated in Figure 28. The fracture surface contains in (a) above contains some dimples and smeared metal, less evidence of ductility compared to the other portions of the fracture surface. The fracture surface in (b) contains dimples. The dimples are consistent with ductile fracture.

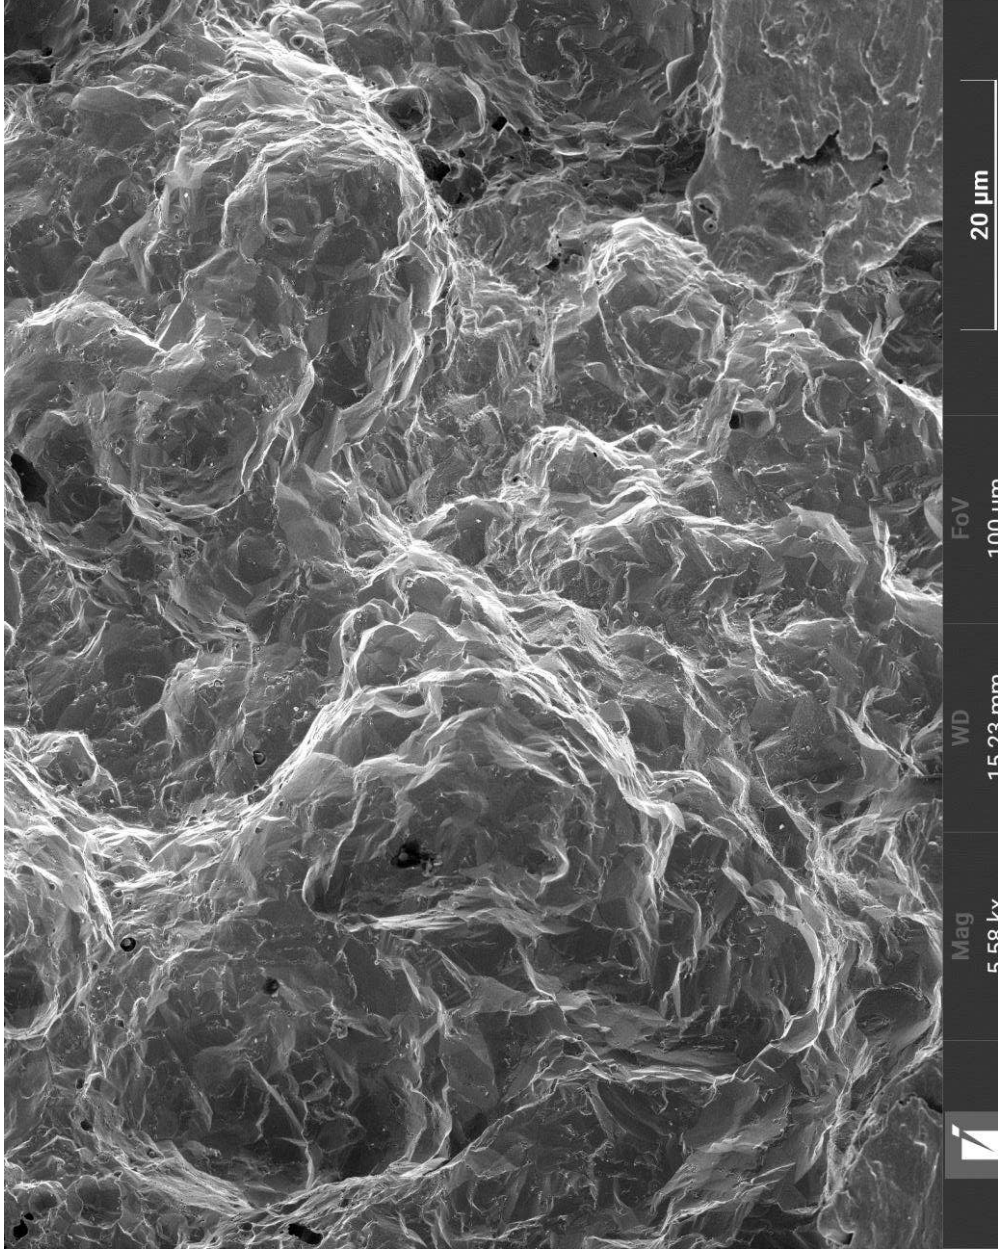
Figure 30. High magnification SEM images of Sample S1 showing the fracture surfaces where there was less evidence of ductility; area indicated in Figure 29. The fracture surface has a “glassy” appearance and appears to be quasi cleavage, and thus is likely more brittle compared to the other areas of the fracture surface that just contain dimples.

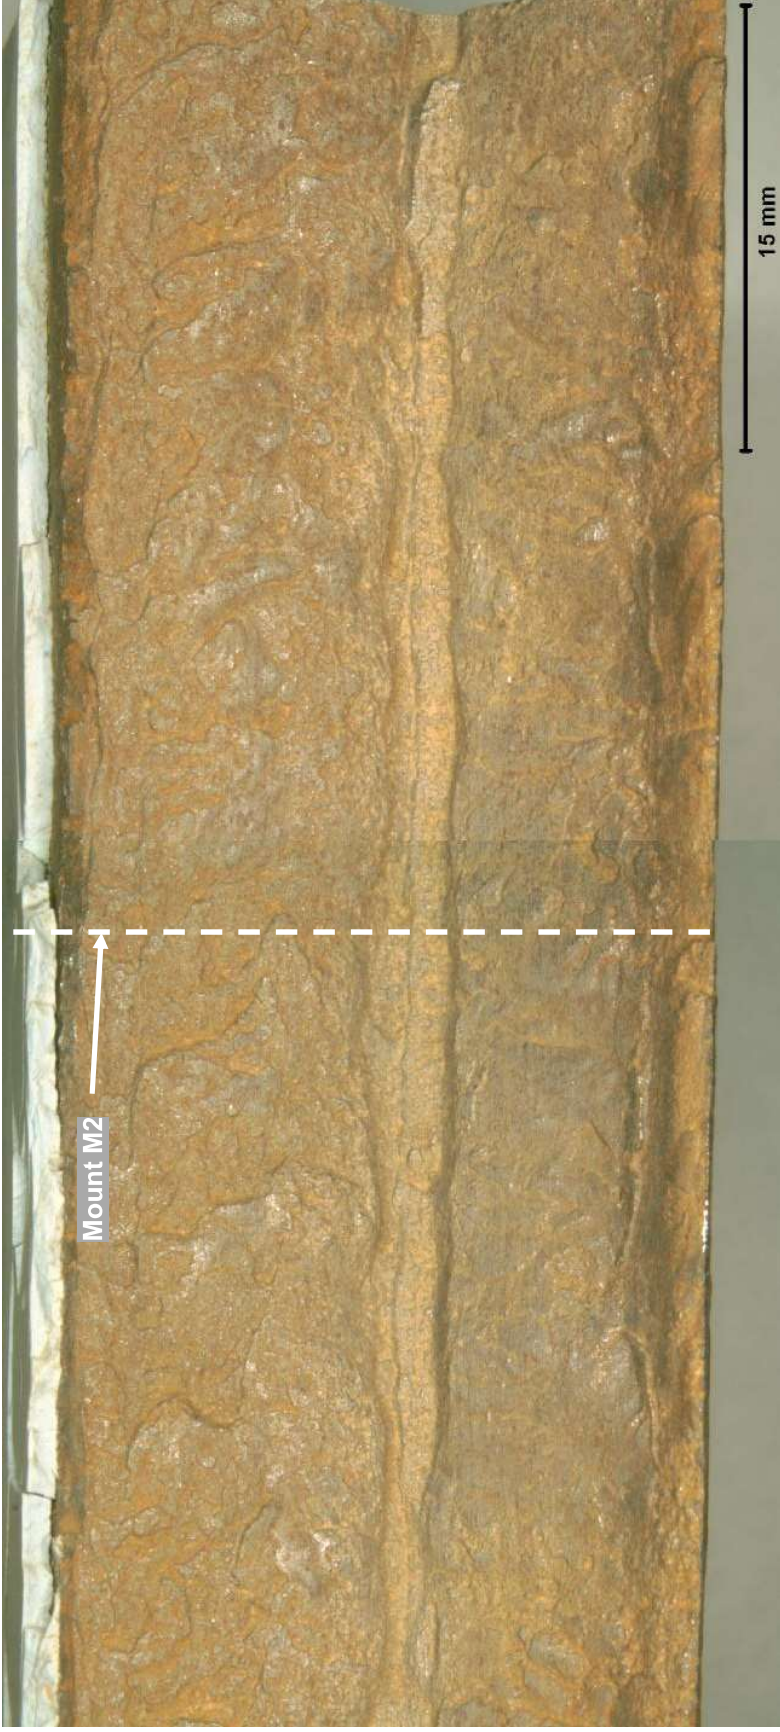
Figure 31. Light photomicrograph of Sample S2 showing the fracture surface; area indicated in Figure 5. The figure shows where Mount M2 was removed. Examination in the SEM showed similar features as Sample S1, with areas of smearing and areas of dimples. There was no evidence of pre-existing flaws. The slight difference in this fracture surface from Sample S1 is that midwall is flatter in the thickness direction, which is obvious when looking at the fracture surface in cross-section in Mount M2 in Figure 16. As mentioned above, this sample was removed from this location along the fracture surface in order to examine the midwall vertical portion.

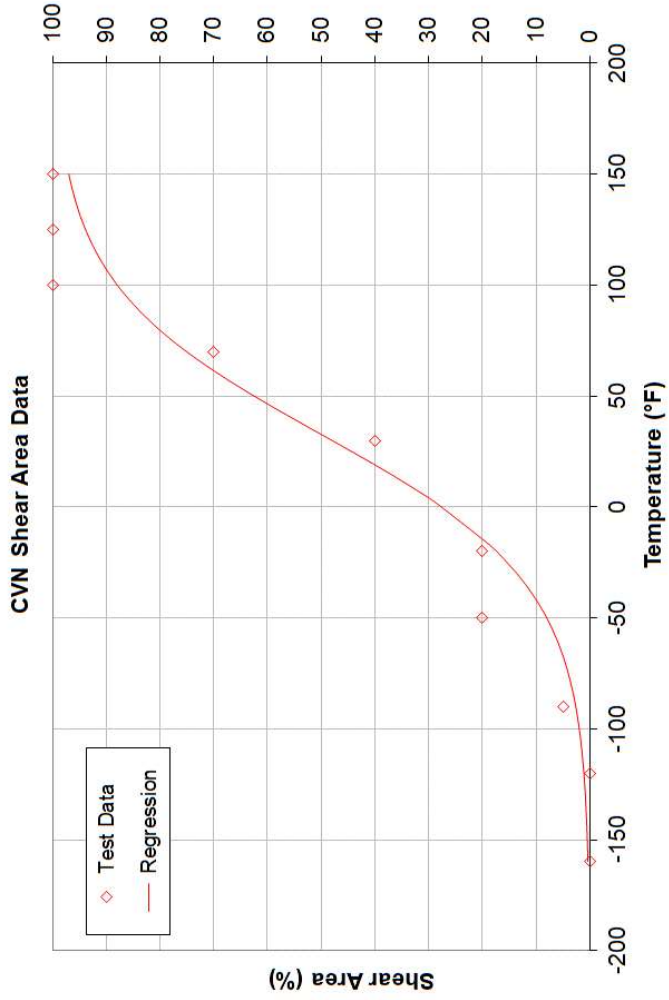
Figure 32. Percent shear from Charpy V-notch tests as a function of temperature for transverse seam weld (HAZ notch) specimens removed from the sister elbow fitting.
