STREAM BIOLOGICAL CONDITIONS ENVIRONMENTAL AUDITOR REPORT

Stream ID: S-D2	Crossing Start Date: 11/04/2024	Crossing Completion Date: 11/04/2024
Milepost: 284.8	Pre-Con Assessment Date: 10/31/2024	Post-Con Assessment Date: 11/05/2024
Station: 15044+79	Stream Classification: Perennial (Perennial, Intermittent, Ephemeral)	Bankfull Width (ft.): 18
County: Pittsylvania	303(d) Impairment Listing: Impaired	Riffle:Pool Complexes Present? No

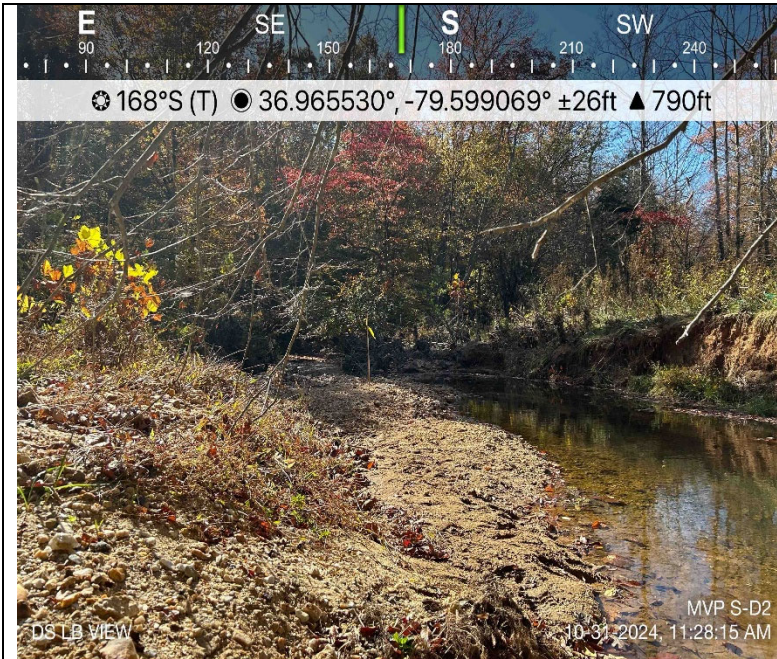
Photo Description: Downstream view of permitted impact area during pre-construction assessment.

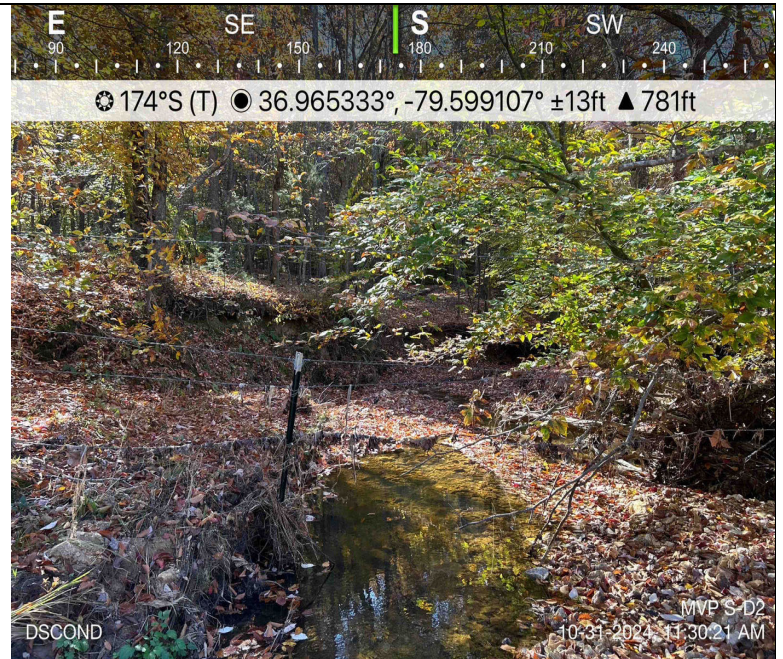
Photo Description: Conditions of the downstream area outside the ROW during pre-construction assessment.

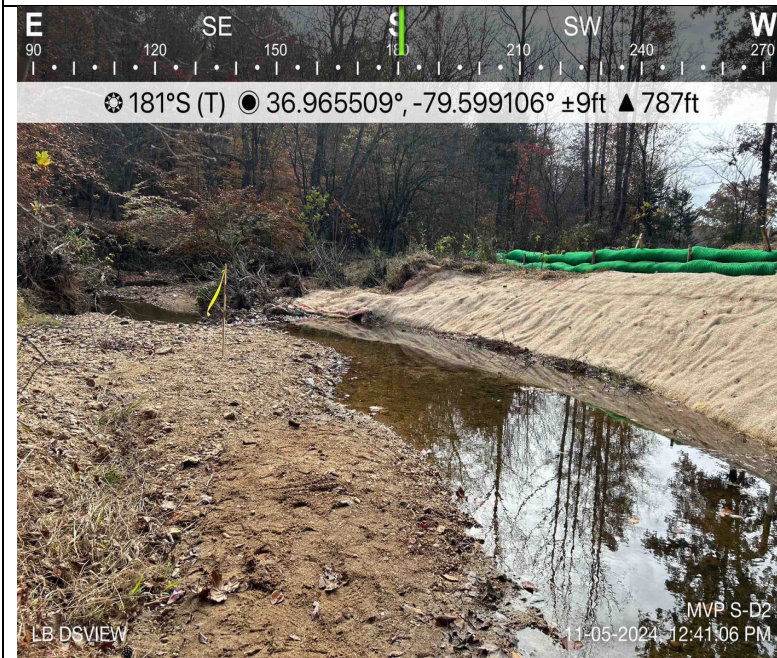
Photo Description: Downstream view of permitted impact area during post-construction assessment.

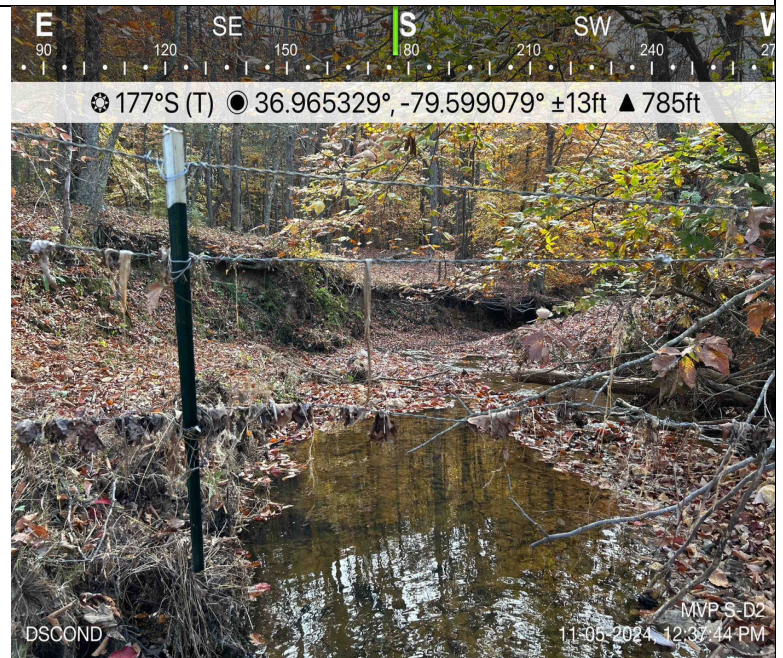
Photo Description: Conditions of the downstream area outside the ROW during post-construction assessment.

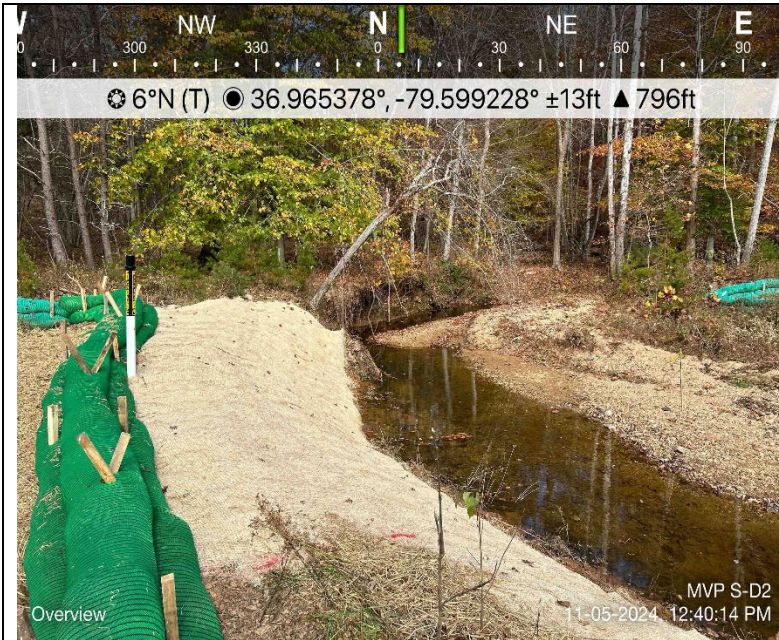
Photo Description: View of regraded bank. Erosion control matting installed, keyed-in, and stapled.

11/04/2024: Controls were placed along the damaged slope and a turbidity curtain was placed within the resource around the work area to limit material from moving off site. Once controls were in place the banks were regraded to a 3:1 slope. Stabilization and ECDs were re-installed along the banks and buffers of the resource and the crew began pulling out of the area. -N. Phillip

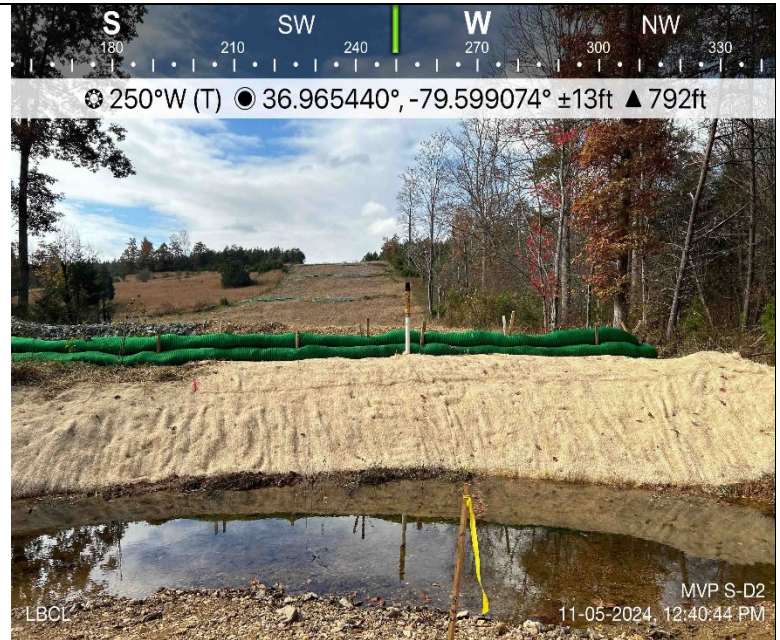
Photo Description: View of the regraded right bank from standing on the left bank.

Item #8: Field modification to the right bank was implemented to address the erosion and provide a stable angle of repose for long-term stabilization goals.

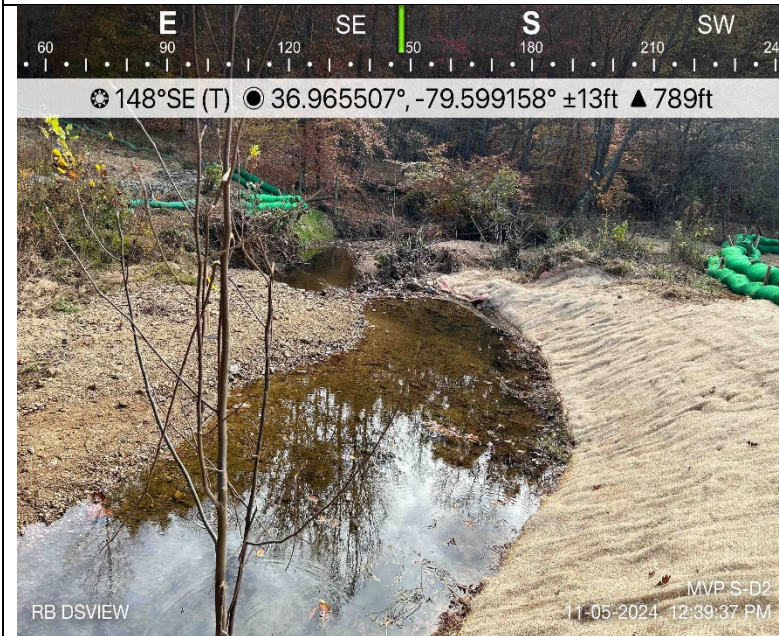
Photo Description: Looking downstream at the right bank. Erosion control matting installed properly.
