STREAM BIOLOGICAL CONDITIONS ENVIRONMENTAL AUDITOR REPORT

Stream ID: S-H42	Crossing Start Date: 10/14/2024	Crossing Completion Date: 10/28/2024
Milepost: 303.2	Pre-Con Assessment Date: 10/04/2024	Post-Con Assessment Date: 10/29/2024
Station: 15982+56	Stream Classification: Perennial (Perennial, Intermittent, Ephemeral)	Bankfull Width (ft.): 5
County: Pittsylvania	303(d) Impairment Listing: Not Impaired	Riffle:Pool Complexes Present? No

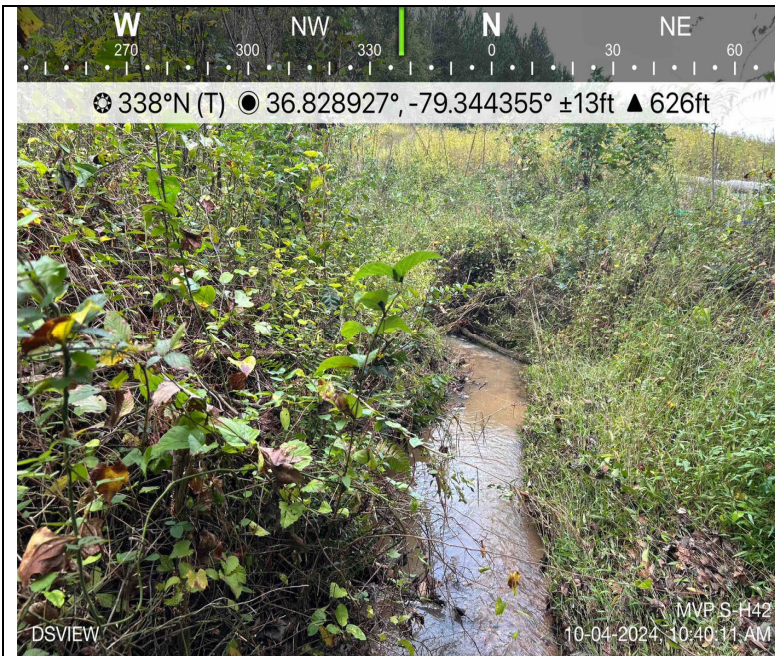
Photo Description: Downstream view of permitted impact area during pre-construction assessment.

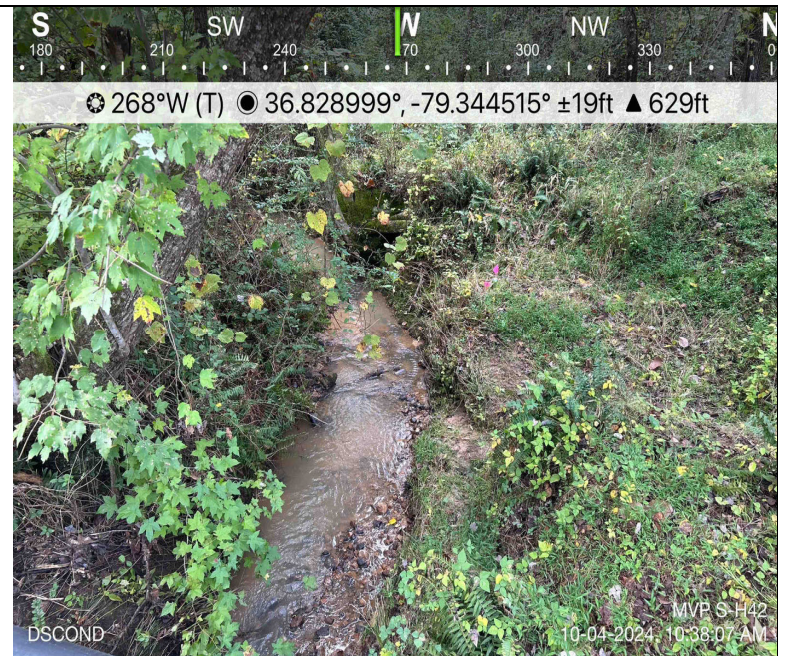
Photo Description: Conditions of the downstream area outside the ROW during pre-construction assessment.

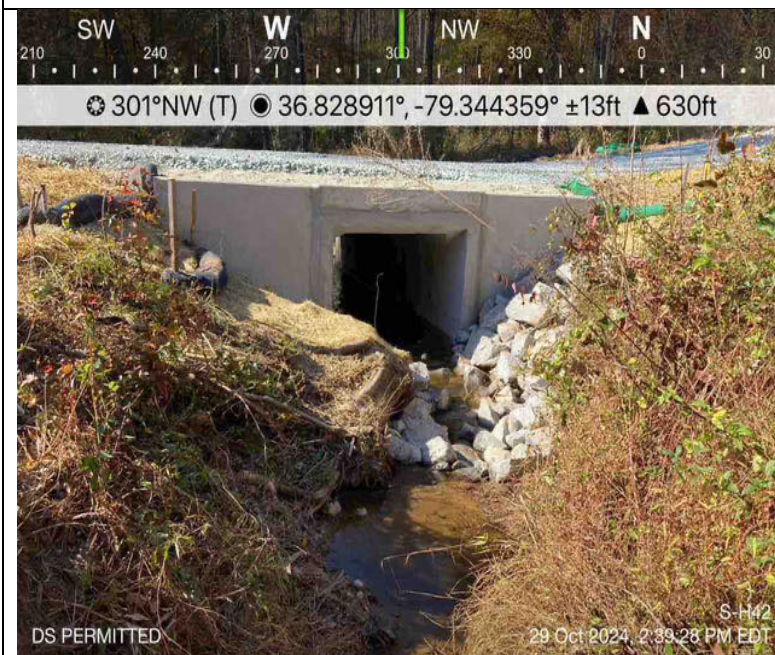
10/29/2024: Permanent access road installation has completed around the culvert, and resource remains in good condition. Post-construction assessment was completed and post-construction photos were taken. -A. Breeding

Photo Description: Downstream view of permitted impact area during post-construction assessment.

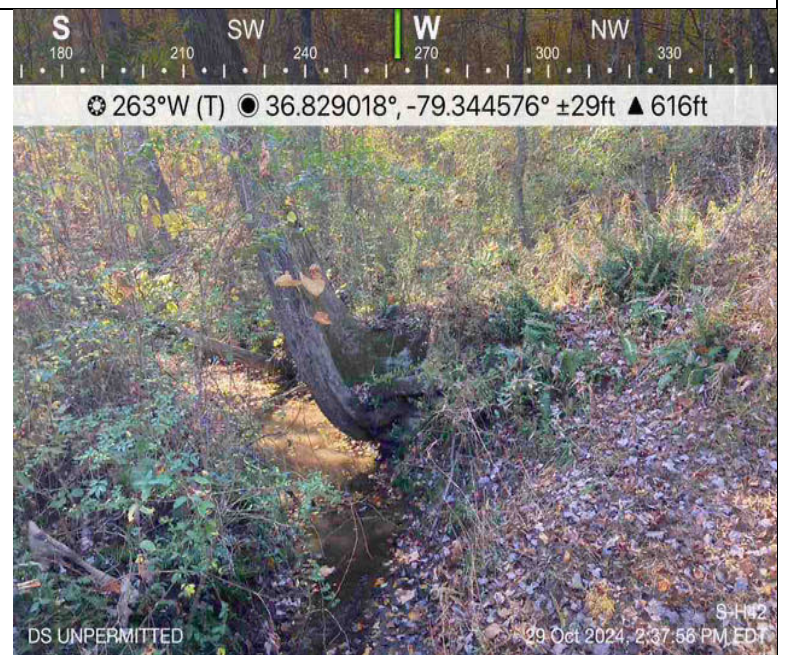
Photo Description: Conditions of the downstream area outside the ROW during post-construction assessment.

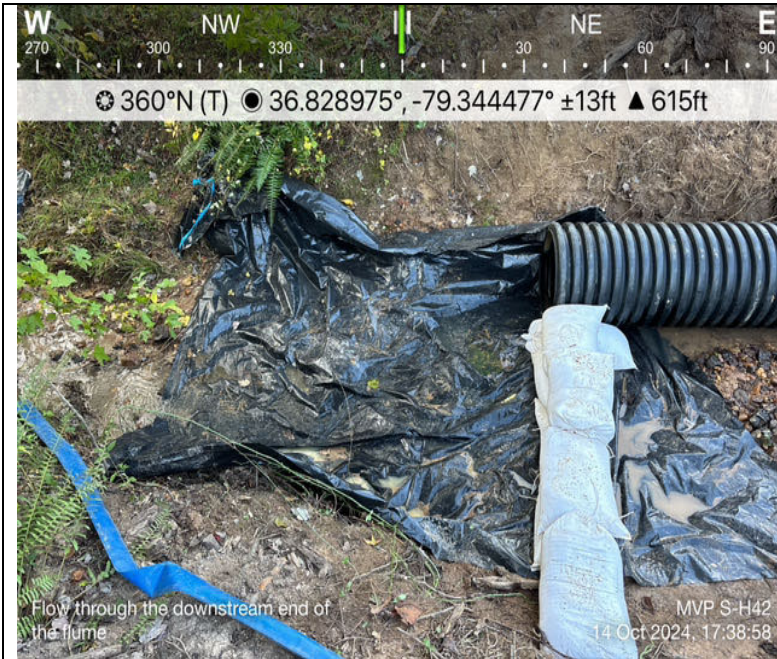
Photo Description: Flume installed to convey stream flow.

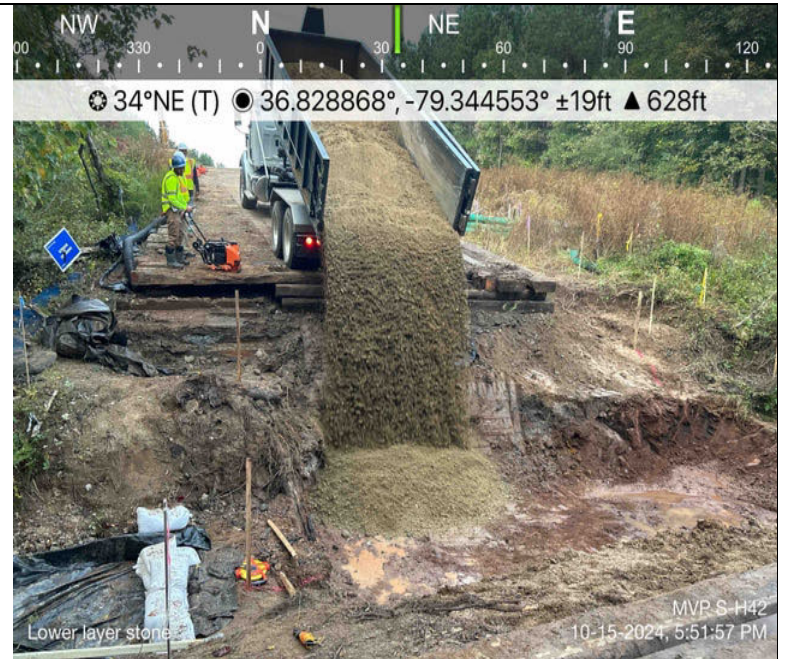
10/15/2024: Flume was removed and dam and pump set up. Ground water that entered the work area overnight was pumped out to the dewatering structure. Topsoil, subsoil, and stream substrate were segregated appropriately in the upland. The bottom layer of gravel was applied and leveled in preparation for the culvert installation. Flume was installed to allow stream flow overnight without a pump. - N.Fillip

Photo Description: Bottom layer of stone installed.

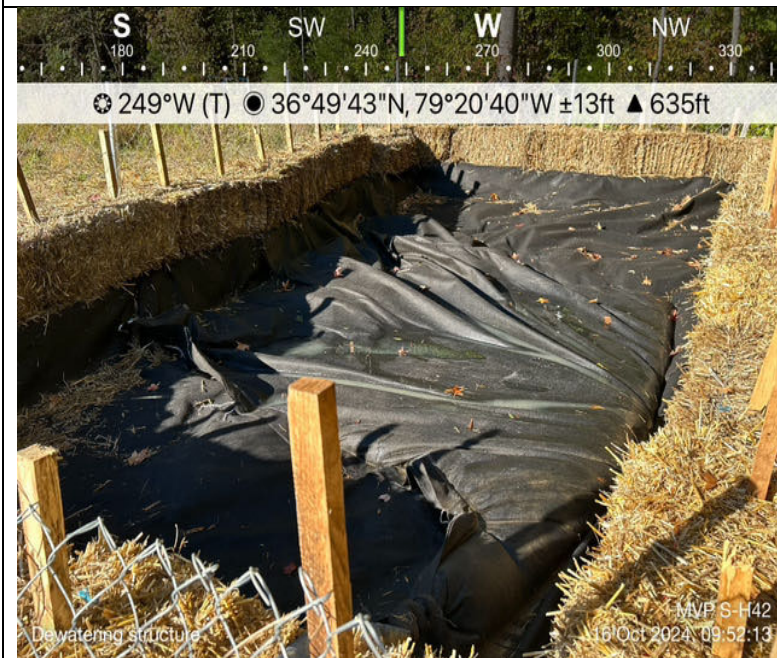
Photo Description: Dewatering structure onsite.

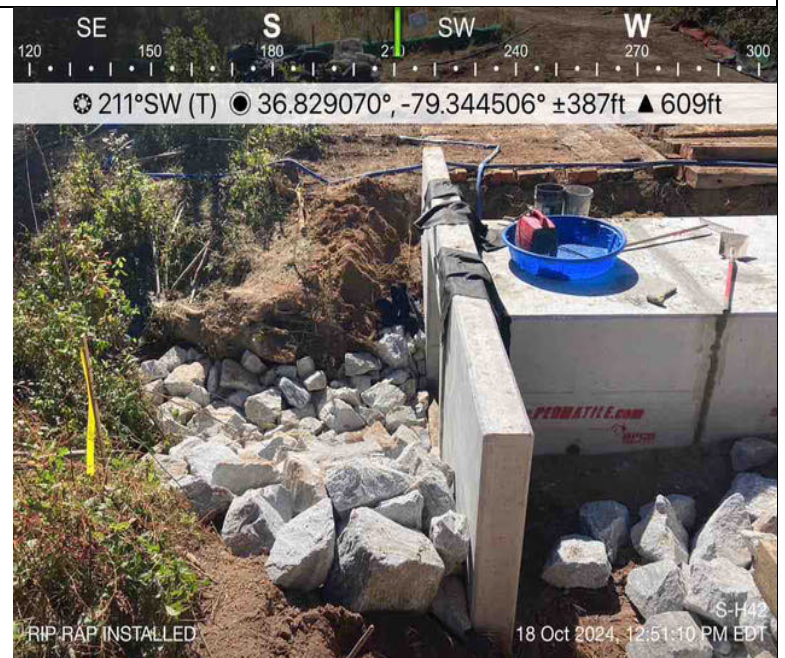
Riprap on upstream side of the box culvert. Backfill walls with #57 stone. Precast walls for culvert. No Concrete pouring needed.

Photo Description: Riprap installed on inflow of culvert.
