# STREAM BIOLOGICAL CONDITIONS ENVIRONMENTAL AUDITOR REPORT

Version 2.3

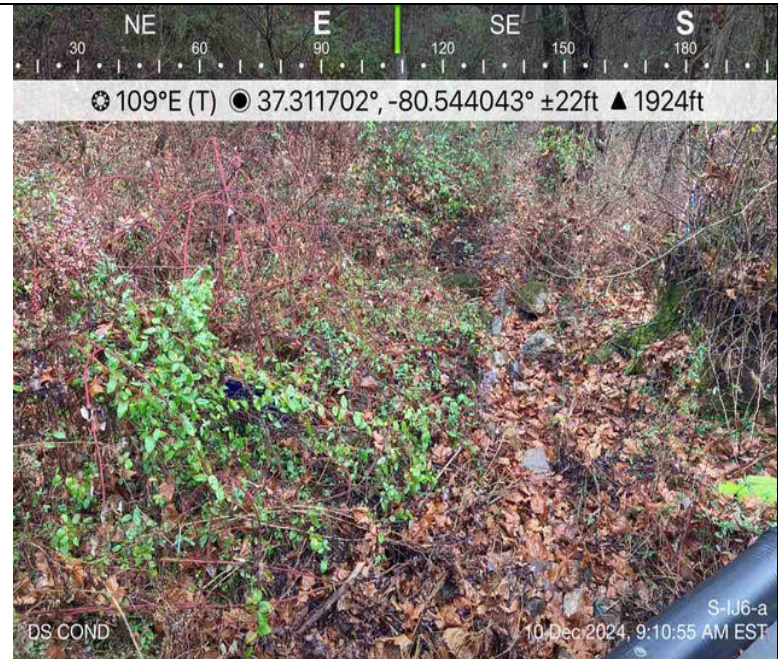
**Photo Description:** Conditions of the downstream area outside the ROW during pre-construction assessment.

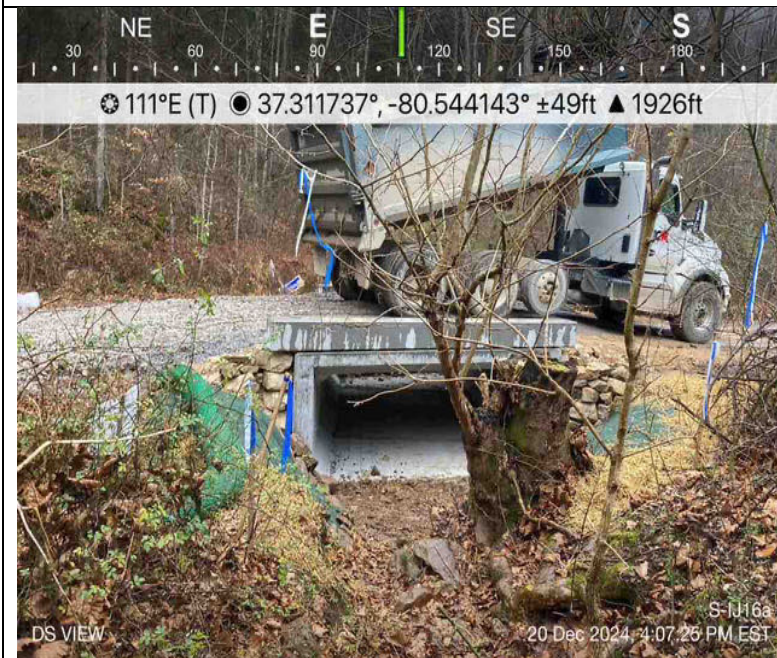
**Photo Description:** Downstream view of permitted impact area during post-construction assessment.

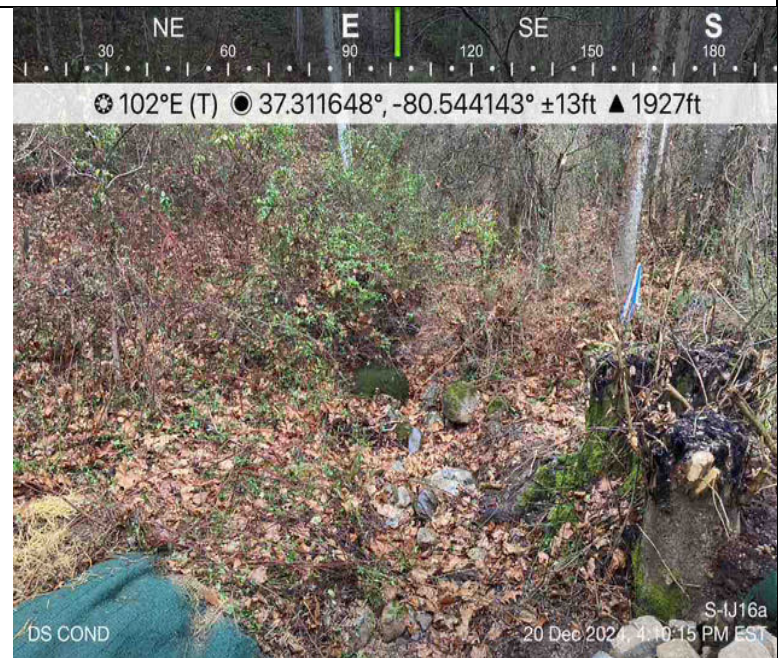
**Photo Description:** Conditions of the downstream area outside the ROW during post-construction assessment.
