# STREAM BIOLOGICAL CONDITIONS ENVIRONMENTAL AUDITOR REPORT

<b>Stream ID:</b> S-KL6	<b>Crossing Start Date:</b> 11/04/2024	<b>Crossing Completion Date:</b> 11/04/2024
<b>Milepost:</b> N/A	<b>Pre-Con Assessment Date:</b> 11/01/2024	<b>Post-Con Assessment Date:</b> 11/04/2024
<b>Station:</b> N/A	<b>Stream Classification:</b> Perennial (Perennial, Intermittent, Ephemeral)	<b>Bankfull Width (ft.):</b> 4
<b>County:</b> Montgomery	<b>303(d) Impairment Listing:</b> Not Impaired	<b>Riffle:Pool Complexes Present?</b> No

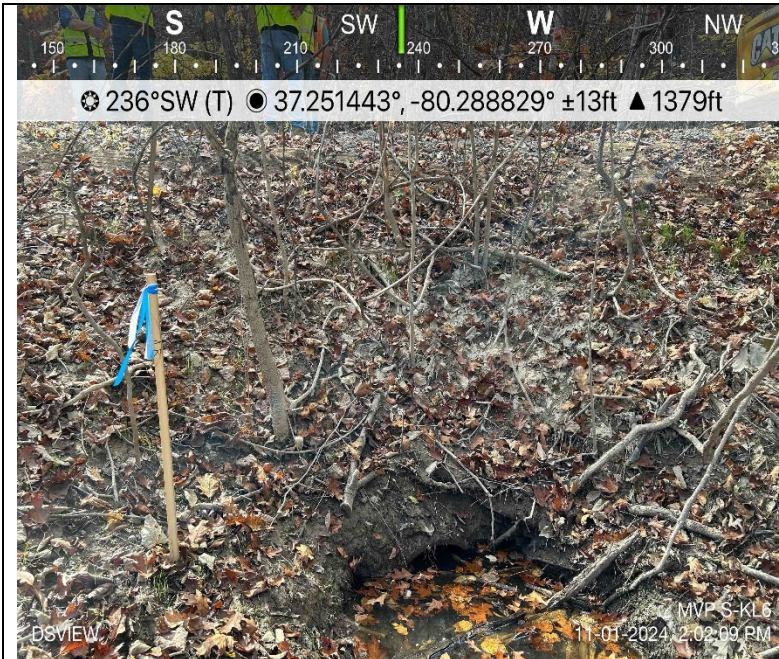
**Photo Description:** Downstream view of permitted impact area during pre-construction assessment.

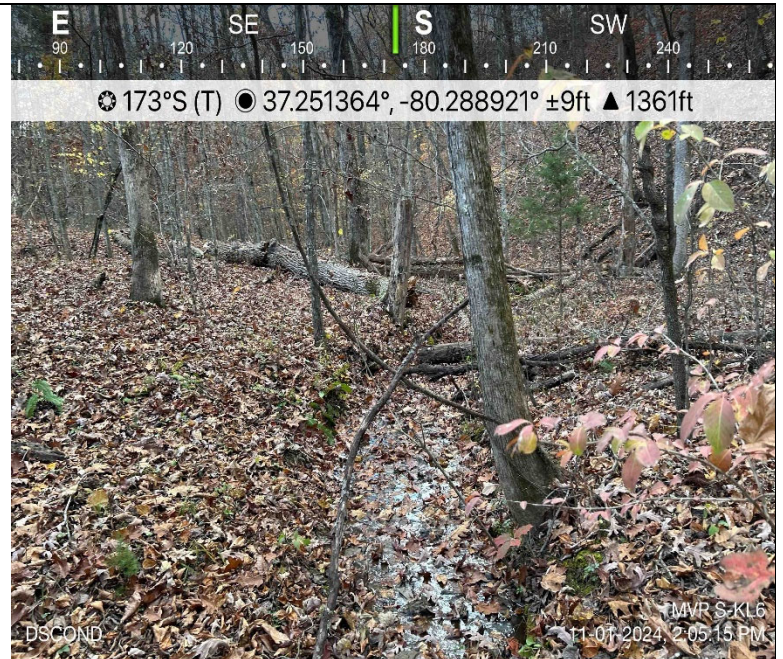
**Photo Description:** Conditions of the downstream area outside the ROW during pre-construction assessment.

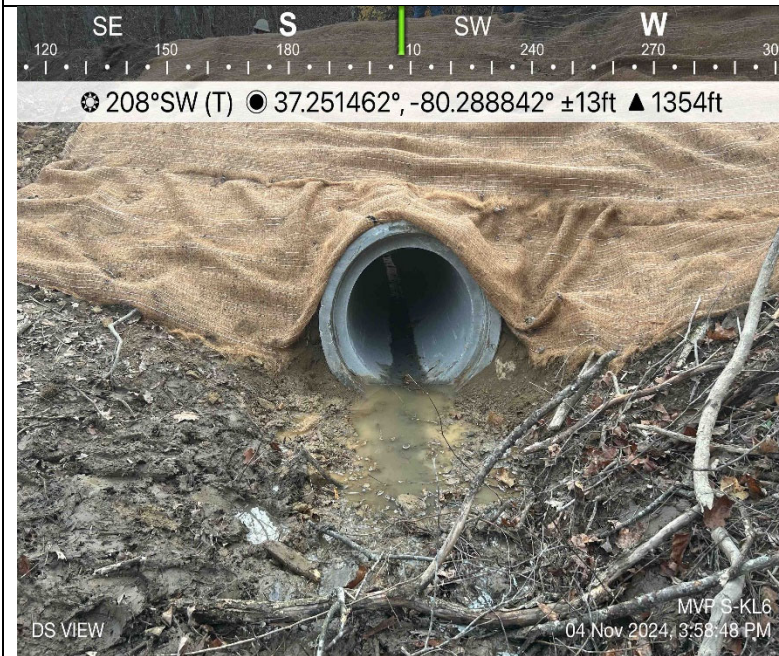
**Photo Description:** Downstream view of permitted impact area during post-construction assessment.

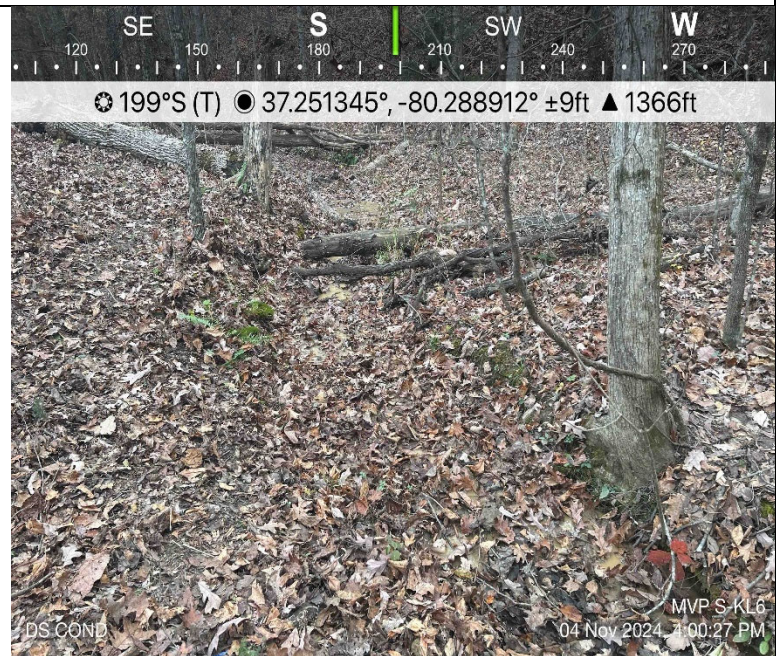
**Photo Description:** Conditions of the downstream area outside the ROW during post-construction assessment.

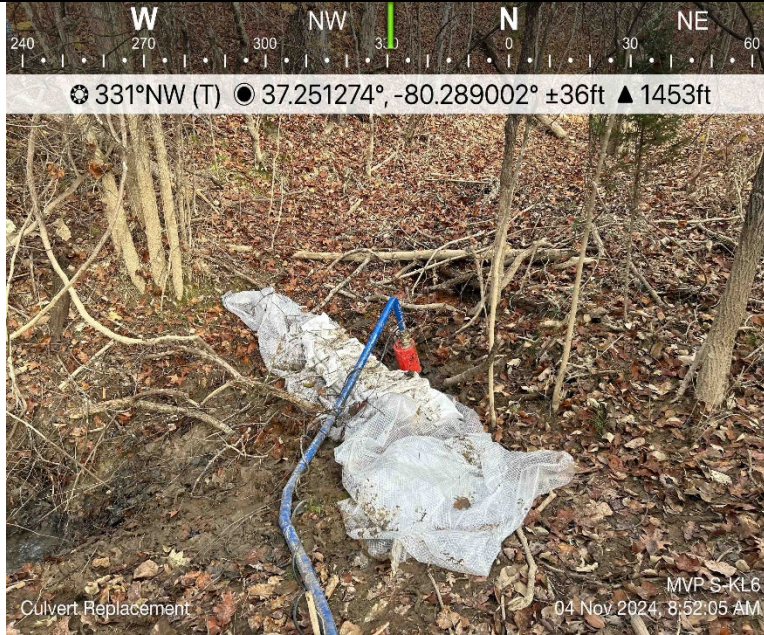
**Photo Description:** Dam and pump installation on upstream side of culvert.

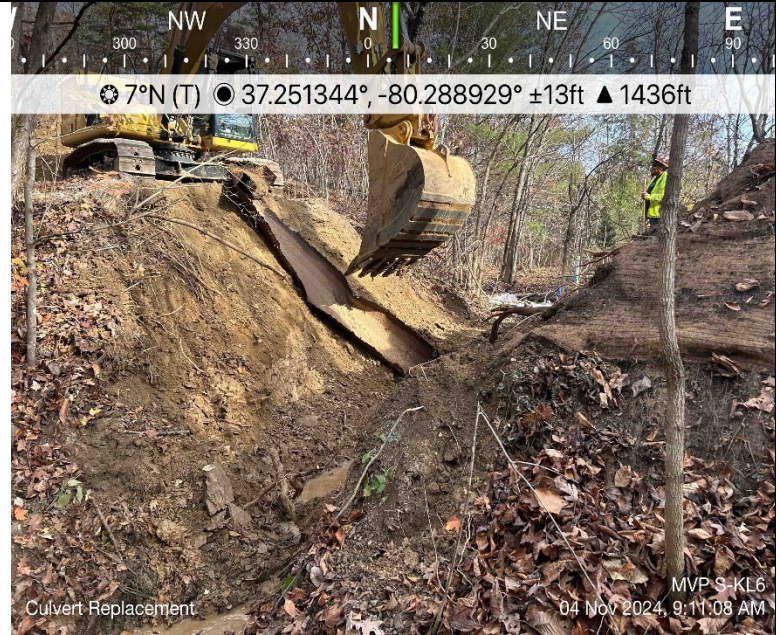
11/01/2024: Pre-construction meeting and assessment completed. This impact is associated with the replacement of a pre-existing culvert along MVP access road MVP-MN-270. Pre-existing culvert is clogged/blocked with debris and transitions from a 27" concrete culvert to an 18" steel culvert underneath the roadway. -N. Fillip

**Photo Description:** Existing culvert removal. Steel culvert was heavily rusted and disintegrated during removal.

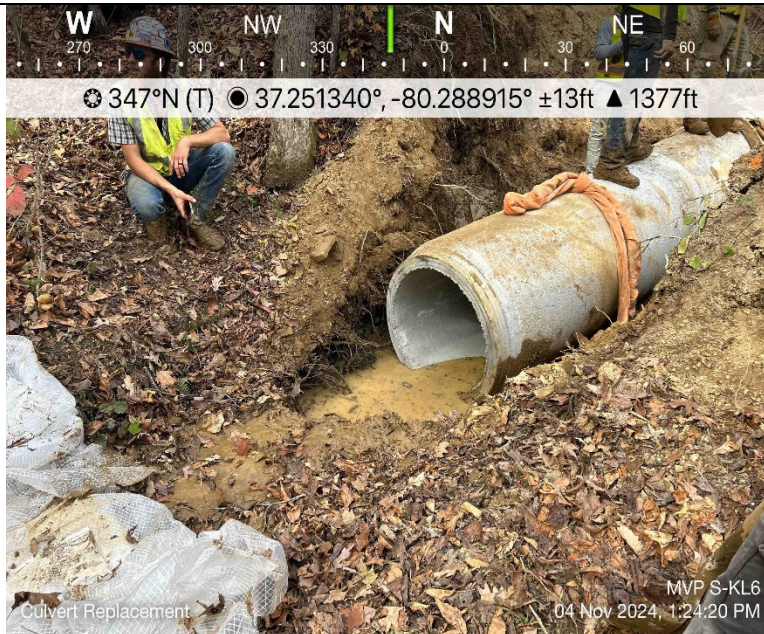
**Photo Description:** New culvert installed with proper countersinking depth of 6" below natural stream bottom.

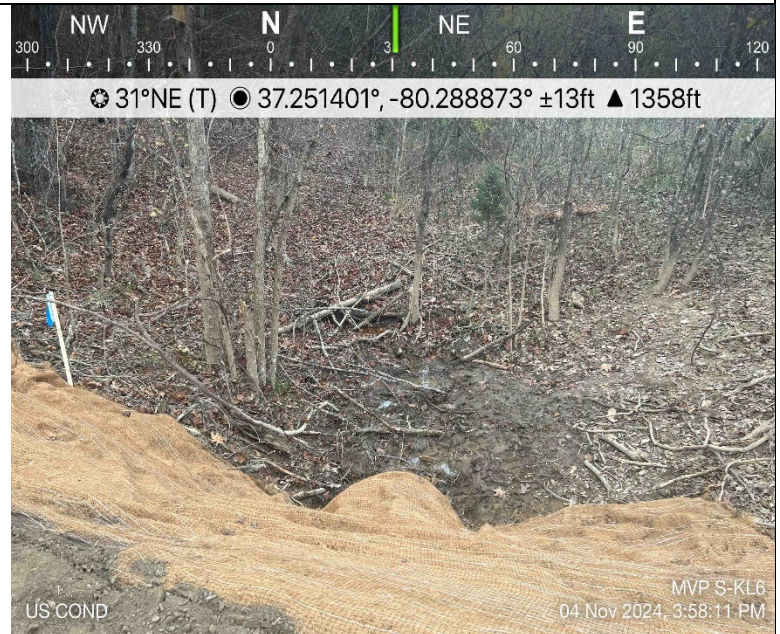
**Photo Description:** View of upstream conditions from the new culvert installation after final stabilization.
