STREAM BIOLOGICAL CONDITIONS ENVIRONMENTAL AUDITOR REPORT

Stream ID: S-NN11	Crossing Start Date: 10/31/2024	Crossing Completion Date: 10/31/2024
Milepost: 214.8	Pre-Con Assessment Date: 10/24/2024	Post-Con Assessment Date: 10/31/2024
Station: 11352+97	Stream Classification: Intermittent (Perennial, Intermittent, Ephemeral)	Bankfull Width (ft.): 5
County: Giles	303(d) Impairment Listing: Not Impaired	Riffle:Pool Complexes Present? No

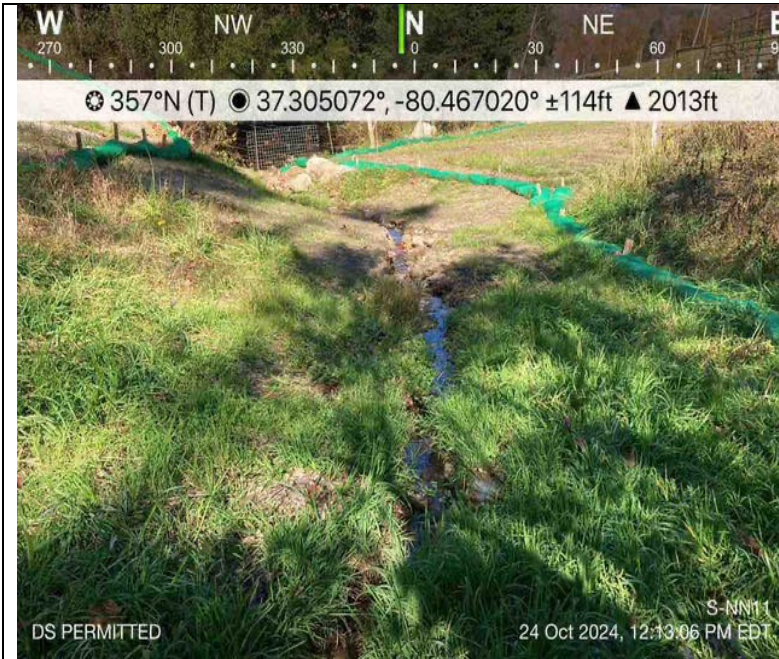
Photo Description: Downstream view of permitted impact area during pre-construction assessment.

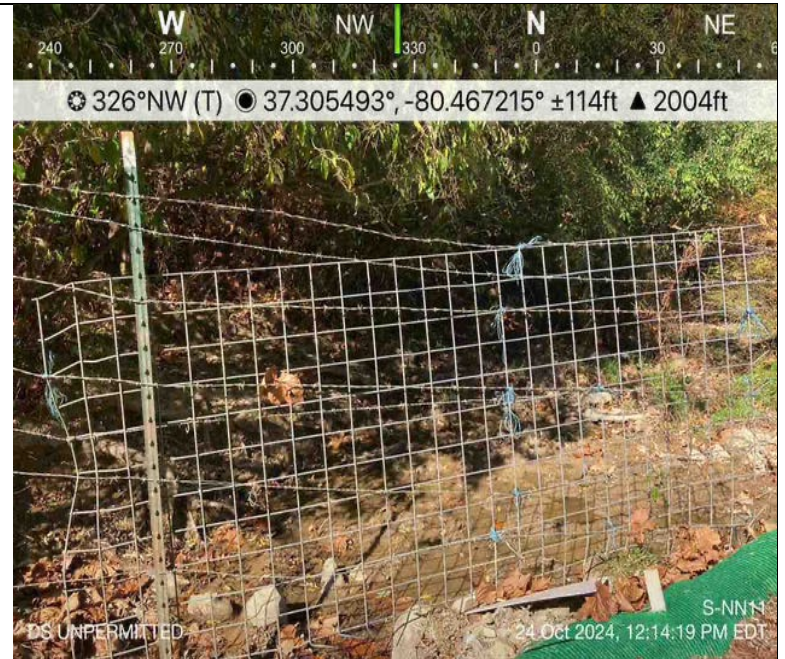
Photo Description: Conditions of the downstream area outside the ROW during pre-construction assessment.

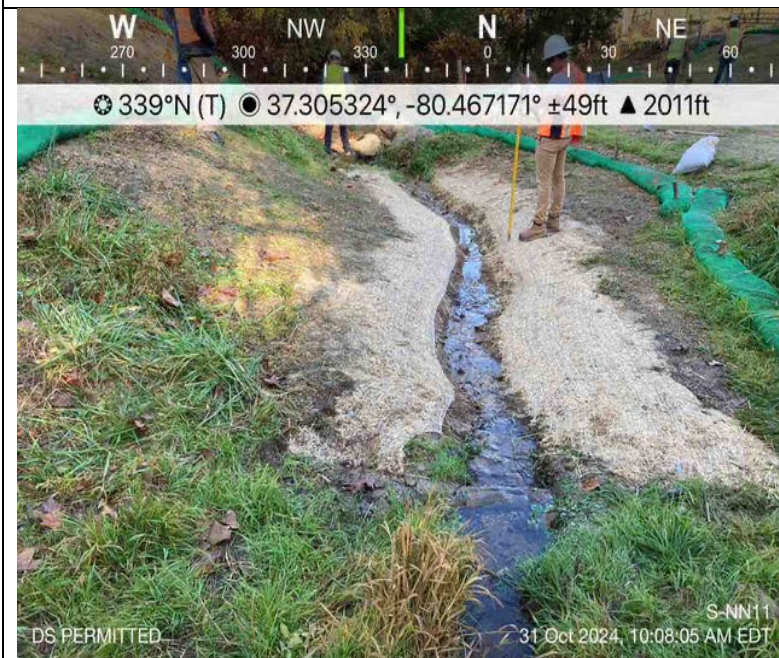
Photo Description: Downstream view of permitted impact area during post-construction assessment.

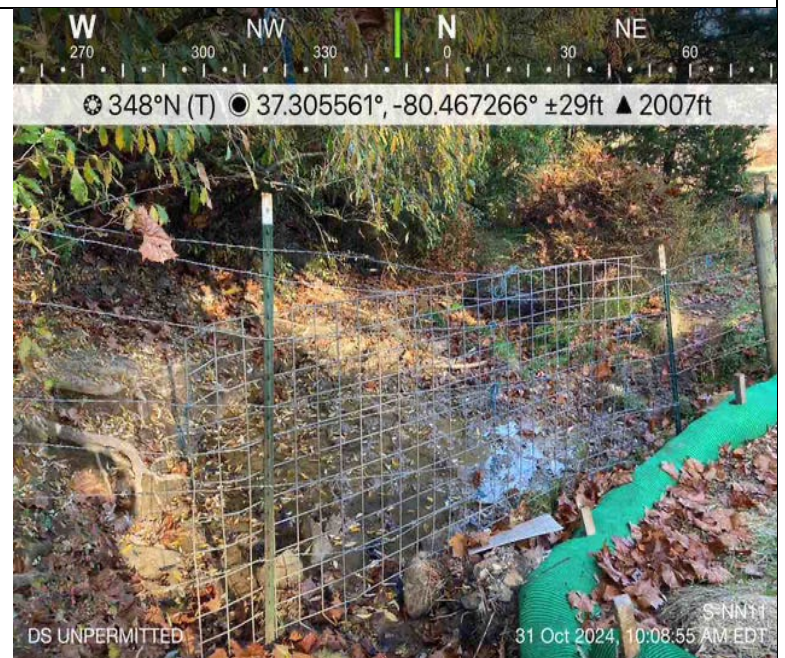
Photo Description: Conditions of the downstream area outside the ROW during post-construction assessment.

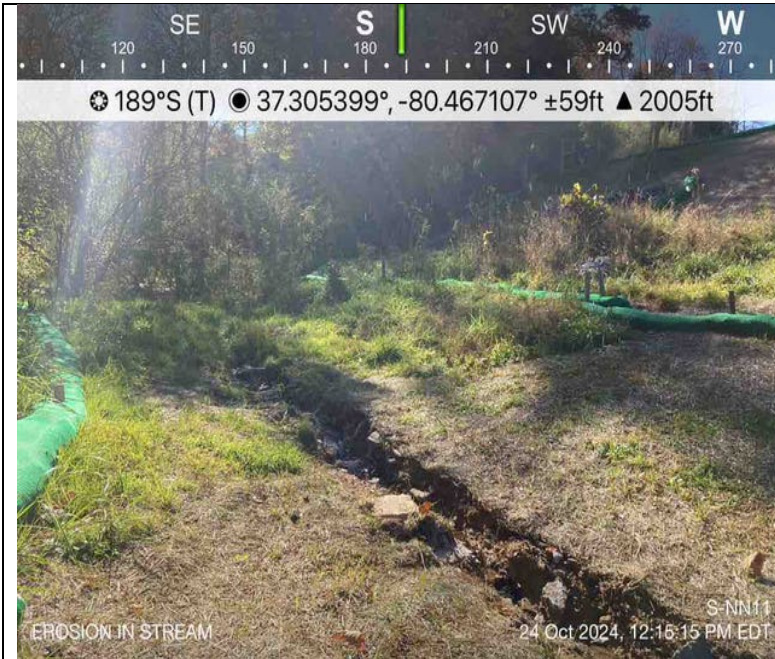
Photo Description: Erosion within the stream bed.

10/31/2024- Pre-construction meeting held. All work will be conducted by hand. Dams upstream and downstream installed. Energy dissipator was placed atop visqueen downstream. Substrate was removed and stored in a 5-gallon bucket. Banks were tamped back to grade and substrate was restored to the stream bed. The banks were seeded and strawed and ECM was installed and keyed in with biodegradable stakes per landowner request. The dams were removed and flow was restored to the stream. New survey shots will be taken. There were no impacts to biological conditions observed during the stream repair activities. -A. Breeding

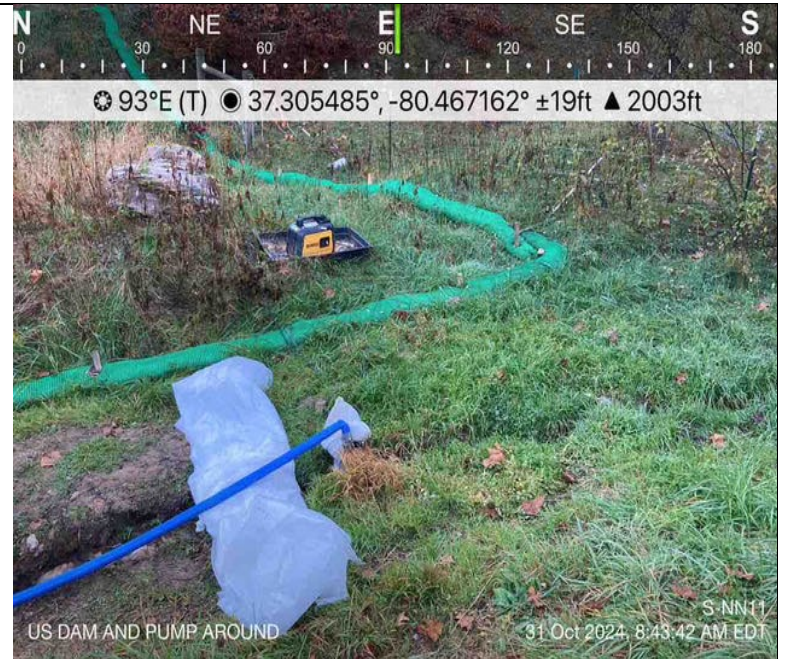
Photo Description: Dam and pump around installed.

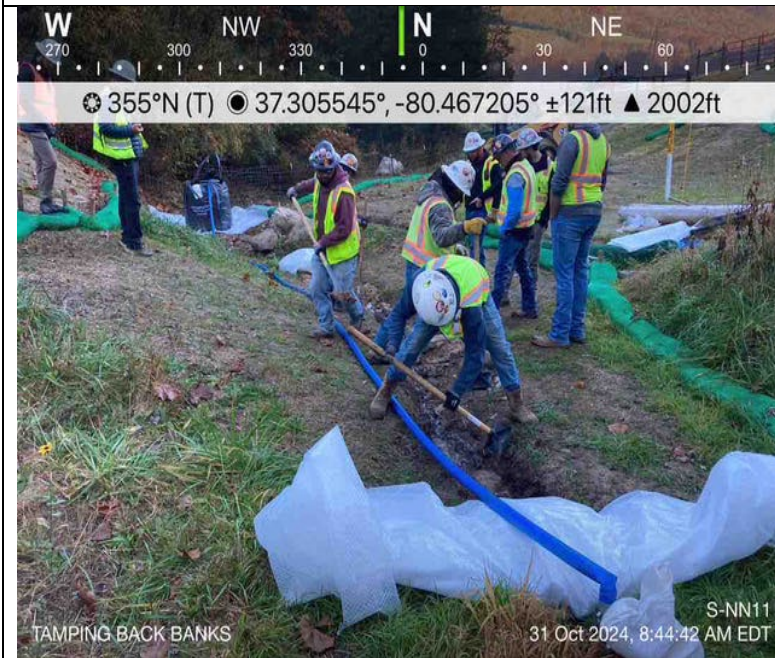
Photo Description: Tamping back banks.

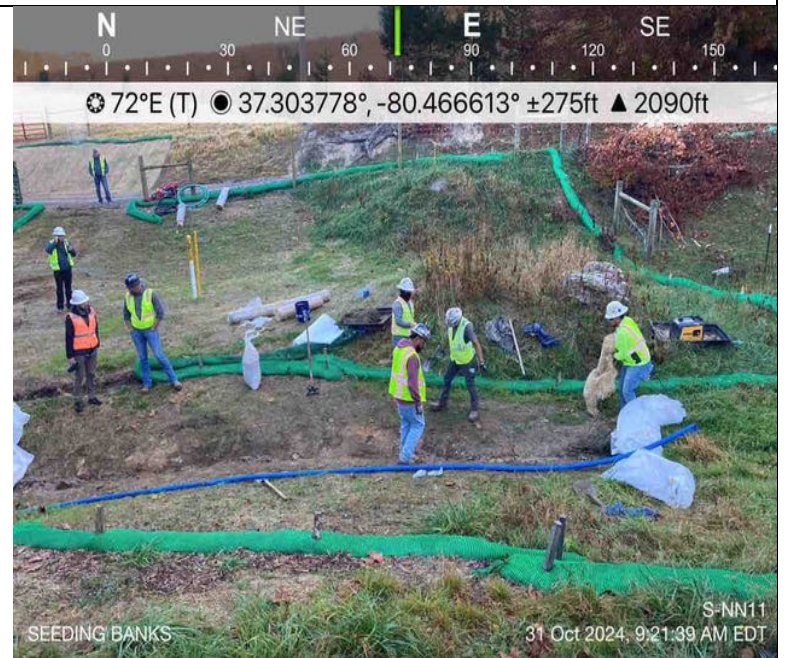
Photo Description: Applying seed to the banks before installing ECM.
