STREAM BIOLOGICAL CONDITIONS ENVIRONMENTAL AUDITOR REPORT

Stream ID: S-NN13

Milepost: 214.4

Please note that this report is for a culvert replacement along an approved MVP access road. This stream was not crossed during active pipeline construction, therefore, no report was generated.

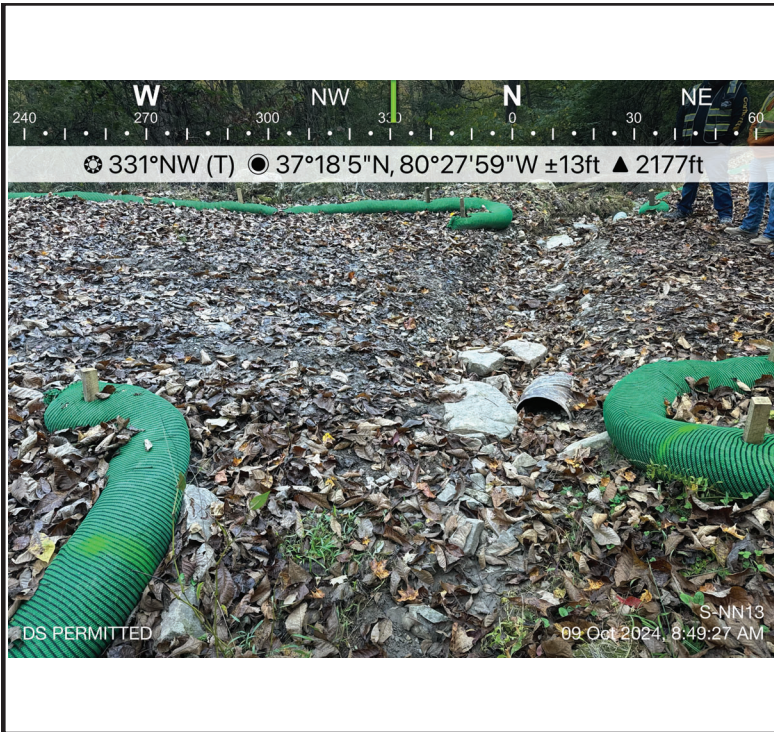
Photo Description: Downstream view of permitted impact area during pre-construction assessment.

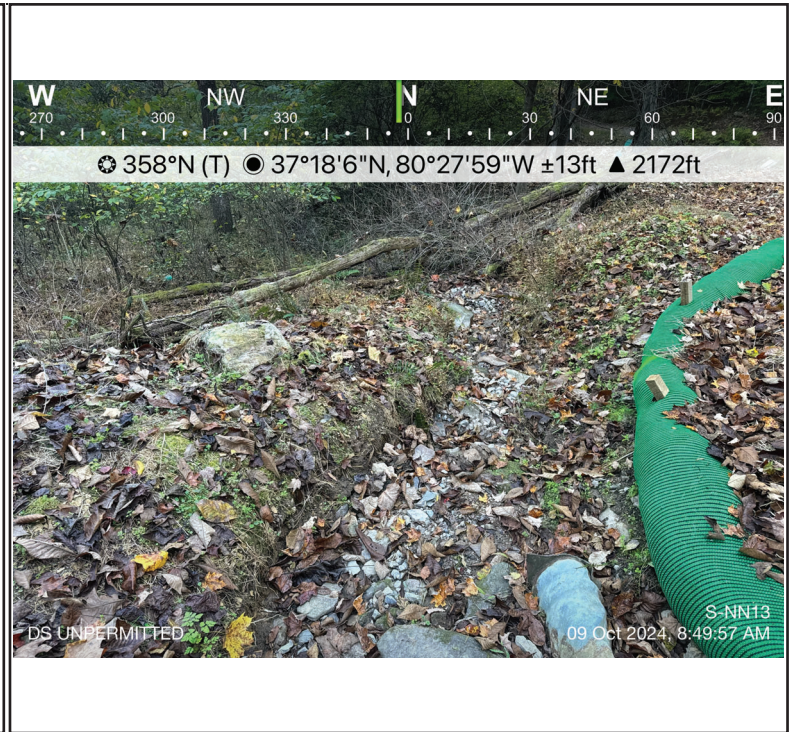
Photo Description: Downstream view of unpermitted area during pre-construction assessment.

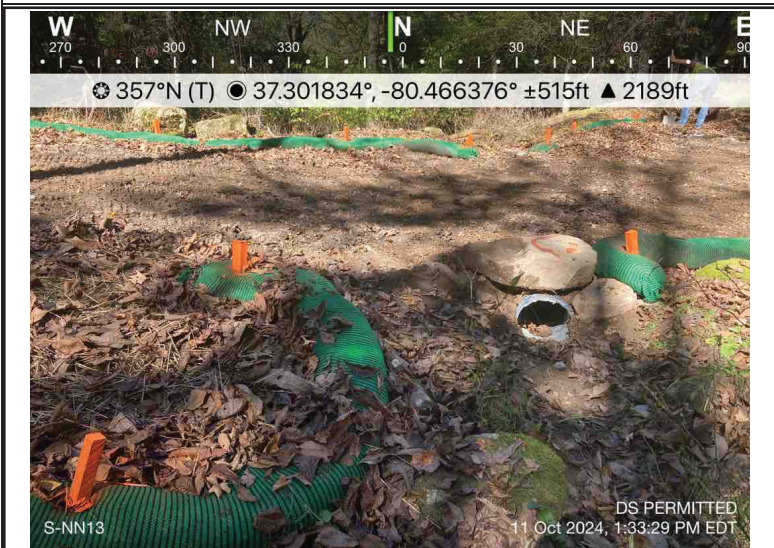
Photo Description: Downstream view of permitted impact area during post-construction assessment.

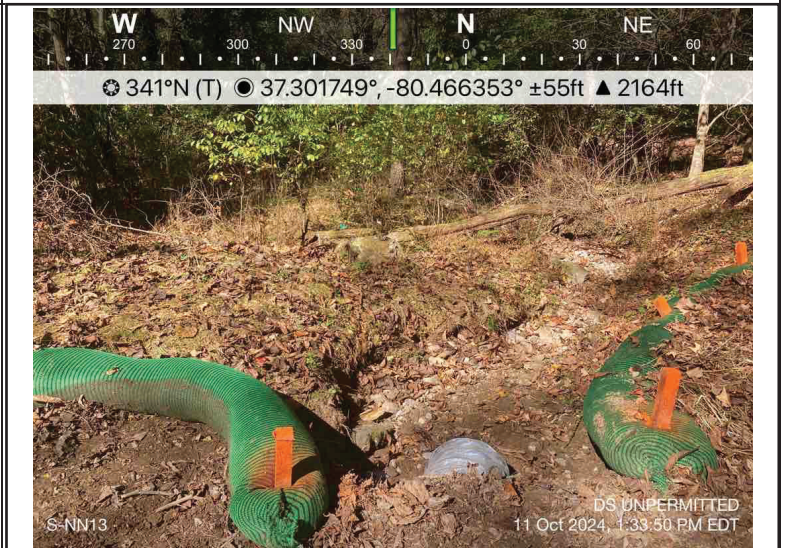
Photo Description: Downstream view of unpermitted area during post-construction assessment.

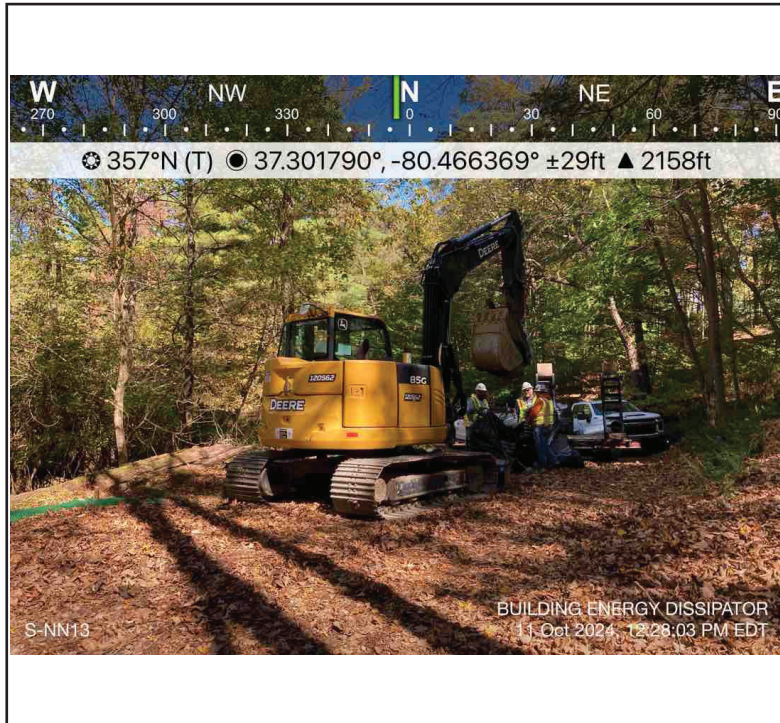
Photo Description:
Building energy dissipator.

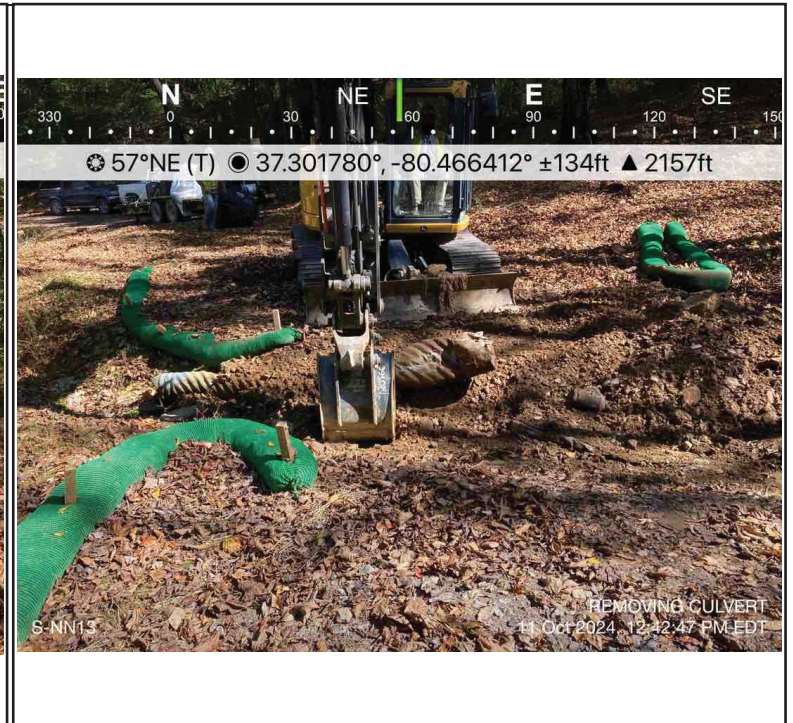
Photo Description:
Removing old culvert.

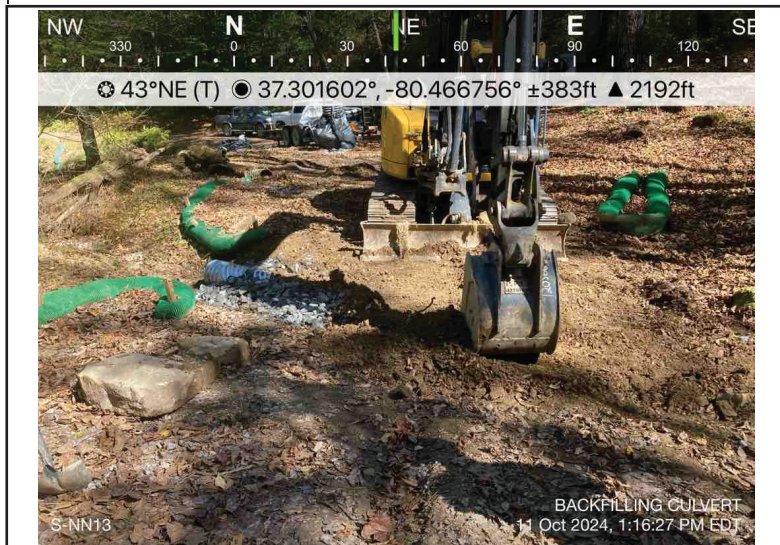
Photo Description:
Backfilling around new culvert.

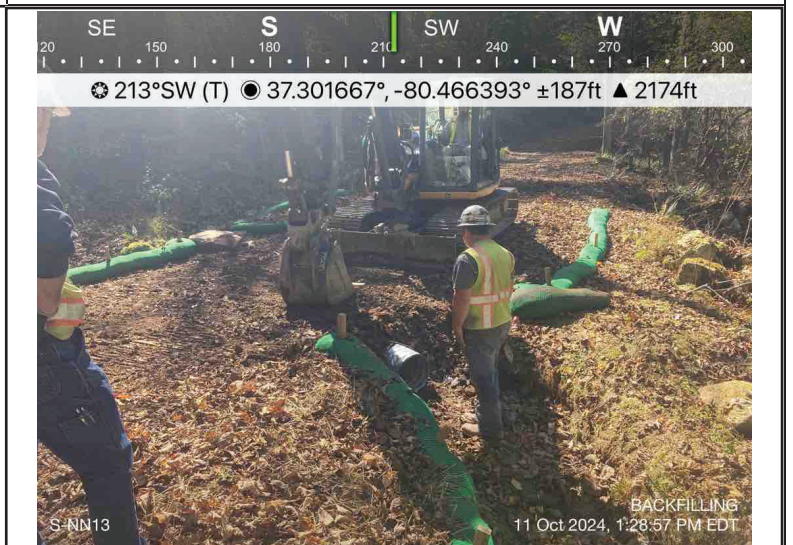
Photo Description:
Culvert backfill complete.
