STREAM BIOLOGICAL CONDITIONS ENVIRONMENTAL AUDITOR REPORT

Stream ID: S-D20	Crossing Start Date: 03/10/2025	Crossing Completion Date: 03/11/2025
Milepost: 261.3	Pre-Con Assessment Date: 03/10/2025	Post-Con Assessment Date: 03/11/2025
Station: 13805+52	Stream Classification: Intermittent (Perennial, Intermittent, Ephemeral)	Bankfull Width (ft.): 8
County: Franklin	303(d) Impairment Listing: Not Impaired	Riffle:Pool Complexes Present? No

Please note that this is a bank repair report.

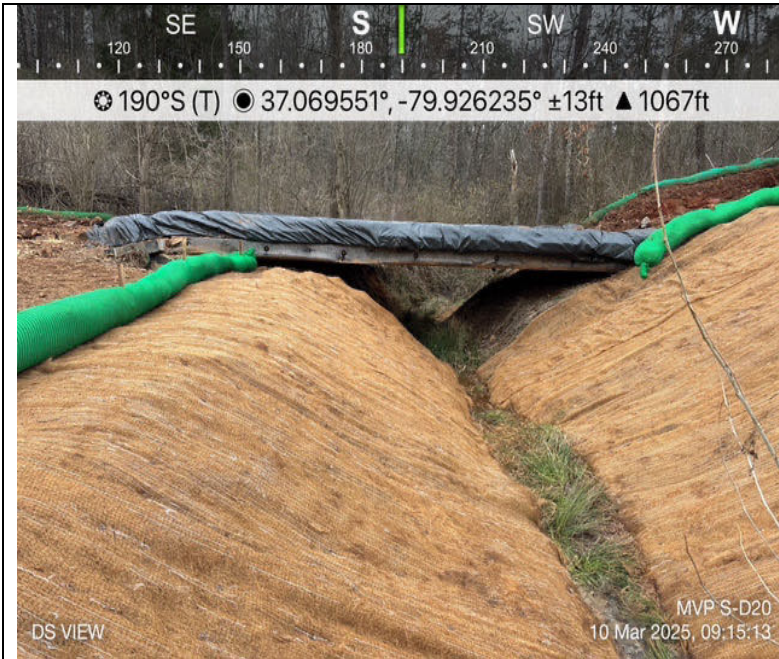
Photo Description: Downstream view of permitted impact area during pre-construction assessment.

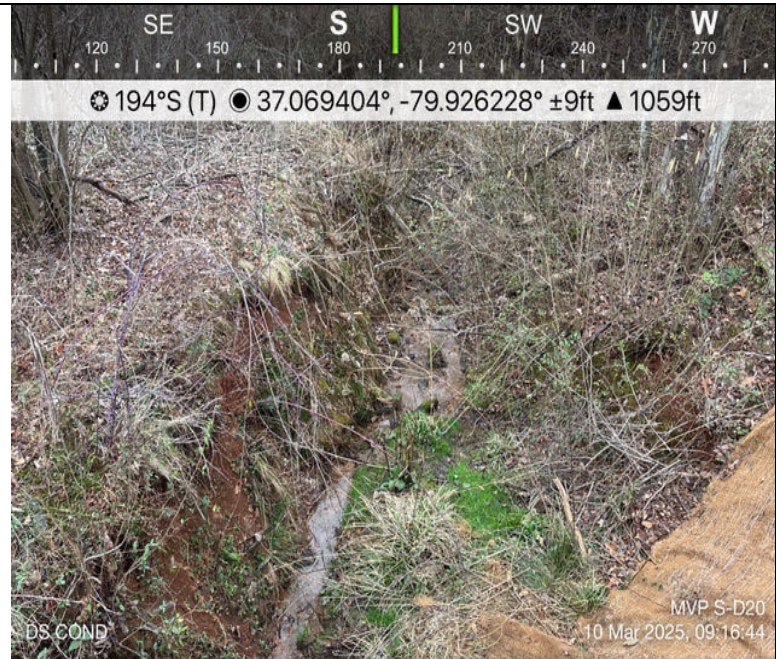
Photo Description: Conditions of the downstream area outside the ROW during pre-construction assessment.

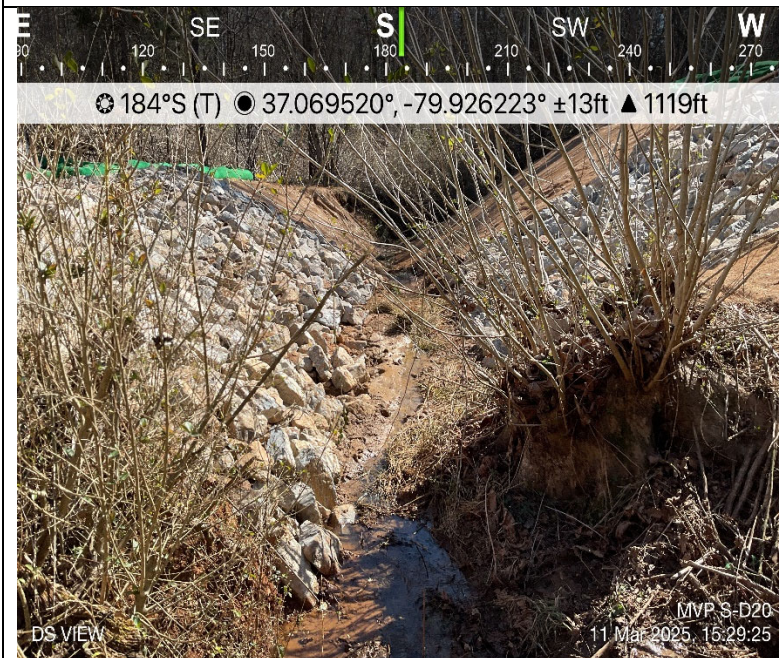
Photo Description: Downstream view of permitted impact area during post-construction assessment.

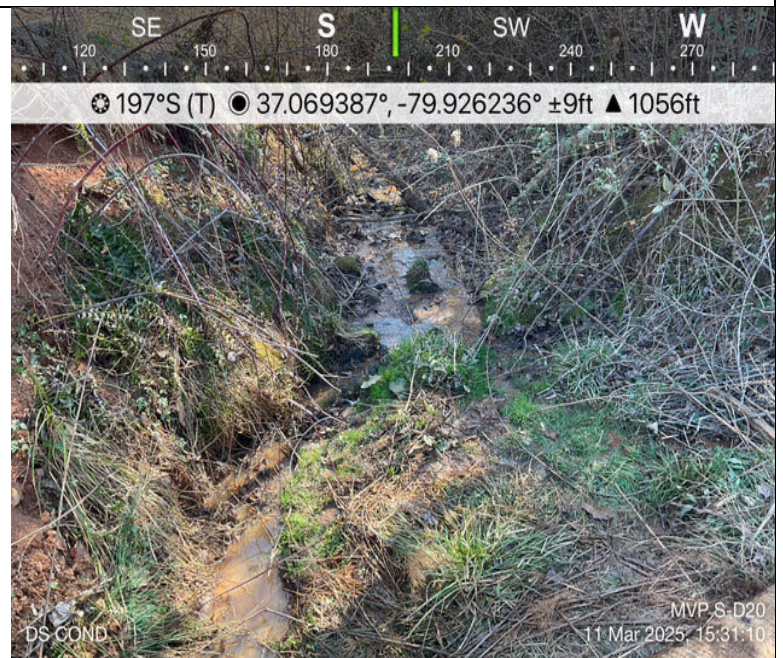
Photo Description: Conditions of the downstream area outside the ROW during post-construction assessment.

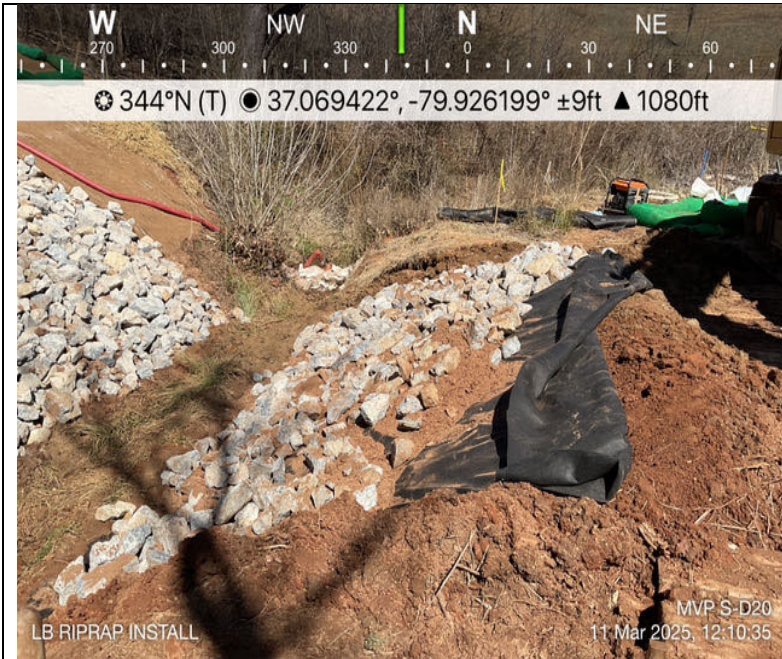
Photo Description: Riprap placement on left bank.

Item #8 & #19: Riprap was installed on the left and right stream banks above the pipe centerline to ensure long term stability of the crossing area.

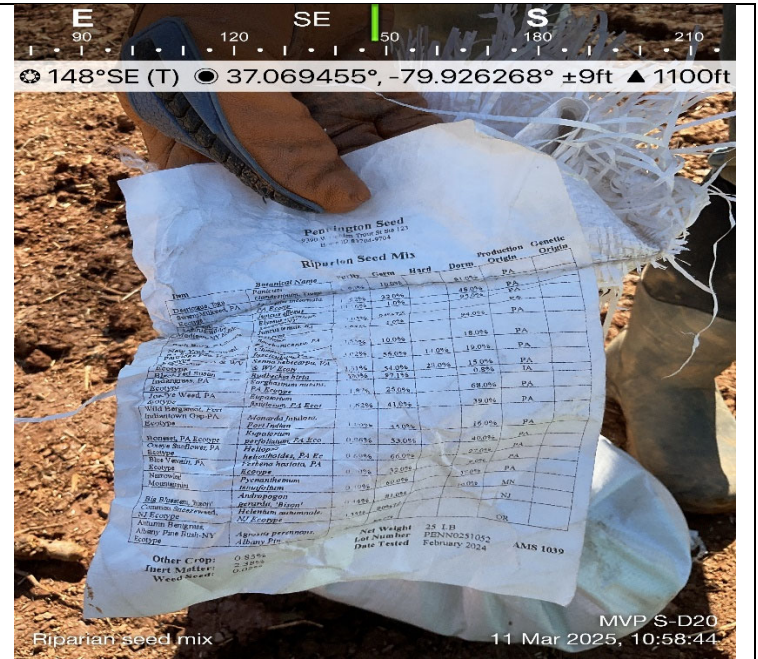
Photo Description: Riparian seed mix used for stabilization.

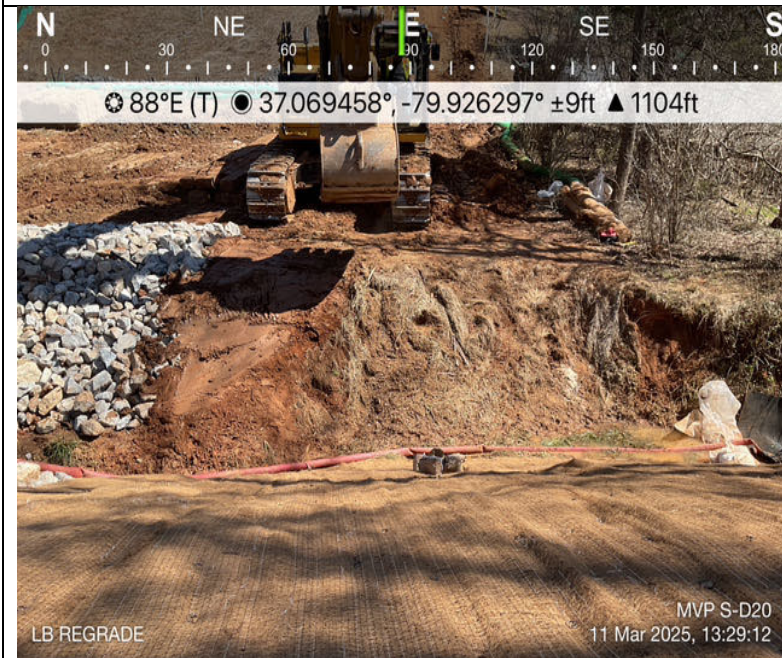
Photo Description: Regrading left bank where bridge was staged.

03/11/2025: Dam and pump was reinstalled and the workspace was staged with timber mats for the site equipment to operate on to reduce compaction. All pumps and fuel cans are stored in secondary containments. Erosion controls were removed from left bank, and the bank was regraded to a stable angle of repose (~3:1). For the area above the pipe installation, a geotextile fabric underlayment was applied, and imported riprap was installed along the left bank to provide long term stability of the crossing area. For the area where the bridge was previously installed, the left bank was regraded to a stable angle of repose, seeded, and stabilized with erosion control matting. The edges of the matting were keyed in and staked appropriately. Post-construction assessment and photos were completed. -S. Fisher

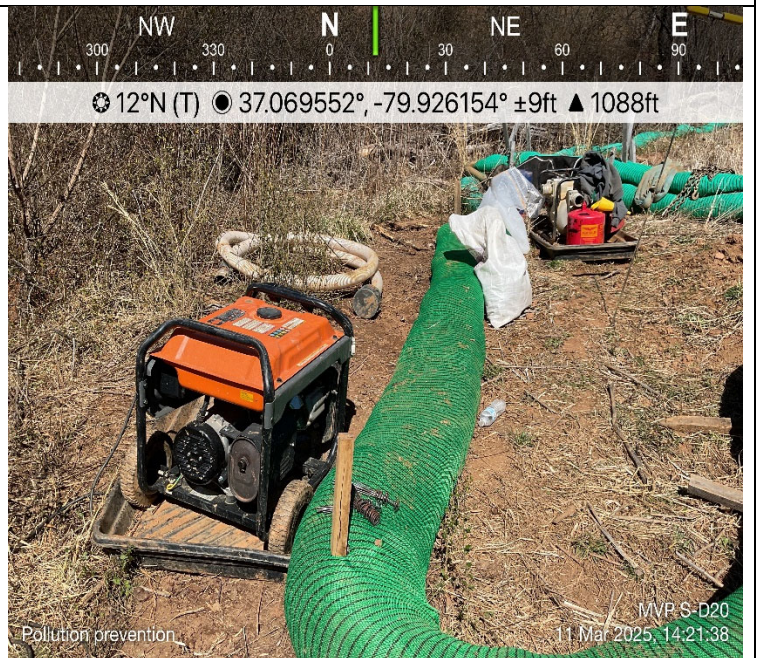
Photo Description: Pollution prevention practices in place during the bank repair.
