STREAM BIOLOGICAL CONDITIONS ENVIRONMENTAL AUDITOR REPORT

Version 2.3

Stream ID: S-D22	Crossing Start Date: 03/03/2025	Crossing Completion Date: 03/03/2025
Milepost: 261.1	Pre-Con Assessment Date: 02/05/2025	Post-Con Assessment Date: 03/03/2025
Station: 13794+66	Stream Classification: Intermittent (Perennial, Intermittent, Ephemeral)	Bankfull Width (ft.): 8
County: Franklin	303(d) Impairment Listing: Not Impaired	Riffle:Pool Complexes Present? No

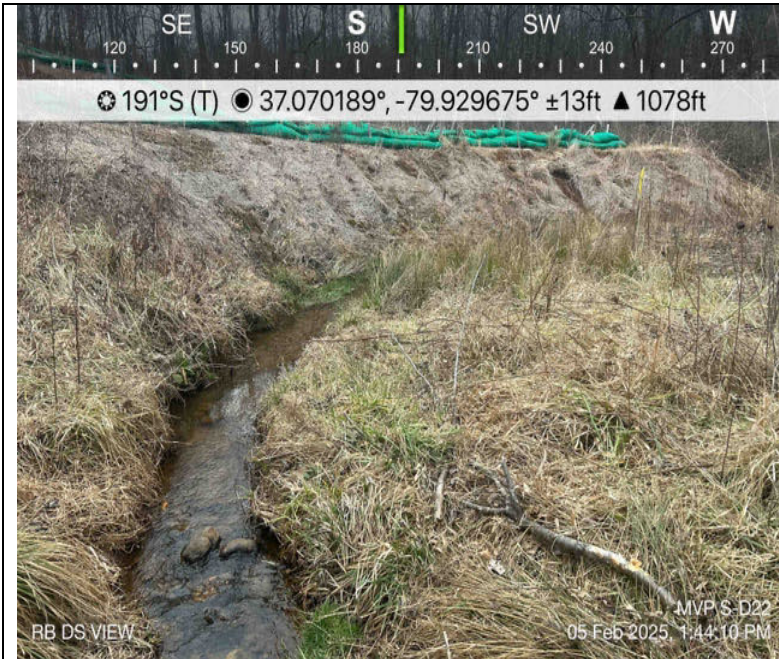
Photo Description: Downstream view of permitted impact area during pre-construction assessment.

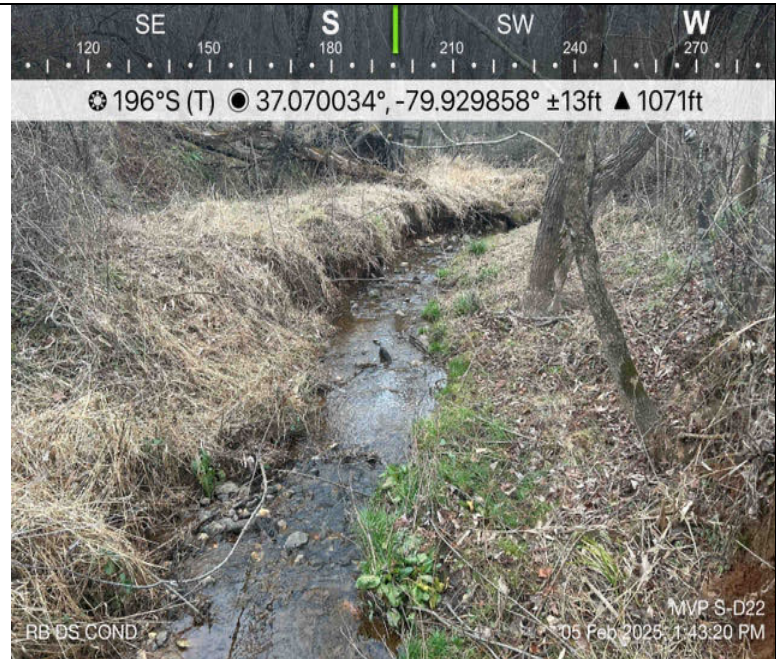
Photo Description: Conditions of the downstream area outside the ROW during pre-construction assessment.

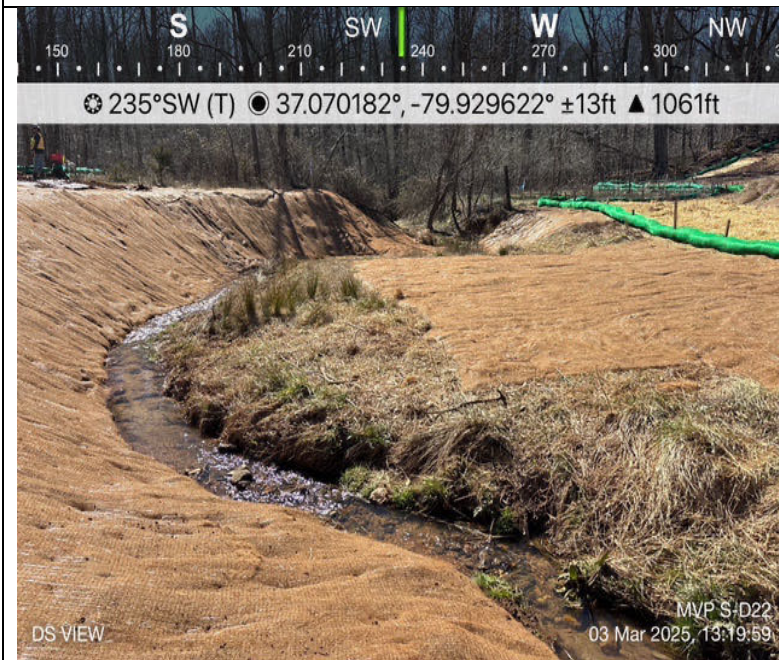
Photo Description: Downstream view of permitted impact area during post-construction assessment.

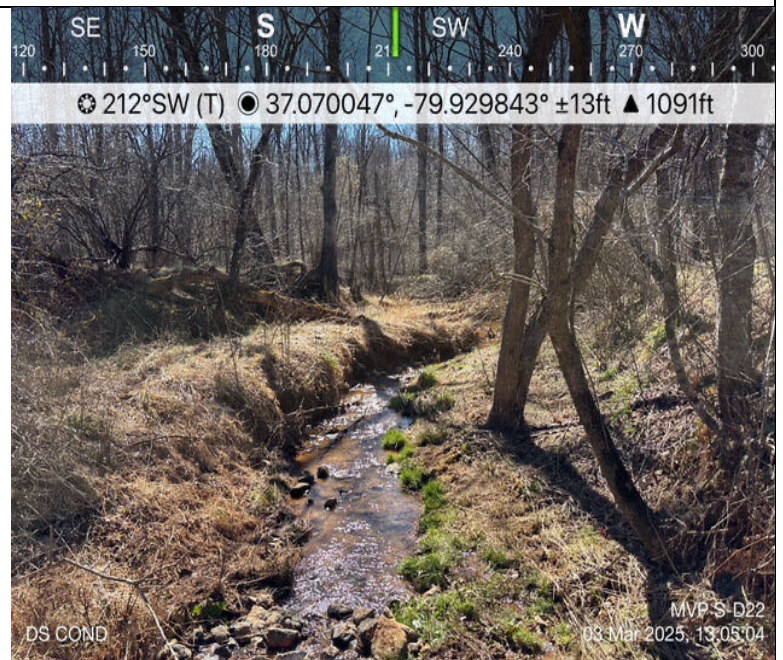
Photo Description: Conditions of the downstream area outside the ROW during post-construction assessment.

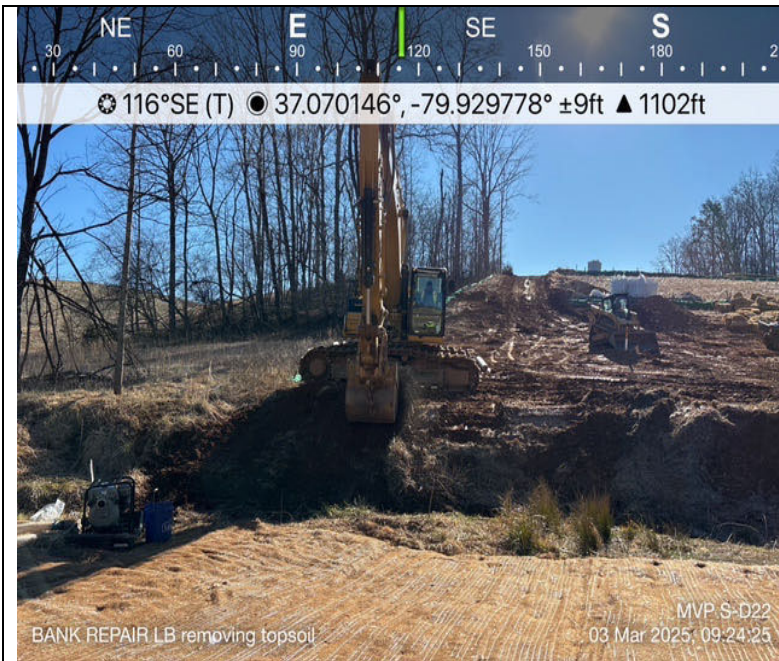
Photo Description: The topsoil was removed from the left bank and stockpiled.

3/3/2025: Fish removal was conducted prior to starting the bank repair on the left bank. An upstream and downstream dam & pump around was installed. Topsoil was removed from the left bank and stockpiled. The bank was regraded to a more stable angle of repose to repair the eroding slope. Topsoil was then returned to the bank and temporary and permanently seeded. The left bank and part of the right bank were stabilized with curlex. The dam & pump was deconstructed and flow was returned to the stream. Post-construction photos were taken and the post-construction assessment was completed. -A. Thorpe

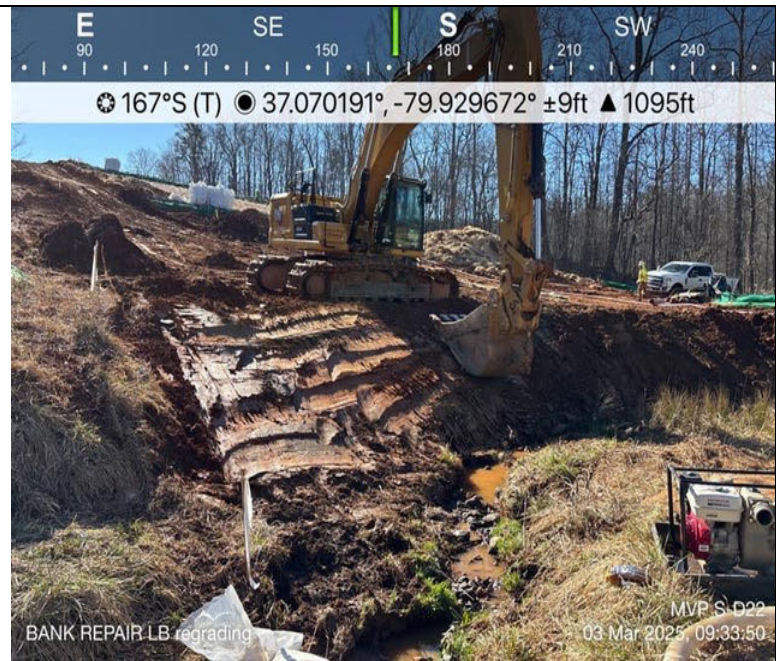
Photo Description: The bank was regraded to repair the slope.

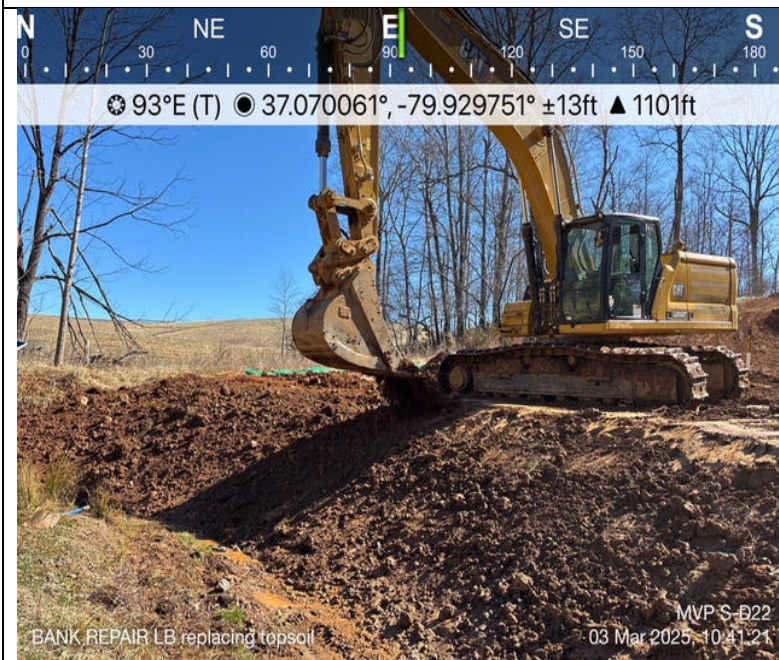
Photo Description: The topsoil was returned to the left bank and then seeded.

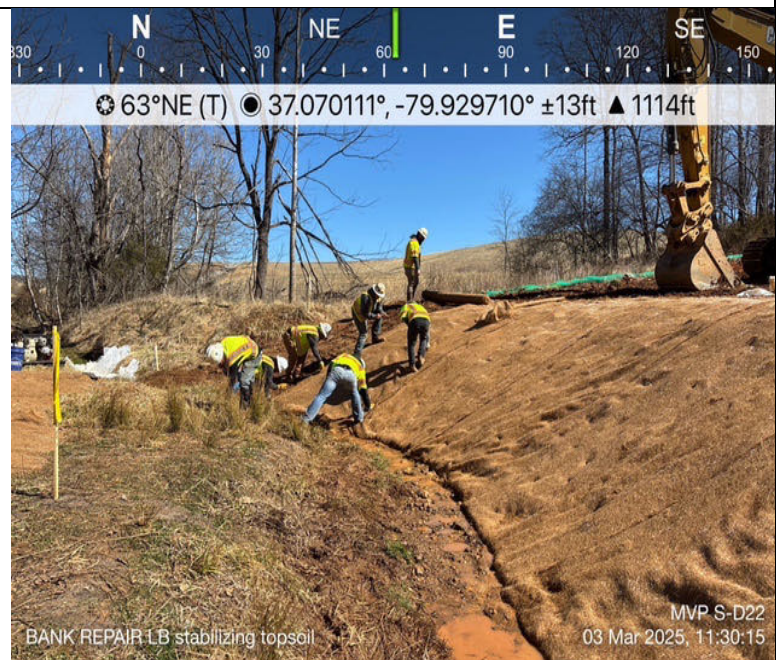
Photo Description: The bank was stabilized with curlex.
