STREAM BIOLOGICAL CONDITIONS ENVIRONMENTAL AUDITOR REPORT

| Stream ID: S-D23 | Crossing Start Date: 02/26/2025 | Crossing Completion Date: 02/27/2025 |
| Milepost: 261 | Pre-Con Assessment Date: 02/05/2025 | Post-Con Assessment Date: 02/27/2025 |

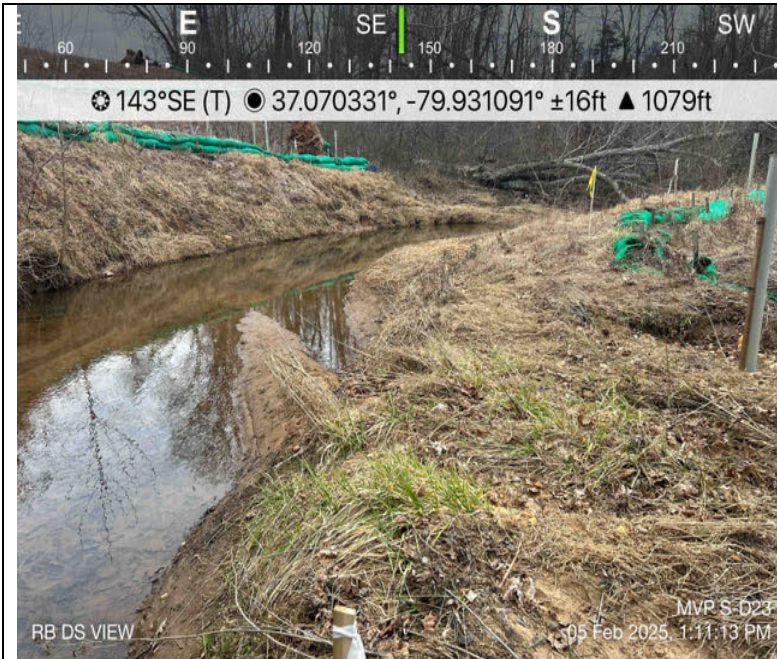
Photo Description: Downstream view of permitted impact area during pre-construction assessment.

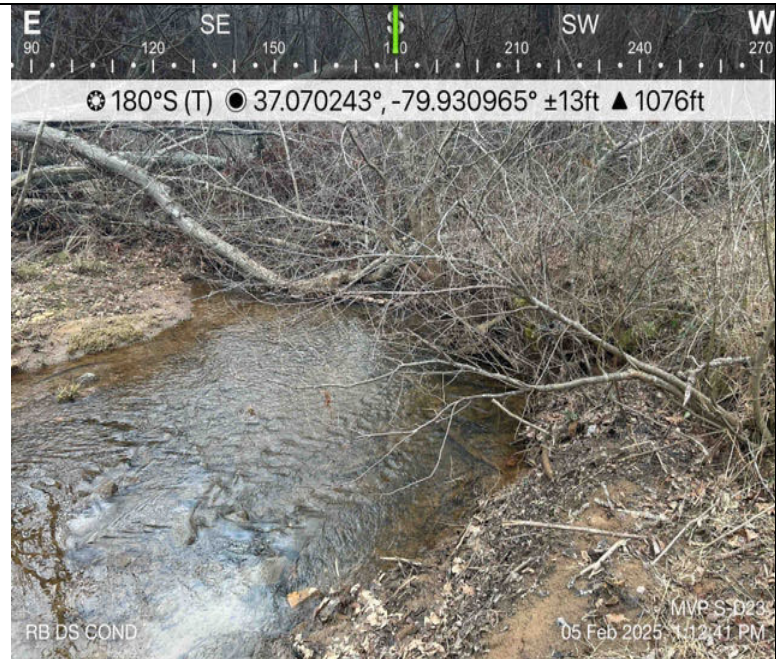
Photo Description: Conditions of the downstream area outside the ROW during pre-construction assessment.

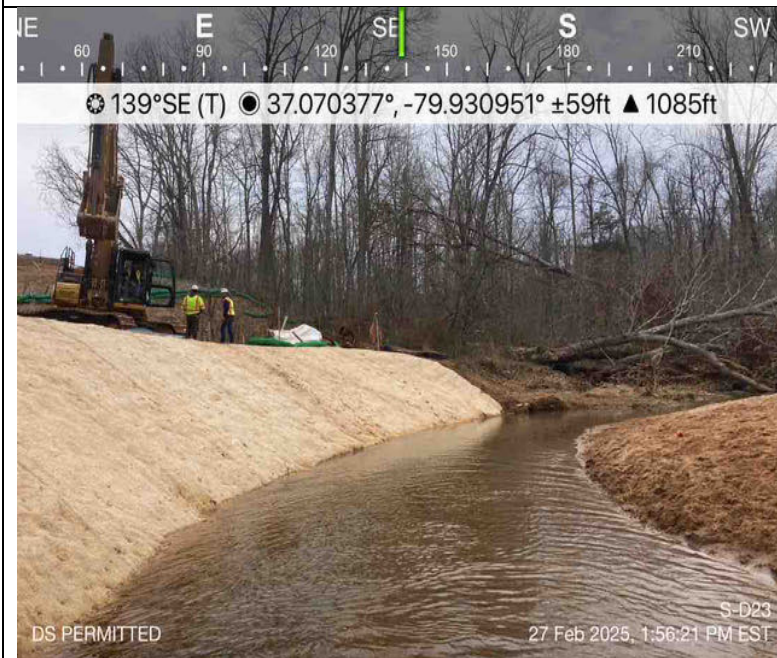
Photo Description: Downstream view of permitted impact area during post-construction assessment.

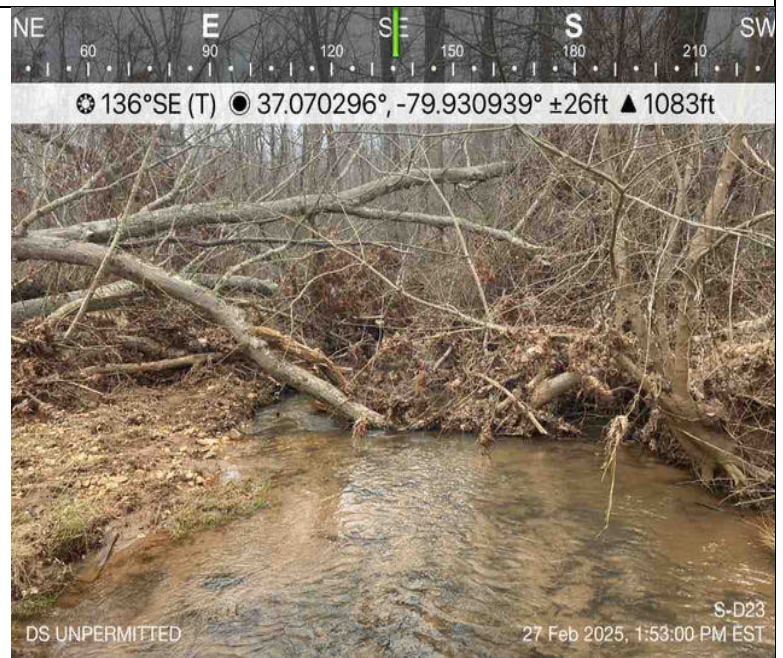
Photo Description: Conditions of the downstream area outside the ROW during post-construction assessment.

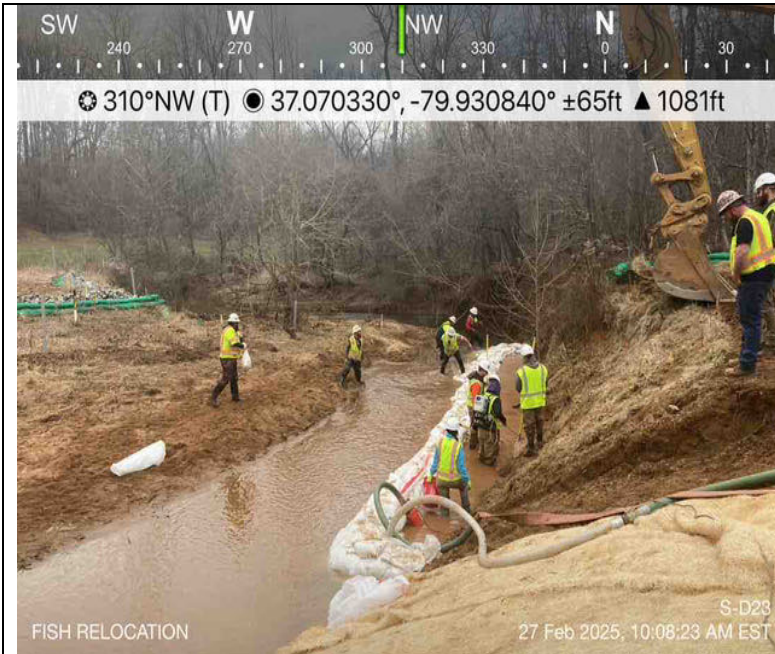
Photo Description: Fish relocation services relocated fish from within cofferdam.

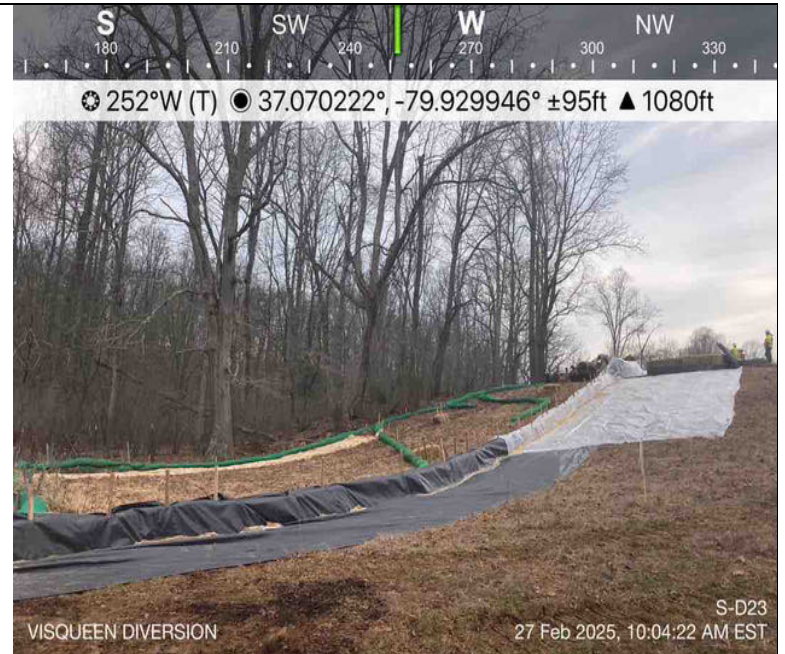
Photo Description: Dewatering operations onsite, visqueen and Geotech fabric were laid out along the slope to prevent erosion.

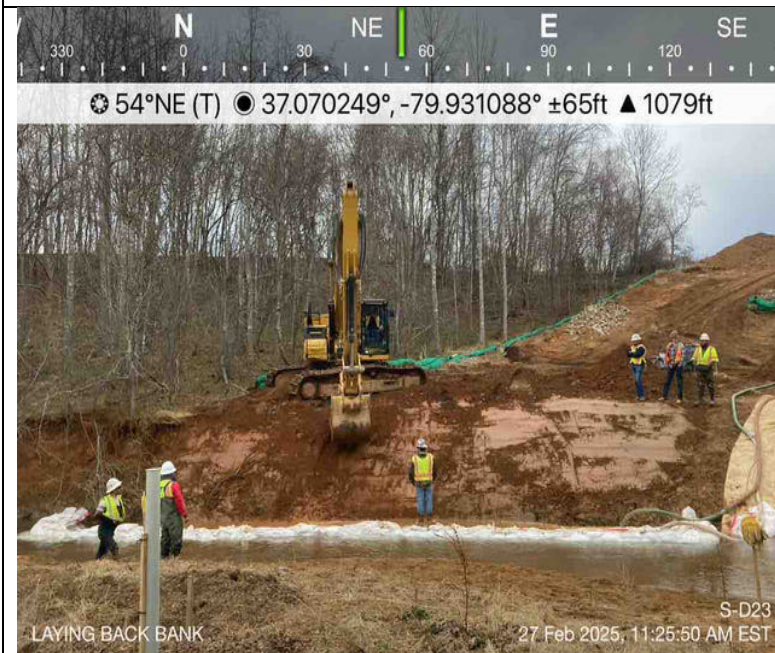
2-5-2025: Preconstruction meeting with PPL crew. Stream bank repair on the left bank due to accelerated erosion. Crew plans to regrade the bank in three sections, utilizing a cofferdam at each section to isolate the workspace from the stream. Topsoil stockpile locations and dewatering operation to be set up in upland area on the GAS. Anticipated start date is 2/7/2025 depending on weather conditions. PPL foreman is Shane. -S. Fisher

Photo Description: Slope was laid back to allow for new grade to prevent further damage to banks.

2-27-2025: The same dewatering structure was utilized for the second section of the bank repair. The new cofferdam was built and fish relocation was conducted within the cofferdam. Dewatering operations continued. Topsoil was removed and the banks were laid back to establish the new grade. Once grade was established, topsoil was restored and seeded and ECM was installed. The cofferdam was removed and flow was fully restored. ECD's were installed in the 50 ft buffer. Any saplings that were removed during construction are scheduled to be replaced in March. There were no impacts to biological conditions observed during the bank repair activities. -A. Breeding

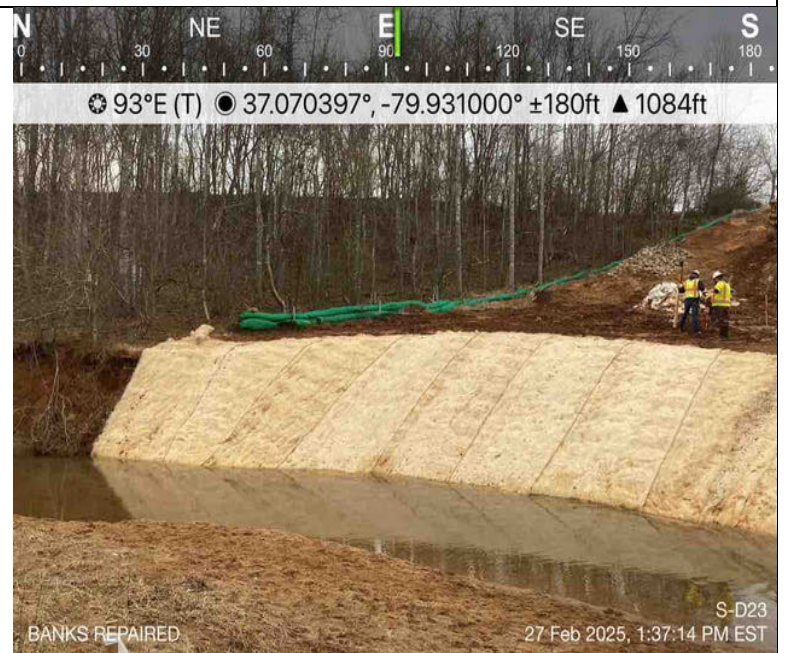
Photo Description: Area was seeded and ECM was installed after soil was appropriately restored.
