# STREAM BIOLOGICAL CONDITIONS ENVIRONMENTAL AUDITOR REPORT

<b>Stream ID:</b> S-CD8	<b>Crossing Start Date:</b> 04/10/2025	<b>Crossing Completion Date:</b> 04/10/2025
<b>Milepost:</b> 281.7	<b>Pre-Con Assessment Date:</b> 04/10/2025	<b>Post-Con Assessment Date:</b> 04/10/2025
<b>Station:</b> 14881+45	<b>Stream Classification:</b> Intermittent (Perennial, Intermittent, Ephemeral)	<b>Bankfull Width (ft.):</b> 4.5
<b>County:</b> Franklin	<b>303(d) Impairment Listing:</b> Not Impaired	<b>Riffle:Pool Complexes Present?</b> No

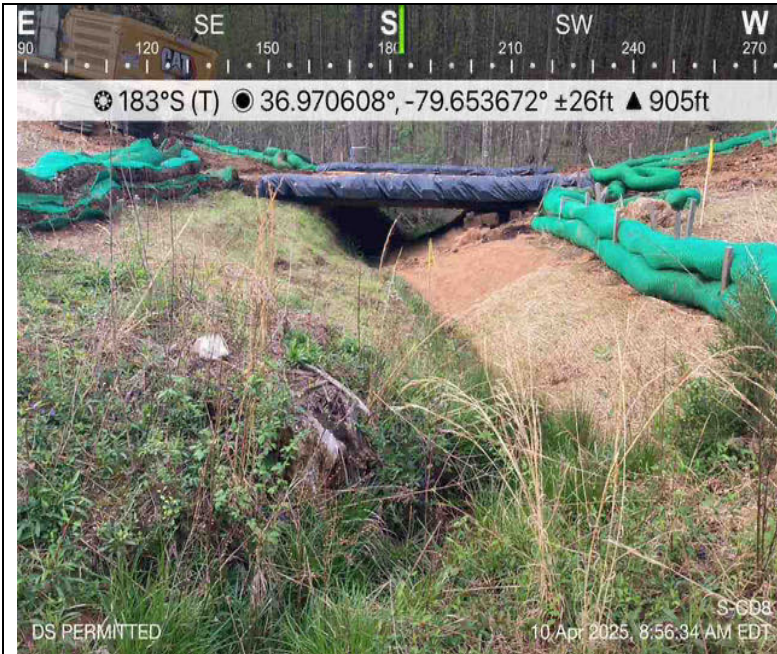
**Photo Description:** Downstream view of permitted impact area during pre-construction assessment.

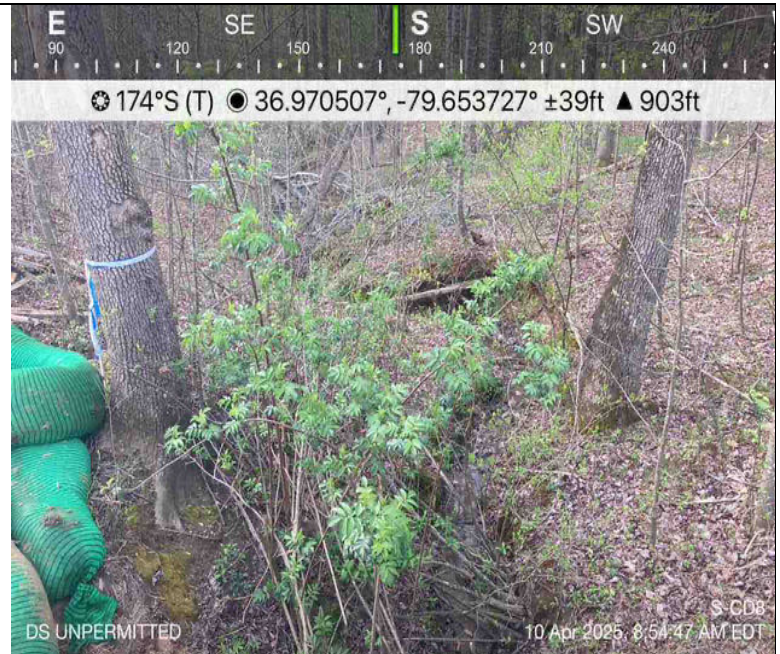
**Photo Description:** Conditions of the downstream area outside the ROW during pre-construction assessment.

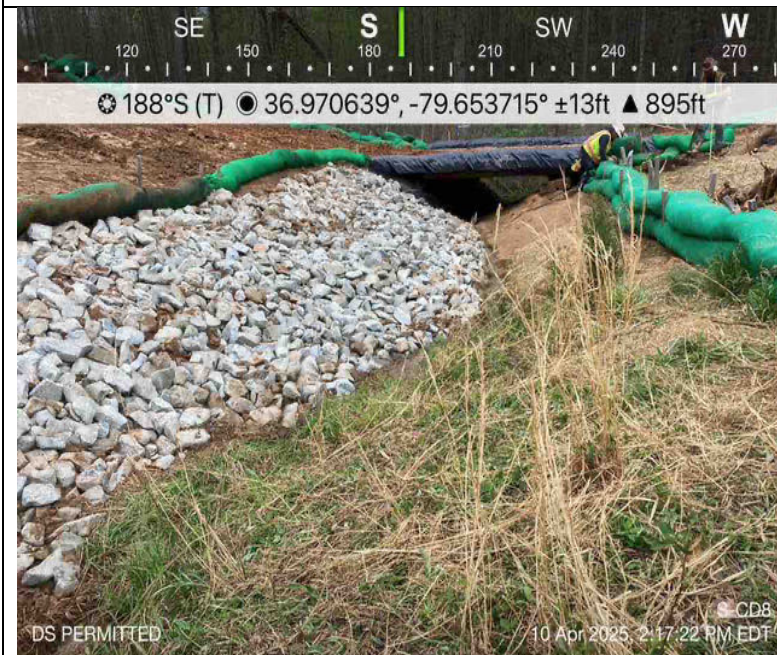
**Photo Description:** Downstream view of permitted impact area during post-construction assessment.

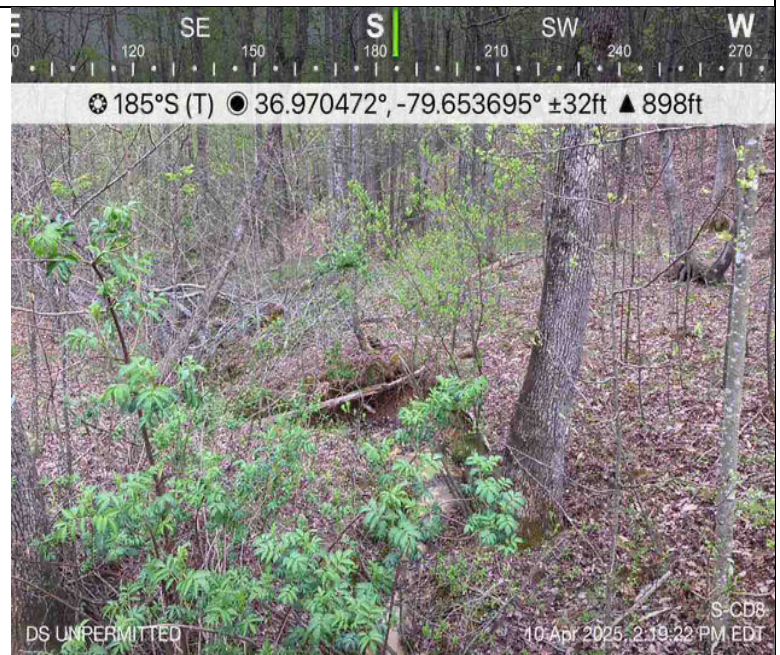
**Photo Description:** Conditions of the downstream area outside the ROW during post-construction assessment.

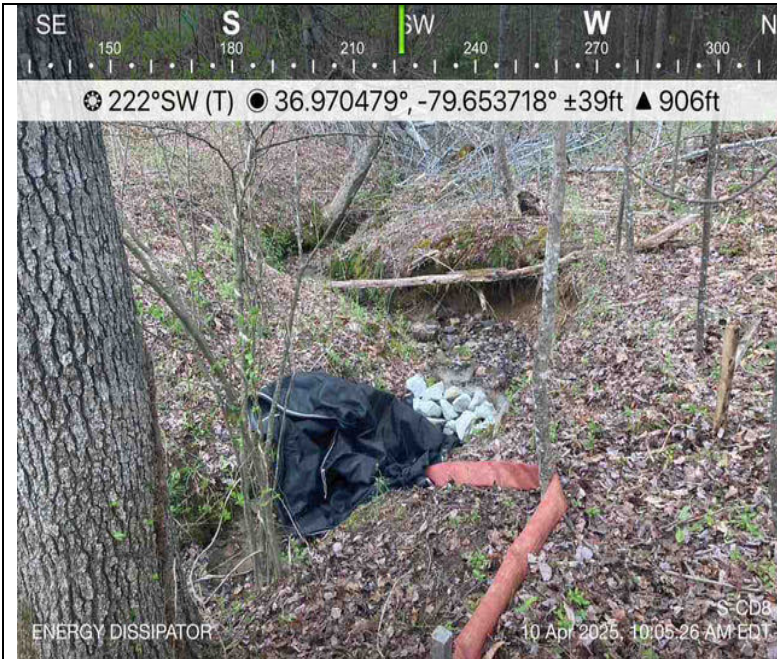
**Photo Description:** Energy dissipator installed downstream.

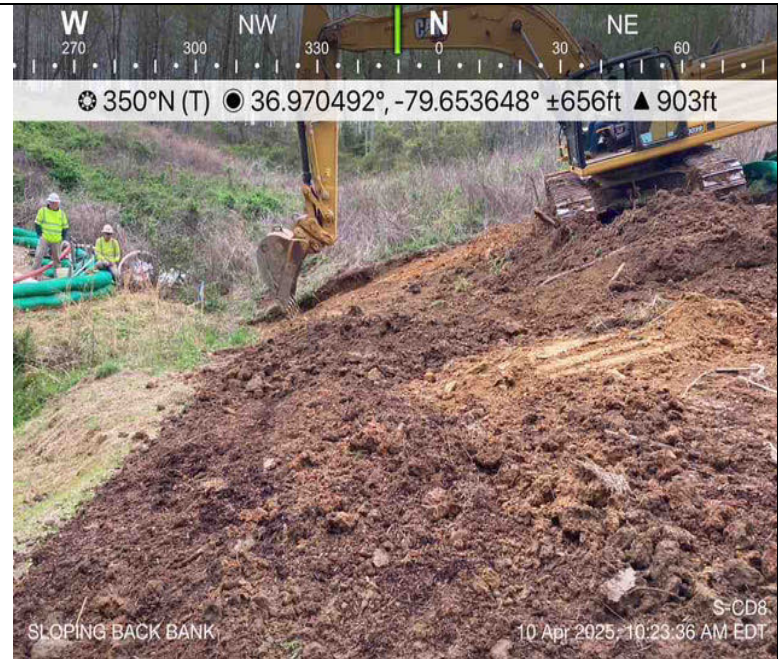
**Photo Description:** Sloping back banks.

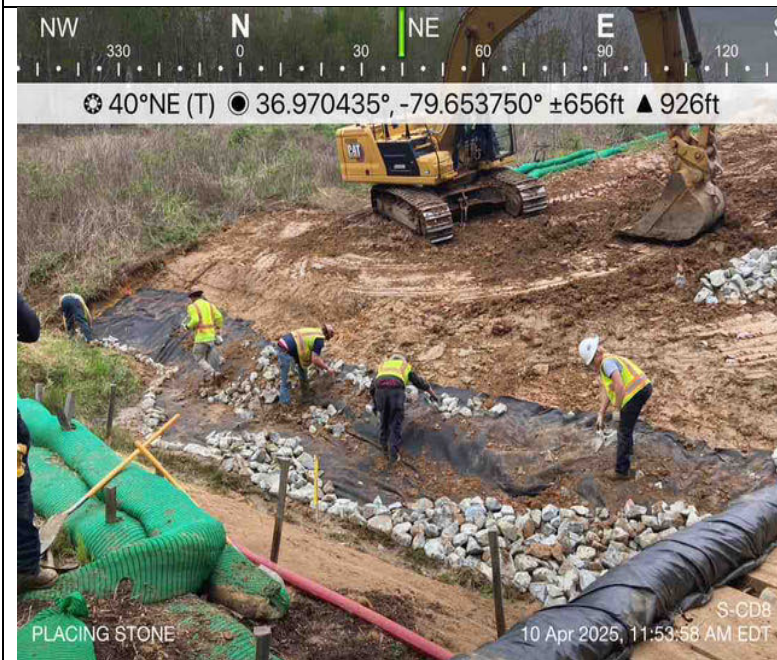
**Photo Description:** Geotech installed and stone placed for bank stabilization.

Item #8: Rip rap bank stabilization installed on left bank to provide long term stabilization to the crossing area.

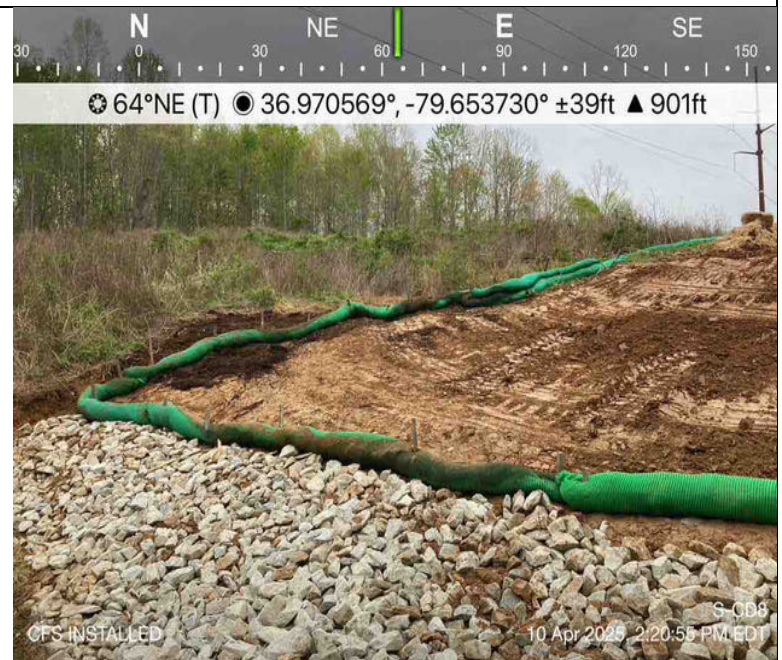
**Photo Description:** CFS installed along recently repaired banks.
