STREAM BIOLOGICAL CONDITIONS ENVIRONMENTAL AUDITOR REPORT

Stream ID: S-EF12	Crossing Start Date: 03/21/2025	Crossing Completion Date: 03/21/2025
Milepost: 260.3	Pre-Con Assessment Date: 03/21/2025	Post-Con Assessment Date: 03/21/2025
Station: 13755+73	Stream Classification: Perennial (Perennial, Intermittent, Ephemeral)	Bankfull Width (ft.): 20
County: Franklin	303(d) Impairment Listing: Impaired	Riffle:Pool Complexes Present? No

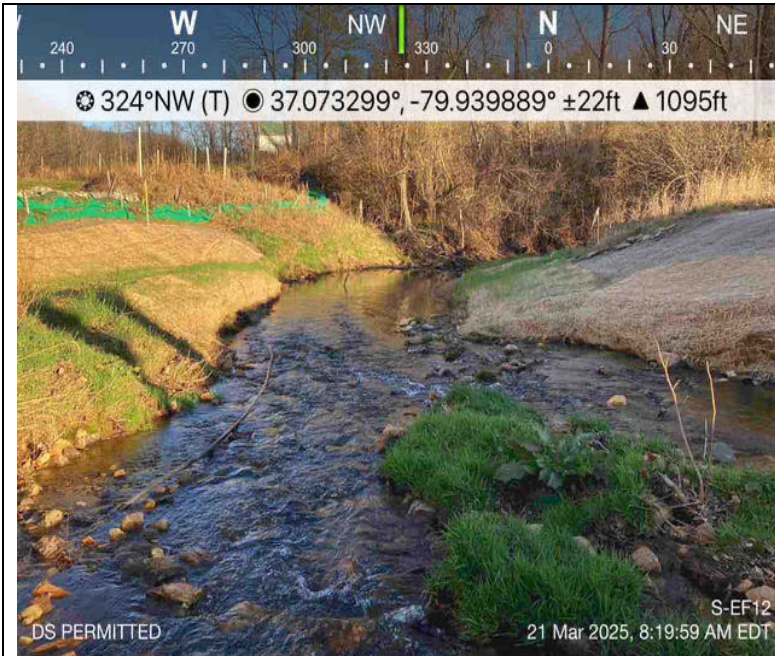
Photo Description: Downstream view of permitted impact area during pre-construction assessment.

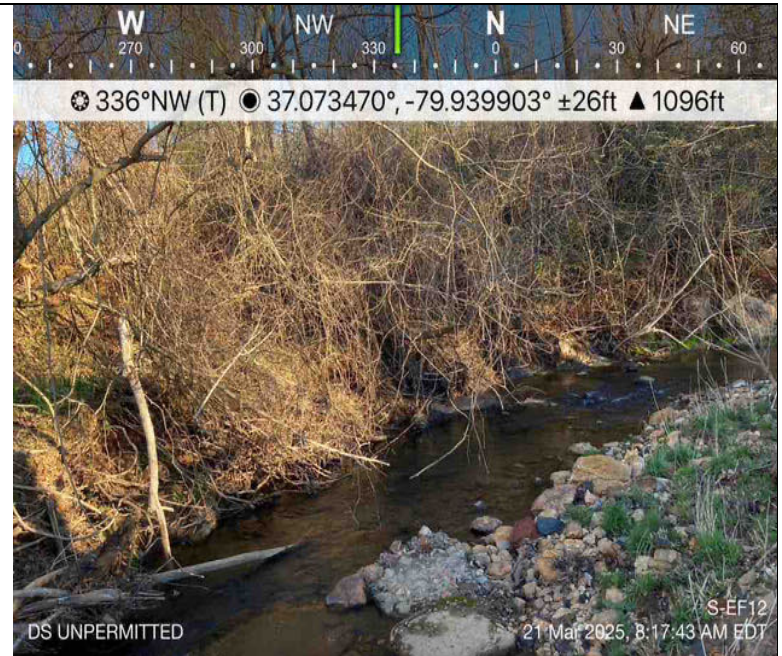
Photo Description: Conditions of the downstream area outside the ROW during pre-construction assessment.

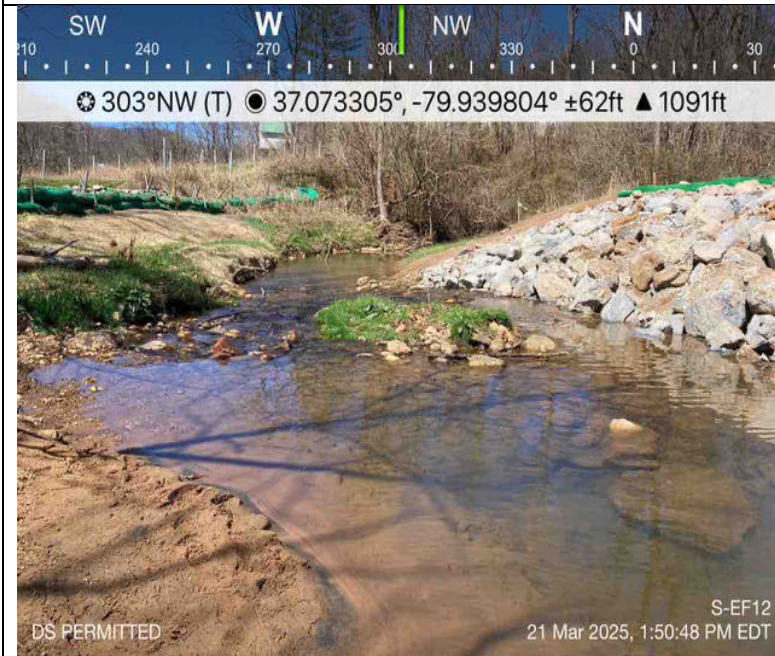
Photo Description: Downstream view of permitted impact area during post-construction assessment.

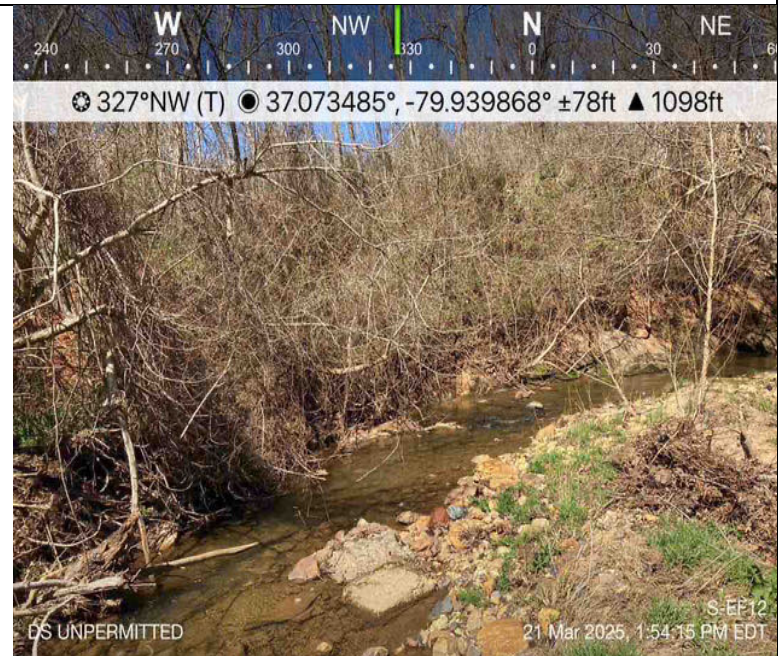
Photo Description: Conditions of the downstream area outside the ROW during post-construction assessment.

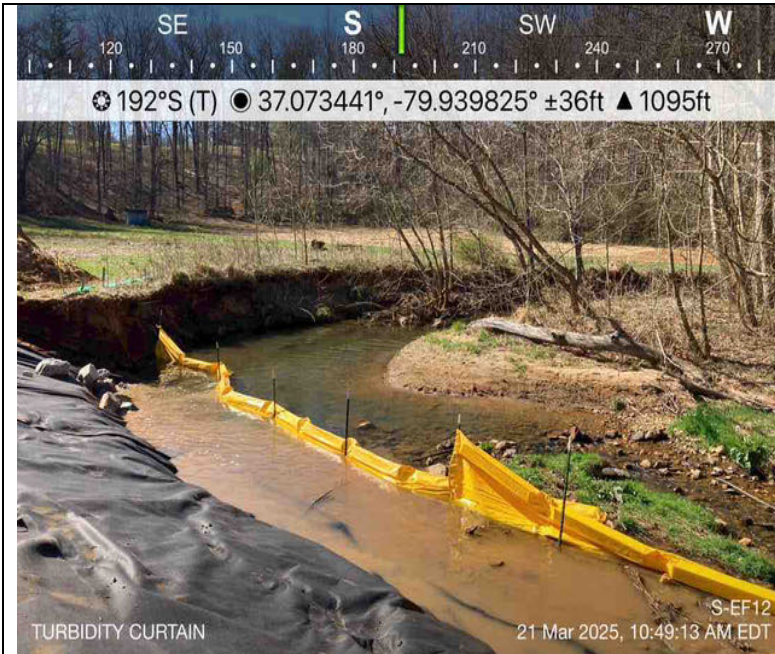
Photo Description: Turbidity curtain installed and functioning.

03/21/2025: Pre-construction meeting was held and pre-construction auditor assessment was completed. A turbidity curtain was installed along the right bank in need of repair. Once the curtain was installed, the stream bank was laid back to a stable angle of repose (~3:1) slope. Geotech fabric was laid out, and keyed in on the bank, and class III riprap was installed. The adjacent bank grades were tied in and CFS was installed. The turbidity curtain was removed, temporary and permanent seed was applied over the disturbed area on the bank, and ECM was installed. The bank restoration was completed and no unauthorized impacts to the resource or biological conditions were observed during the completion of the stream bank repair. Post-construction auditor assessment and photo documentation were completed. -A. Breeding

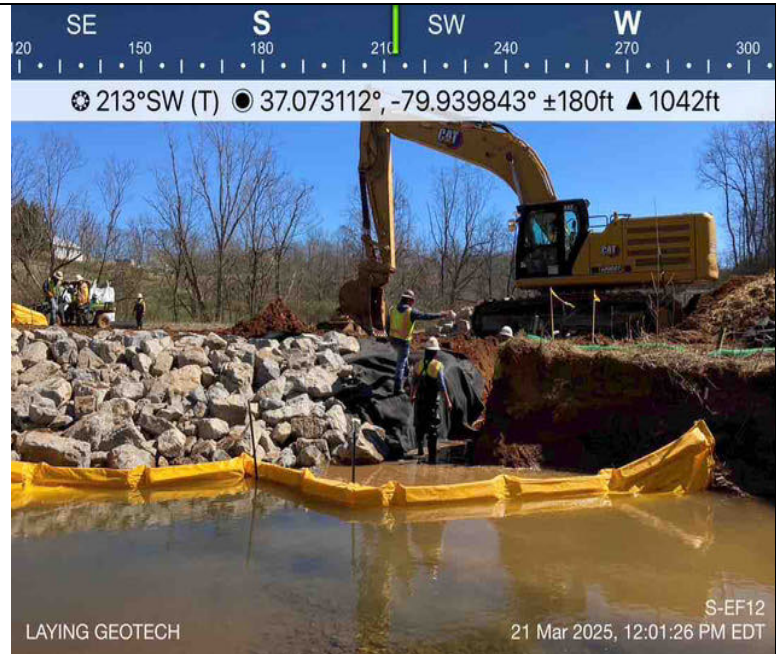
Photo Description: Geotech installed under class 3 riprap.

Item #8: Class III riprap was installed along the right bank to provide long term stability to the bank and pipe crossing area.

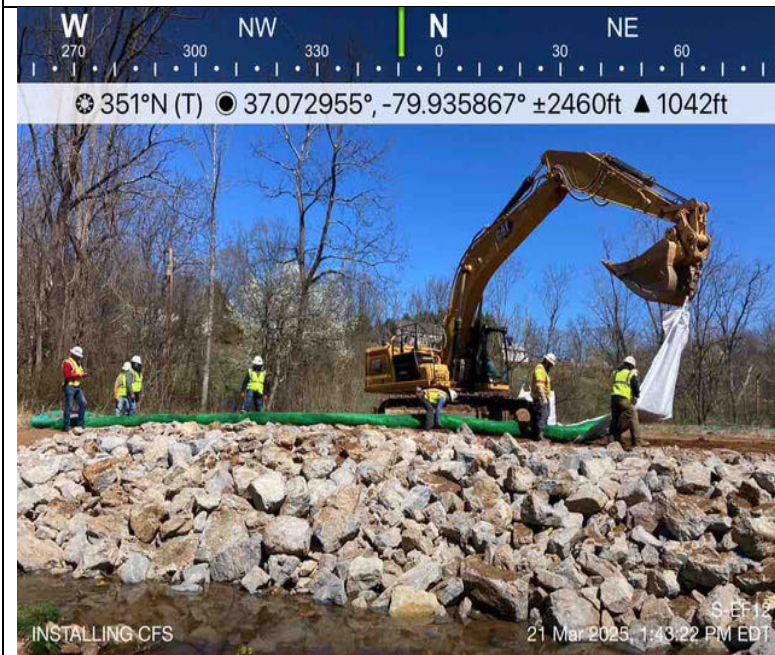
Photo Description: CFS installed around newly repaired stream bank.

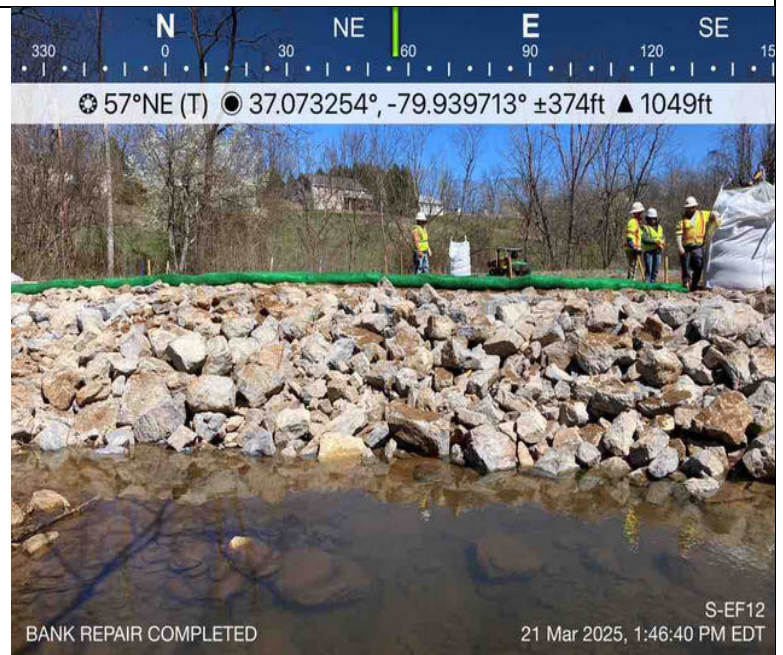
Photo Description: Stream bank repaired in full.
