STREAM BIOLOGICAL CONDITIONS ENVIRONMENTAL AUDITOR REPORT

Stream ID: S-NN11	Crossing Start Date: 04/18/2025	Crossing Completion Date: 04/18/2025
Milepost: 214.8	Pre-Con Assessment Date: 04/16/2025	Post-Con Assessment Date: 04/18/2025
Station: 11352+97	Stream Classification: Intermittent (Perennial, Intermittent, Ephemeral)	Bankfull Width (ft.): 5
County: Giles	303(d) Impairment Listing: Not Impaired	Riffle:Pool Complexes Present? No

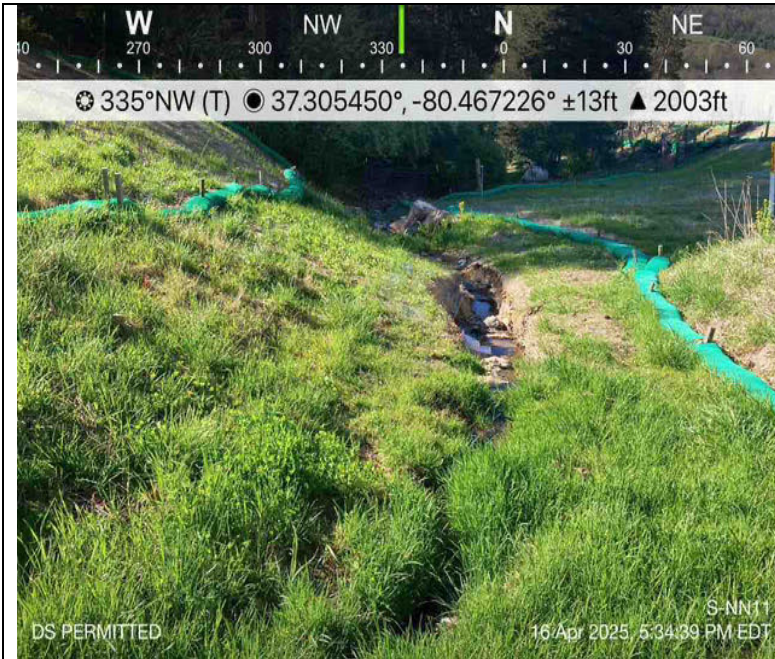
Photo Description: Downstream view of permitted impact area during pre-construction assessment.

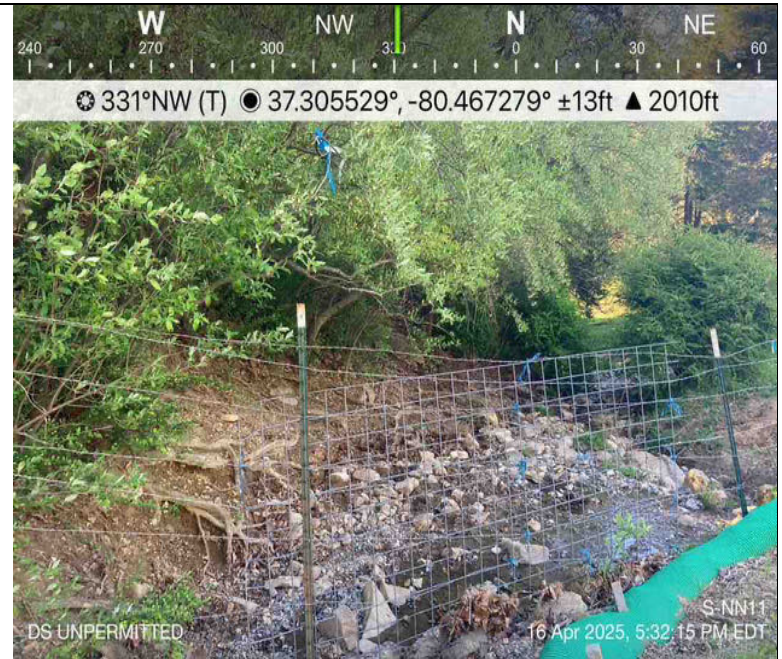
Photo Description: Conditions of the downstream area outside the ROW during pre-construction assessment.

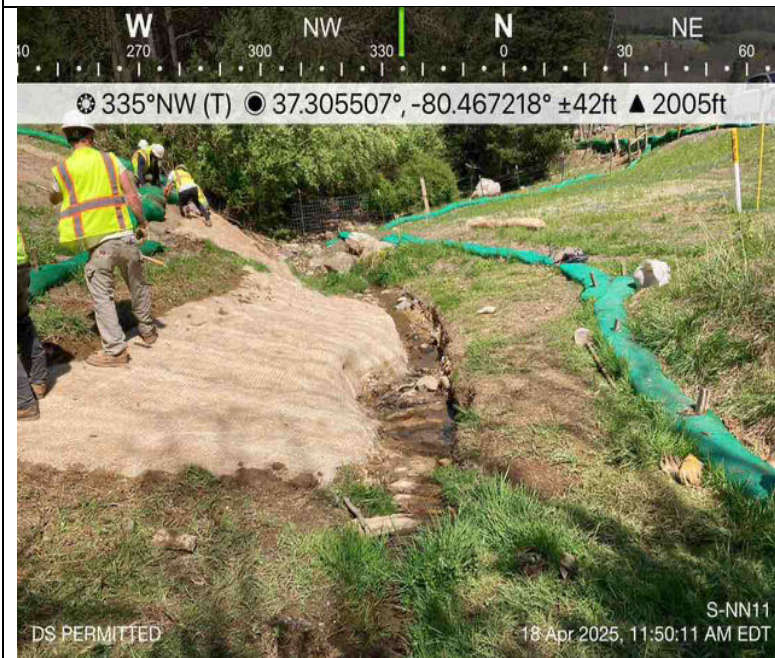
Photo Description: Downstream view of permitted impact area during post-construction assessment.

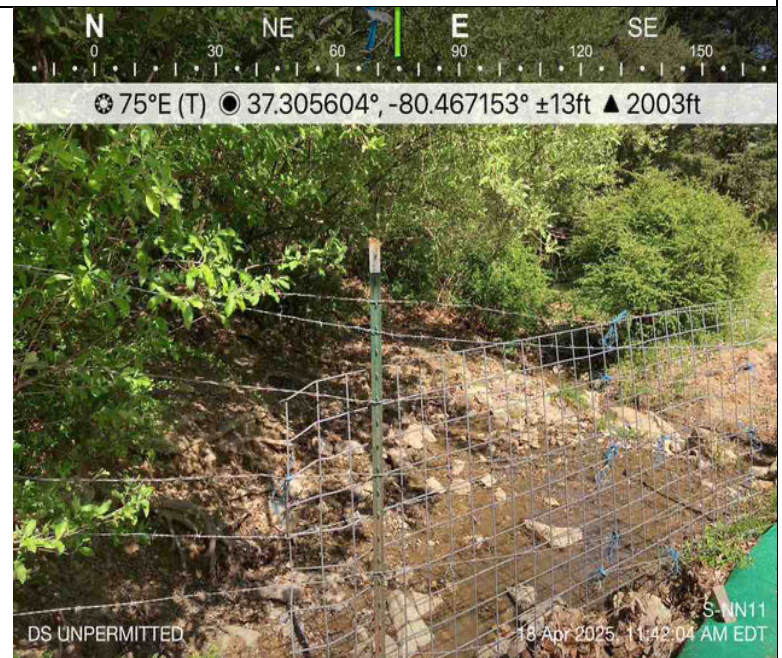
Photo Description: Conditions of the downstream area outside the ROW during post-construction assessment.

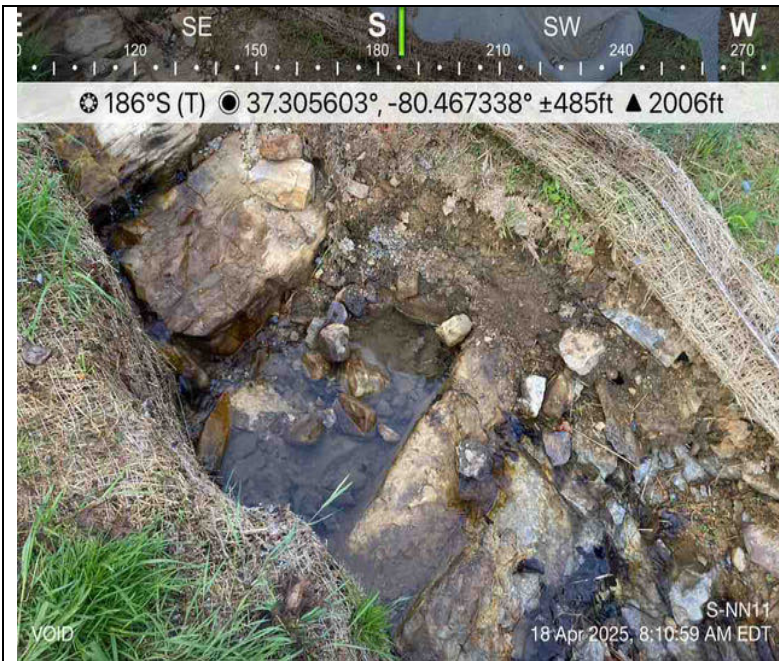
04/16/2025: WSSI staff were notified of the void in stream S-NN11. Pre-construction photos were taken and the pre-construction assessment was completed. A temporary cofferdam was observed within the stream in order to restore flow to supply water to downstream cattle. -A. Breeding

Photo Description: A void appeared in stream S-NN11 that was channeling the stream underground.

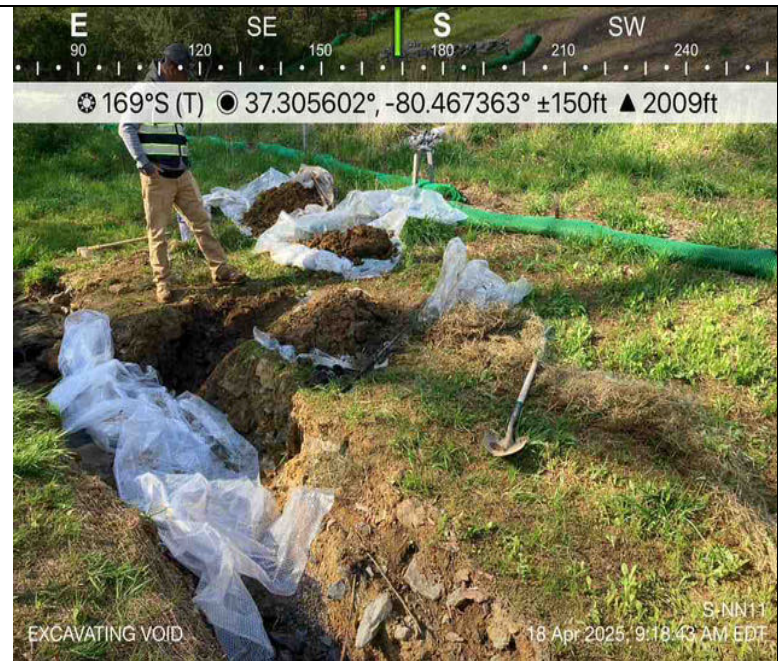
Photo Description: A cofferdam was installed and soil properly segregated.

04/18/2025: A pre-construction meeting was held with MVP, WSSI, and TRC representatives present. The temporary cofferdam was removed for a larger cofferdam to be installed. Once the cofferdam was installed, the void was excavated, with soils properly segregated, to determine the extent of the problem. Safety concerns arose when the excavation of the void progressed closer to the existing pipe. DCR was called to verify additional potential future repairs and examine the excavated void. The void was layered with bentonite and subsoil and tamped in to seal off the void. Once the void was repaired, topsoil was restored and seed applied. ECM was installed and properly keyed in. The cofferdam was removed and full flow restored to the stream. Post construction photos were taken and post-construction assessment was completed. There were no impacts to biological conditions observed during restoration efforts. -A. Breeding

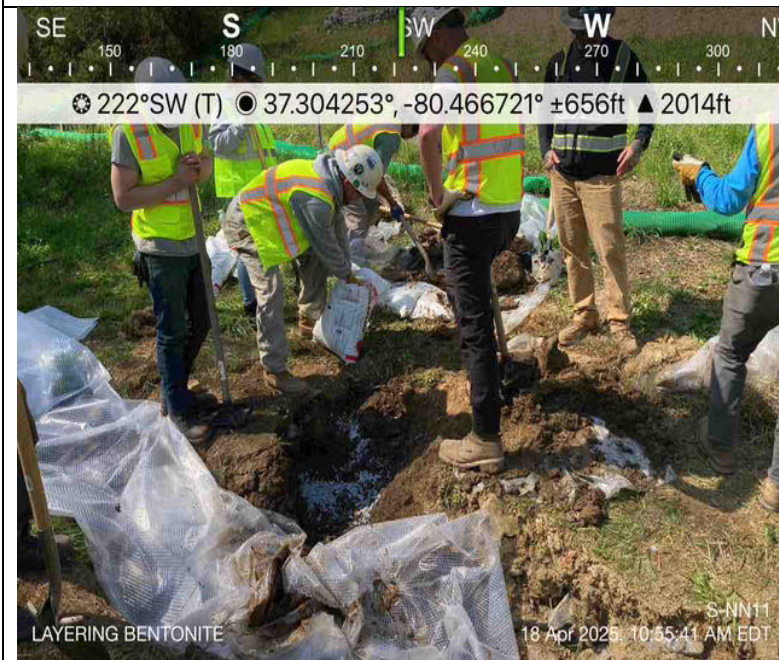
Photo Description: Void was excavated and layered with bentonite and native soil to repair.

Item #8: The bank was pulled back and excavated with hand tools, and the void repaired with backfilling the subgrade with layers of bentonite and native subsoil.

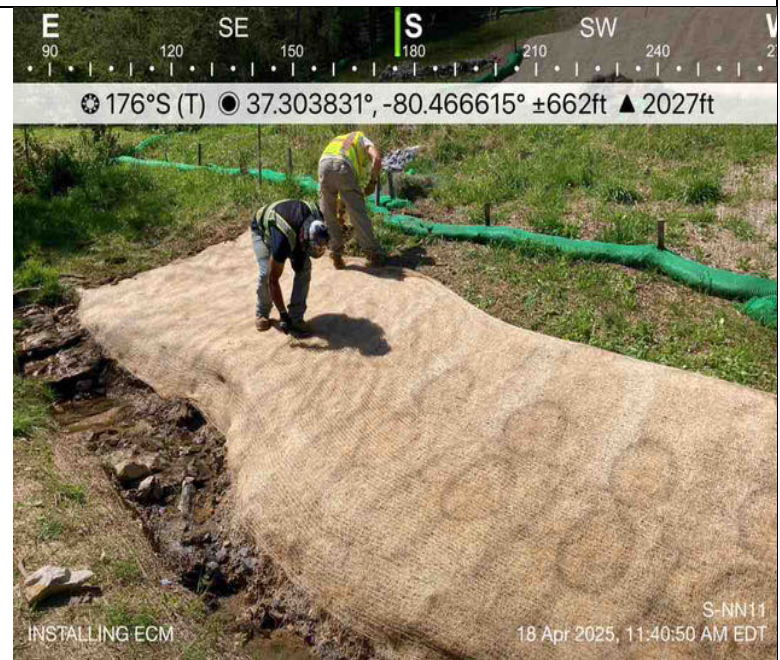
Photo Description: ECM was installed and properly keyed in.
