STREAM BIOLOGICAL CONDITIONS ENVIRONMENTAL AUDITOR REPORT

Stream ID: S-A33	Crossing Start Date: 05/22/2025	Crossing Completion Date: 05/22/2025
Milepost: 205.4	Pre-Con Assessment Date: 05/20/2025	Post-Con Assessment Date: 05/22/2025
Station: 10763+97	Stream Classification: Ephemeral (Perennial, Intermittent, Ephemeral)	Bankfull Width (ft.): 7
County: Giles	303(d) Impairment Listing: Not Impaired	Riffle:Pool Complexes Present? No

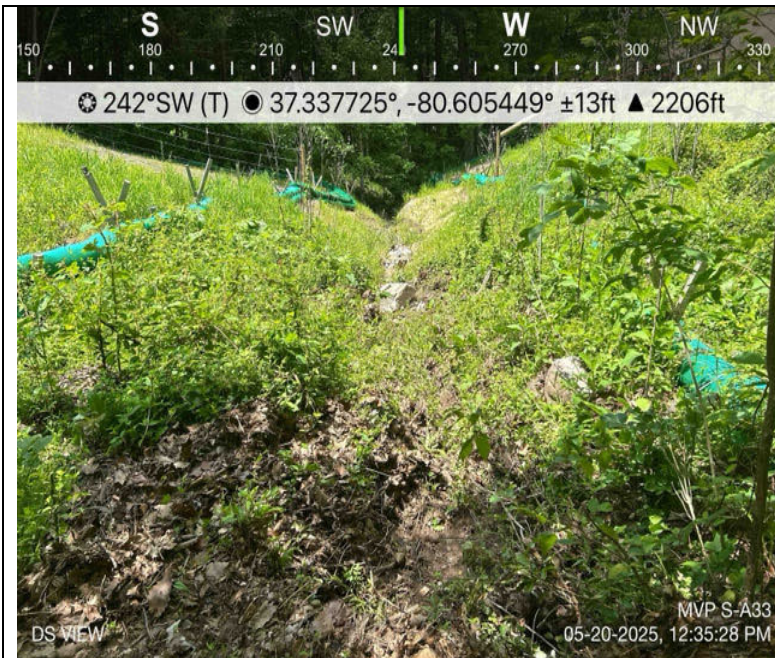
Photo Description: Downstream view of permitted impact area during pre-construction assessment.

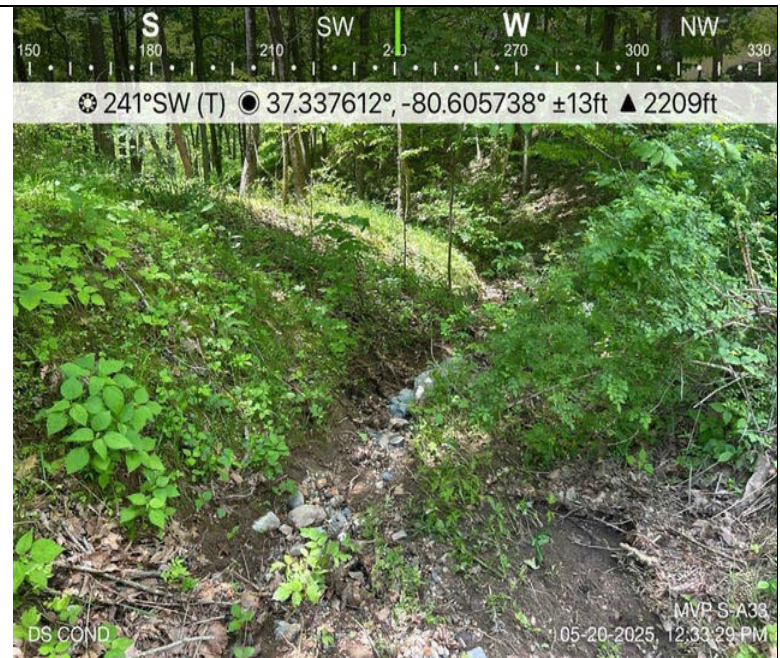
Photo Description: Conditions of the downstream area outside the ROW during pre-construction assessment.

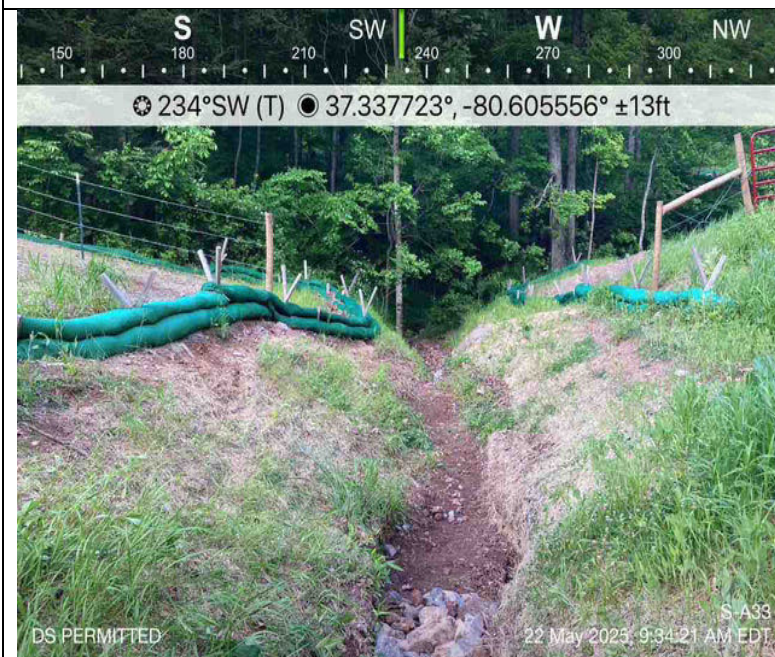
Photo Description: Downstream view of permitted impact area during post-construction assessment.

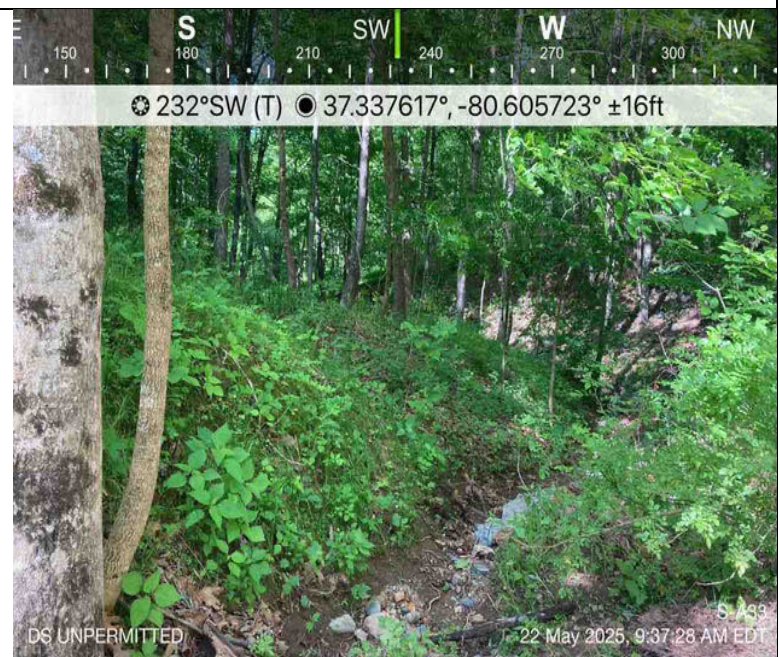
Photo Description: Conditions of the downstream area outside the ROW during post-construction assessment.
