# STREAM BIOLOGICAL CONDITIONS ENVIRONMENTAL AUDITOR REPORT

<b>Stream ID:</b> S-II2	<b>Crossing Start Date:</b> 07/15/2025	<b>Crossing Completion Date:</b> 07/22/2025
<b>Milepost:</b> 263.4	<b>Pre-Con Assessment Date:</b> 07/15/2025	<b>Post-Con Assessment Date:</b> 07/22/2025
<b>Station:</b> 13915+82	<b>Stream Classification:</b> Perennial (Perennial, Intermittent, Ephemeral)	<b>Bankfull Width (ft.):</b> 60
<b>County:</b> Franklin	<b>303(d) Impairment Listing:</b> Impaired	<b>Riffle:Pool Complexes Present?</b> No

\*Please note that this is a bank repair report. The original pipe crossing report was submitted in November 2023.

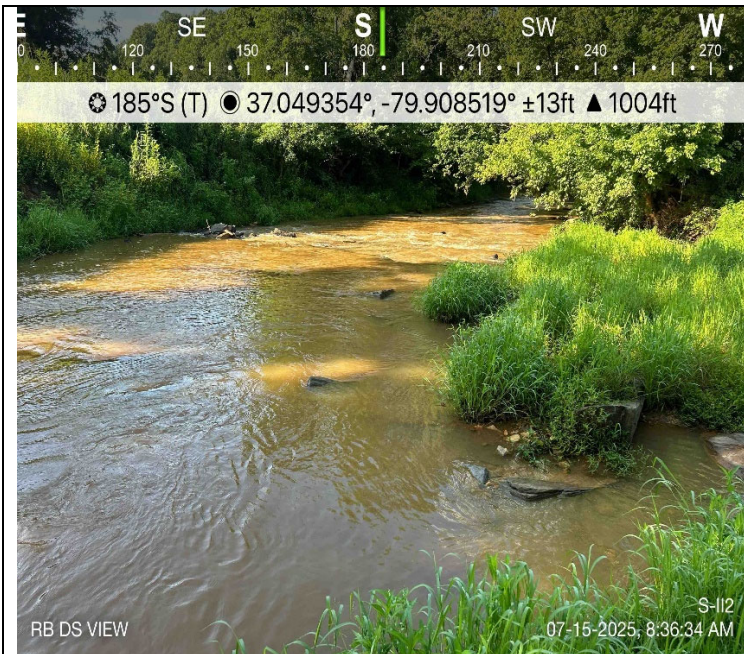
**Photo Description:** Downstream view of permitted impact area during pre-construction assessment.

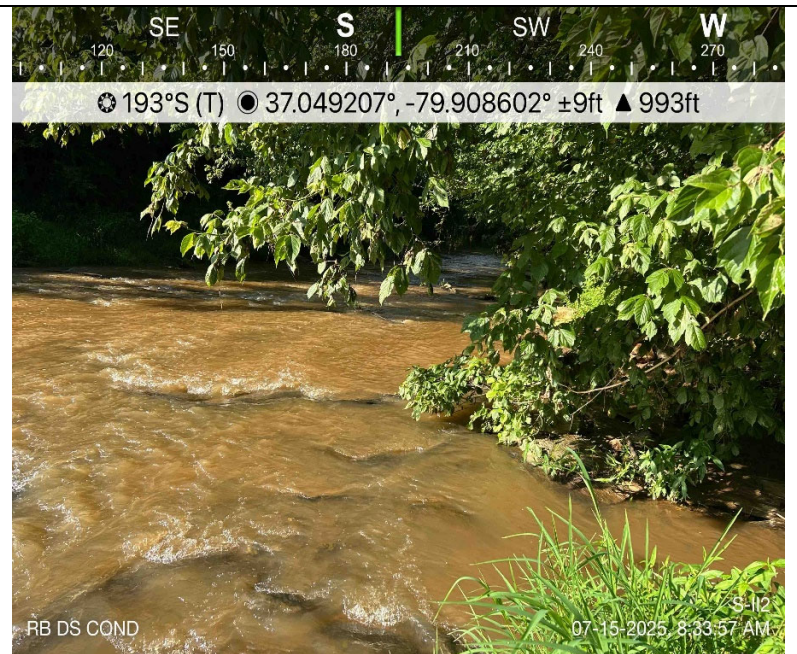
**Photo Description:** Conditions of the downstream area outside the ROW during pre-construction assessment.

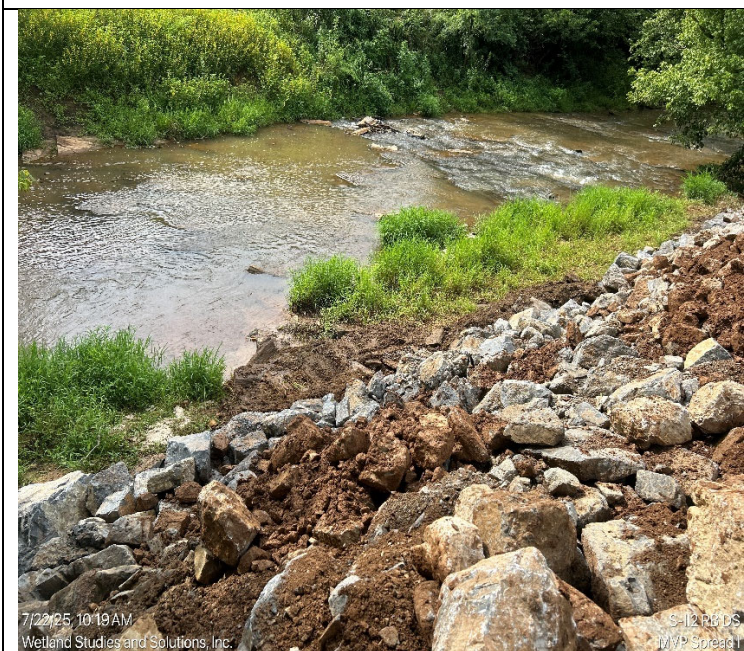
Item #17: Post-Construction condition marked “2 – Suboptimal” due to installation of rip rap layer over the entire right bank of the resource instead of vegetative cover.

Item #19: Post-Construction condition marked “2 – Minor” due to installation of non-native rip rap layer over the entire right bank of the resource.

**Photo Description:** Downstream view of permitted impact area during post-construction assessment.

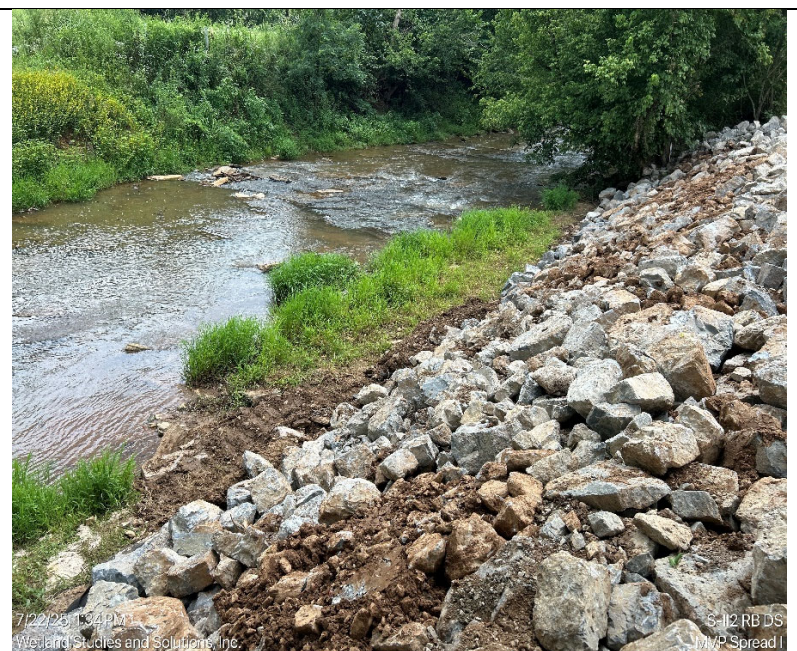
**Photo Description:** Conditions of the downstream area outside the ROW during post-construction assessment.

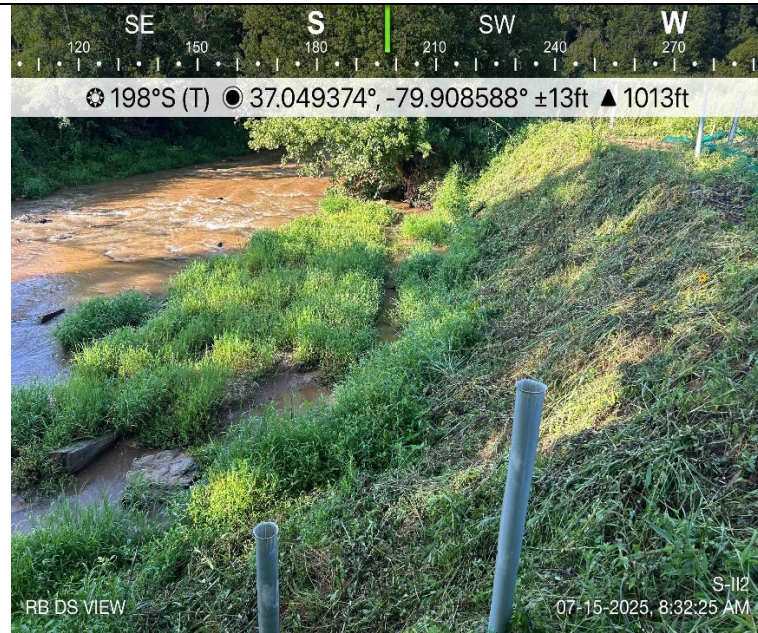
07/15/2025: Access road was established to the resource prior to initiation of resource work. MVP EI is Laura C. Work plan was discussed. Per landowner request, the right bank has receded over the years and is to be restored back to the approximate pre-construction grade conditions. The right bank has eroded and a small side channel adjacent to the main channel of S-II2 formed within the project's permitted area. This side channel within the right-of-way is to be backfilled with soil and a stable right bank re-established and stabilized with Class III riprap. Pre-construction assessment was completed and photos collected. Precision crews installed cofferdams on the upstream and downstream sides of the side channel to isolate the workspace. Edge (contractor) was on-site and completed a fish relocation from within the isolated workspace. Fish and other aquatic species were collected and relocated from the workspace safely into the adjacent main channel of S-II2. Due to potential thunderstorms and need for additional dewatering equipment, land disturbance within the resource area was not initiated. -S. Fisher

**Photo Description:** Overview of eroded right bank repair area and side channel before the repair.

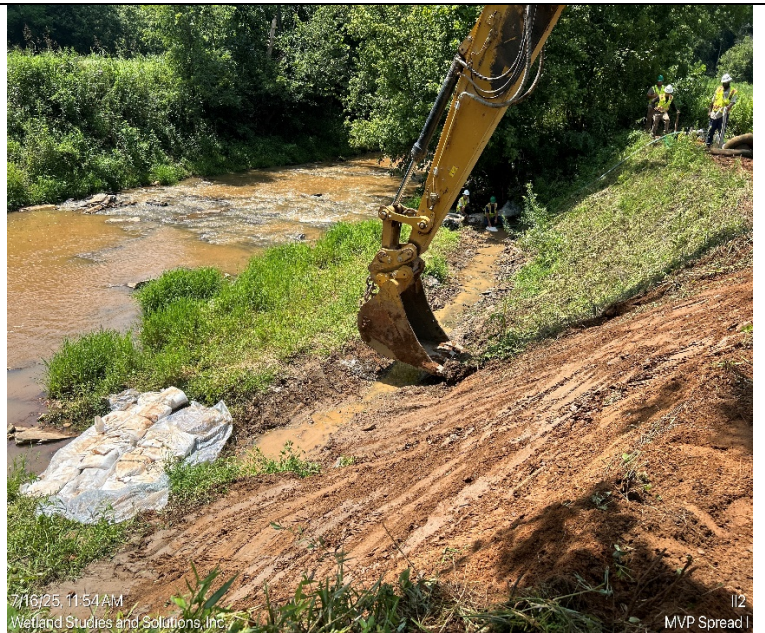
**Photo Description:** Topsoil was removed from the right bank and stockpiled.

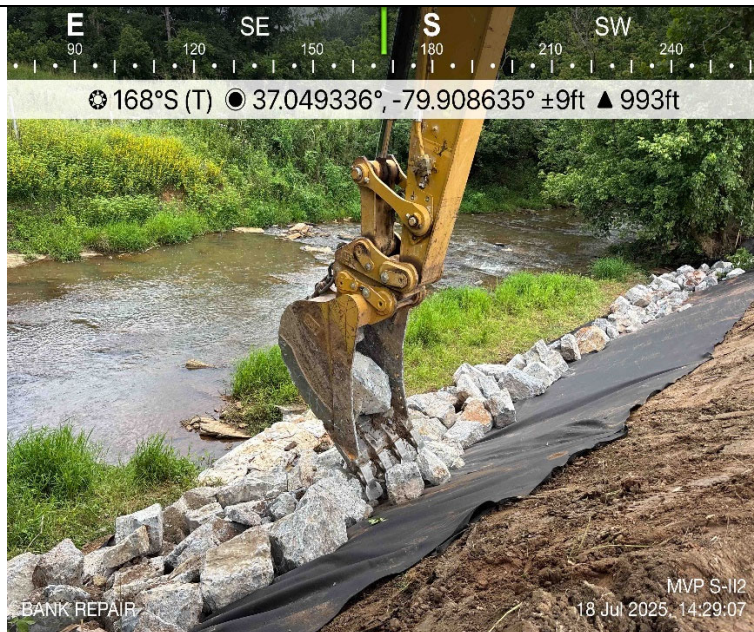
**Photo Description:** Class III rip rap was placed over geotextile fabric along the right bank.

07/18/2025: Trucks continued to bring fill to the working area. Fill was compacted and layered on the right bank to match the preexisting grade. Class III rip rap was delivered to be installed over the fill. The toe of the bank was keyed in to leave room for the rip rap layer. The slope was smoothed out and excess sediment was hand removed from the bottom. Geotextile fabric was installed over the bank and keyed in. Rip rap began to be placed over the fabric until inclement weather conditions occurred. Work was halted and the ROW was stabilized. -A. Thorpe

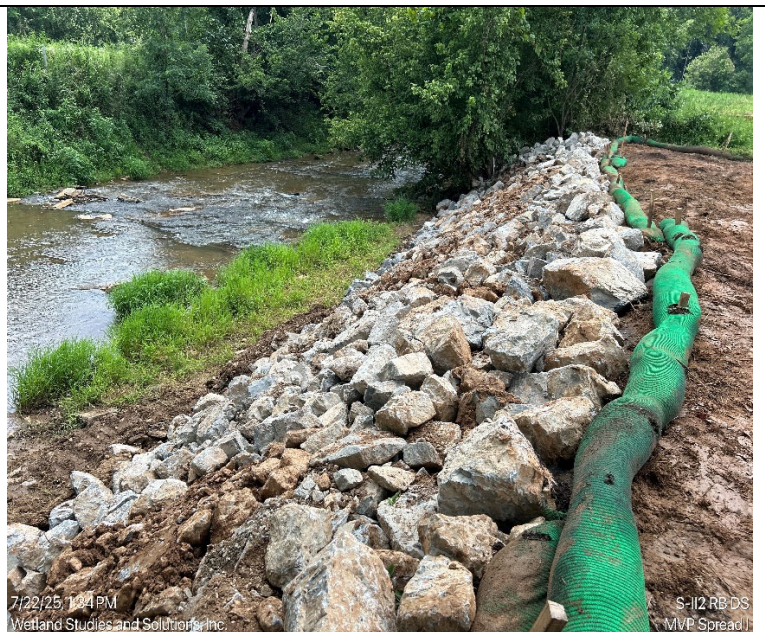
**Photo Description:** Overview of right bank after the repair.

Item #8: Marked “Yes” due to installation of rip rap along right bank.
