Visual Site Inspection Report

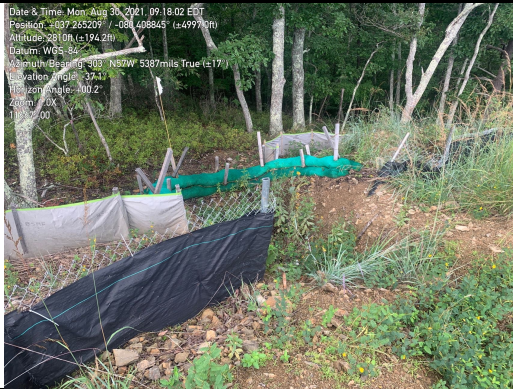
<p>Date & Time: Mon, Aug 30, 2021, 09:18:02 EDT Position: +037.295291 / -080.408845 (+14997.0ft) Altitude: 2810ft (+194.2ft) Datum: WGS 84 Azimuth: Bearing: 303 N50W 5387mils True (+17) Elevation Angle: 34.1 Horizon Angle: -00.2 Zoom: 1.0x 11667+00</p>			
GPS Location	See photo for GPS location.		GPS Location	See photo for GPS location.	
Field Station#	11613+00		Field Station#	11667+00	
Pic 1 Desc.	Rain gauge at Craig Creek Road reads 0.1 inches.		Pic 2 Desc.	Waterbar, sump pit, and end treatment in place.

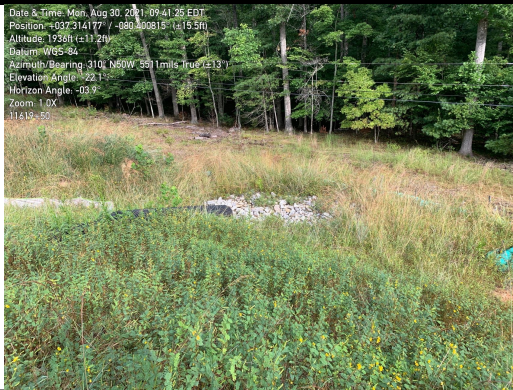
<p>Date & Time: Mon, Aug 30, 2021, 09:41:25 EDT Position: +037.314177 / -080.406151 (+116.5ft) Altitude: 1938ft (+11.2ft) Datum: WGS 84 Azimuth: Bearing: 310 N50W 5911mils True (+13) Elevation Angle: -22.1 Horizon Angle: -09.9 Zoom: 1.0x 11619+50</p>			
GPS Location	See photo for GPS location.		GPS Location	See photo for GPS location.	
Field Station#	11626+00		Field Station#	11619+50	
Pic 5 Desc.	Sensitive resource buffer in place at stream S-HH18.		Pic 6 Desc.	Clean water diversion pipe and plunge pool in place.

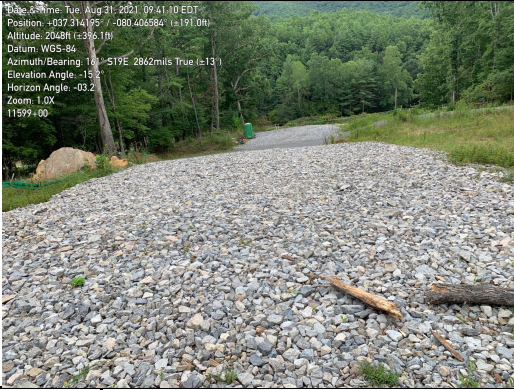
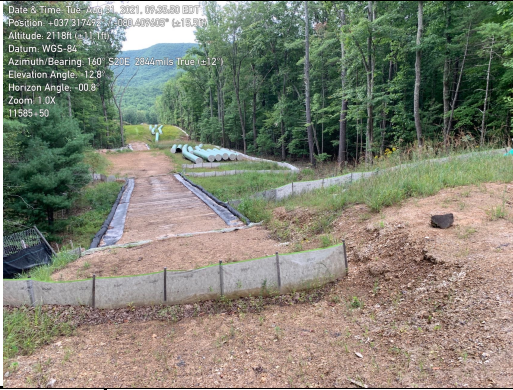
GPS Location	See photo for GPS location.		GPS Location	See photo for GPS location.	
Field Station#	11599+00		Field Station#	11585+50	
Pic 1 Desc.	RCE in place at Craig Creek Road.		Pic 2 Desc.	Sensitive resource buffer in place at stream S-PP21.

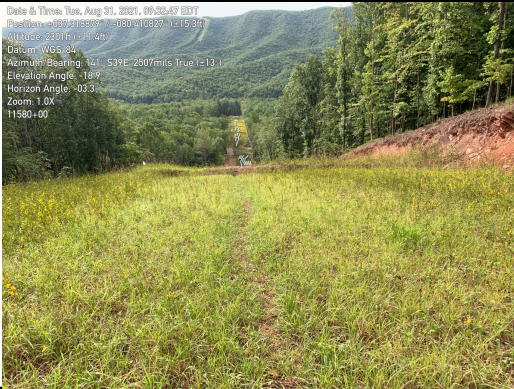
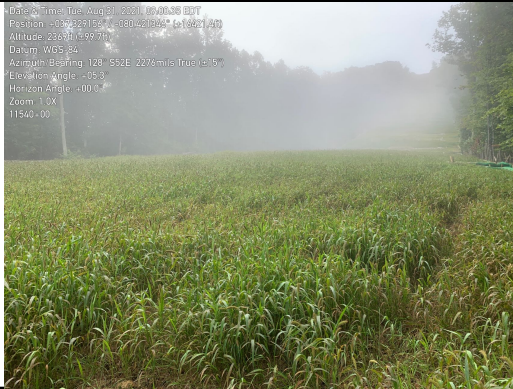
GPS Location	See photo for GPS location.		GPS Location	See photo for GPS location.	
Field Station#	11580+00		Field Station#	11540+00	
Pic 3 Desc.	ROW temporary stabilization vegetation and waterbar in place.		Pic 4 Desc.	Final restoration vegetation growth.

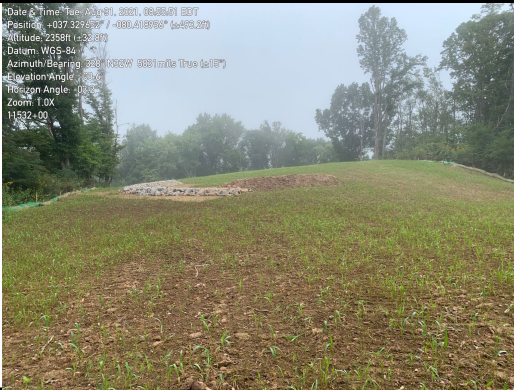
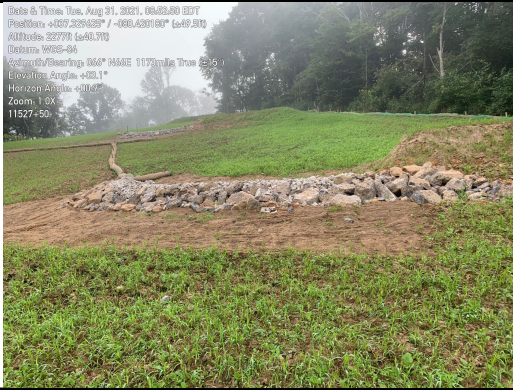
GPS Location	See photo for GPS location.		GPS Location	See photo for GPS location.	
Field Station#	11532+00		Field Station#	11527+50	
Pic 5 Desc.	Minor vegetation growth present in final restoration area.		Pic 6 Desc.	Level spreader in place.

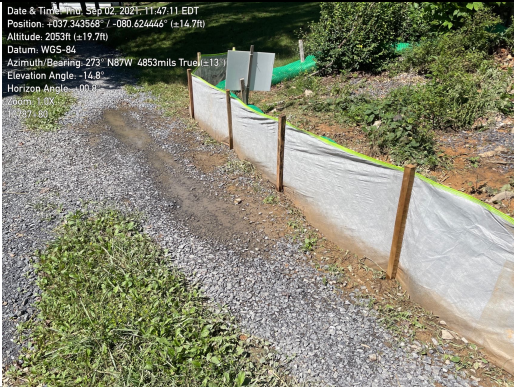
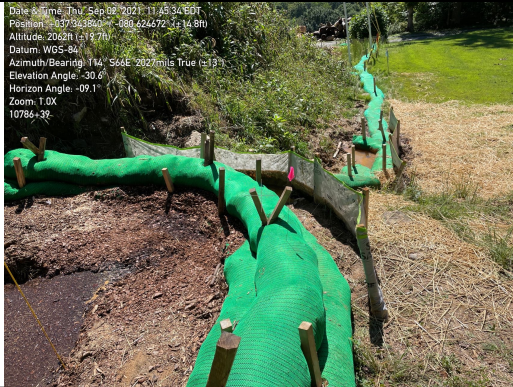
GPS Location	See photo	GPS Location	See photo		
Field Station#	10787+80	Field Station#	10786+39		
Pic 3 Desc.	Upgrade P1 behind perimeter controls functional	Pic 4 Desc.	CFS needs cleaned off

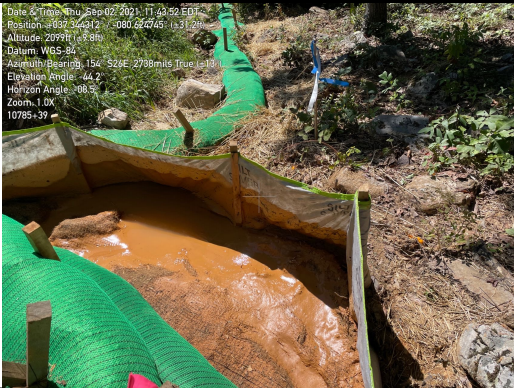
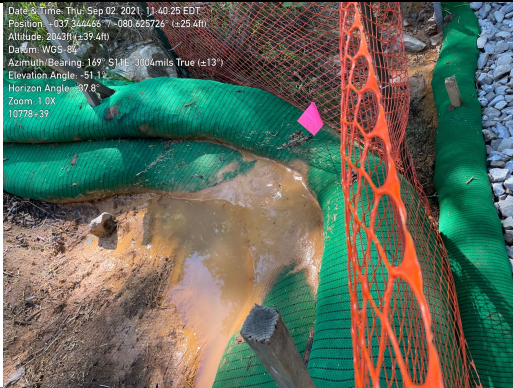
GPS Location	See photo	GPS Location	See photo		
Field Station#	10785+39	Field Station#	10778+39		
Pic 5 Desc.	P1 needs cleaned	Pic 6 Desc.	CFS needs sediment removed

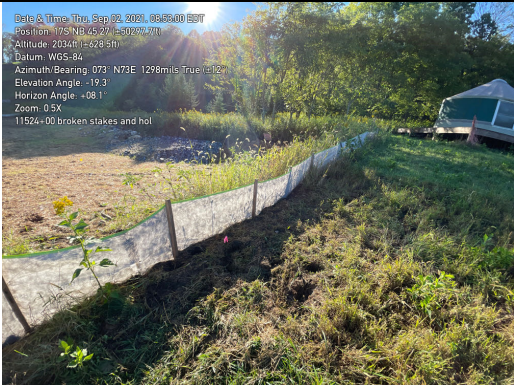
<p>Date & Time: Thu, Sep 02, 2021, 08:56:00 EDT Position: 175° NB 50.31' (=16.6m) Altitude: 2034ft (=620m) Datum: WGS-84 Azimuth/Bearing: 073° N73E 1298mils True (=12°) Elevation Angle: -19.3° Horizon Angle: +08.1° Zoom: 0.5X 11524+00 broken stakes and hole</p>

GPS Location	3	GPS Location	4		
Field Station#	11524+00	Field Station#	11524+16		
Pic 3 Desc.	Repair hole and broken stakes.		Pic 4 Desc.	Regrade AR 258.02.

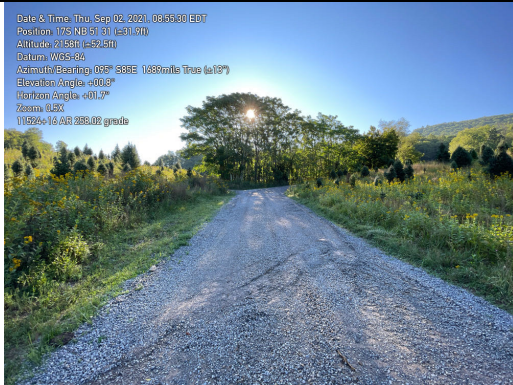
<p>Date & Time: Thu, Sep 02, 2021, 08:56:00 EDT Position: 175° NB 50.31' (=16.6m) Altitude: 2115ft (=645m) Datum: WGS-84 Azimuth/Bearing: 008° S88E 1888mils True (=12°) Elevation Angle: +00.8° Horizon Angle: +01.7° Zoom: 0.5X 11524+16 AR 258.02 grade</p>

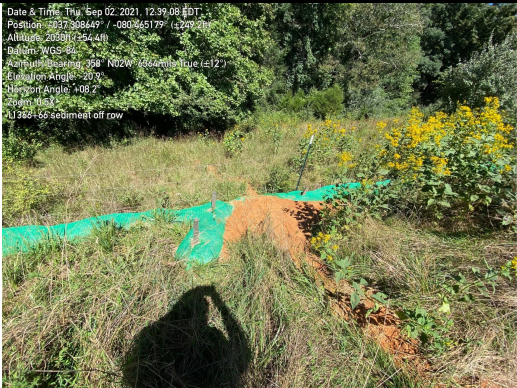
<p>Date & Time: Thu, Sep 02, 2021, 12:39:08 EDT Position: -937.326447, -890.445179, 1220.1ft Altitude: 2287ft (±12.2ft) Datum: WGS-84 Azimuth/Bearing: 258° N42W 436mils True (±12°) Elevation Angle: -21.9° Horizon Angle: -08.2° Zoom: 0.5X 11366+66 sediment off row</p>

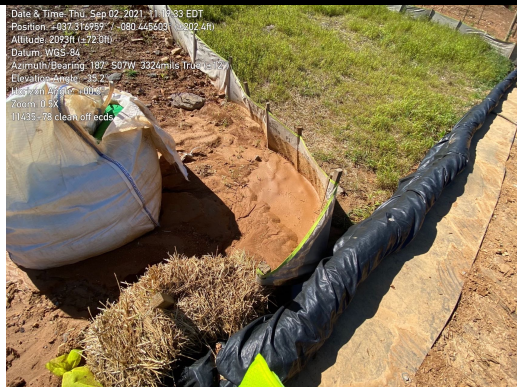
<p>Date & Time: Thu, Sep 02, 2021, 11:43:33 EDT Position: -937.319957, -890.445503, 1202.4ft Altitude: 2079ft (±12.2ft) Datum: WGS-84 Azimuth/Bearing: 182° S07W 322mils True (±12°) Elevation Angle: -25.2° Horizon Angle: -00.0° Zoom: 0.5X 11435+78 clean off road</p>

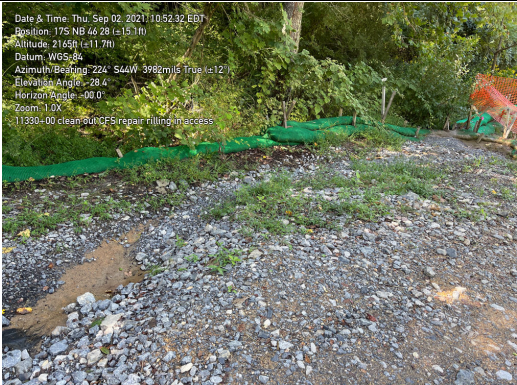
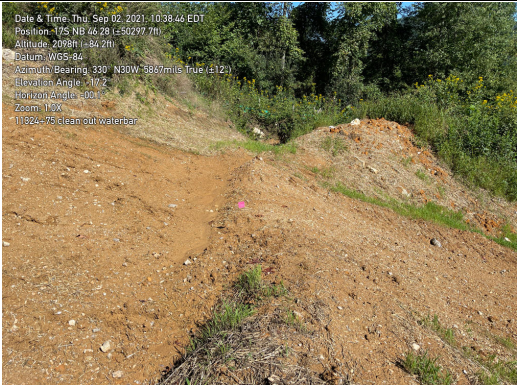
<p><small>Date & Time: Thu, Sep 02, 2021 10:38:44 EDT Position: +035 NB 46.28 (+15.02) Altitude: 2089ft (+4.20) Datum: WGS 84 Azimuth/Bearing: 330° N30W 387m/mis True (+12) Elevation Angle: -17.2 Horizon Angle: -00.0 Zoom: 1.0X 11324-75 clean out waterbar</small></p>

GPS Location	17	GPS Location	18		
Field Station#	11330+00	Field Station#	11324+75		
Pic 17 Desc.	Repair rilling in gravel and clean out sediment from end treatment.	Pic 18 Desc.	Remove sediment from throat of waterbar.

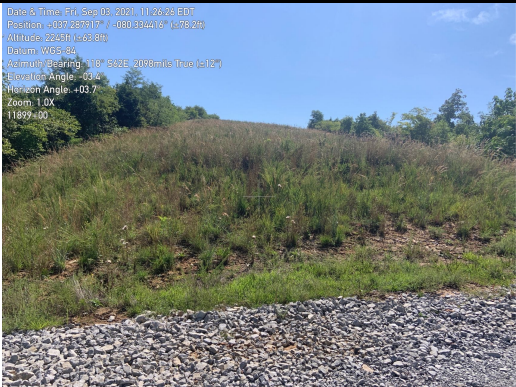
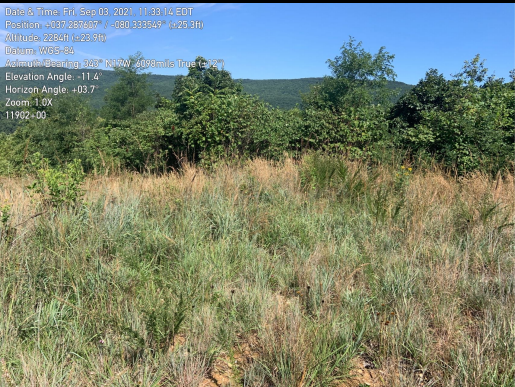
GPS Location	See photo		GPS Location	see photo	
Field Station#	11899+00		Field Station#	11902+00	
Pic 1 Desc.	AR266.03 clean and functional		Pic 2 Desc.	Vegetation adequate

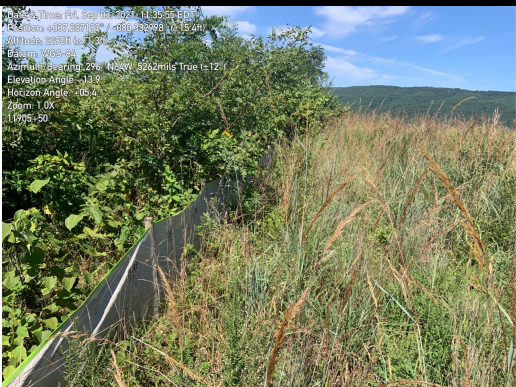
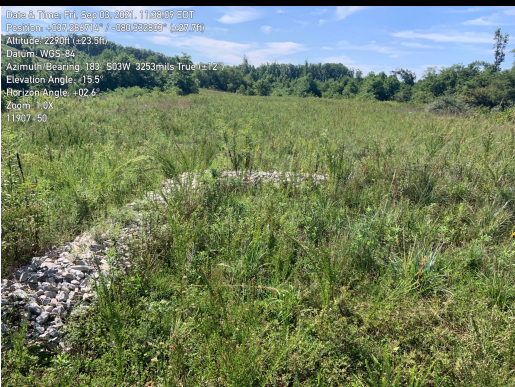
GPS Location	See photo		GPS Location	see photo	
Field Station#	11905+50		Field Station#	11907+50	
Pic 3 Desc.	P1 silt fence functional		Pic 4 Desc.	Level spreader at permanent water bar is functioning as it should

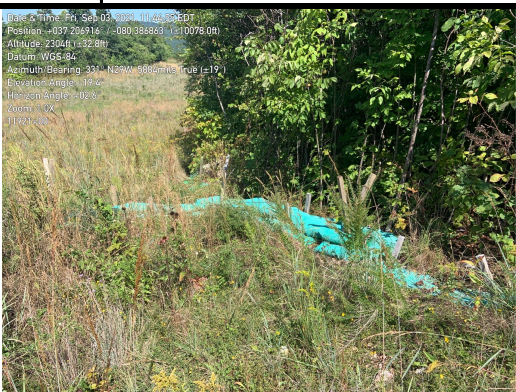
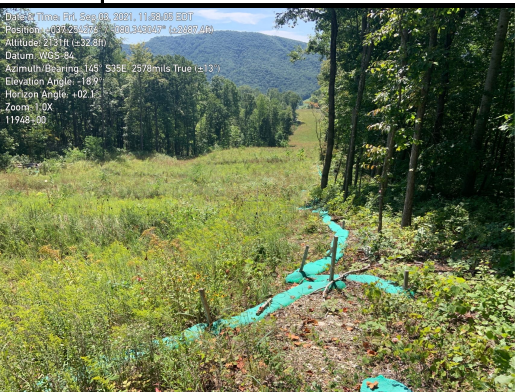
GPS Location	See photo		GPS Location	see photo	
Field Station#	11921+00		Field Station#	11948+00	
Pic 5 Desc.	Triple stacked CFS functional		Pic 6 Desc.	CFS at LOD functional

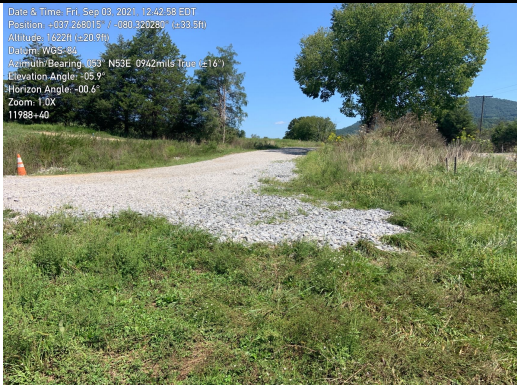
GPS Location		See photo		GPS Location	
Field Station#		11989+91		Field Station#	
Pic 11 Desc.		Area needs to be reseeded and stabilized		Pic 12 Desc.	
				RCE and access road functional

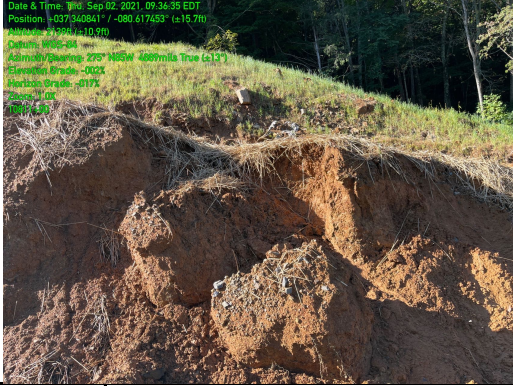
<p>Date & Time: Wed, Sep 02, 2021, 09:36:35 EDT Position: +037.340841° / -080.617453° (±15.7m) Altitude: 2295ft (±10.9m) Datum: WGS-84 Azimuth/Bearing: 225° NMAW 4000mils True (±13°) Elevation Grade: -000% Horizon Grade: -017% Zoom: 1.0x 10811+00</p>			
GPS Location	See Photo	GPS Location	See Photo		
Field Station#	10880+00	Field Station#	10811+00		
Pic 1 Desc.	View of water bar restoration end of days activities.	Pic 2 Desc.	View of travel lane fill slope needing repairs. Recommended erosion repair and stabilize fill slopes.

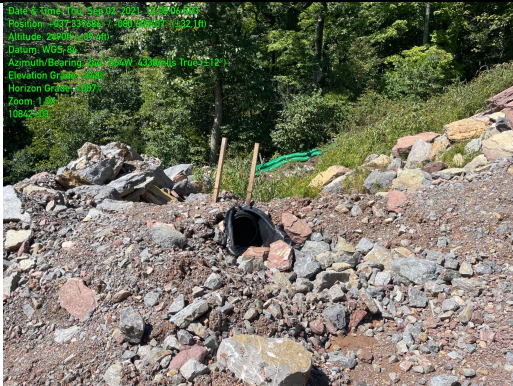
<p>Date & Time: Thu, Sep 02, 2021, 09:55:59 EDT Position: +037.340841° / -080.617453° (±15.7m) Altitude: 2295ft (±10.9m) Datum: WGS-84 Azimuth/Bearing: 225° NMAW 4000mils True (±13°) Elevation Grade: -000% Horizon Grade: -017% Zoom: 1.0x 10842+03</p>			
GPS Location	See Photo	GPS Location	See Photo		
Field Station#	10830+89	Field Station#	10842+03		
Pic 5 Desc.	View of stone inlet needing maintenance.	Pic 6 Desc.	Slope drain pipe needing 6" soil over the inlet flange and re-secured.

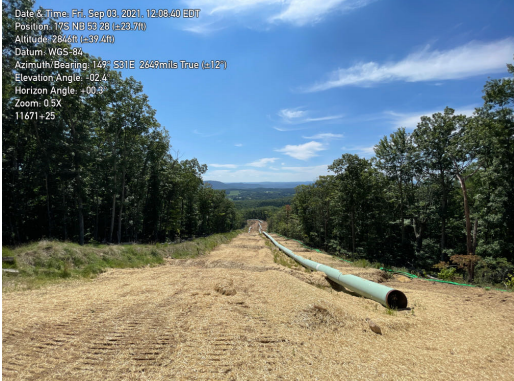
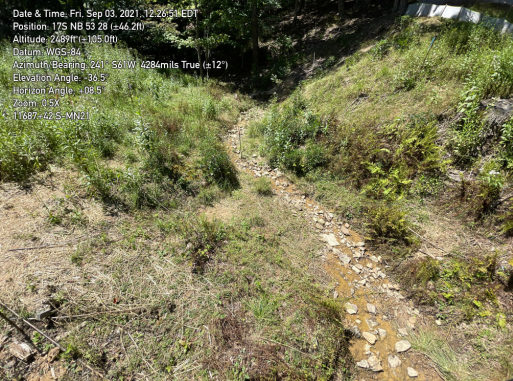
GPS Location	1	GPS Location	2		
Field Station#	11671+25	Field Station#	11687+42		
Pic 1 Desc.	Section of RoW showing conditions and controls.		Pic 2 Desc.	S-MN21.

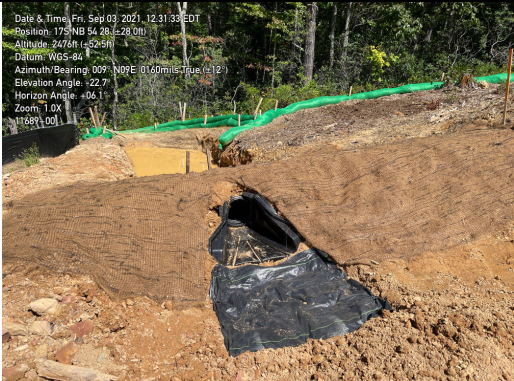
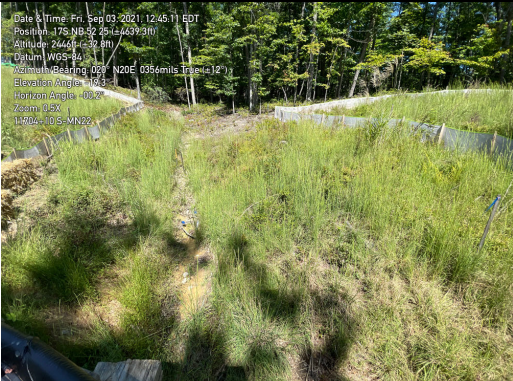
GPS Location	3	GPS Location	4		
Field Station#	11689+00	Field Station#	11704+10		
Pic 3 Desc.	Replacing slope drain inlet.		Pic 4 Desc.	S-MN22.

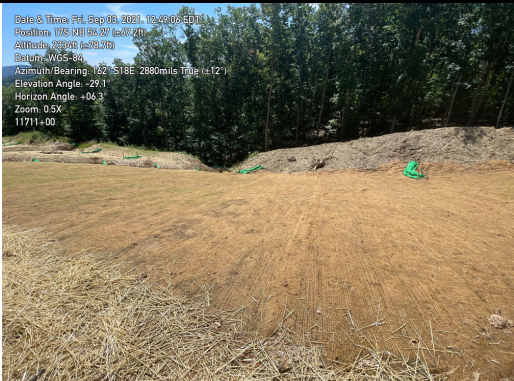
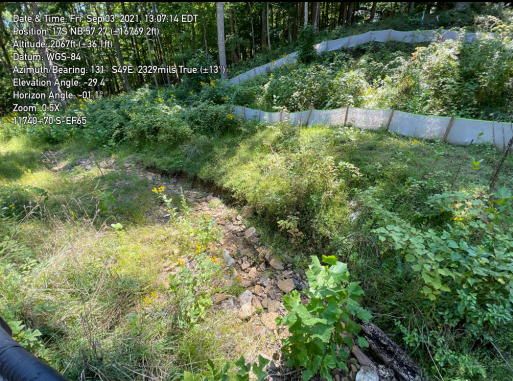
GPS Location	5	GPS Location	6		
Field Station#	11711+00	Field Station#	11740+70		
Pic 5 Desc.	Erosion control blanket in good condition.		Pic 6 Desc.	S-EF65.
