# Baseline Assessment – Stream Attributes

## Reach S-A92 (Pipeline ROW) Ephemeral Spread C Webster County, West Virginia

# Spread C Stream S-A92 (Pipeline ROW) Webster County

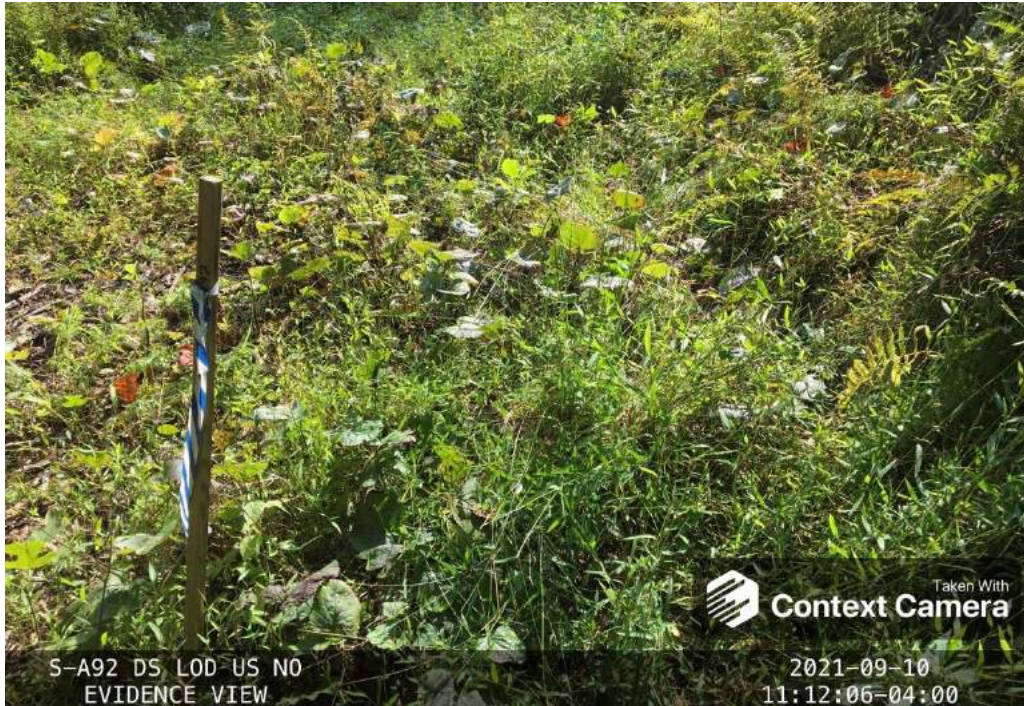
Photo Type: DS, US View  
Location, Orientation, Photographer Initials: Downstream at LOD looking W upstream, HK  
Latitude: 38.556658, Longitude: -80.535607

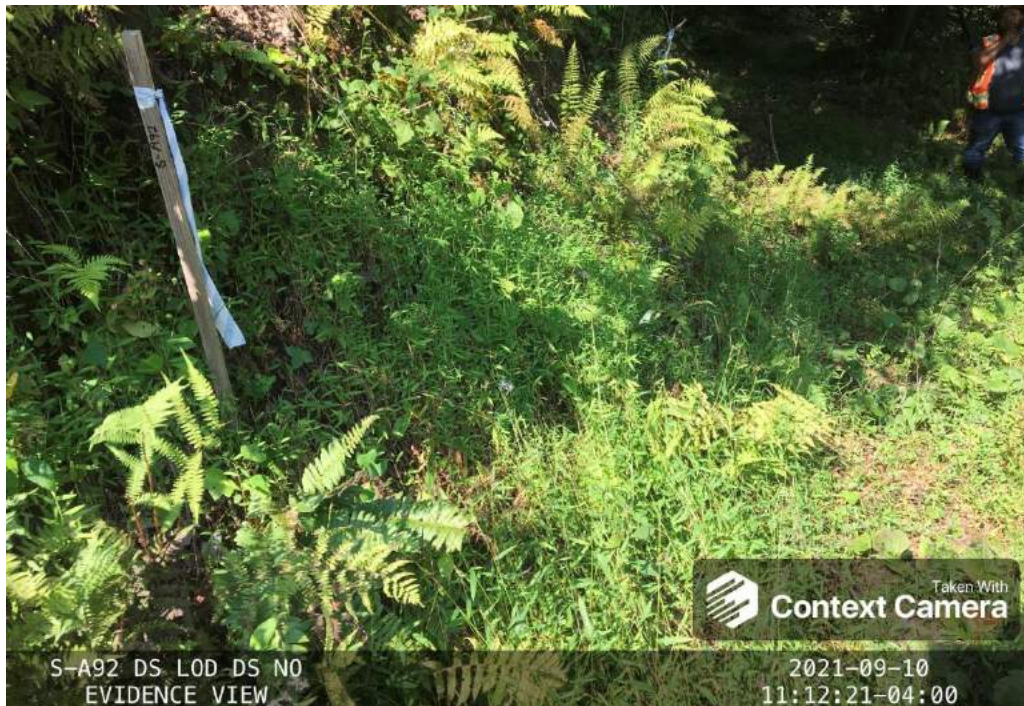
Photo Type: DS, DS View  
Location, Orientation, Photographer Initials: Downstream at LOD looking E downstream, HK  
Latitude: 38.556658, Longitude: -80.535607

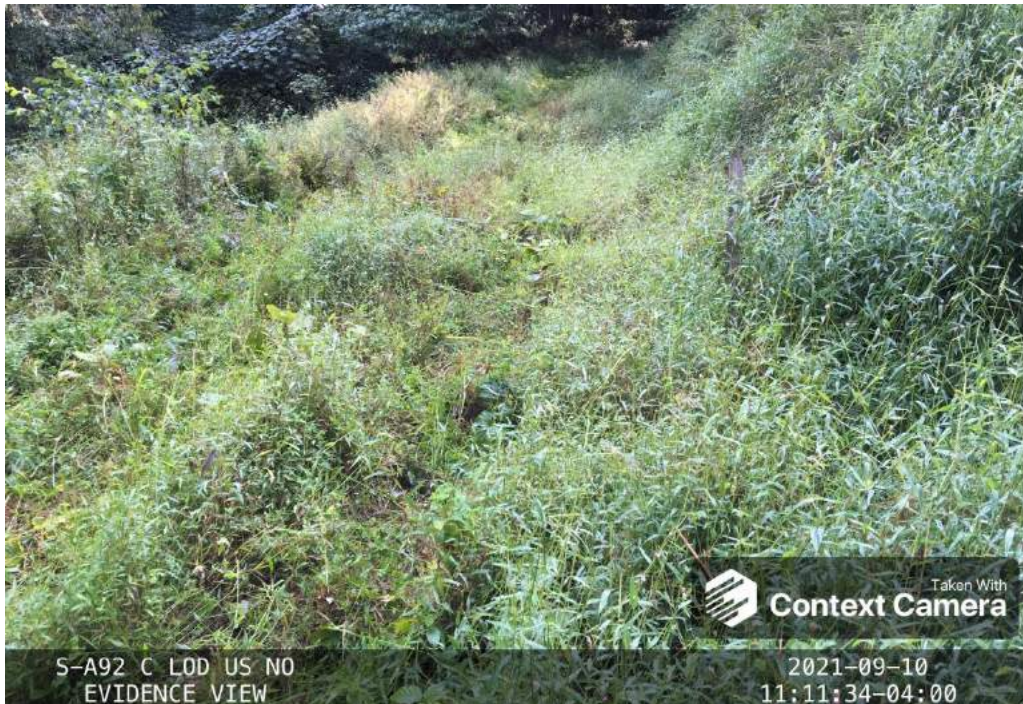
Photo Type: US View from Center

Location, Orientation, Photographer Initials: On thalweg at pipe centerline looking W Upstream, HK  
Latitude: 38.556658, Longitude: -80.535607

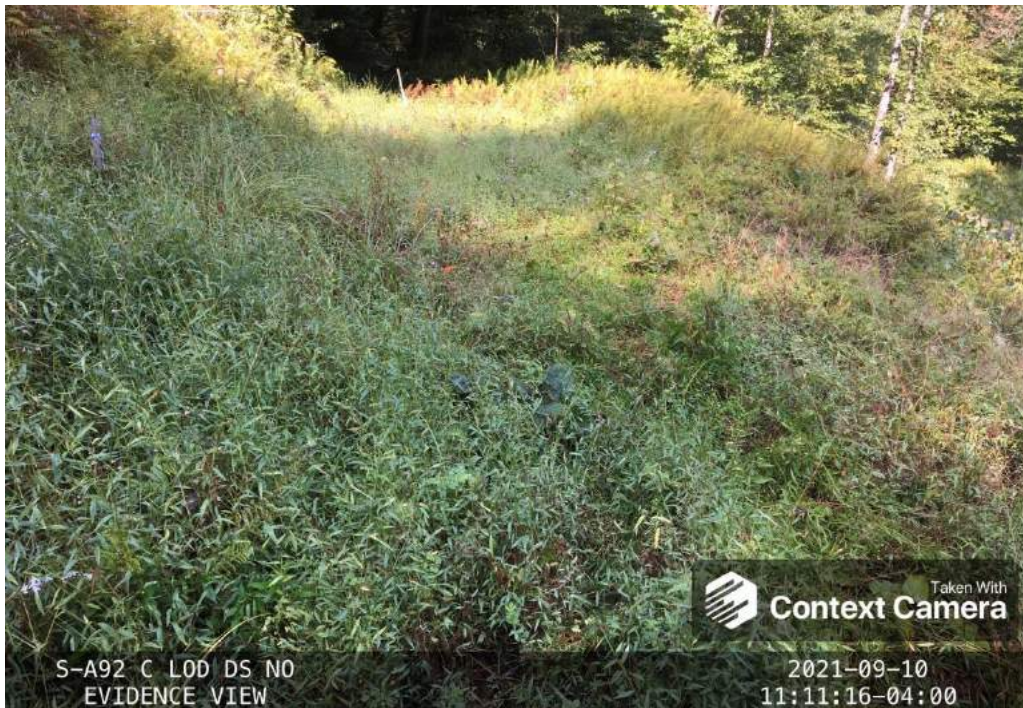
Photo Type: DS View from Center

Location, Orientation, Photographer Initials: On thalweg at pipe centerline looking E Downstream, HK  
Latitude: 38.556658, Longitude: -80.535607

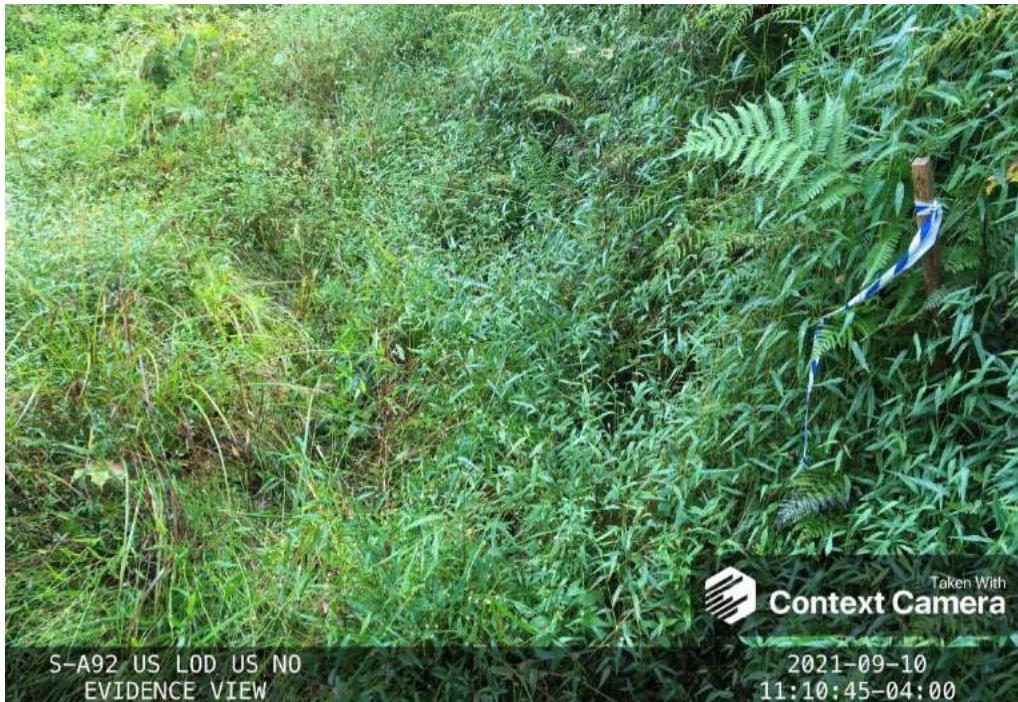
Photo Type: US, US VIEW

Location, Orientation, Photographer Initials: Upstream at LOD looking W upstream, HK  
Latitude: 38.556658, Longitude: -80.535607

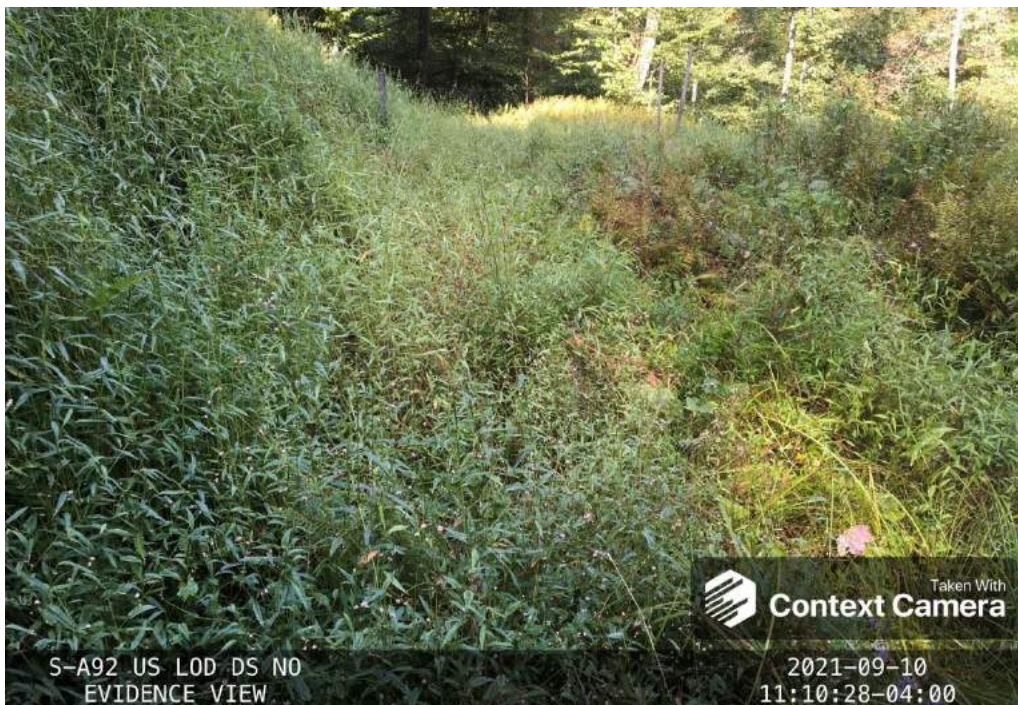
Photo Type: US, DS VIEW

Location, Orientation, Photographer Initials: Upstream at LOD looking W downstream, HK  
Latitude: 38.556658, Longitude: -80.535607
