Baseline Assessment – Stream Attributes

Reach S-CC1 (Pipeline ROW)

Pittsylvania County, Virginia

Profile and Cross-Sections Baseline Survey

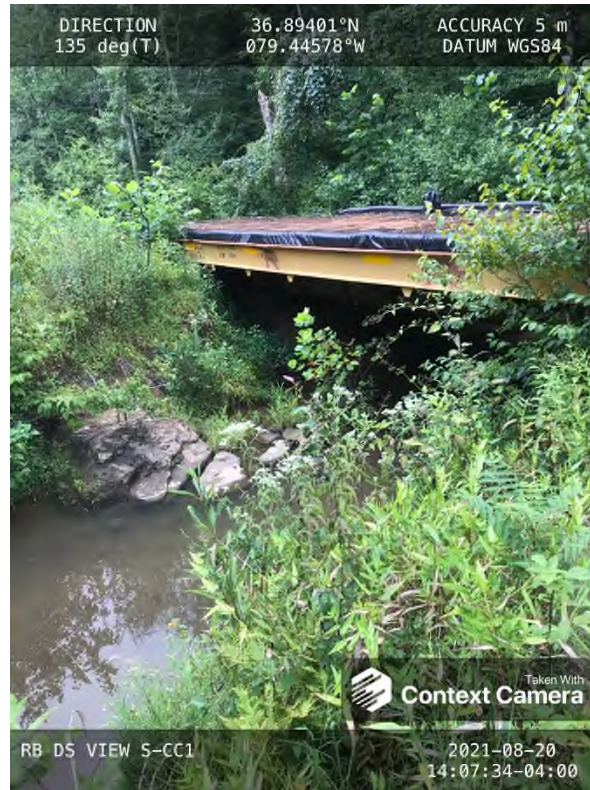
Photo Type: DS VIEW

Location, Orientation, Photographer Initials: Downstream view of ROW/LOC looking SE, AJ, VM

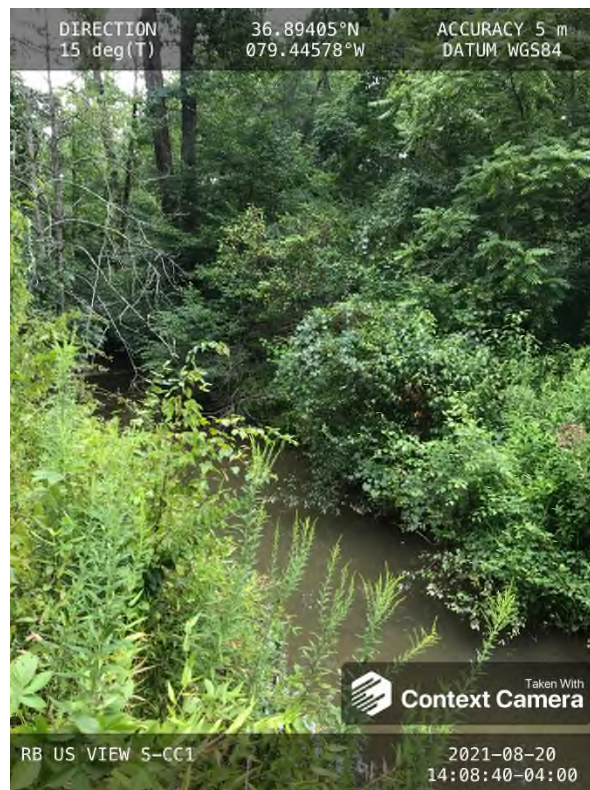
Photo Type: US VIEW

Location, Orientation, Photographer Initials: Upstream view of ROW/LOC looking W, AJ, VM

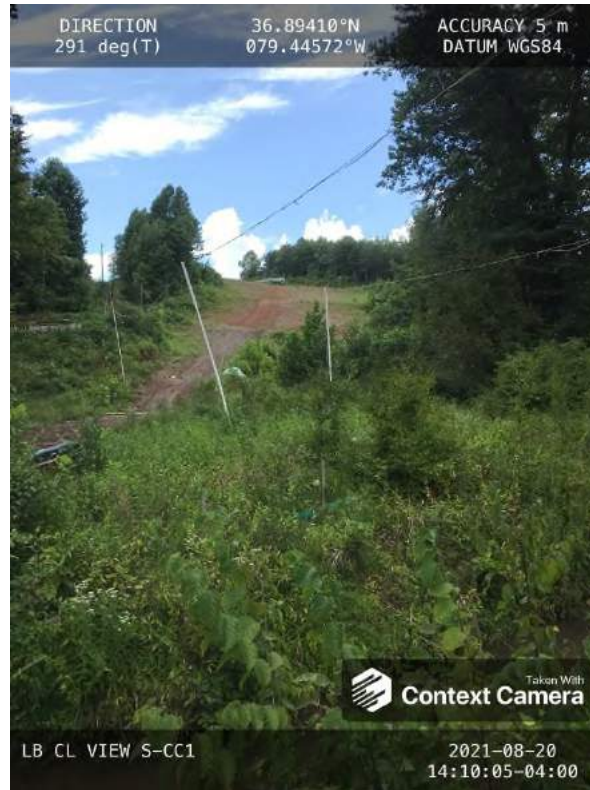
Photo Type: LB CL

Location, Orientation, Photographer Initials: Standing on LB looking at RB along pipe centerline looking S, AJ, VM

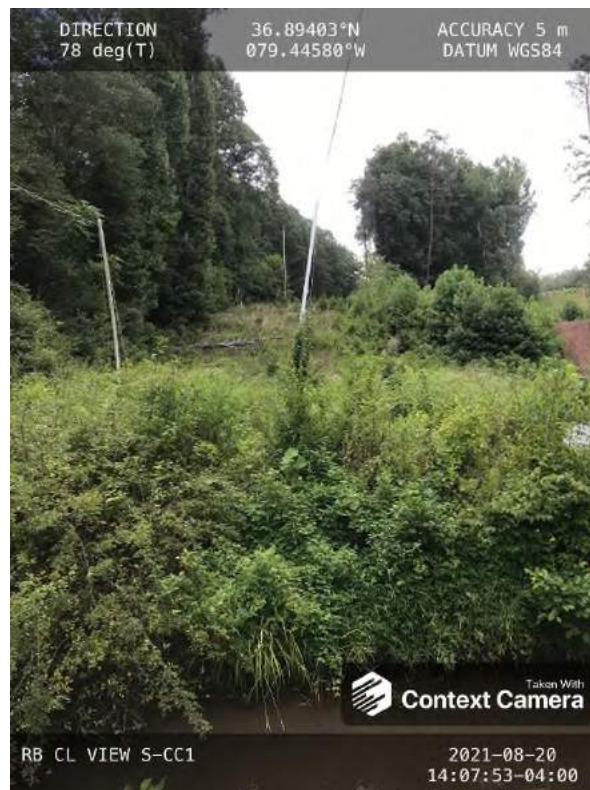
Photo Type: RB CL

Location, Orientation, Photographer Initials: Standing on RB looking at LB along pipe centerline looking S, AJ, VM

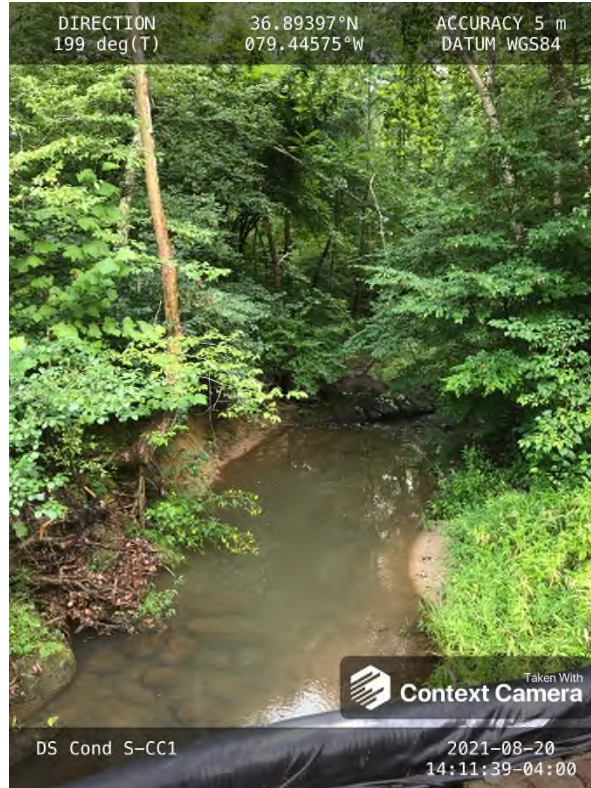
Photo Type: DS COND

Location, Orientation, Photographer Initials: Downstream conditions outside of ROW/LOC looking SE, AJ, VM

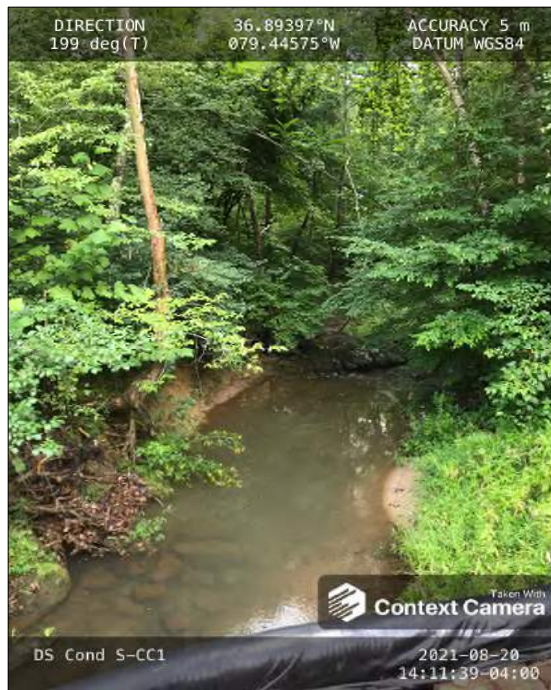
CAPTION. Assessment is limited to areas within the temporary ROW.
