Baseline Assessment – Stream Attributes

**Reach S-CC8
(Timber Mat Crossing)
Intermittent
Spread I
Pittsylvania County, Virginia**

Profile and Cross-Sections Baseline Survey

Crossings S-CC5 & S-CC8-UNT to Cherrystone Creek (MP 293.9)

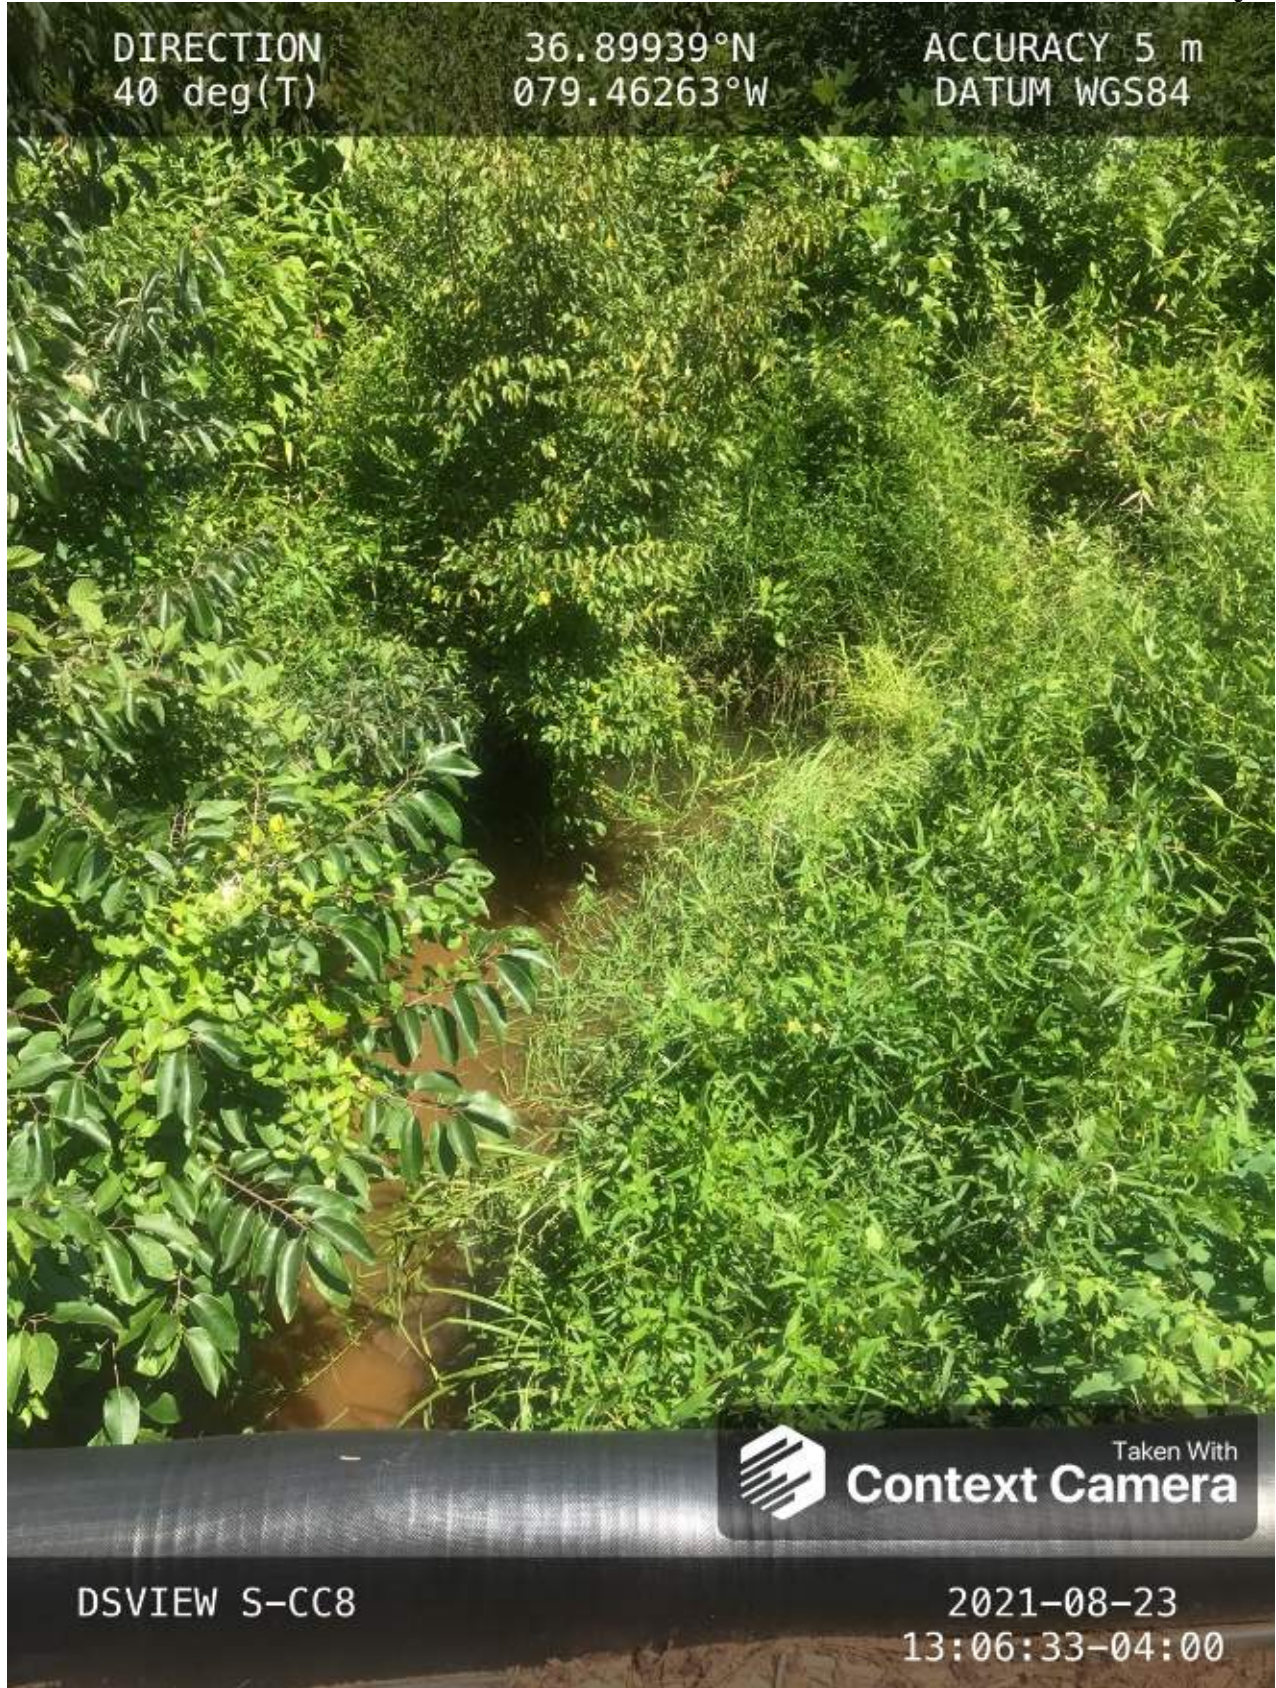
Photo Type: DS VIEW

Location, Orientation, Photographer Initials: Downstream view of ROW/LOC looking SE, RH, CL

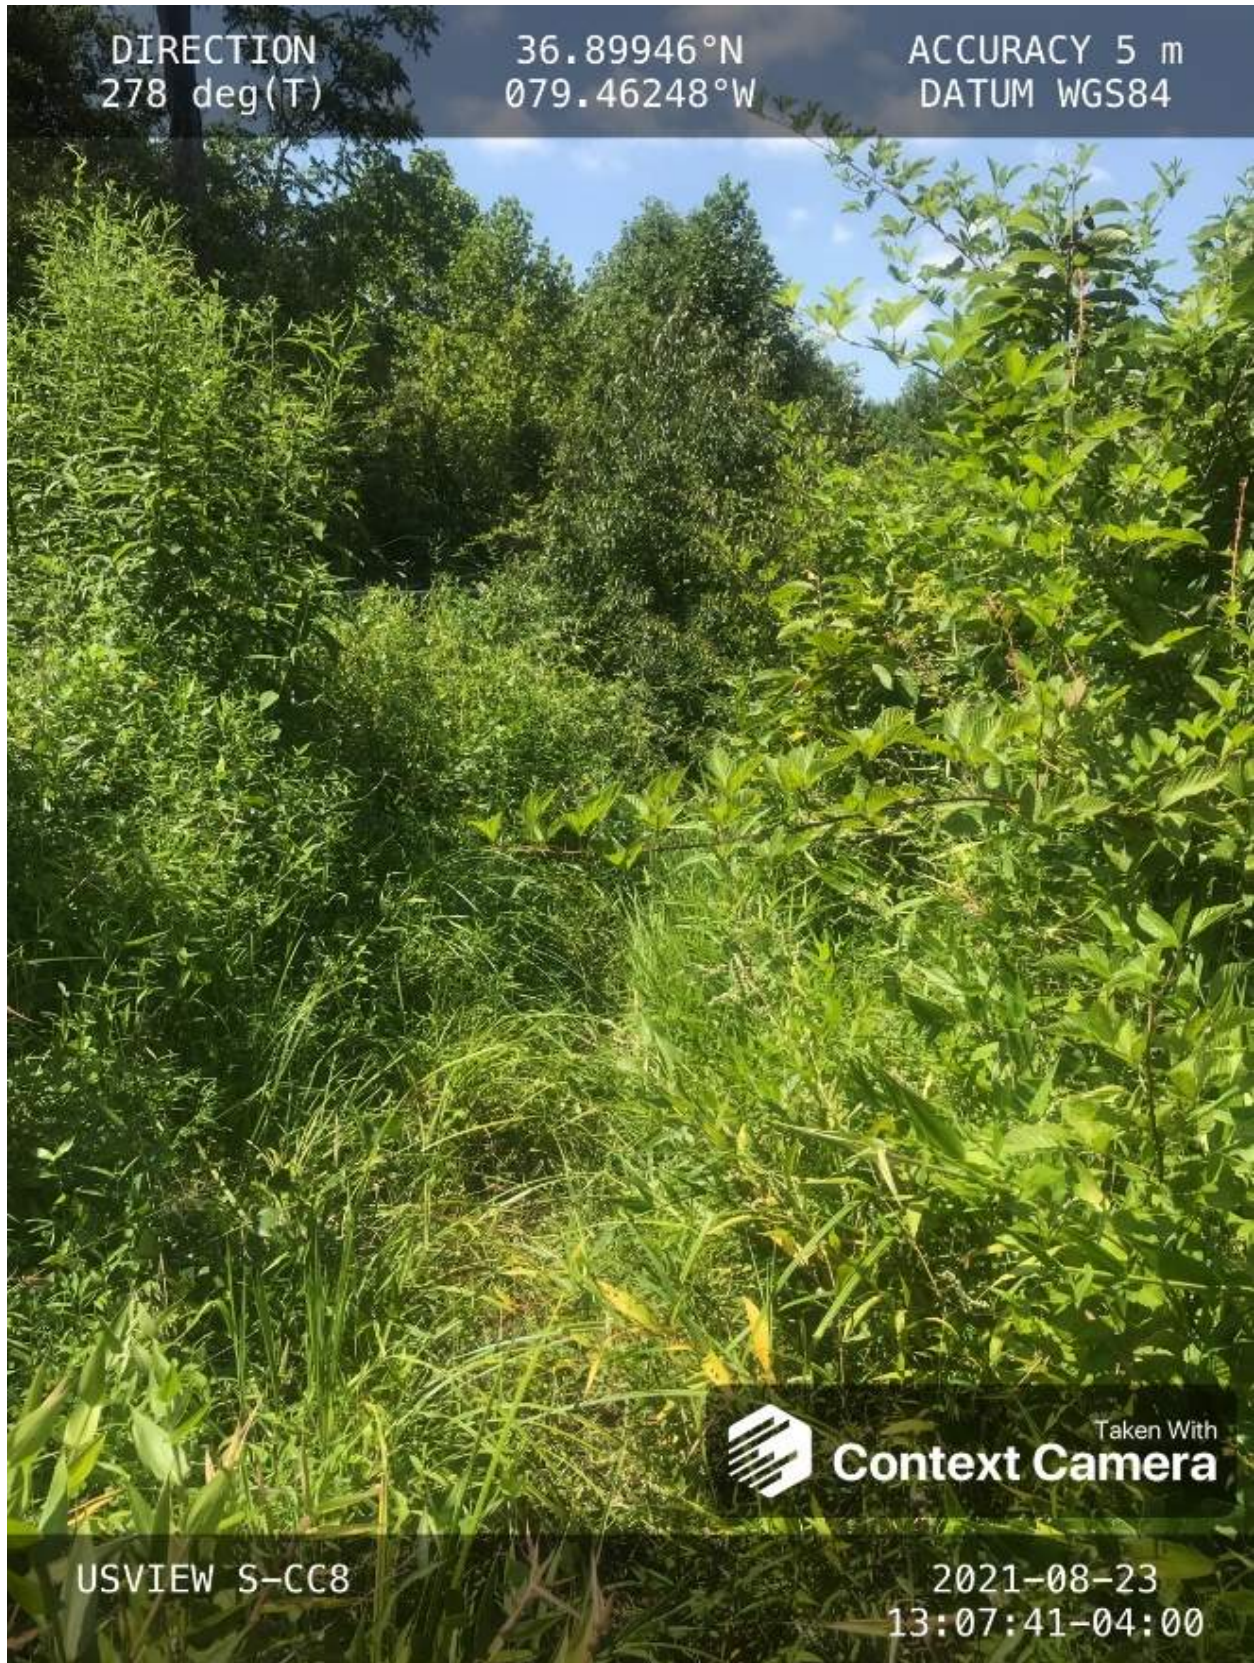
Photo Type: US VIEW

Location, Orientation, Photographer Initials: Upstream view of ROW/LOC looking W, RH, CL

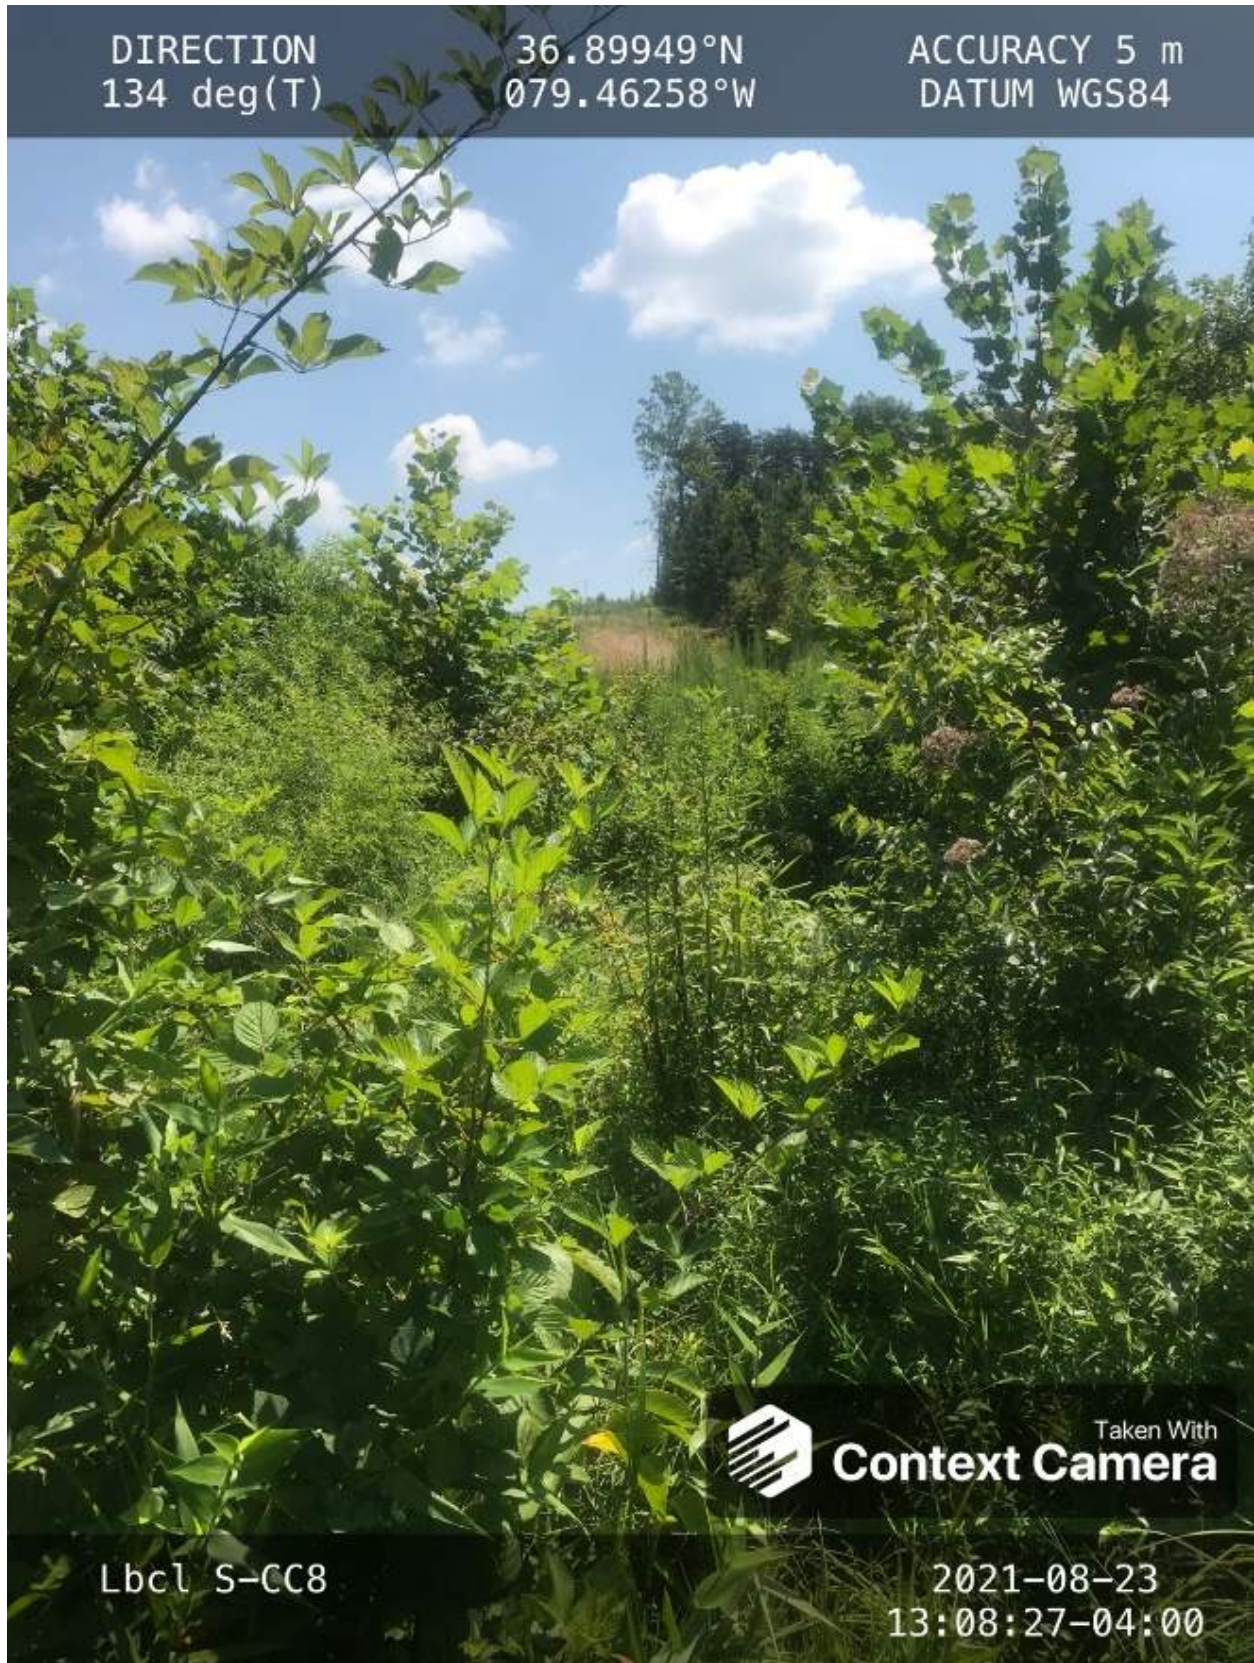
Photo Type: LB CL

Location, Orientation, Photographer Initials: Standing on LB looking at RB along pipe centerline looking S, RH, CL

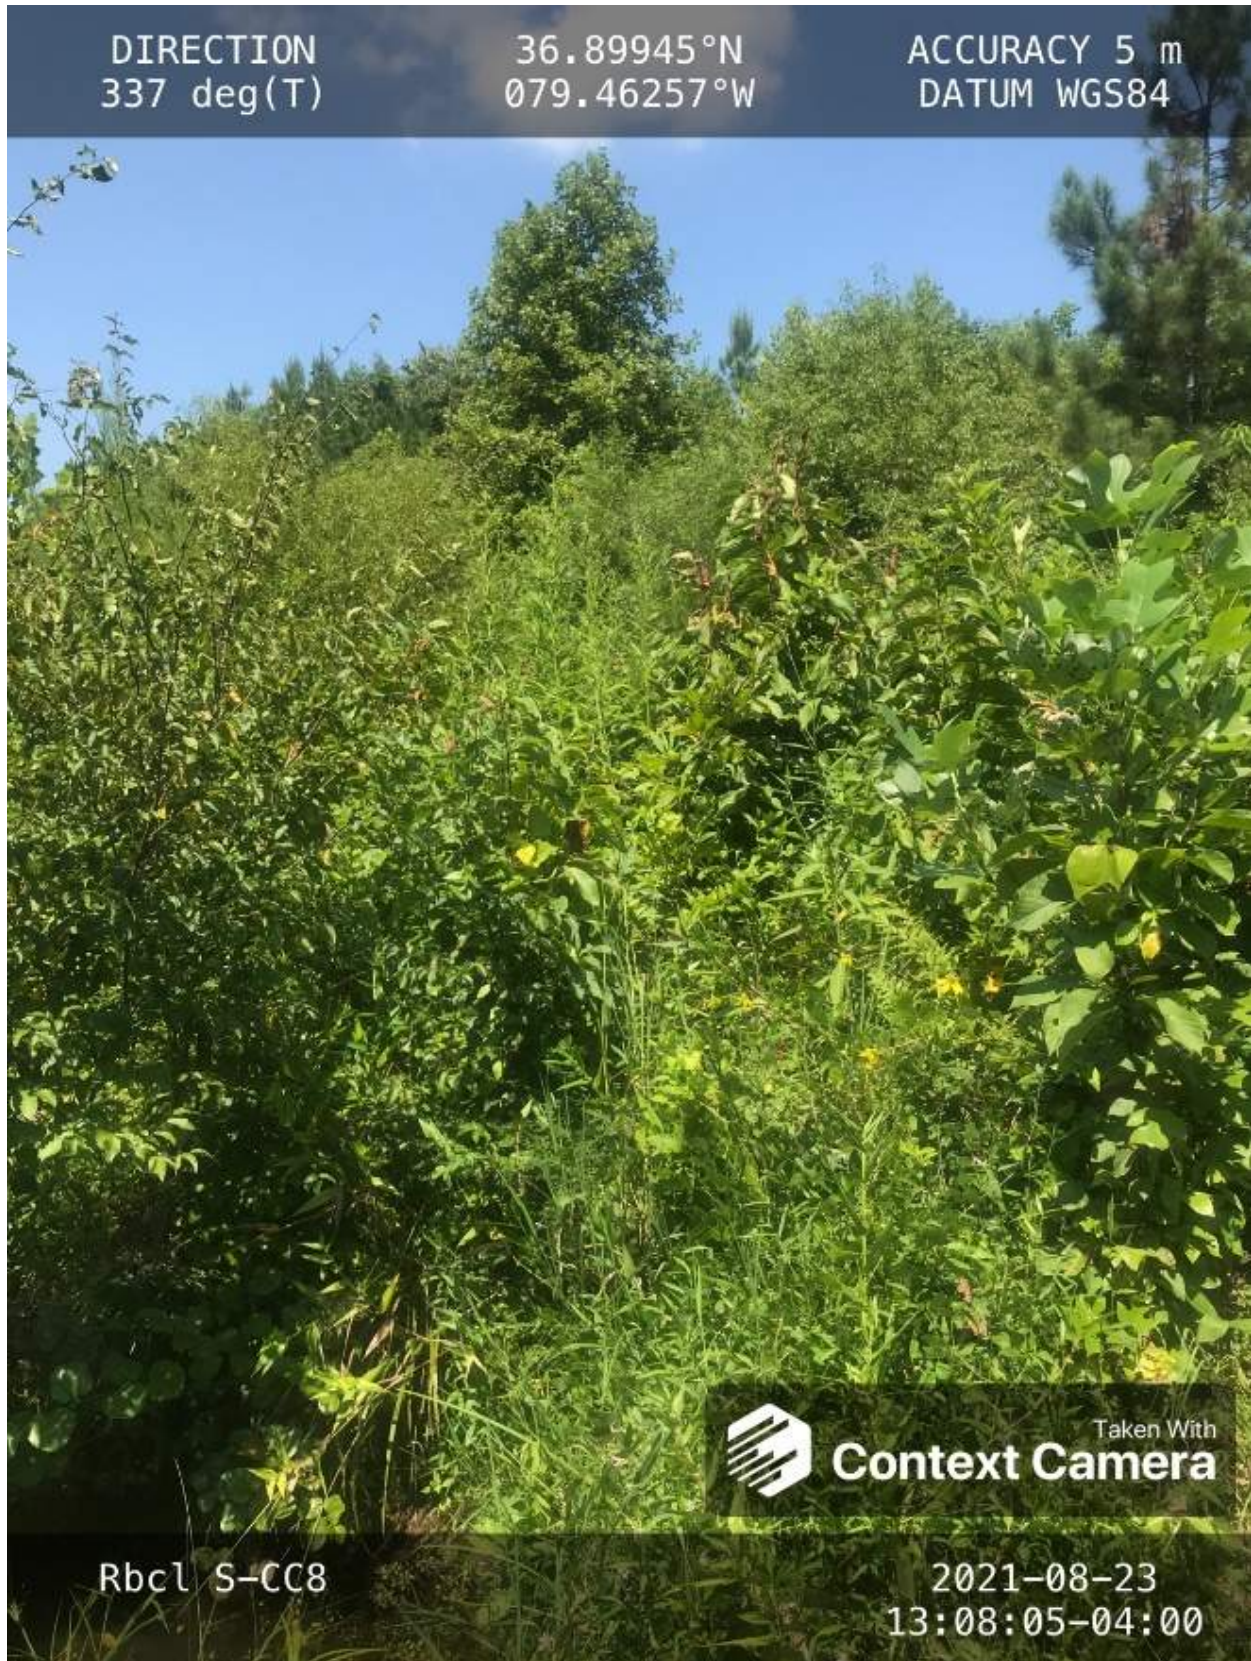
Photo Type: RB CL

Location, Orientation, Photographer Initials: Standing on RB looking at LB along pipe centerline looking S, RH, CL

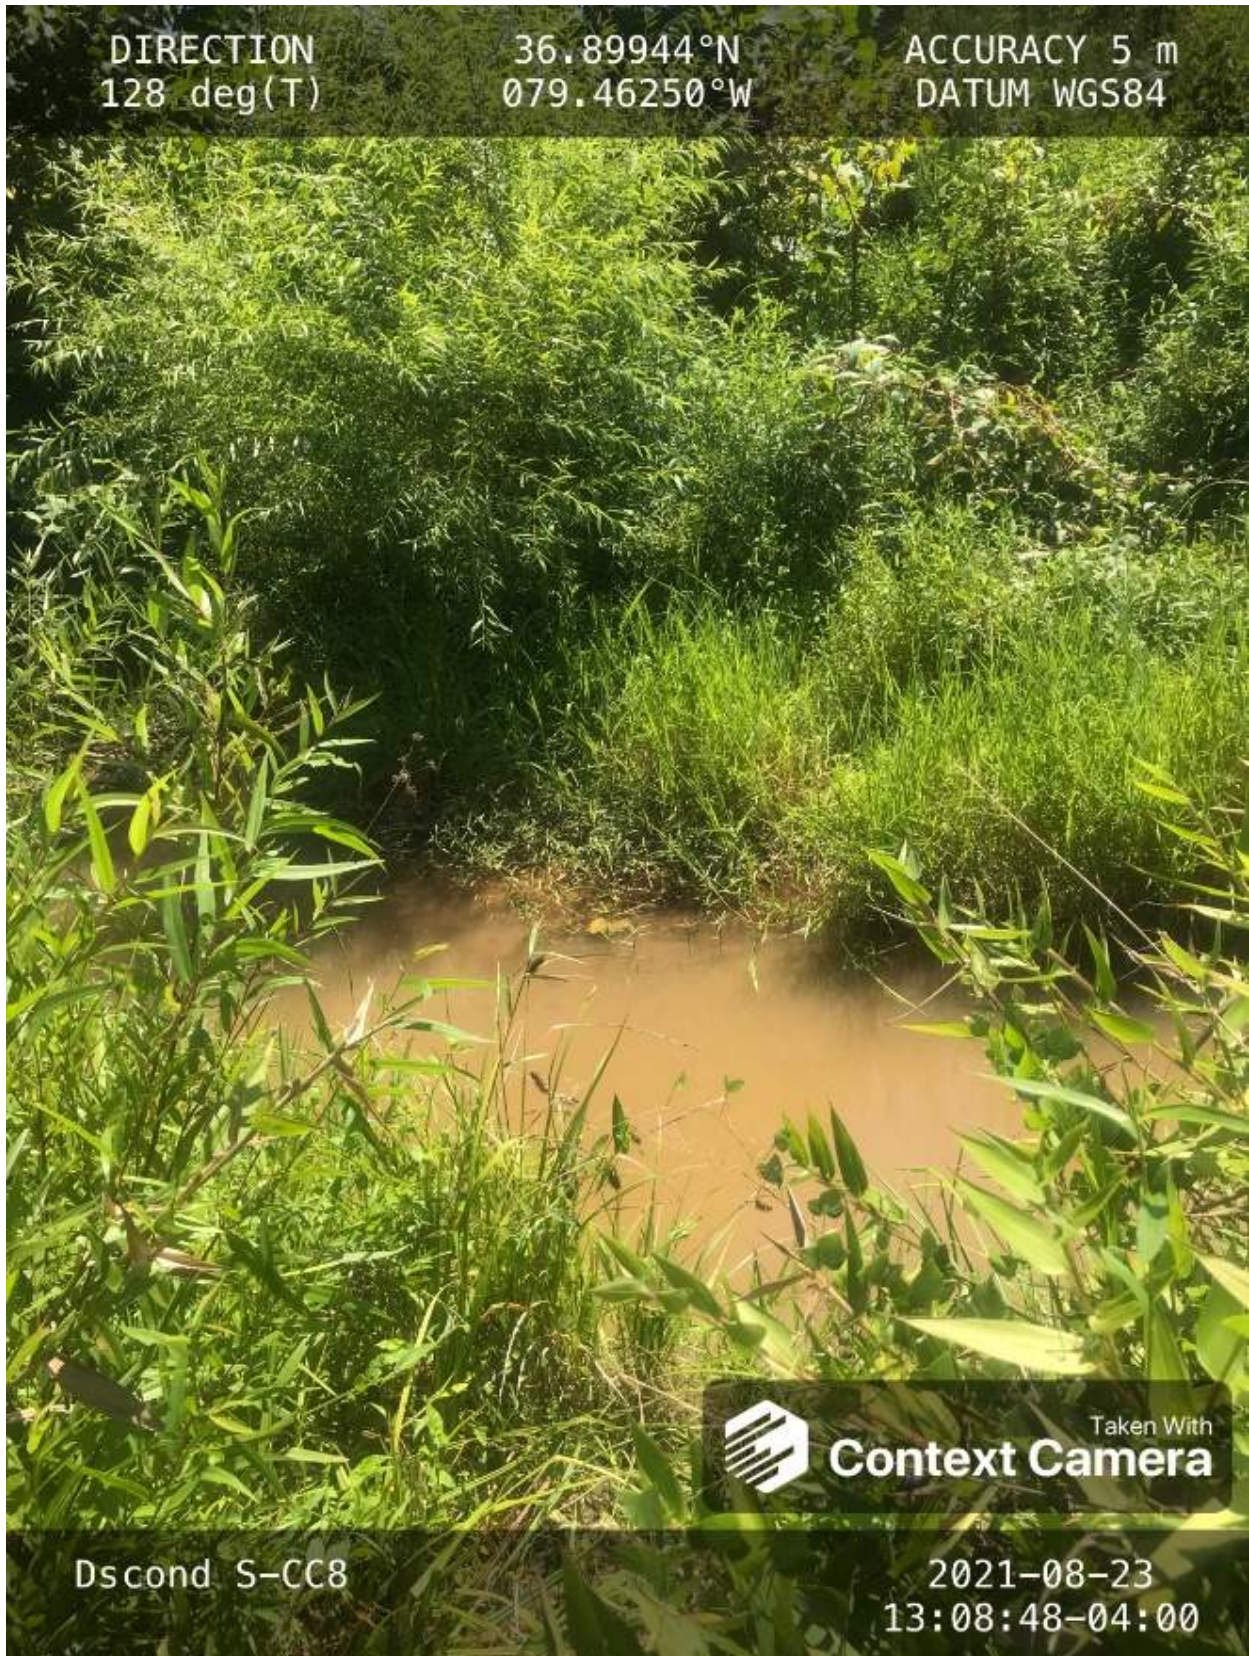
Photo Type: DS COND

Location, Orientation, Photographer Initials: Downstream conditions outside of ROW/LOC looking SE, RH, CL

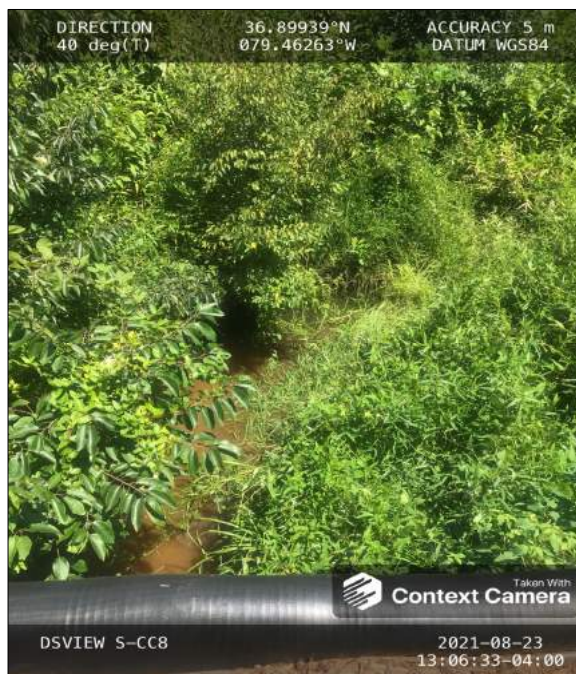
CAPTION. Assessment is limited to areas within the temporary ROW.
