Baseline Assessment – Stream Attributes

Reach S-H54 (Timber Mat Crossing)

Spread I

Pittsylvania County, Virginia

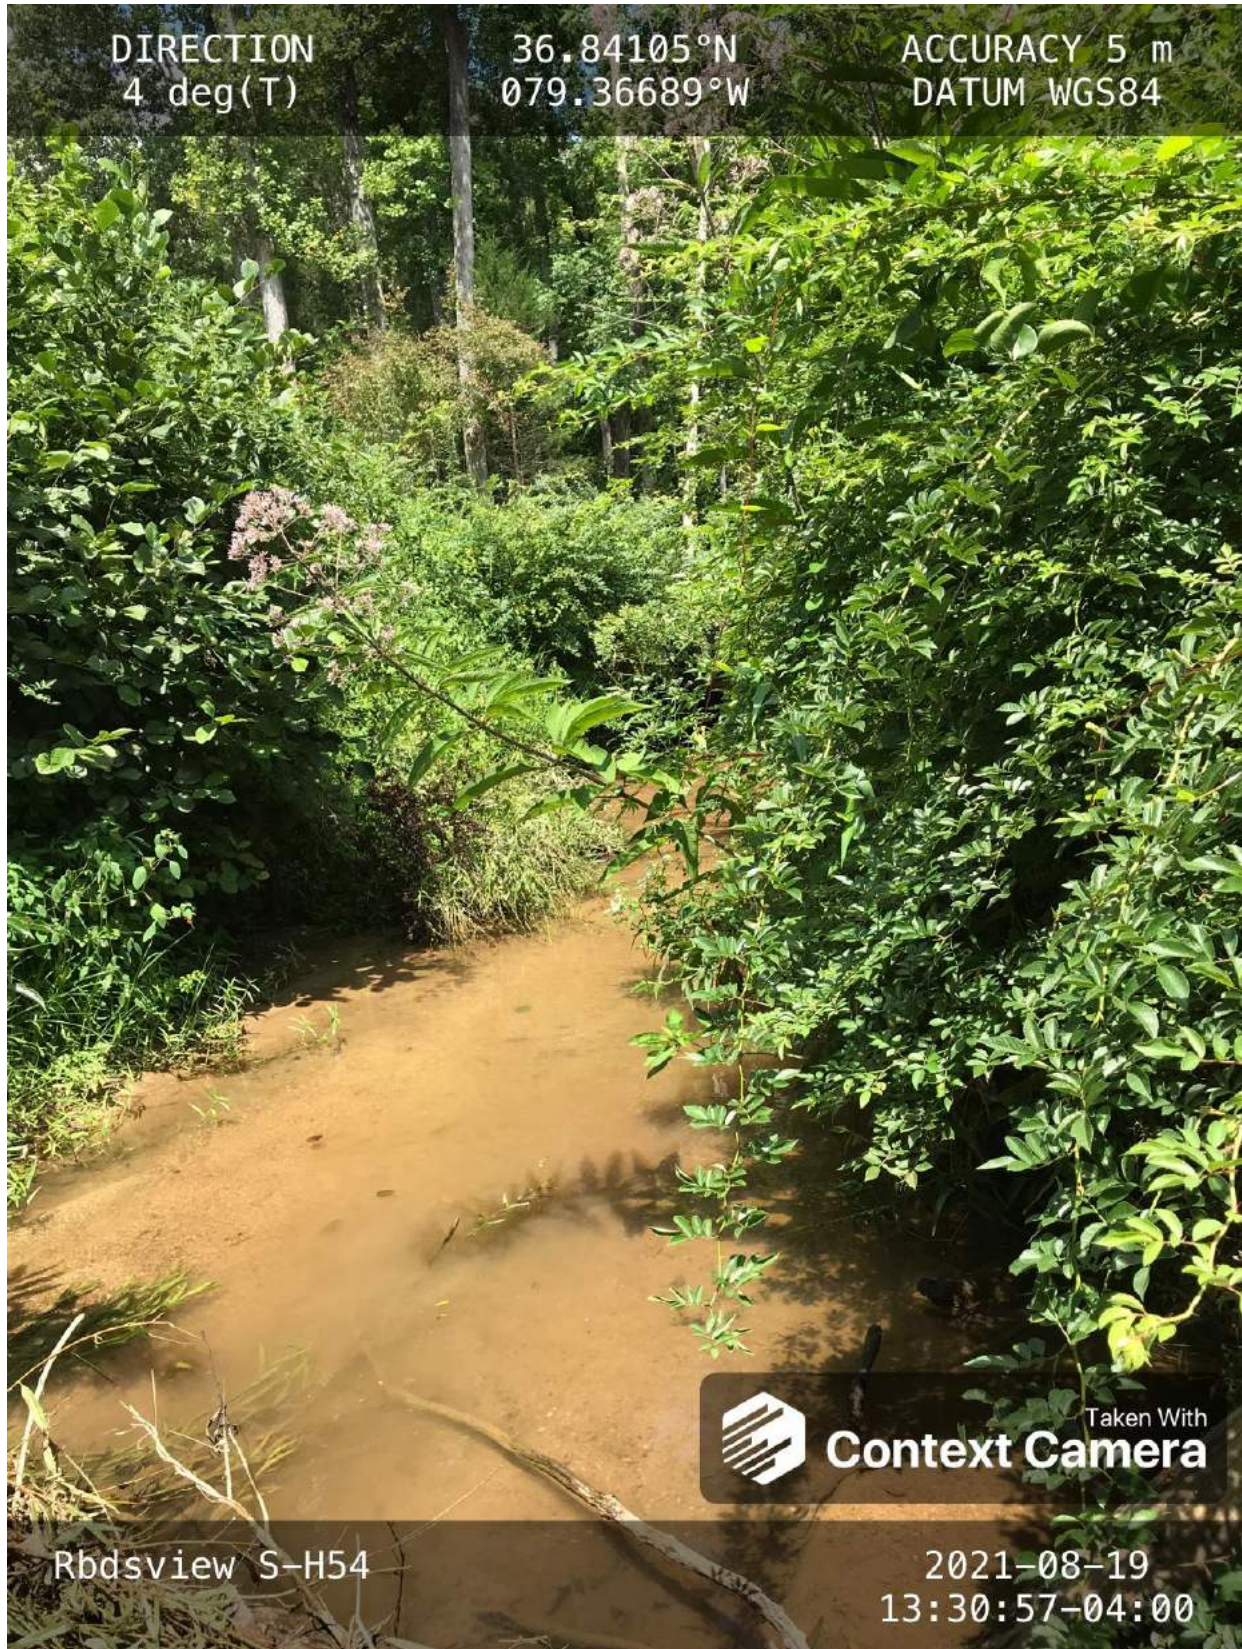
Photo Type: RB DS VIEW

Location, Orientation, Photographer Initials: Downstream View on RB of impact area inside LOD looking NE, RAH

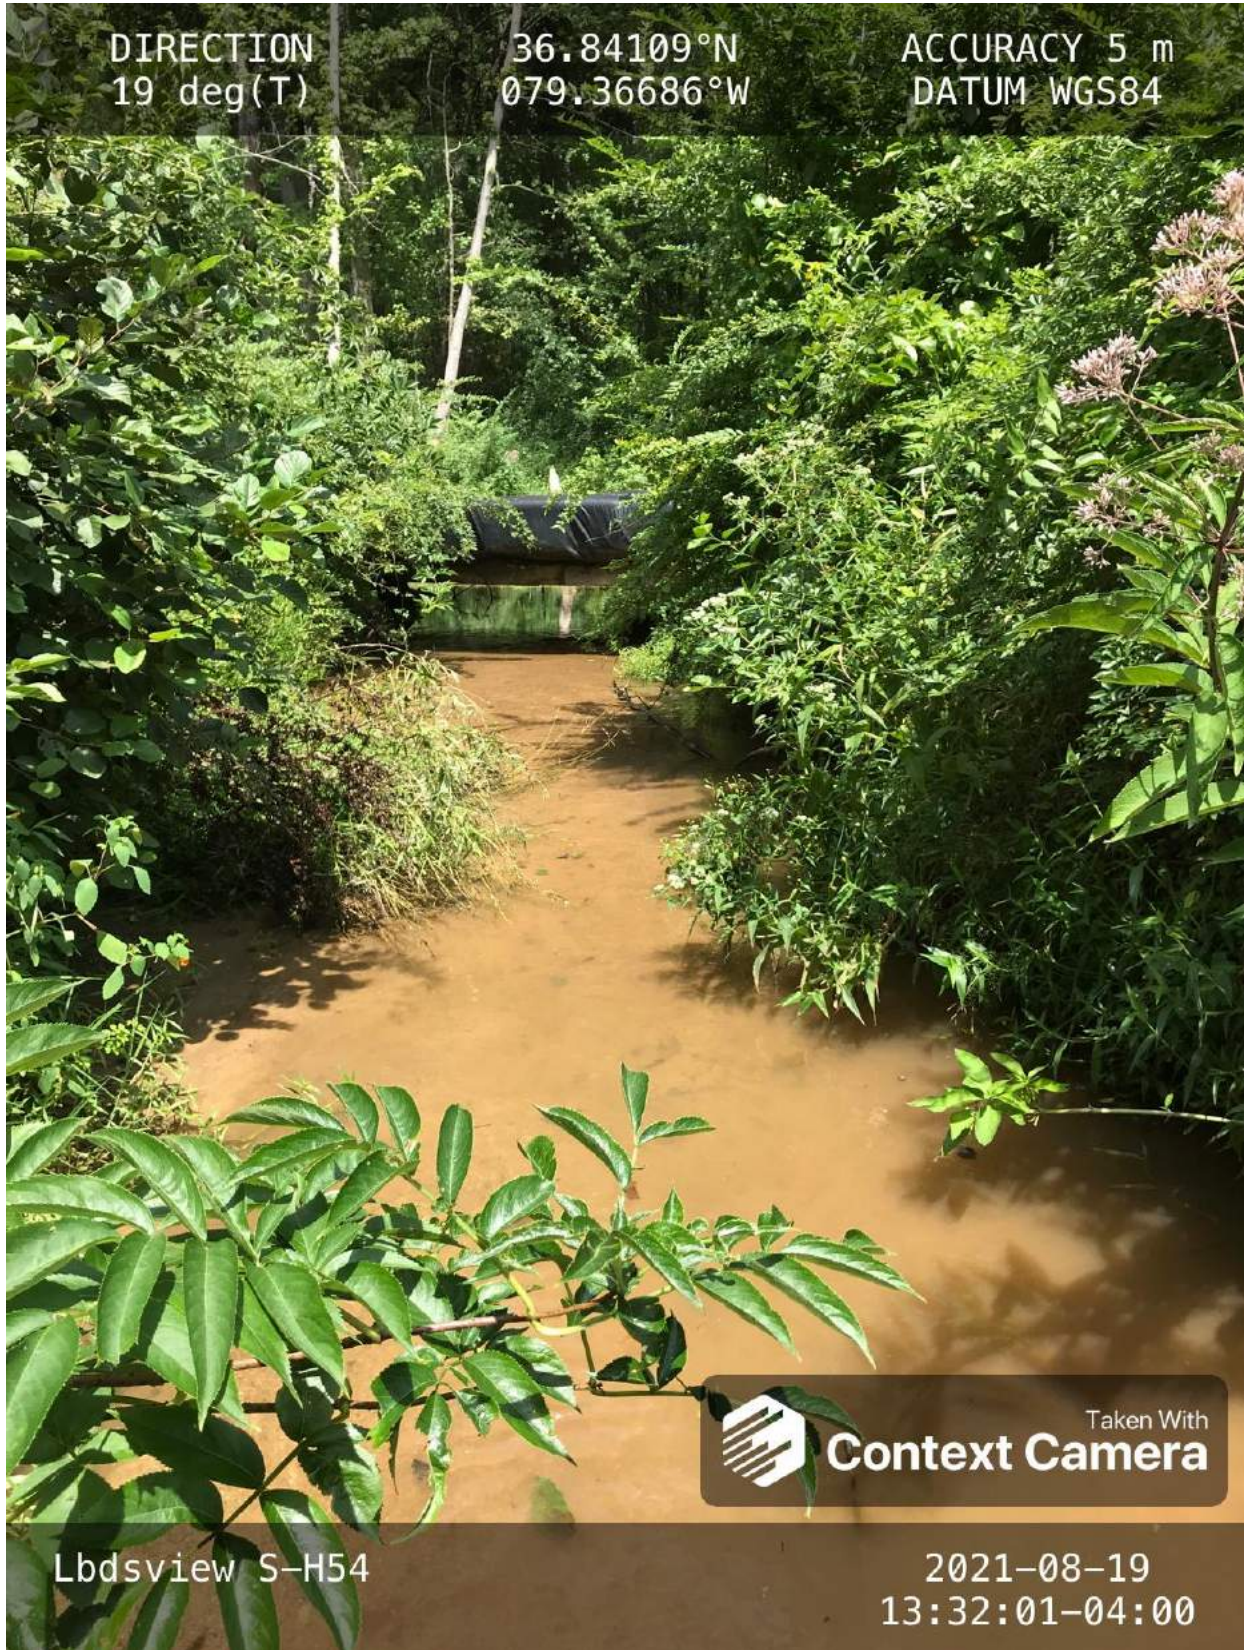
Photo Type: LB DS VIEW

Location, Orientation, Photographer Initials: Downstream View on LB of impact area inside LOD looking NE, RAH

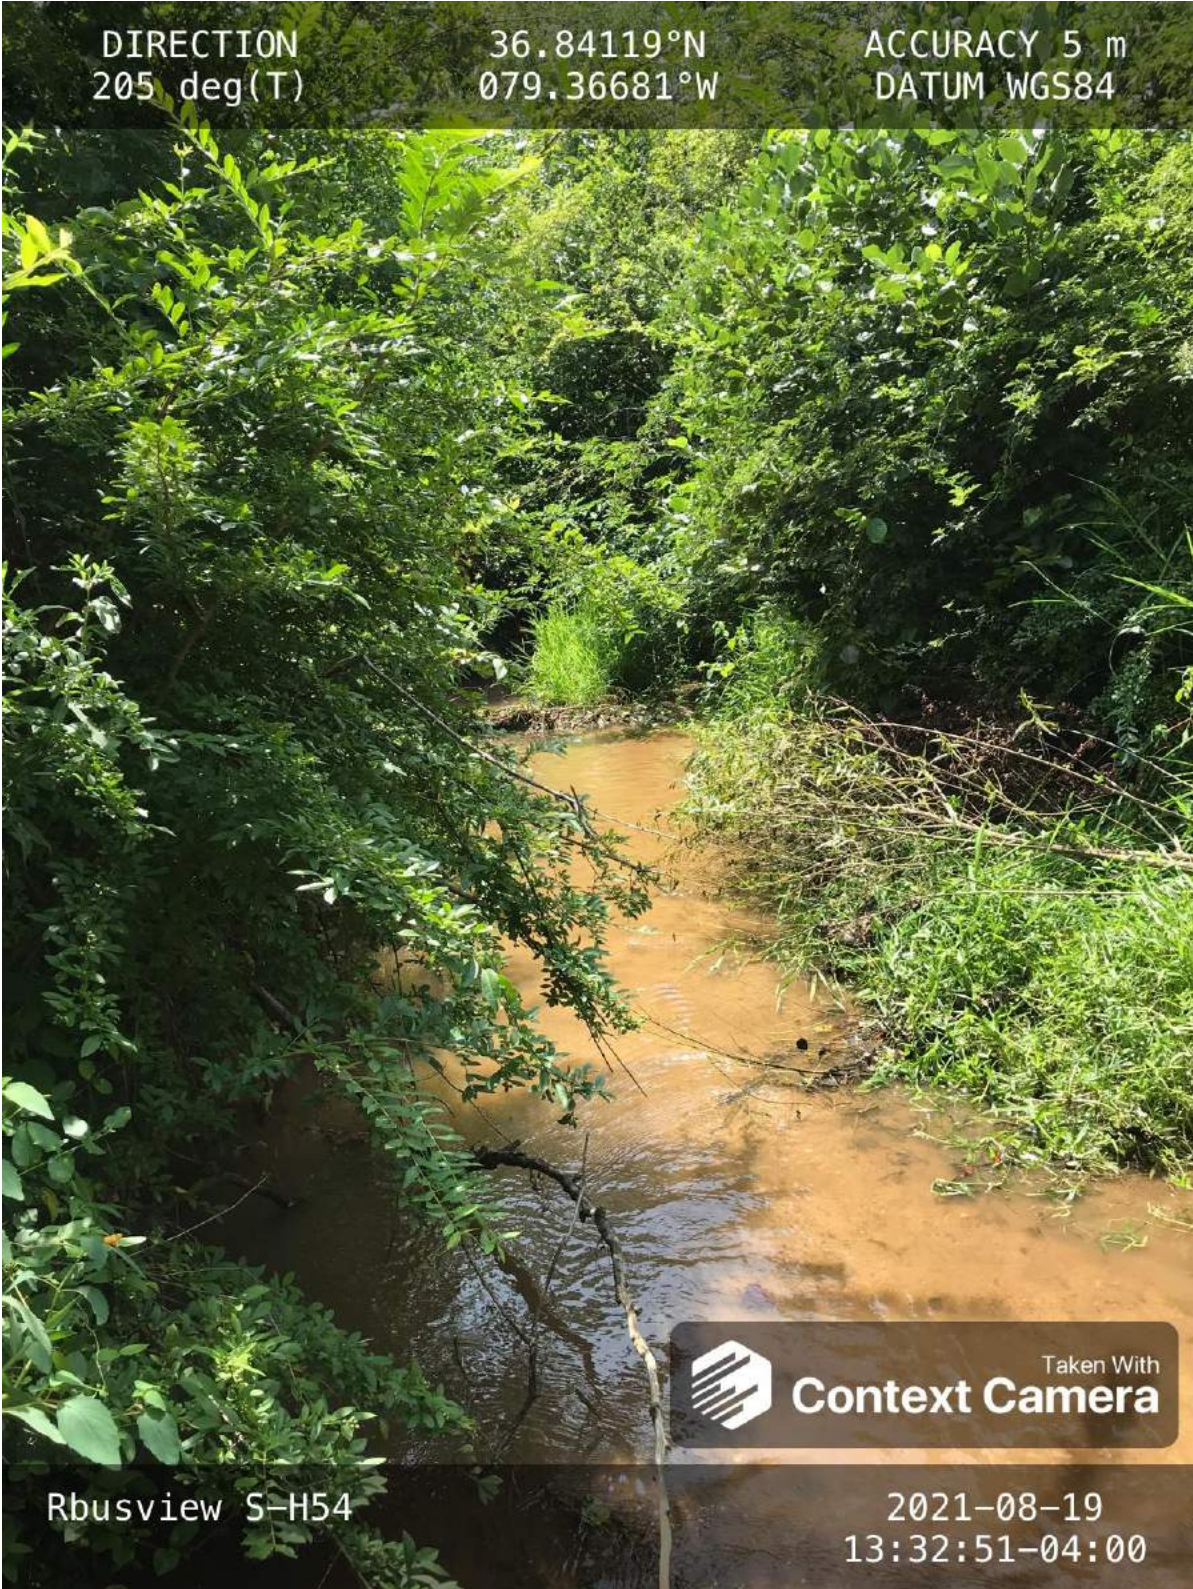
Photo Type: RB US VIEW

Location, Orientation, Photographer Initials: Upstream View on RB of impact area inside LOD looking SW, RAH

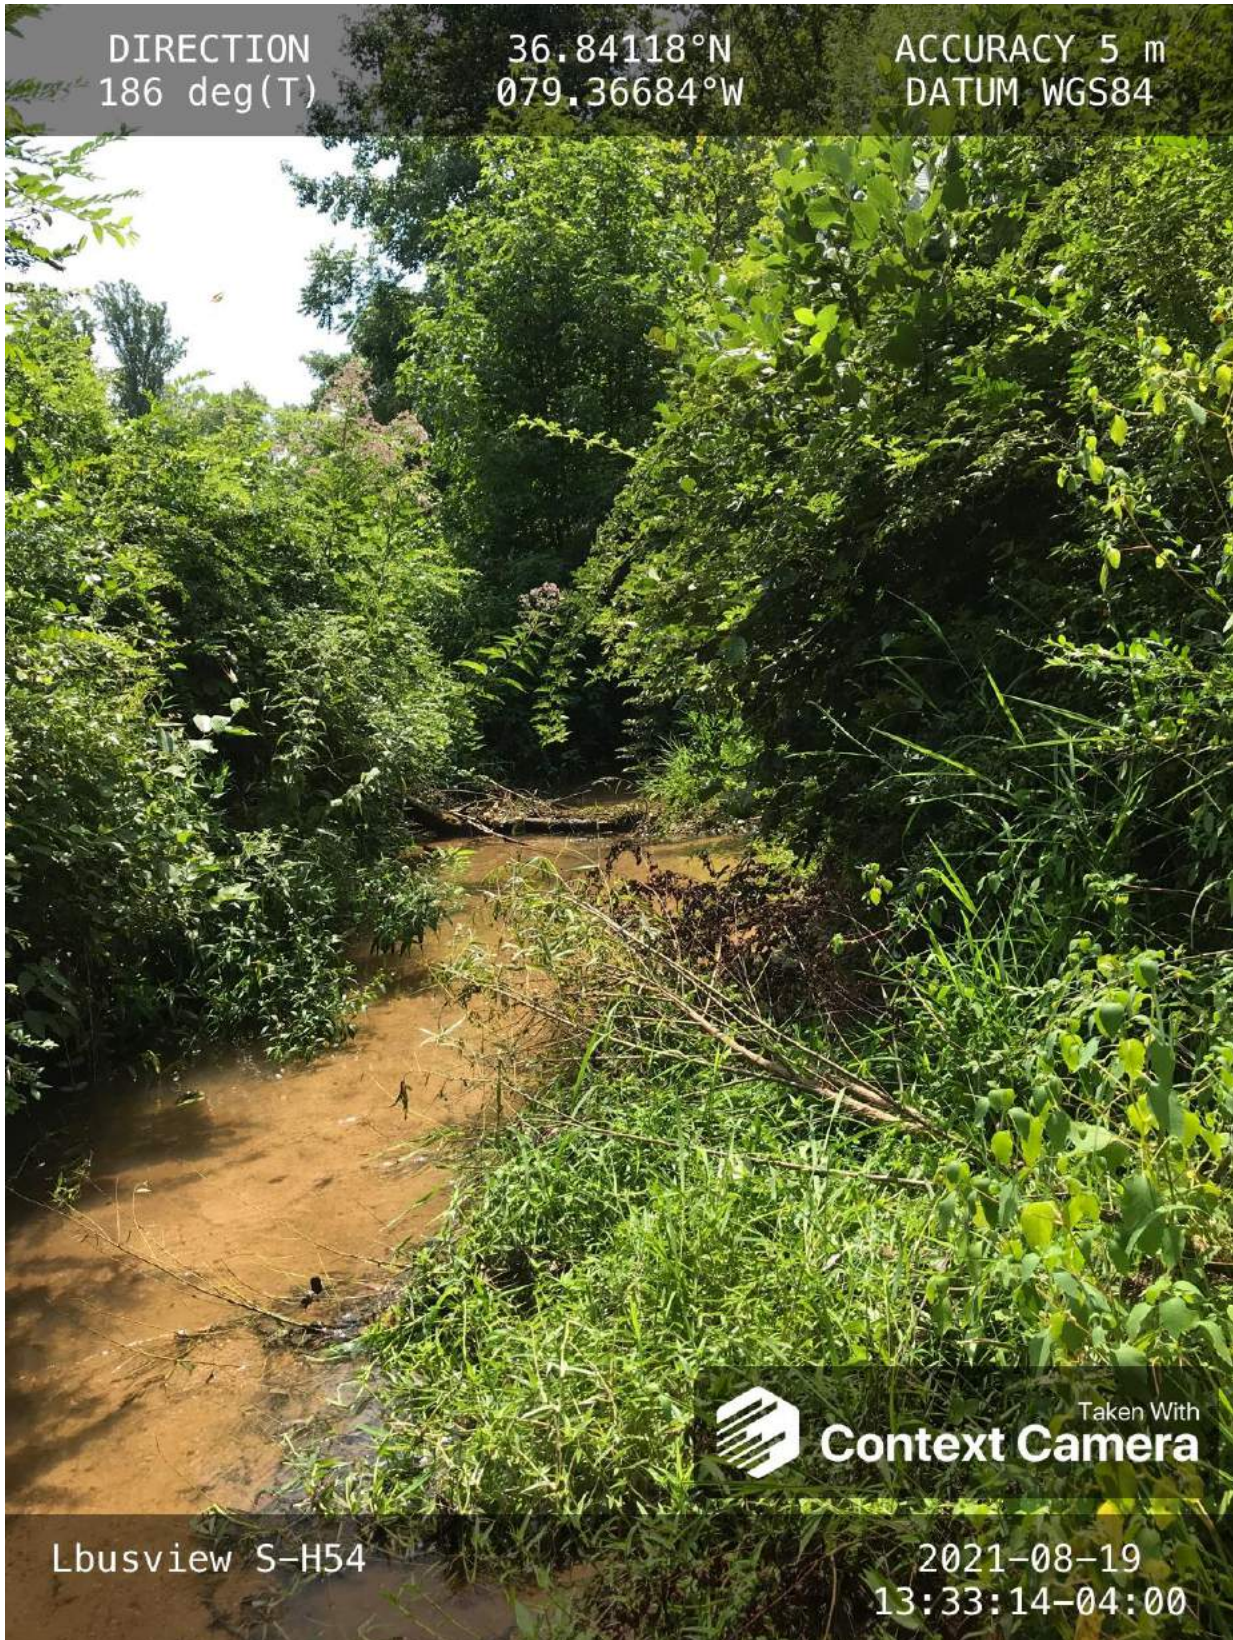
Photo Type: LB US VIEW

Location, Orientation, Photographer Initials: Upstream View on LB of impact area inside LOD looking SW, RAH

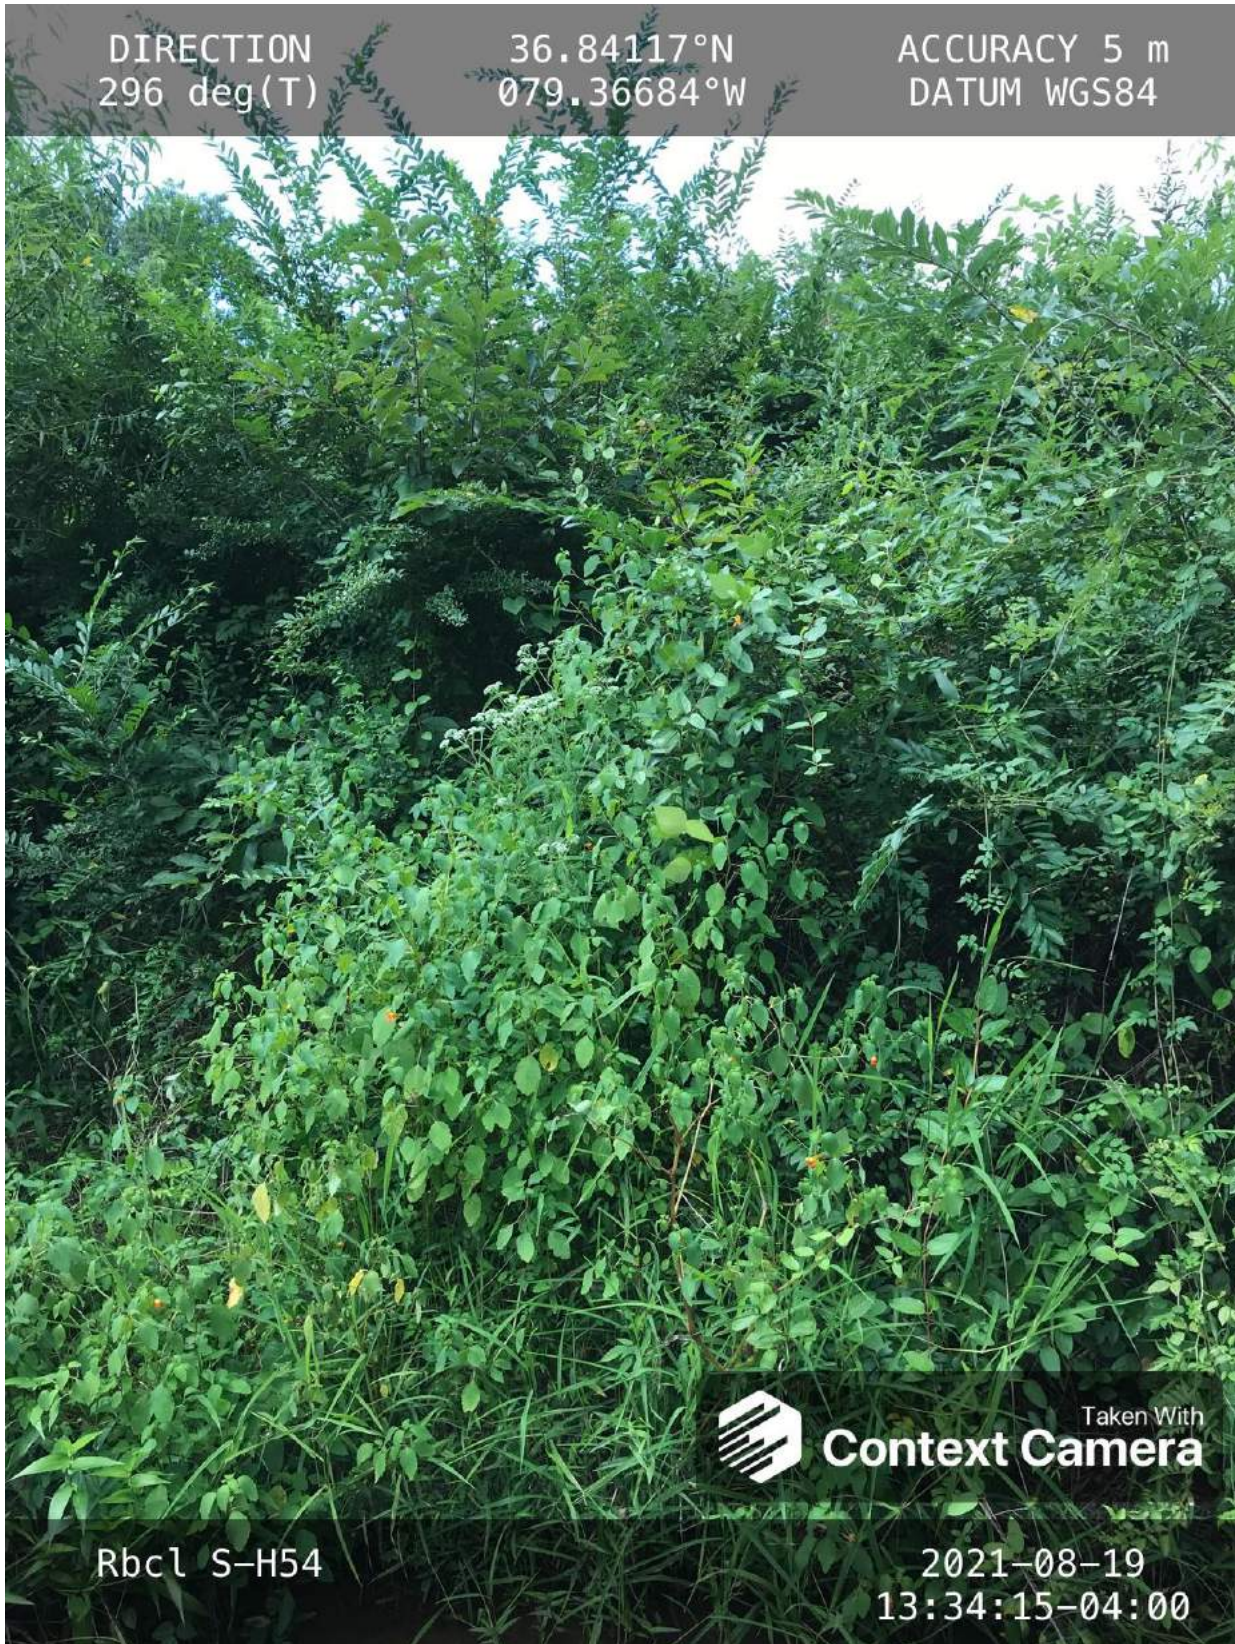
Photo Type: RB CL

Location, Orientation, Photographer Initials: Standing on RB looking at LB along pipe centerline looking NW, RAH

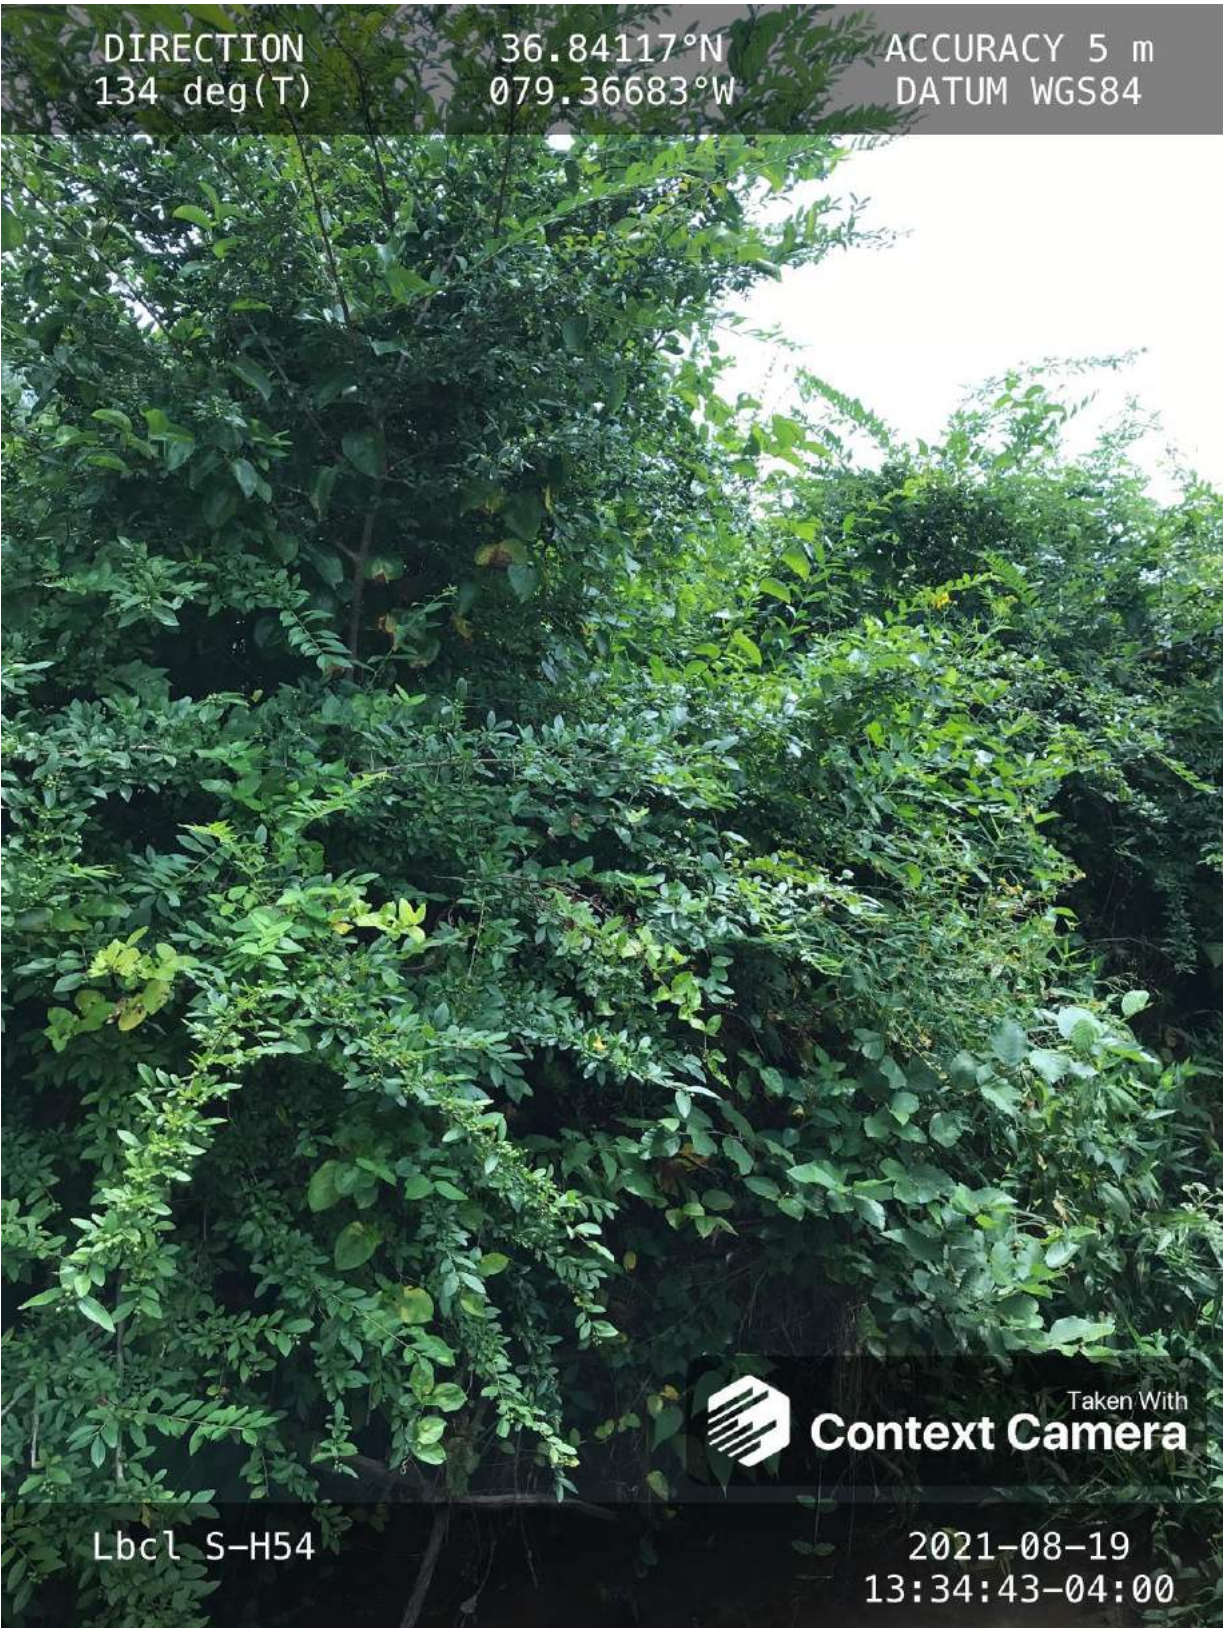
Photo Type: LB CL

Location, Orientation, Photographer Initials: Standing on LB looking at RB along pipe centerline looking SE, RAH

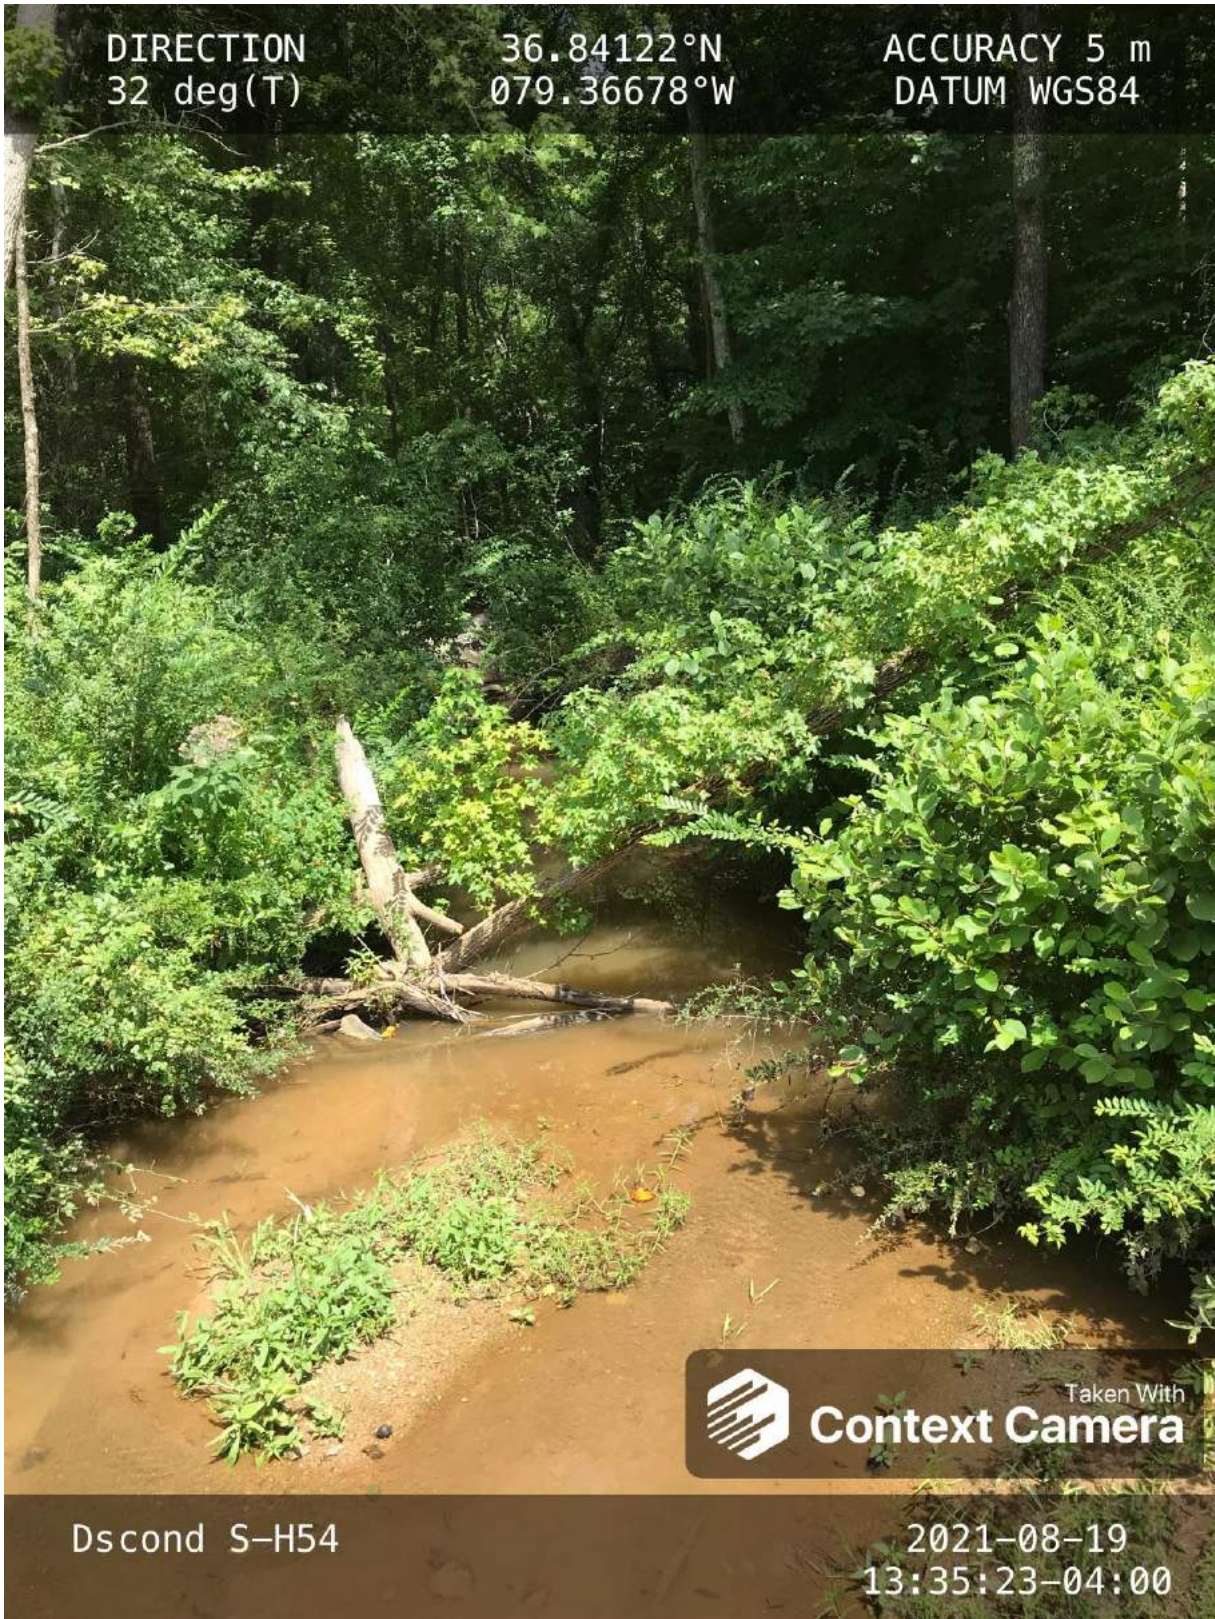
Photo Type: DS COND
Location, Orientation, Photographer Initials: Downstream conditions looking NE, RAH

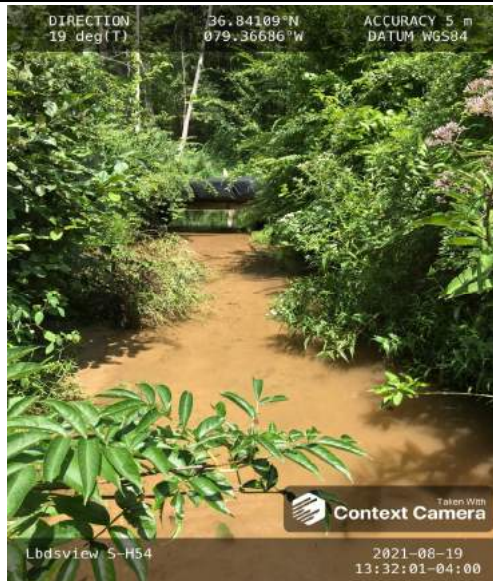
CAPTION. Assessment is limited to areas within the temporary ROW.
