4. SUMMARY OF VISUAL IMPACTS

APPENDIX B

SIMULATIONS AND PHOTOGRAPHY

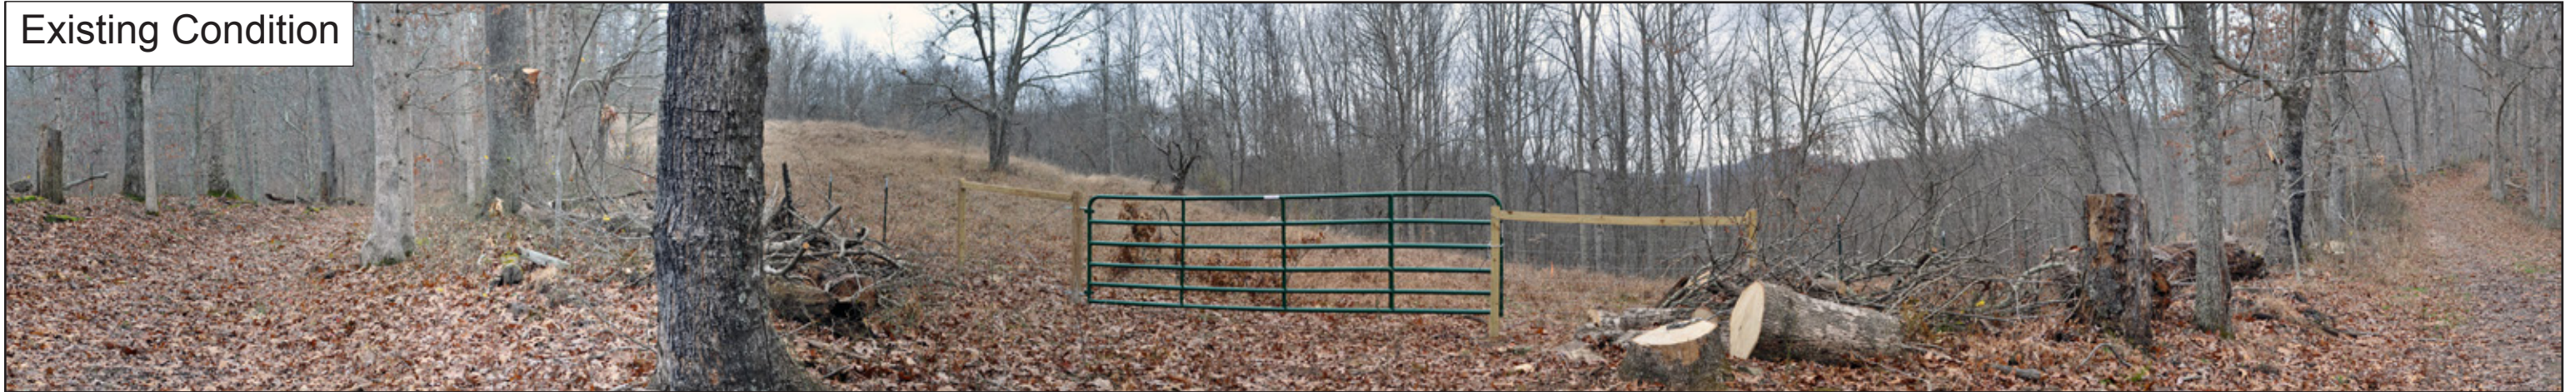
Post Construction

The photo was taken from the Weston and Gauley Bridge Turnpike Trail (Trail) at the Trail/pipeline crossing looking north. The pipeline would be bored under the Trail with the bore pits located approximately 20 feet from the fence line edge of the Trail. Vegetation removal associated with the pipeline right-of-way would be visible beyond the open field on the northern side of the Trail. The yellow dashed line indicates the approximate pipeline alignment.

According to the vegetation-modeled viewshed for the WGBT Trail/pipeline crossing at KOP 105 (Appendix A, Figure 3), visibility will be limited to the Trail/pipeline crossing and less than 100 feet either side of the pipeline ROW. The bore pits will not be visible according to the viewshed. A visual simulation (Appendix A, Figure 6) was prepared showing leaf-off conditions. Vegetation removal associated with the pipeline ROW will be visible beyond the open field on the northern side of the Trail where vegetation clearing will create an opening in the tree canopy. On the southern side of the Trail, some tree thinning associated with the pipeline ROW may be apparent south of the bore pit. However, the bore pit will not be visible as it will be located behind a small rise in the terrain. In leaf-on conditions, the visual impacts at KOP 105 will be minimized as the opening in the tree canopy to the north will be reduced and the tree thinning to the south will be screened by vegetation.

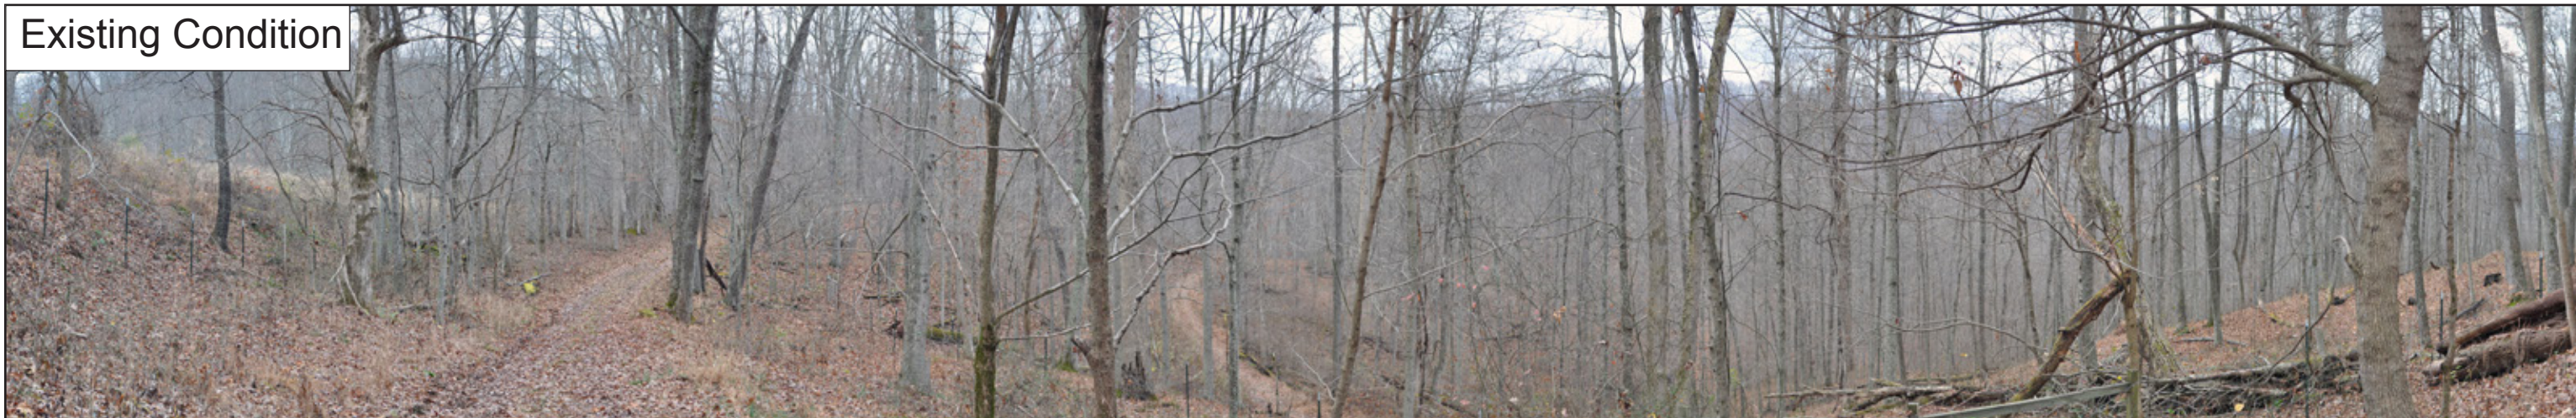
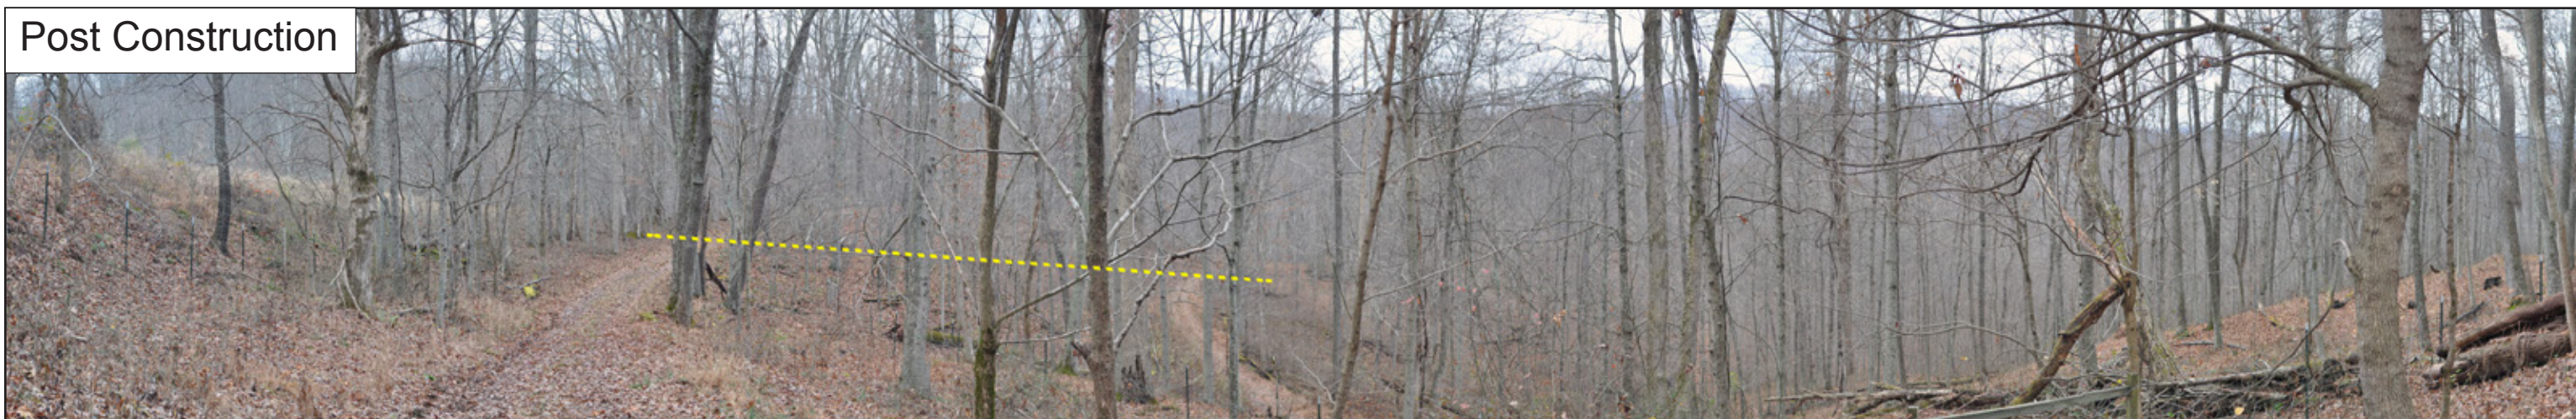
Post Construction

The photo was taken from the Weston and Gauley Bridge Turnpike Trail (Trail) west of the Trail/pipeline crossing looking east. The pipeline would be bored under the Trail with the bore pits located approximately 20 feet from the fence line edge of the Trail. From this viewpoint the bore pit on the northern side of the Trail would be located in an open field and the pipeline right-of-way beyond that would be screened. The bore pit on the southern side of the Trail would be located behind a low ridge and not visible from KOP 106. In “leaf-off” conditions, tree thinning may be apparent further south of the bore pit location, but not readily noticeable. In “leaf-on” conditions, views of the pipeline right-of-way from KOP 106 would be screened by vegetation. The yellow dashed line indicates the approximate pipeline alignment.

According to the vegetation-modeled viewshed for the location west of the WGBT Trail/pipeline crossing at KOP 106 (Appendix A, Figure 4), visibility will be limited to the area immediately adjacent to KOP 106, and the Project will not be visible from this location. A visual simulation (Appendix A, Figure 7) was prepared showing leaf-off conditions. Tree thinning associated with the pipeline ROW may be apparent south of the bore pit located on the south side of the Trail. However, tree thinning will not be very noticeable due to the dense stands of trees between the viewer and the pipeline ROW. Views of the pipeline ROW on the north side of the Trail will be screened by terrain and topography. In leaf-on conditions, views of the pipeline ROW to the south of the Trail will be screened by vegetation.

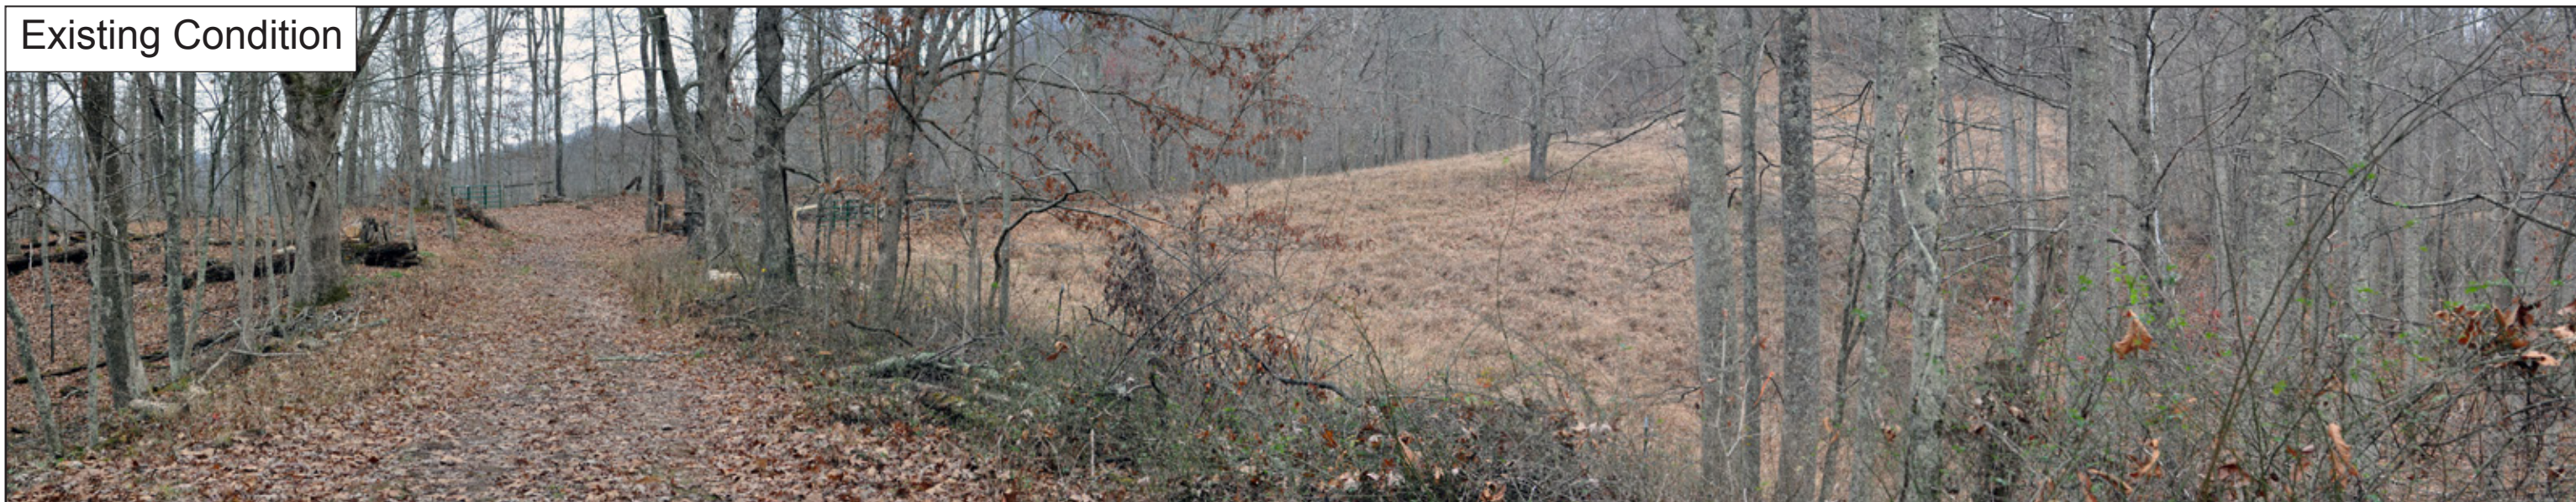
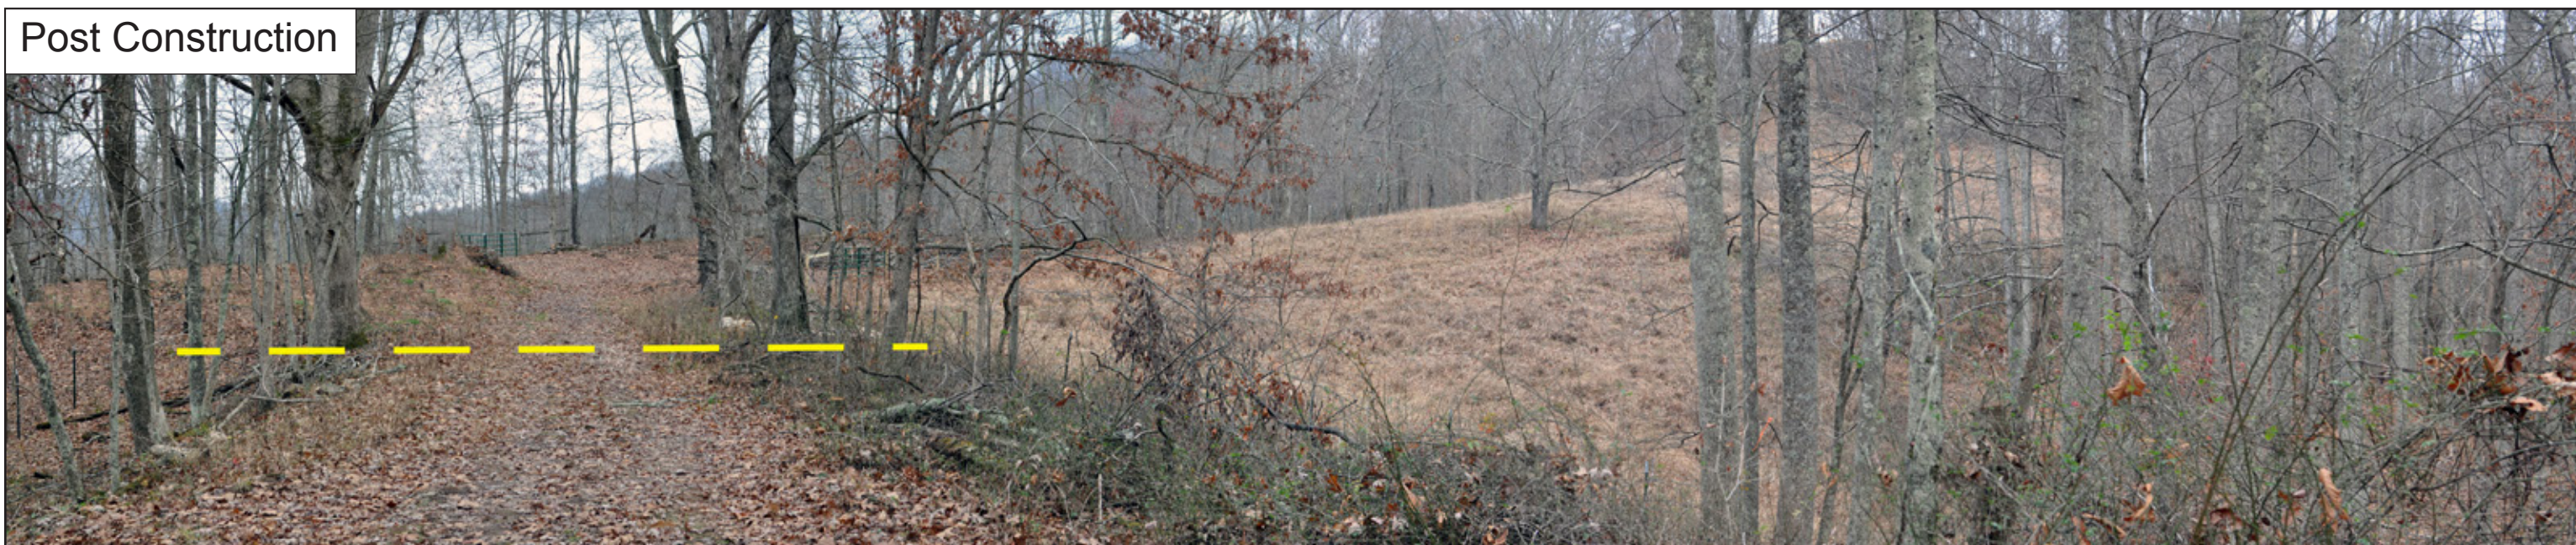
Post Construction

The photo was taken from the Weston and Gauley Bridge Turnpike Trail (Trail) east of the Trail/pipeline crossing looking west. The pipeline would be bored under the Trail with the bore pits located approximately 20 feet from the fence line edge of the Trail. From KOP 107 the bore pit on the northern side would be located in an open field. In “leaf-off” conditions, tree thinning may be apparent where the pipeline right-of-way parallels the Trail. In “leaf-on” conditions, views of the pipeline right-of-way from KOP 107 would most likely be screened by vegetation along the northern side of the Trail. The bore pit and pipeline right-of-way on the southern side of the Trail would be located beyond a small rise and not visible from KOP 107. The yellow dashed line indicates the approximate pipeline alignment.

According to the vegetation-modeled viewshed for the location east of the WGBT Trail/pipeline crossing at KOP 107 (Appendix A, Figure 5), visibility will be limited primarily to the open field on the north side of the Trail. A visual simulation (Appendix A, Figure 8) was prepared showing leaf-off conditions. Tree thinning will be apparent where the pipeline ROW parallels the Trail. In leaf-on conditions, views of the pipeline ROW from this viewpoint will most likely be screened by vegetation along the northern side of the Trail. The bore pit and pipeline ROW on the southern side of the Trail will be located beyond a small rise and not visible from this viewpoint.

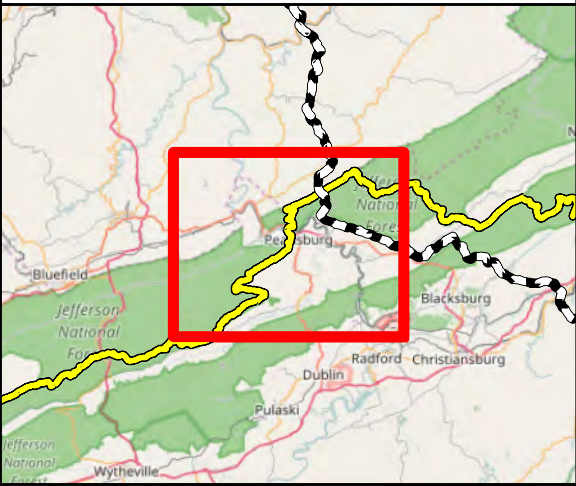
Figure 3

NOTE: Bare earth viewshed does not factor in obstructions in visibility caused by vegetation. Viewer location is within a forested area and will likely not have clear view beyond immediate vicinity.

The bare-earth viewshed for KOP-OID-111 (Appendix A, Figure 3) indicates high areas of visibility across the valley that would have the potential to see miles of ROW. The vista was observed in the field during leaf-off conditions. A visual simulation (Appendix B, Figure 3) was prepared showing leaf-off conditions, which would be worst-case scenario viewing conditions. The view is broad and open. Elements visible in the simulation include the city of Pearisburg, the New River, various mountains, and industrial elements such as the Celanese industrial plant and numerous ROWs. The ROW is visible in the simulation, but it barely perceptible at this distance. The ROW does not stand out due to the numerous other ROWs in the view. The Project crossing will comply with the Moderate SIO because it will remain visually subordinate to the characteristic landscape being viewed. Contrast levels would be low from this KOP due to distance and numerous existing human-made changes. The low contrast and distance of view would result in low visual impacts to KOP-OID-111.

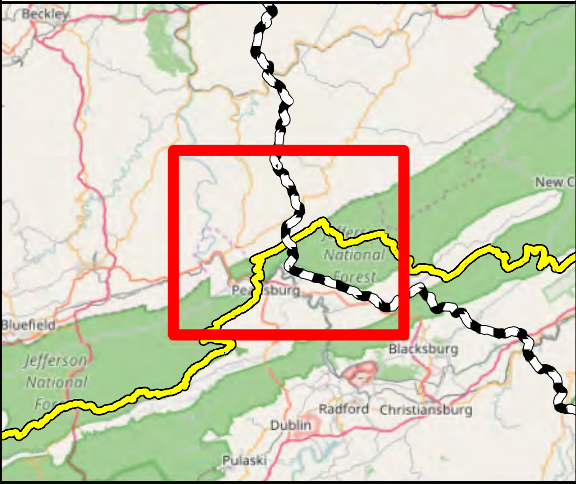
Figure 5

NOTE: Bare earth viewshed does not factor in obstructions in visibility caused by vegetation. Viewer location is within a forested area and will likely not have clear view beyond immediate vicinity.

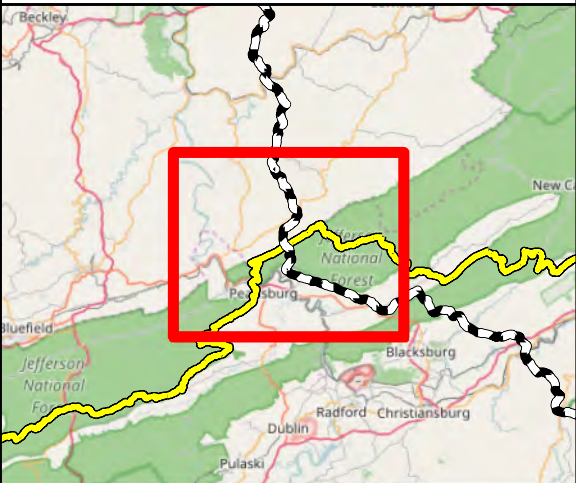
Figure 6

NOTE: Bare earth viewshed does not factor in obstructions in visibility caused by vegetation. Viewer location is within a forested area and will likely not have clear view beyond immediate vicinity.

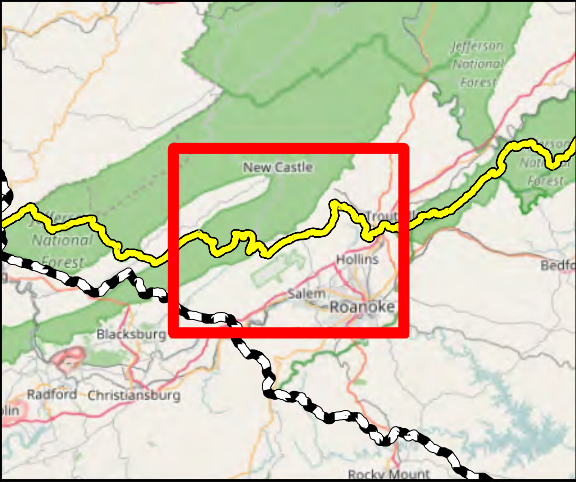
Figure 15

NOTE: Bare earth viewshed does not factor in obstructions in visibility caused by vegetation. Viewer location is within a forested area and will likely not have clear view beyond immediate vicinity.

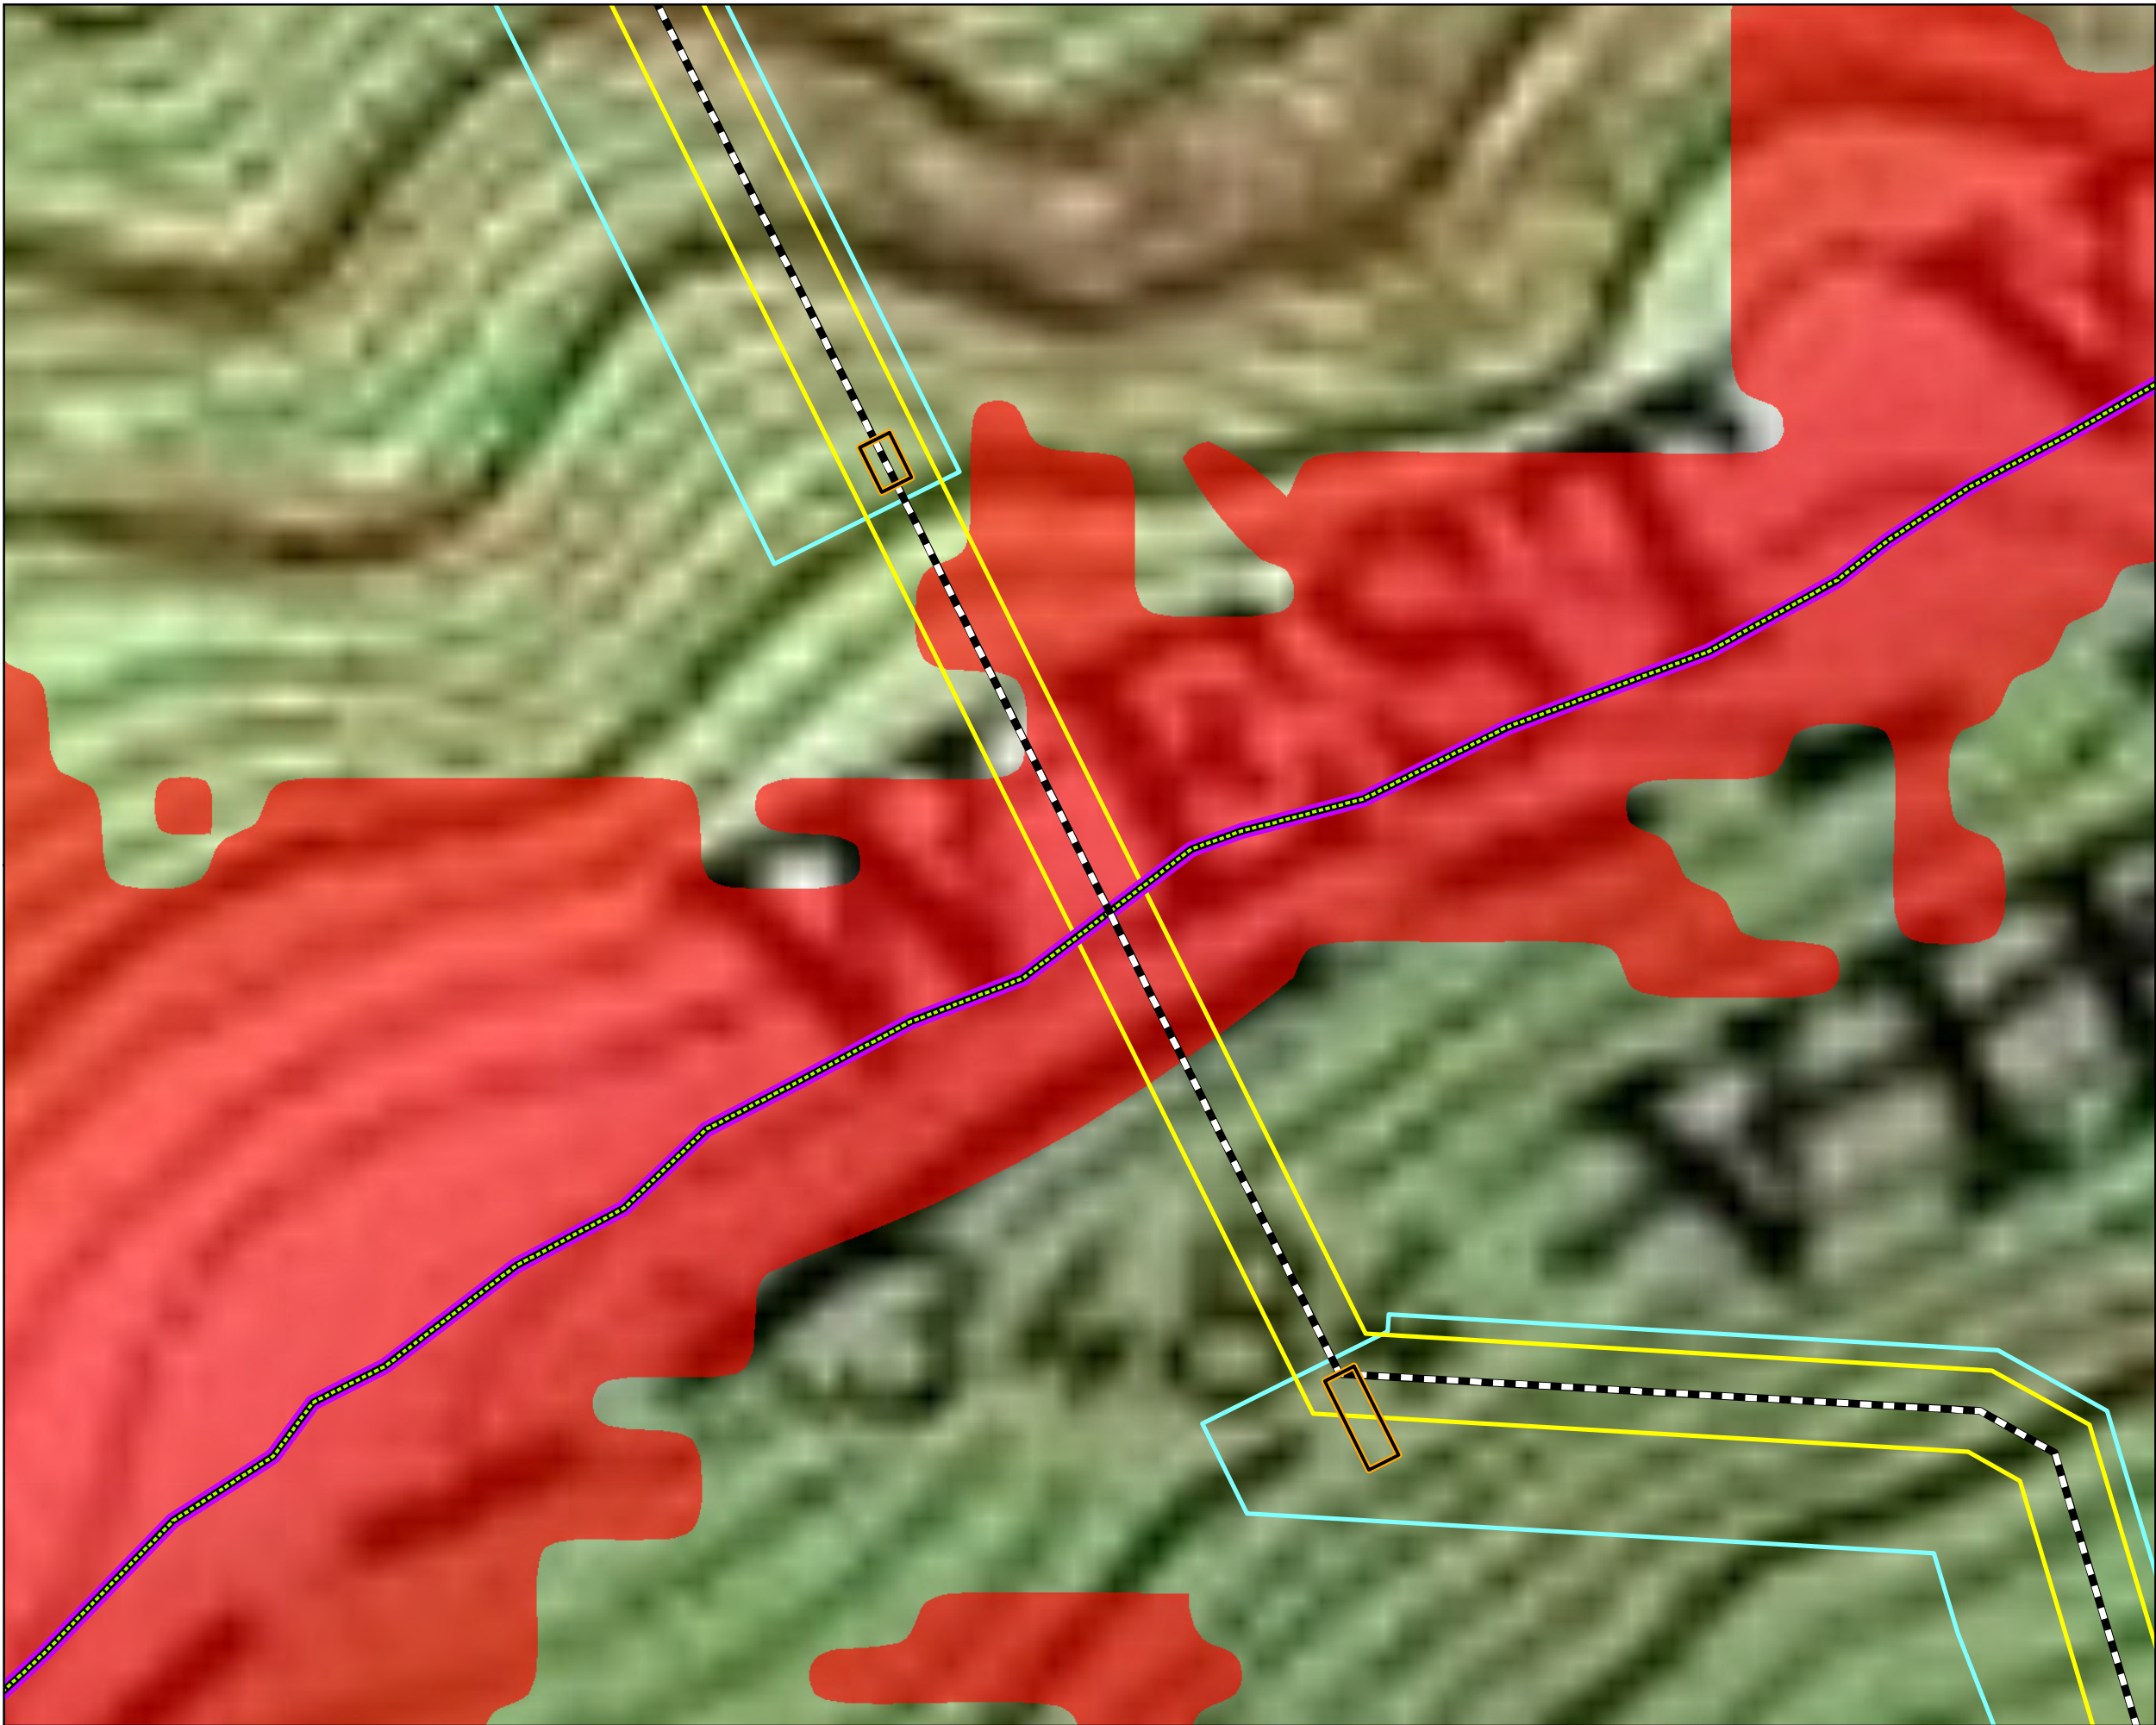
Figure 16

NOTE: Bare earth viewshed does not factor in obstructions in visibility caused by vegetation. Viewer location is within a forested area and will likely not have clear view beyond immediate vicinity. Visibility verified during field data collection.

- KOP PT-26 (Appendix B, Figure 16) is located on Craig Creek Road directly adjacent (96 feet) to the crossing of Craig Creek Road looking east. In the photograph, the road is a typical paved

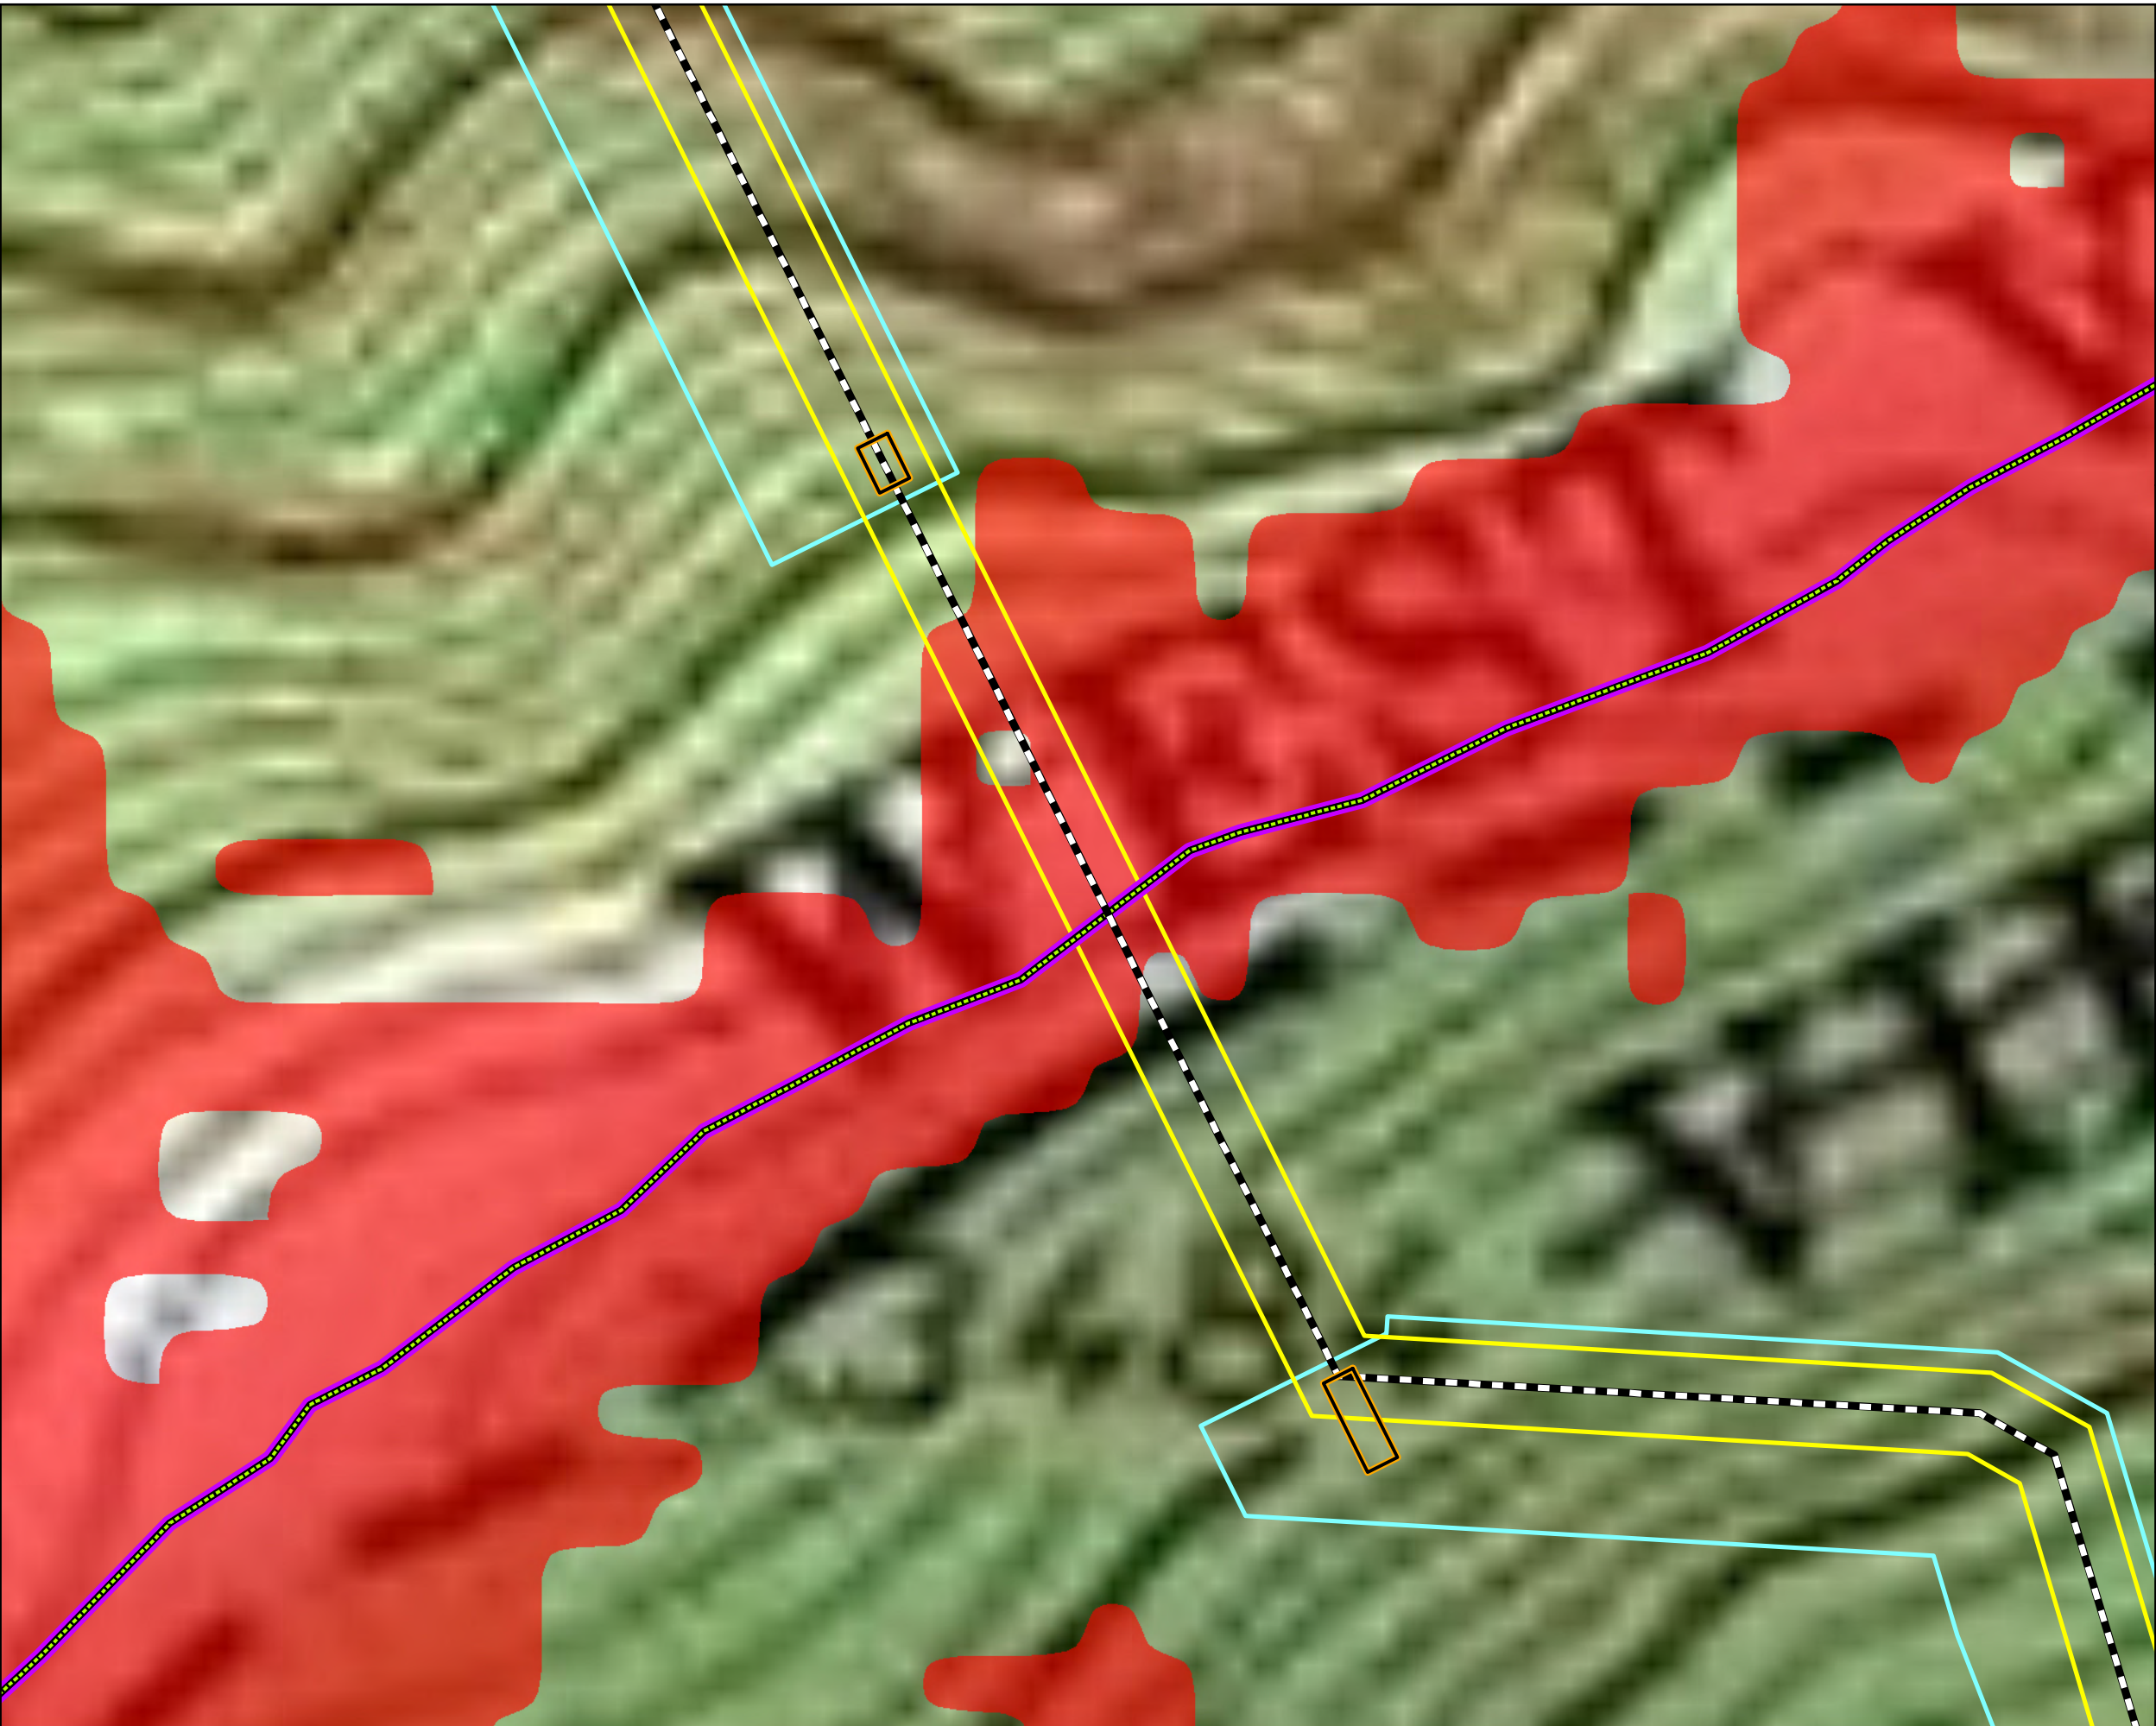
Figure 17

NOTE: Viewshed does factor in obstructions in visibility caused by vegetation (40-ft tree height assumed). Viewer location is within a forested area and will likely not have clear view beyond immediate vicinity. Visibility verified during field data collection.

Viewers traveling eastbound on Craig Creek road will initially have potential visibility of the ROW approximately 0.23 mile from the crossing at KOP PT-28 (Appendix B, Figure 17). Appendix B, Figure 16, KOP PT-26, shows the location of the crossing of Craig Creek Road. Below each KOP is discussed along Craig Creek Road.

- KOP PT-28 (Appendix B, Figure 17) is located on Craig Creek Road approximately 0.2 miles west of the crossing of Craig Creek Road looking east. In the photograph, the road is a typical paved roadway with adjacent fencing and an open pasture. At this distance the trees adjacent to Craig Creek Road would screen views even with leaf-off conditions, and there are no visible Project elements. As the visual simulation indicates, there would be no visual impact to Craig Creek Road at this location.

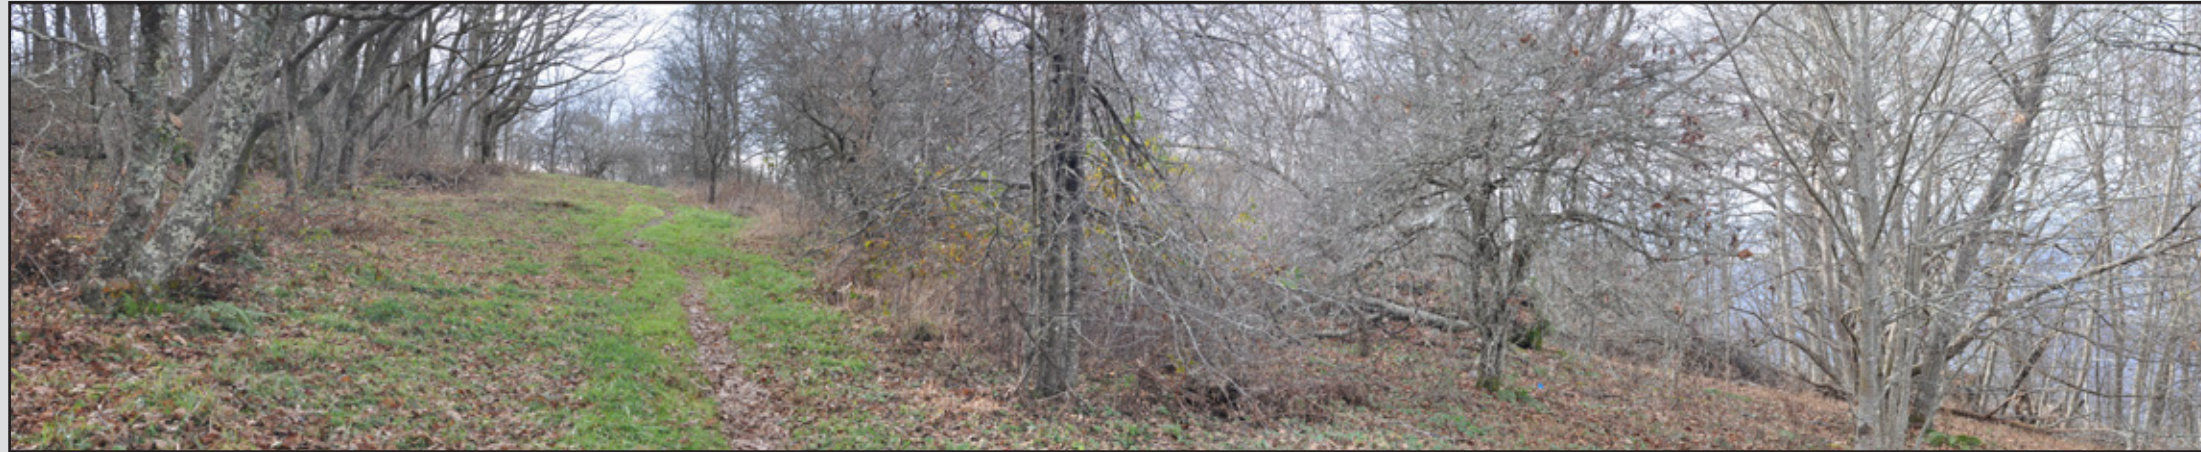
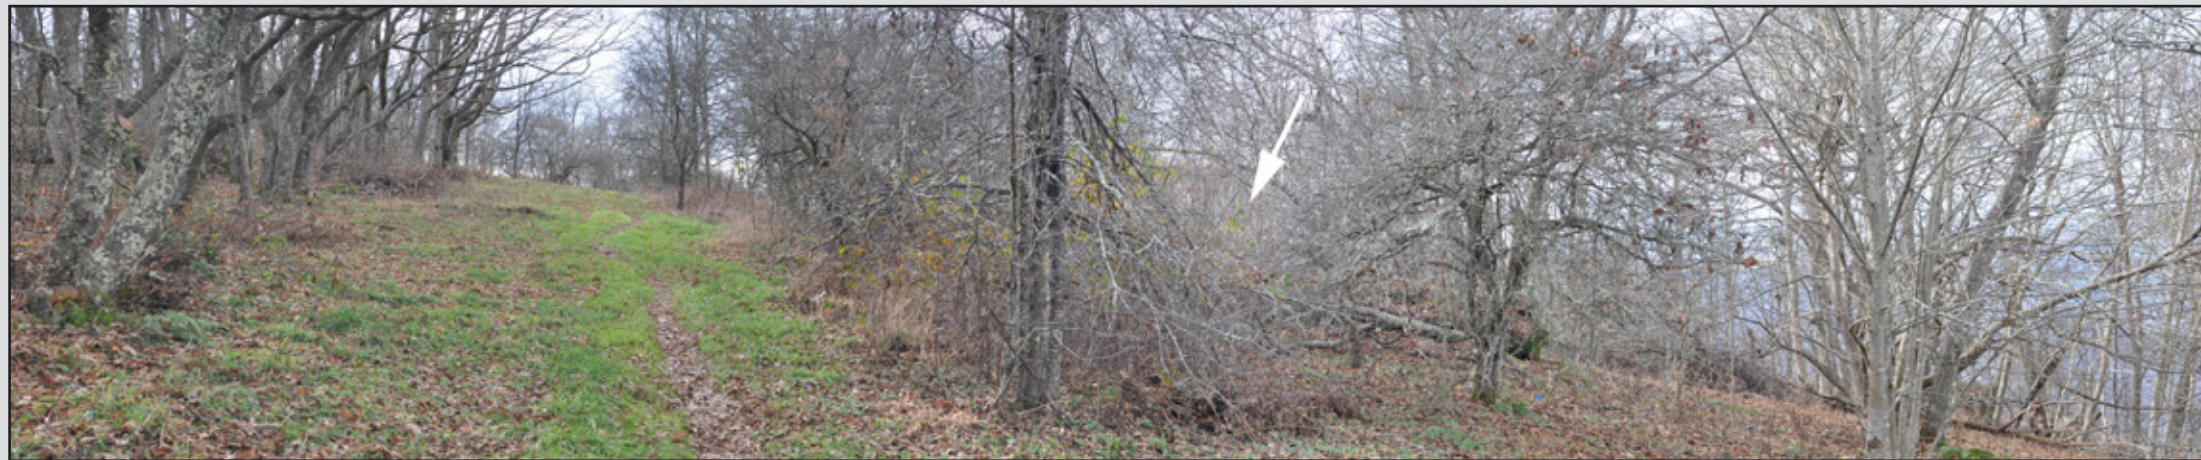
Figure 1

Post Construction (Leaf-off condition) - Viewers from KOP 92 may see some thinning of trees, depending on trees cleared at the time of construction. The white arrow indicates the location of the bore pit, which would be located approximately 49 feet below the ridgeline.

A visual simulation was prepared showing both leaf-off and leaf-on conditions (Appendix B, Figures 1 and 2, respectively). The vegetation with leaf-off conditions would be dense enough to screen views because the bore location is down a ridge on the side of the mountain and is not visible in the simulation. There is a possibility that trees cleared for the ROW would change the density of the forest canopy off the side of the ridge, but that is not apparent in the simulation. The only location where a trail user would be able to see the cleared Project ROW is if the hiker walked approximately 100 feet off the trail and looked off the edge of the ridge that screens the view of the bore location. Otherwise, the ROW will not be visible to hikers on the trail due to the 300-foot buffer of vegetation that will be preserved on each side of the ANST.

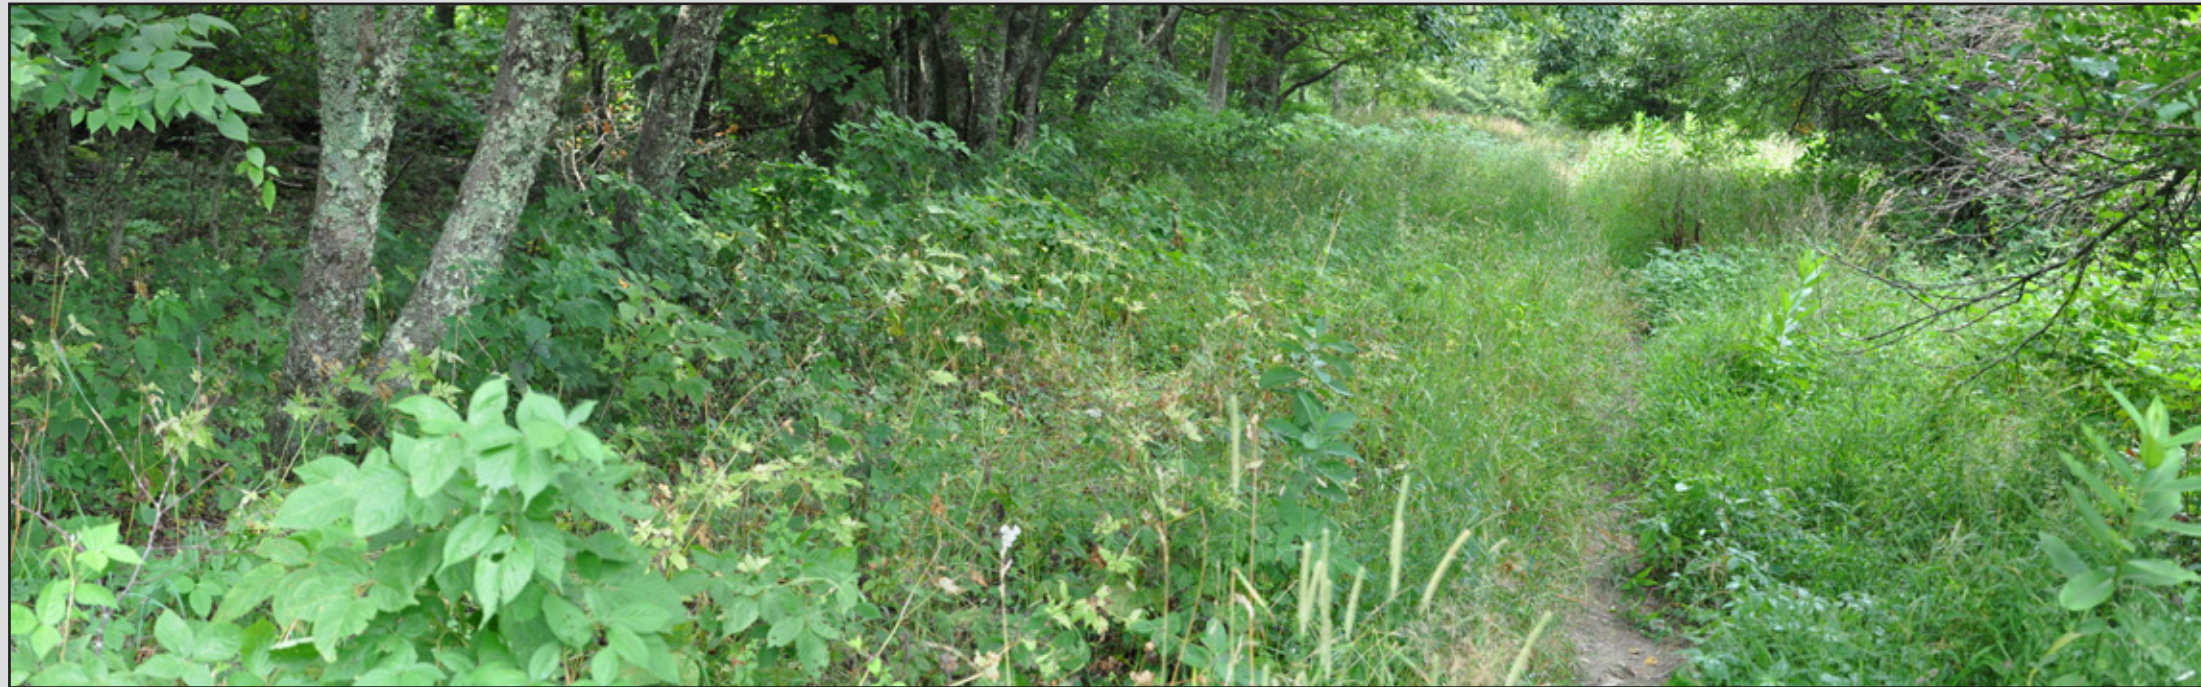
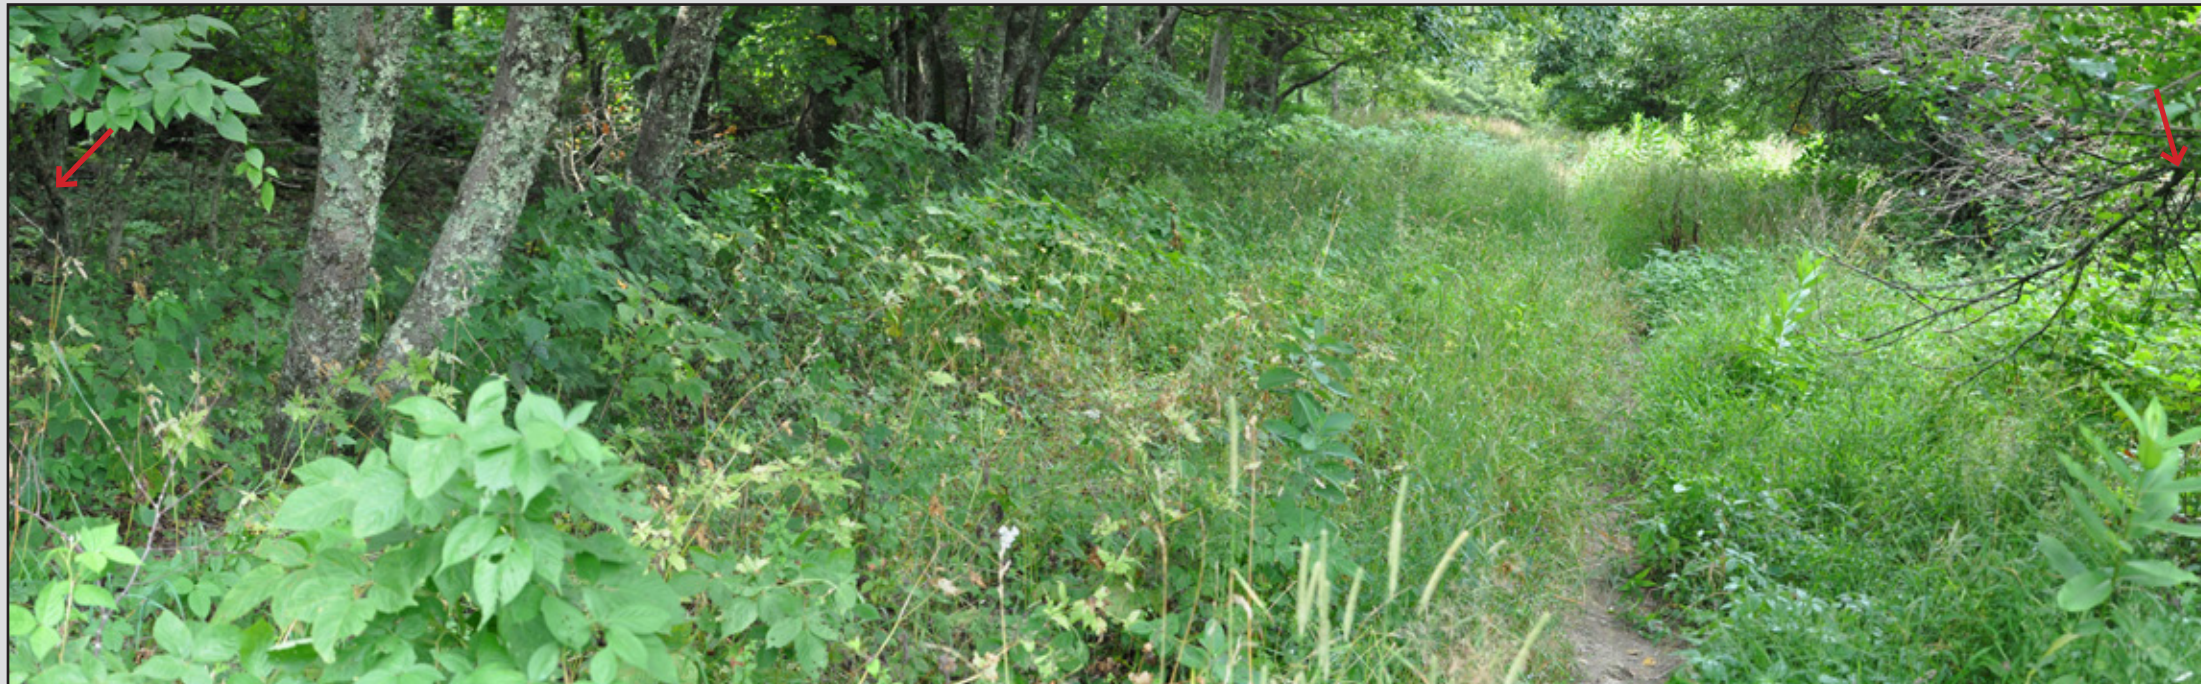
Key Observation Point 110

Post Construction (Leaf-on condition) - From KOP 110, the project is not visible as the bore pit and pipeline are completely screened by terrain and vegetation. The red arrows indicate that the bore pits would be located to the north and south of the trail and would be completely screened by terrain and vegetation.
