4. SUMMARY OF VISUAL IMPACTS

APPENDIX B

SIMULATIONS AND PHOTOGRAPHY

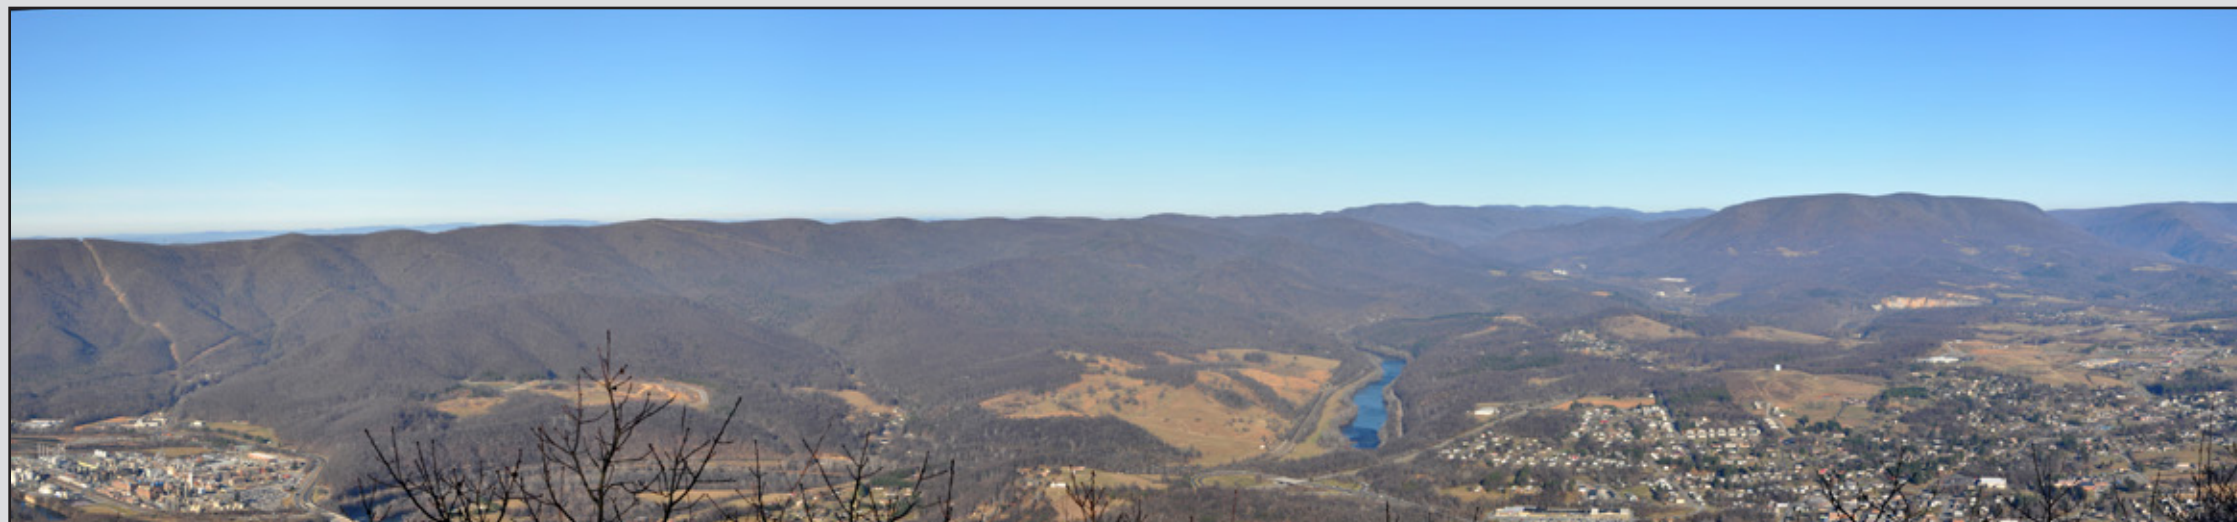
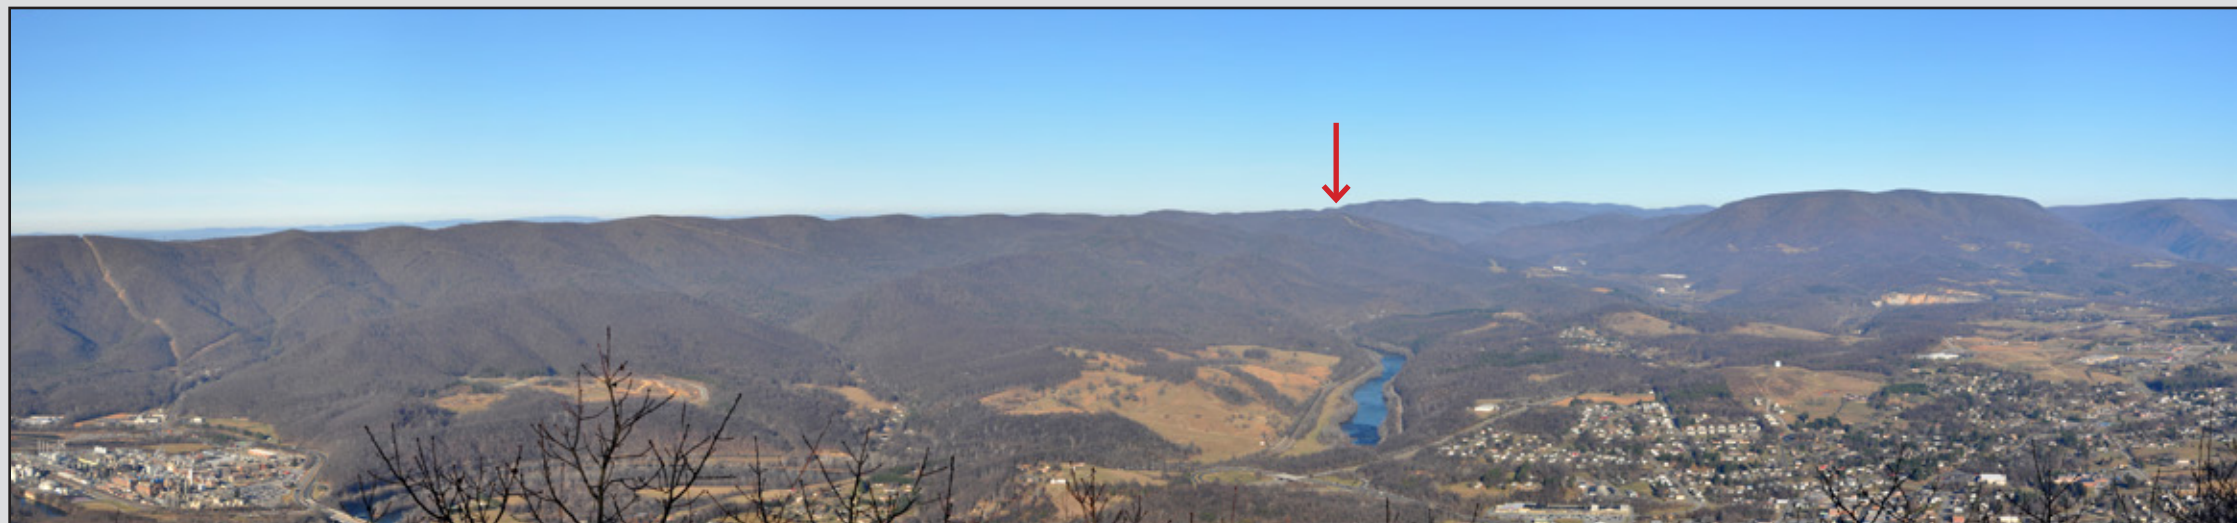
Post Construction - The proposed pipeline would cross over Peters Mountain at a point approximately 6 miles northeast of the Angels Rest overlook. The red arrow indicates where the proposed pipeline would be visible crossing over Peters Mountain.

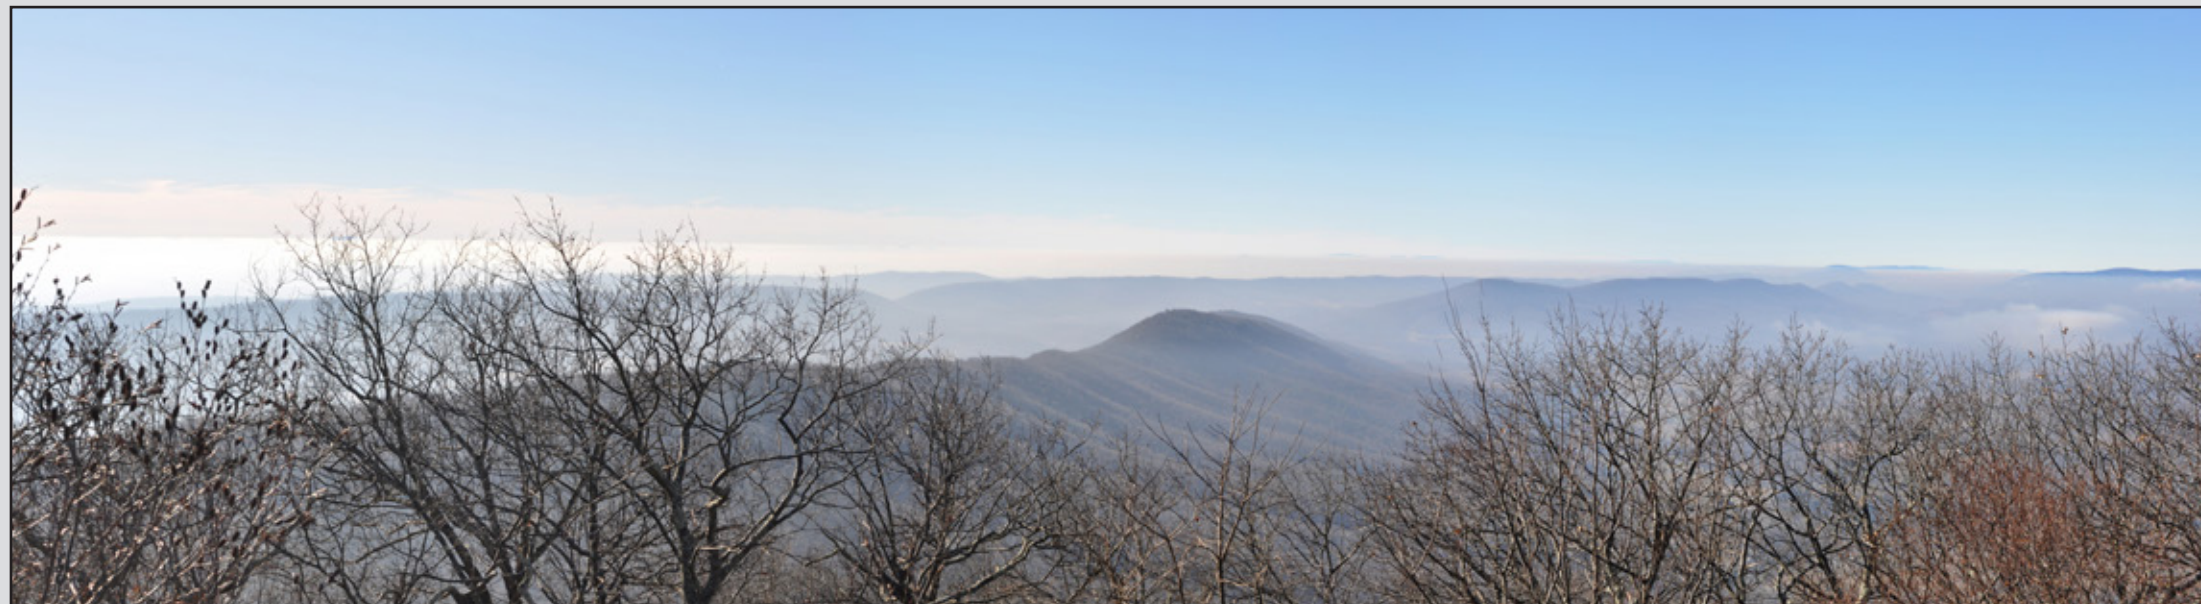
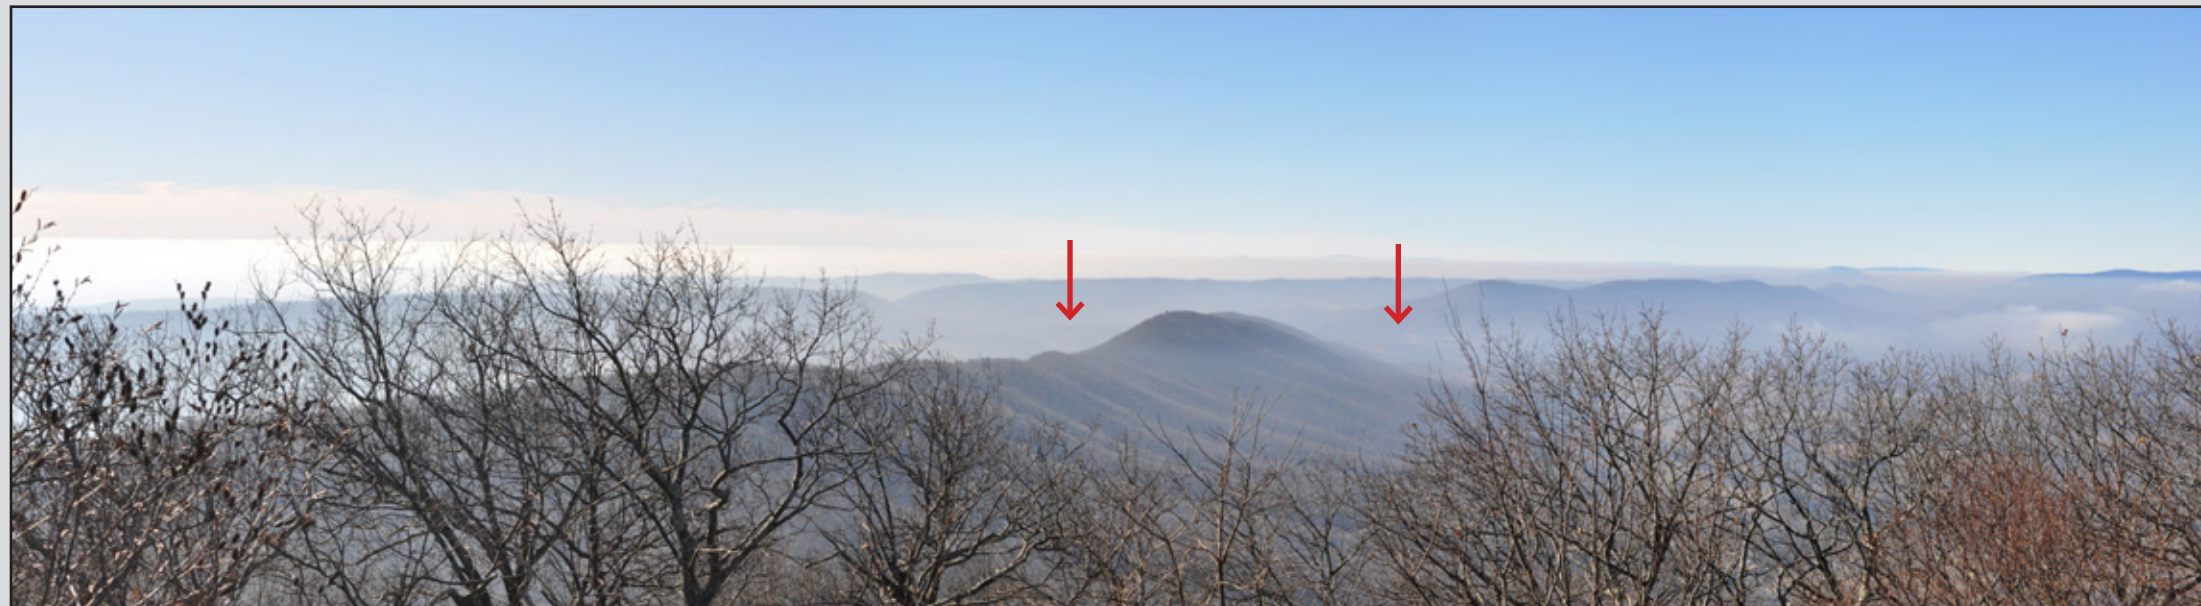
Figure 4

Post Construction - The proposed pipeline would cross the valley south of Johns Creek Mountain and over Peters Mountain at a point approximately 2 miles southeast of the Kelly’s Knob overlook. The red arrows indicate where the proposed pipeline would be visible crossing the valley. The proposed pipeline where it crosses over Peters Mountain is not visible from the overlook.

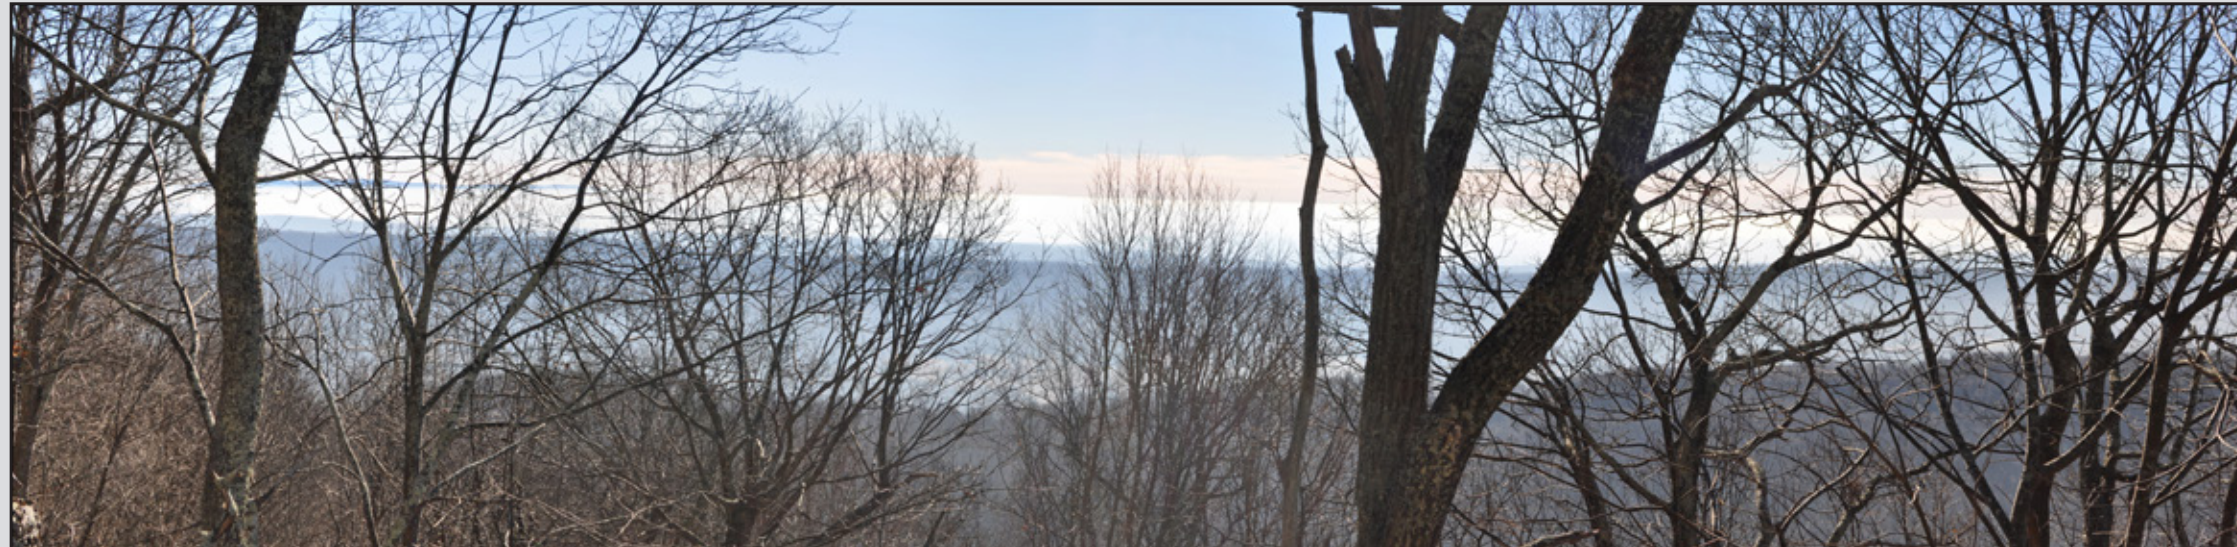
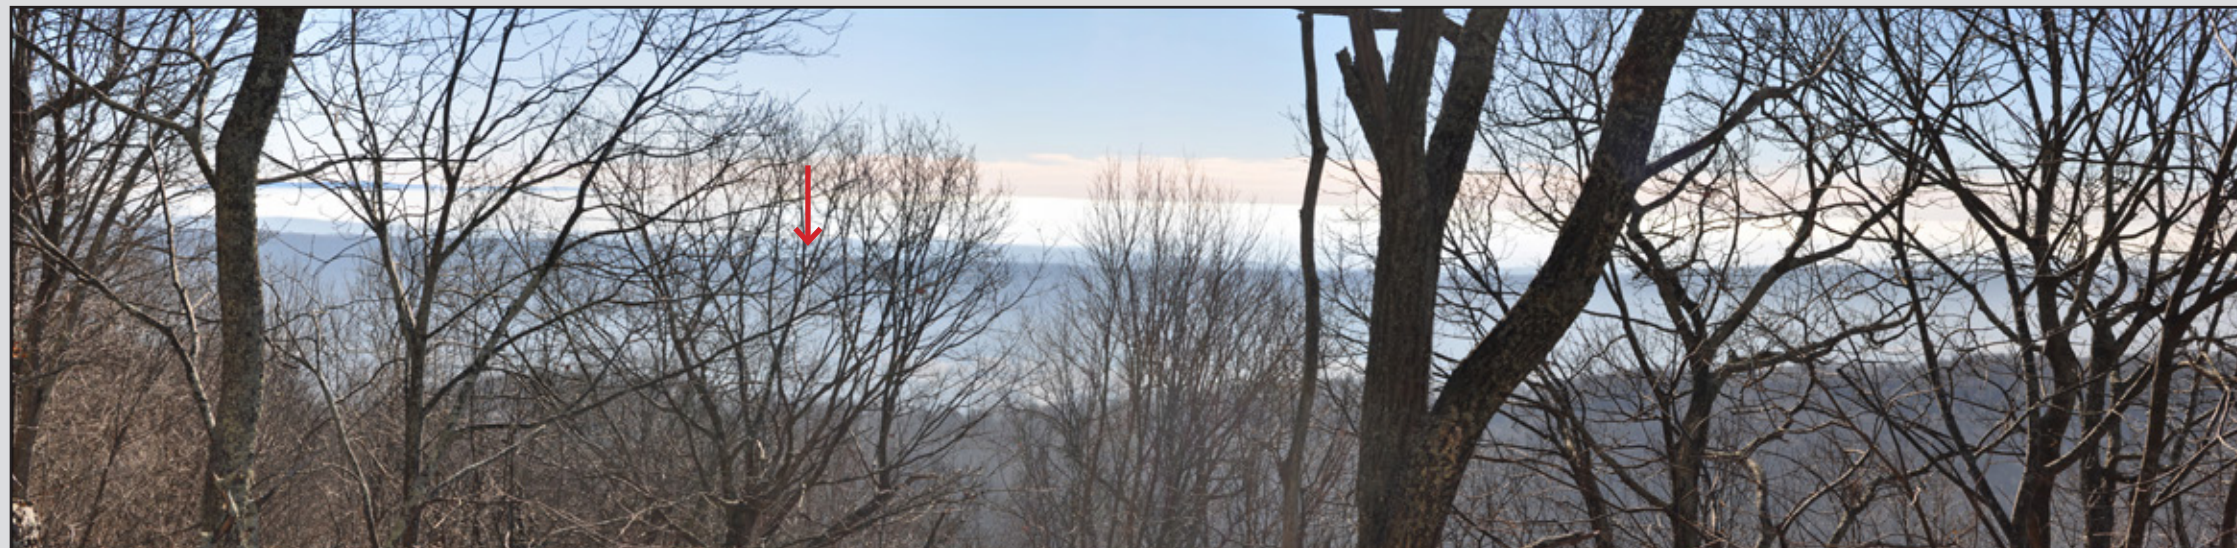
Figure 5

Post Construction - The proposed pipeline would cross over Peters Mountain at a point approximately 2 miles southwest of the overlook near the campsite just east of the main Kelly’s Knob overlook. The red arrow indicates where the proposed pipeline would be visible crossing Sinking Creek Mountain through trees in the foreground. The proposed pipeline where it crosses over Peters Mountain is not visible from this viewpoint

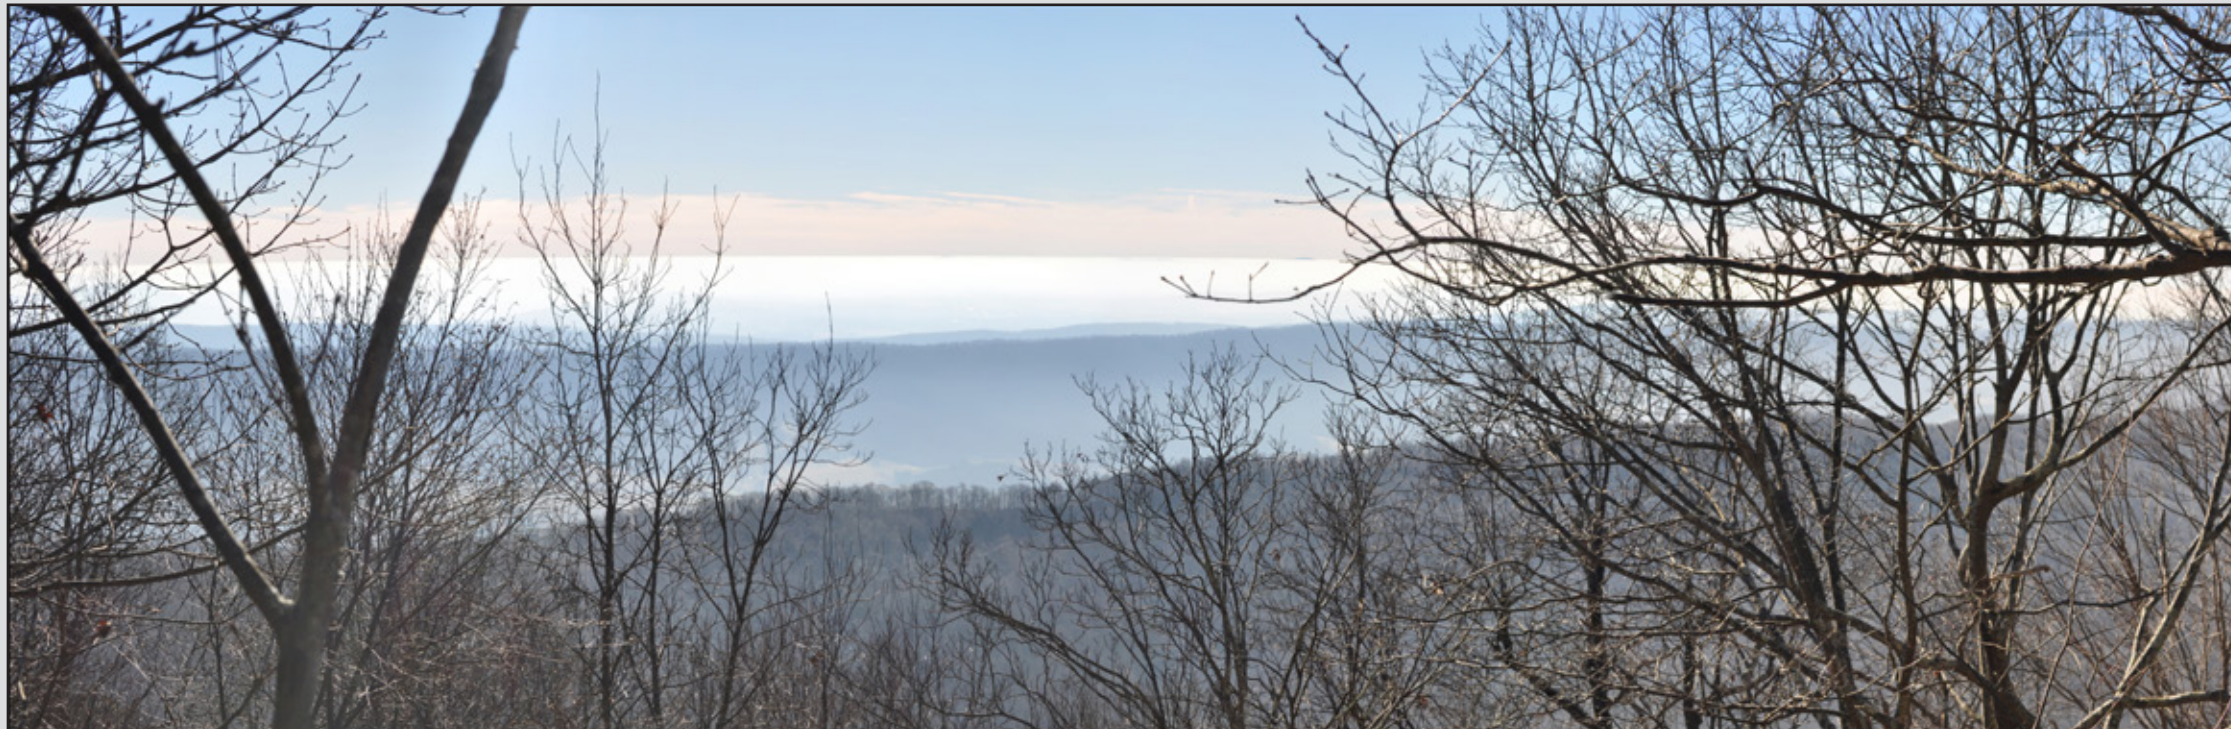
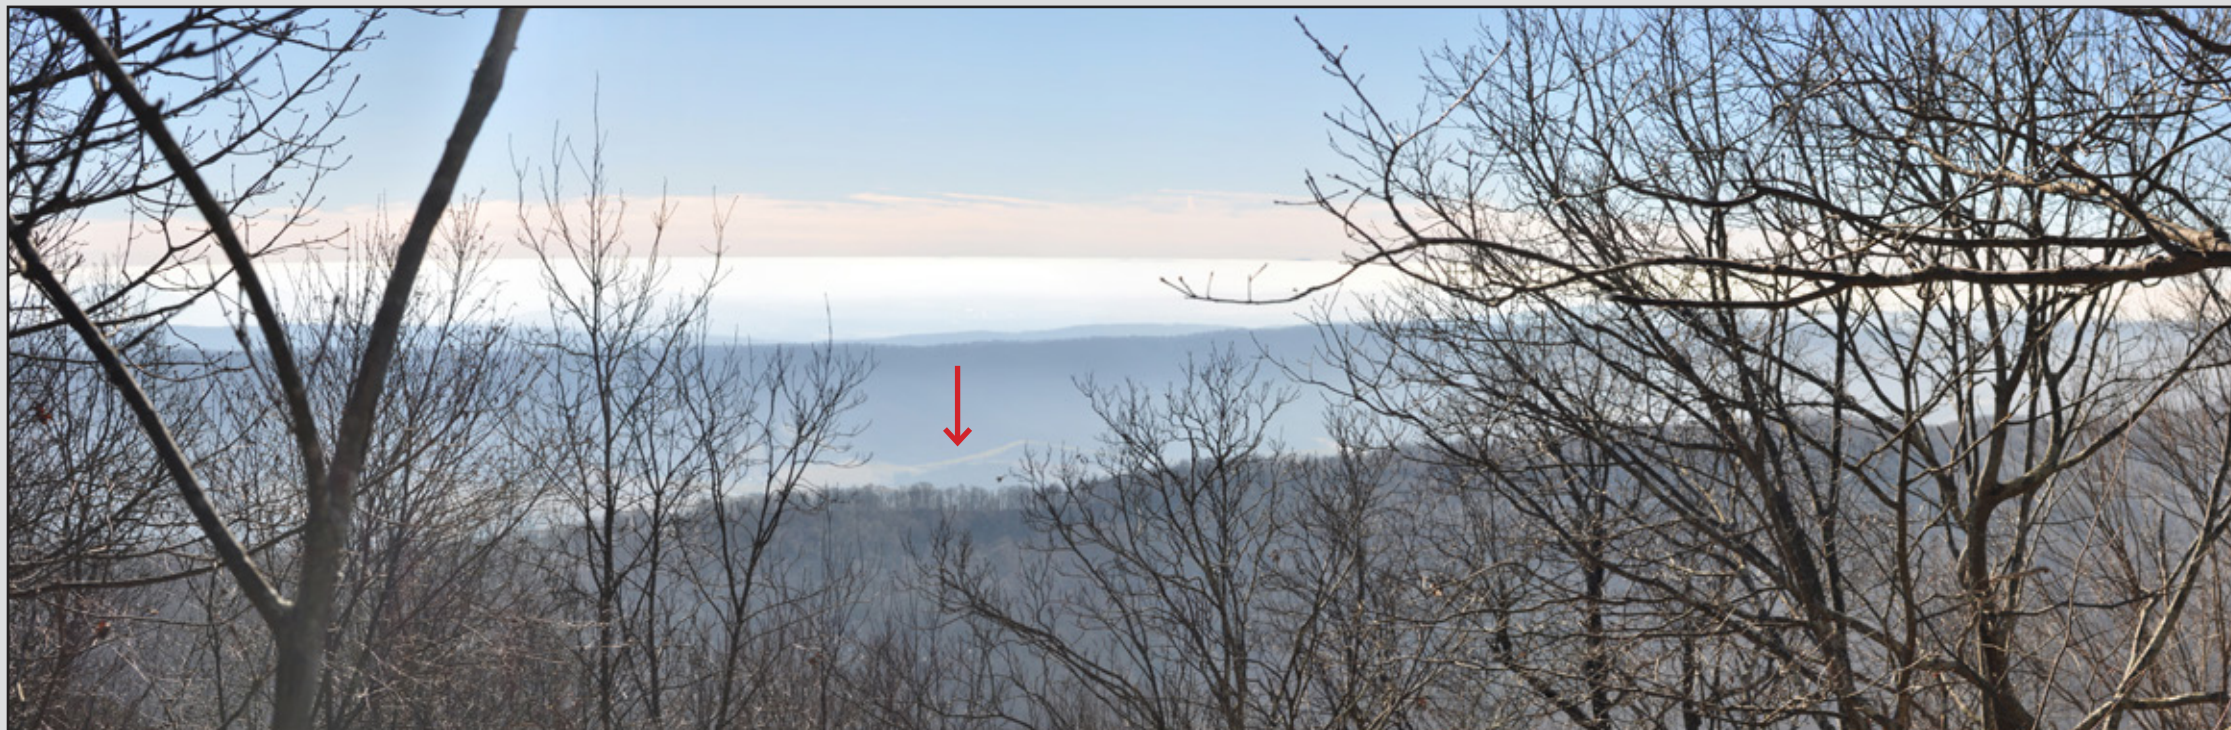
Figure 6

Post Construction - The proposed pipeline would cross along the base of Sinking Creek Mountain approximately 2.25 miles from an overlook located east of the Kelly's Knob overlook. The red arrow indicates where the proposed pipeline would be visible crossing in front of Sinking Creek Mountain. The proposed pipeline where it crosses over Peters Mountain is not visible from this viewpoint.

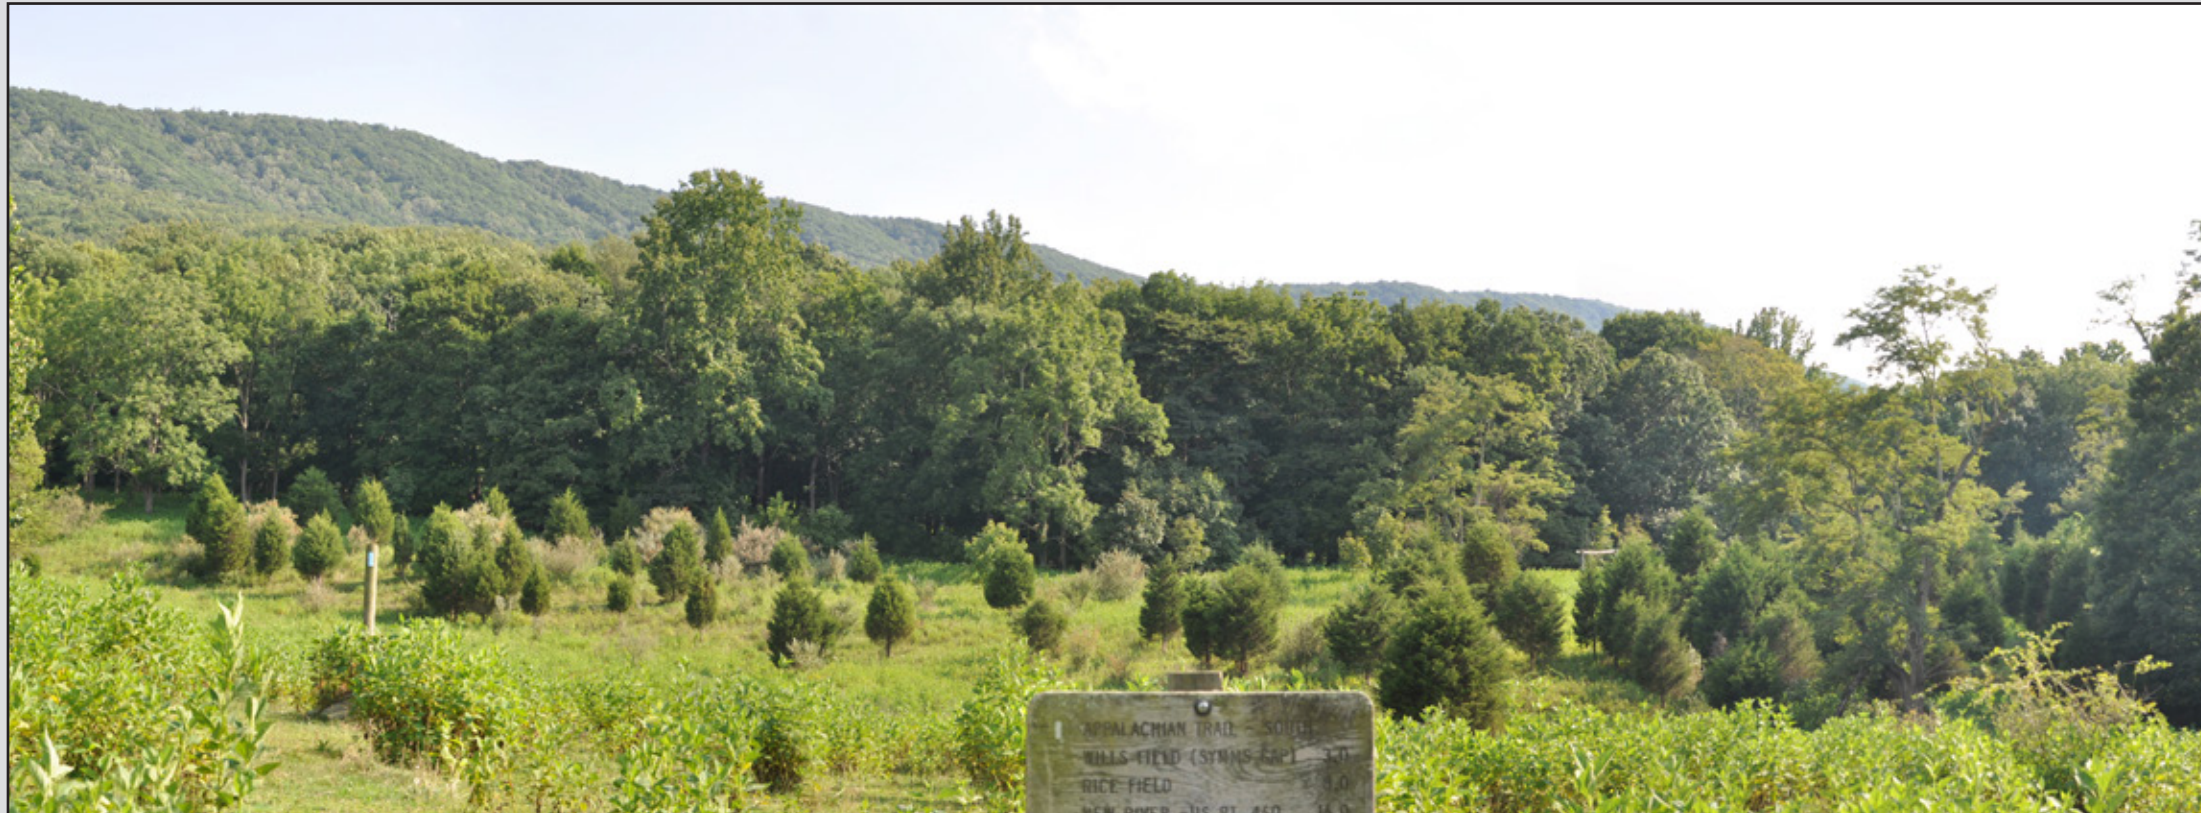
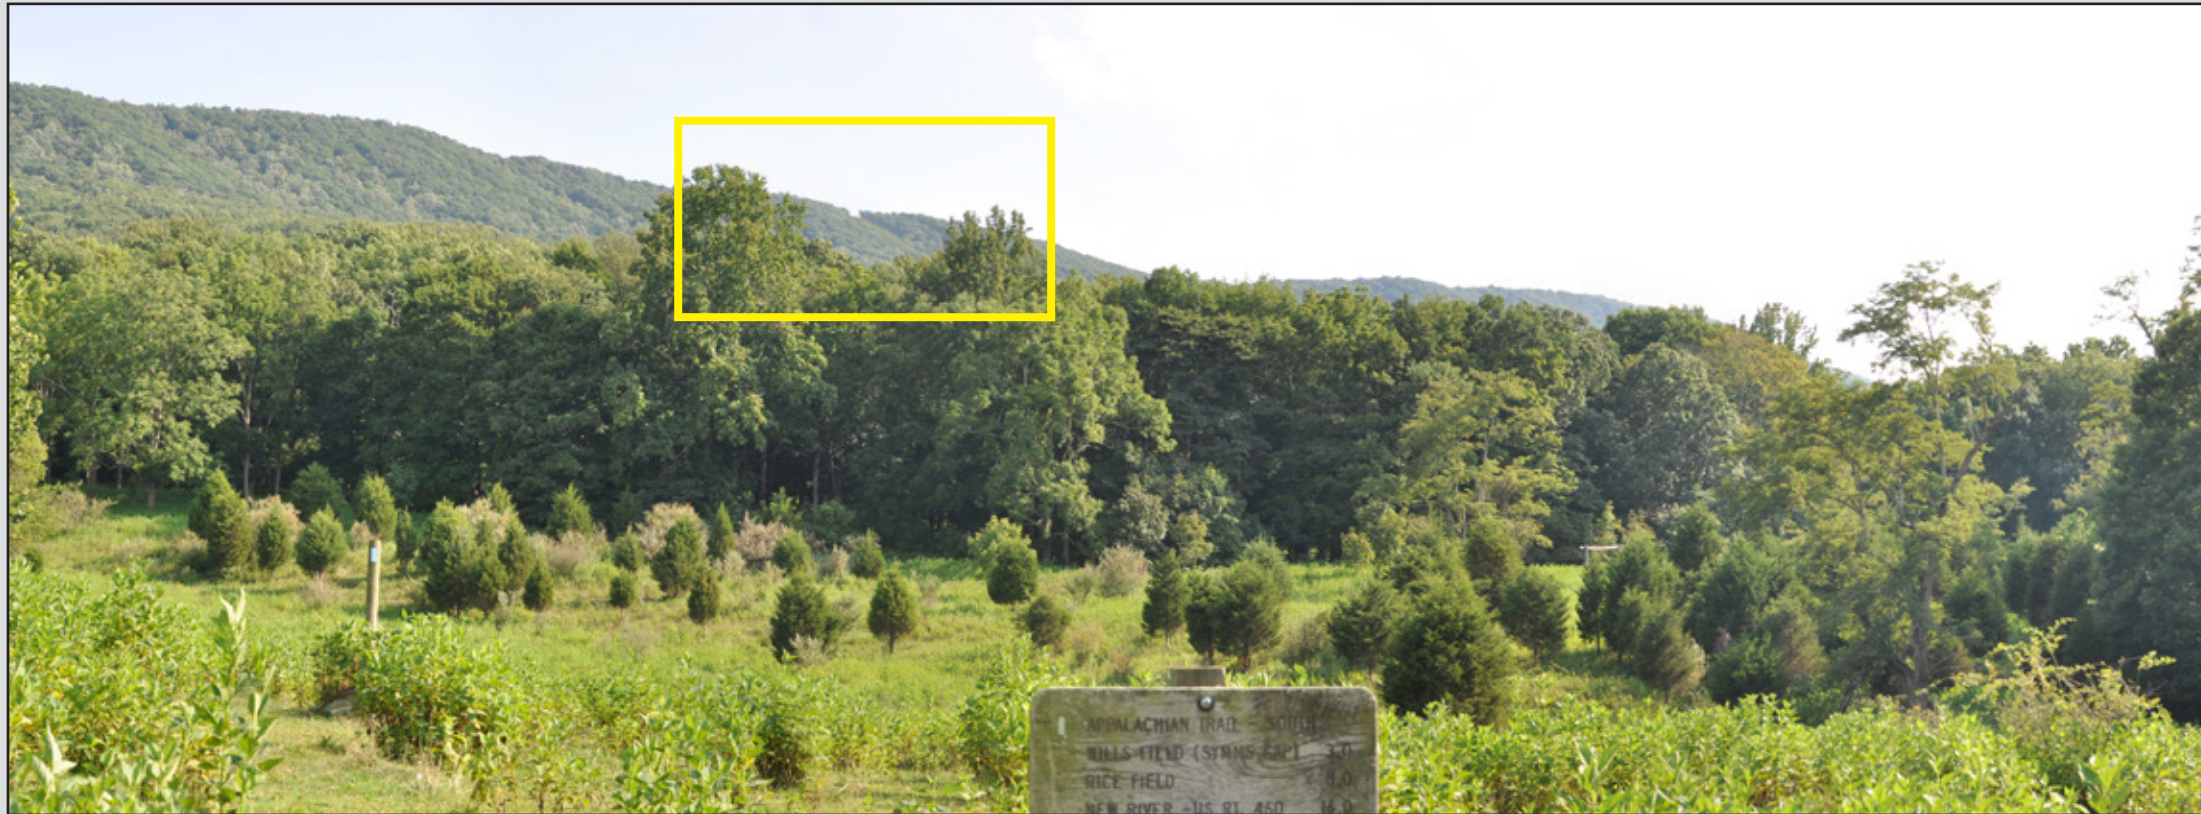
Figure 7

Proposed Condition - Pipeline right-of-way crossing Peters Mountain

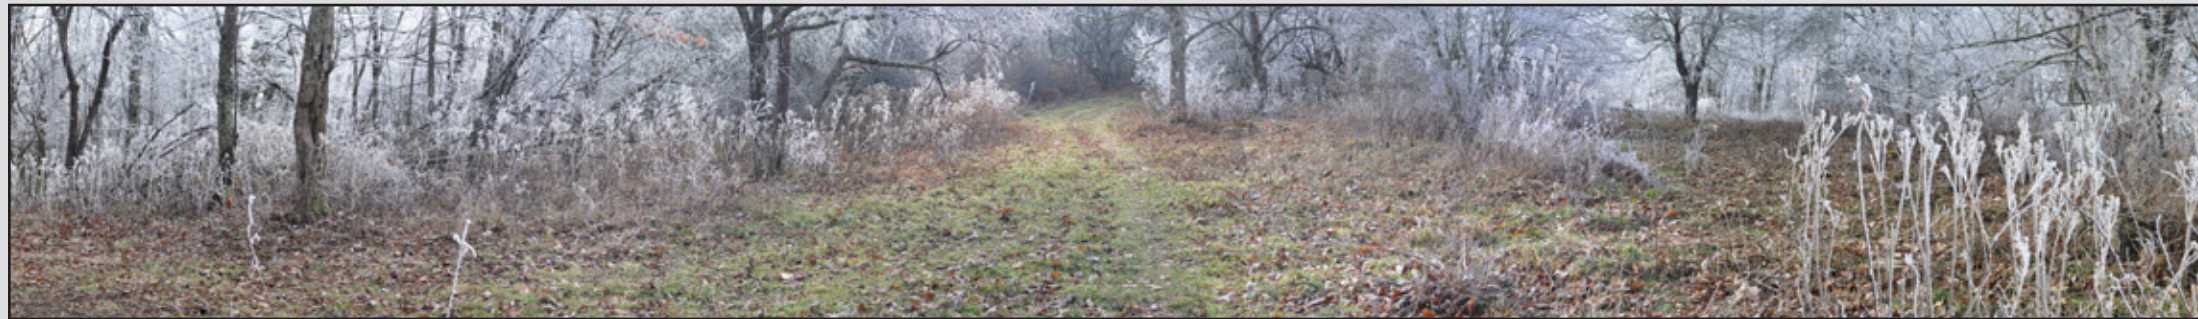
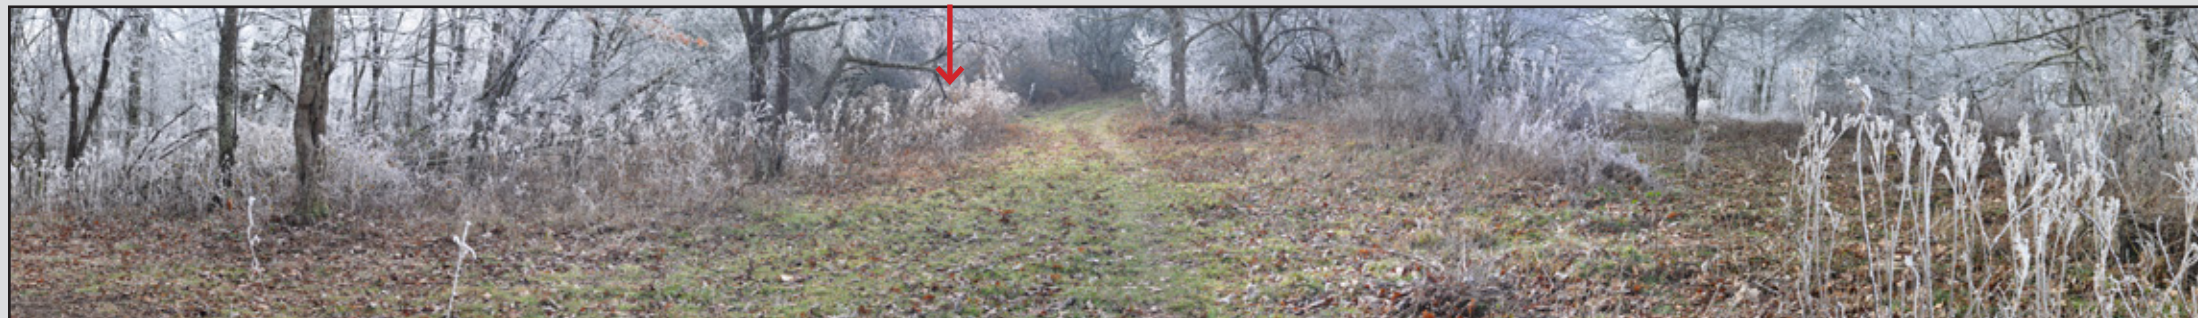
Figure 8

Post Construction - The proposed pipeline would cross the Appalachian Trail approximately 0.4 mile southwest from the Peters Mountain Wilderness boundary. From KOP PT-02, the project is not visible as the bore pit and pipeline are completely screened by terrain and vegetation. The red arrow indicates approximately where the proposed pipeline would be located in the distance. The pipeline would be completely screened by terrain and vegetation.

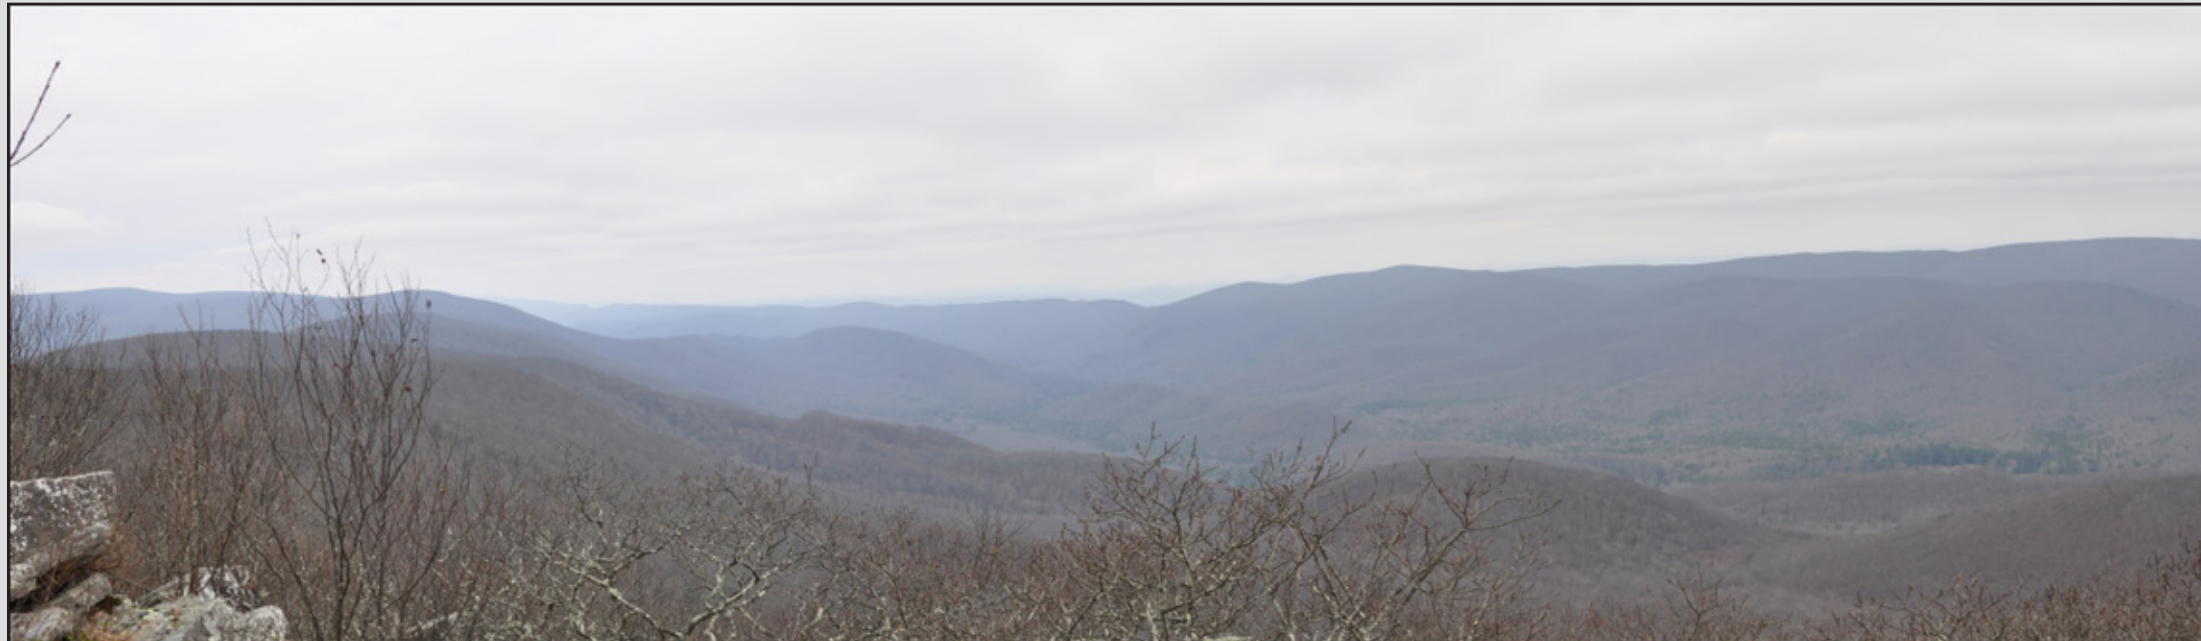
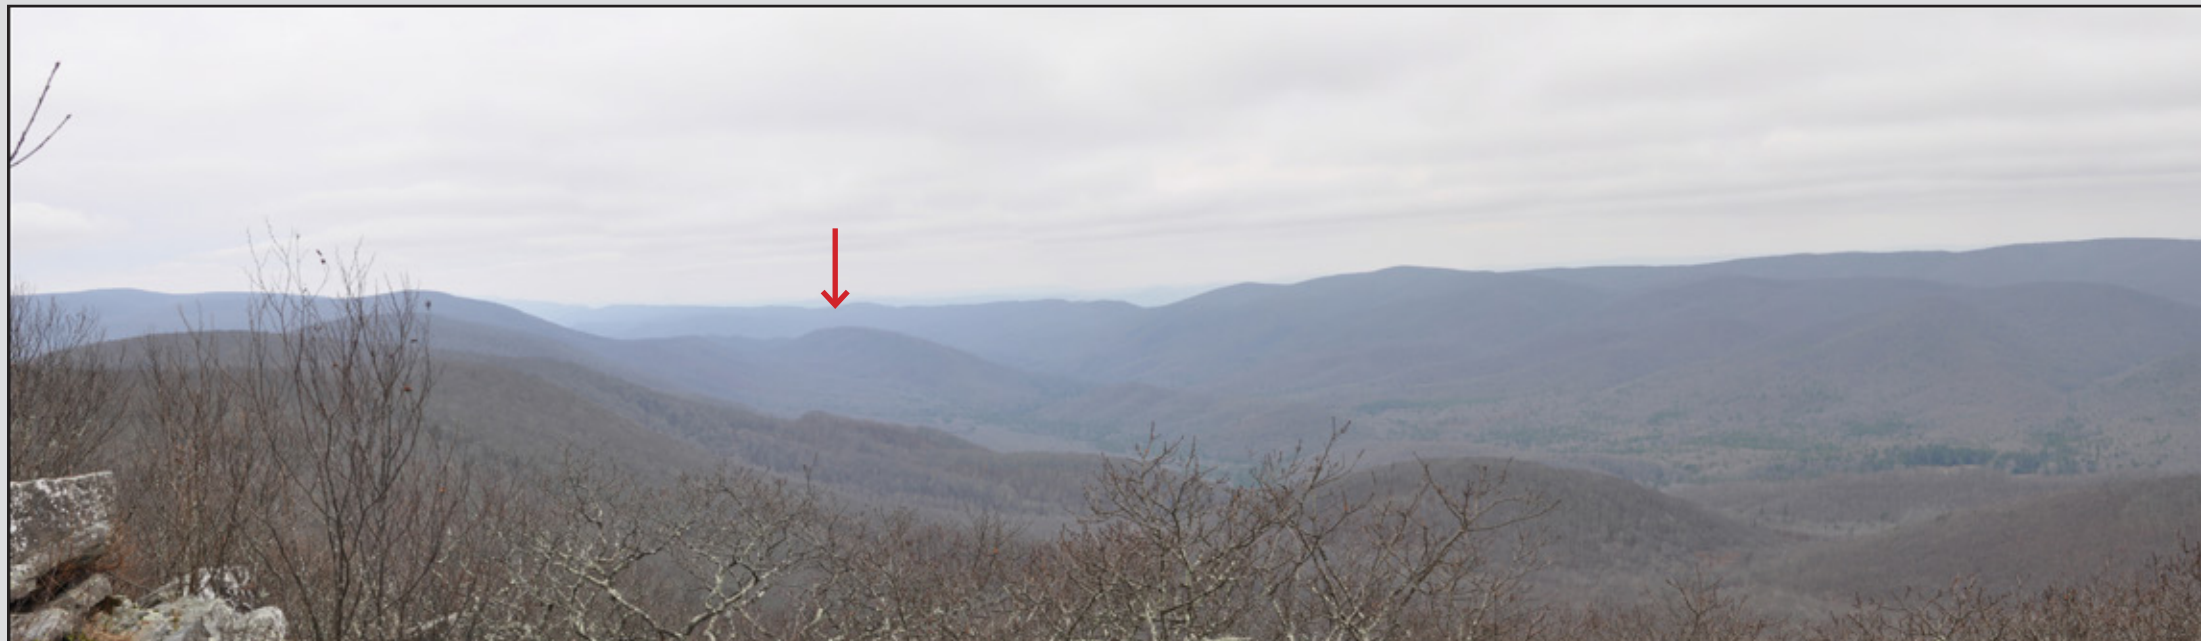
Figure 9

Post Construction - The proposed pipeline would cross over Peters Mountain approximately 7 miles from the Wind Rock overlook. The red arrow indicates where the proposed pipeline would be visible crossing over Peters Mountain.

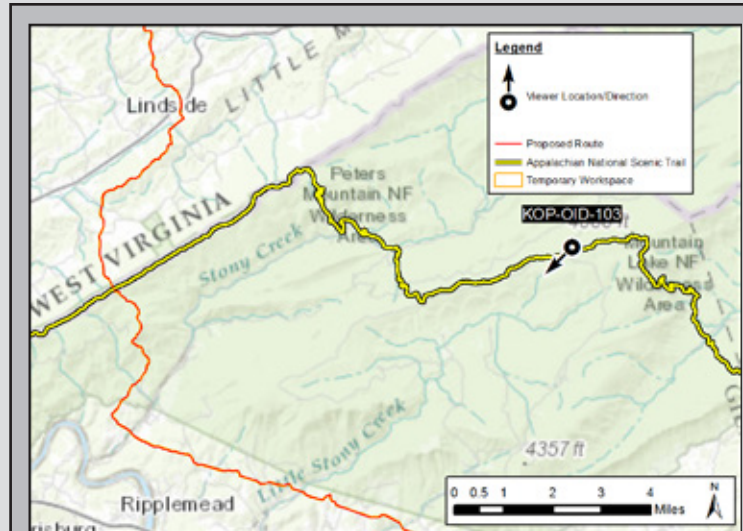
Photograph Information

Time of photograph: 2:44 PM
 Date of photograph: 12.3.2016
 Weather condition: Overcast, hazy
 Viewing direction: Southwest
 Latitude: 37° 24' 51.08" N
 Longitude: 80° 31' 9.58" W
 Photo Location: Photo taken from the Appalachian Trail corridor from the Windy Rock overlook on Salt Pond Mountain in Virginia.

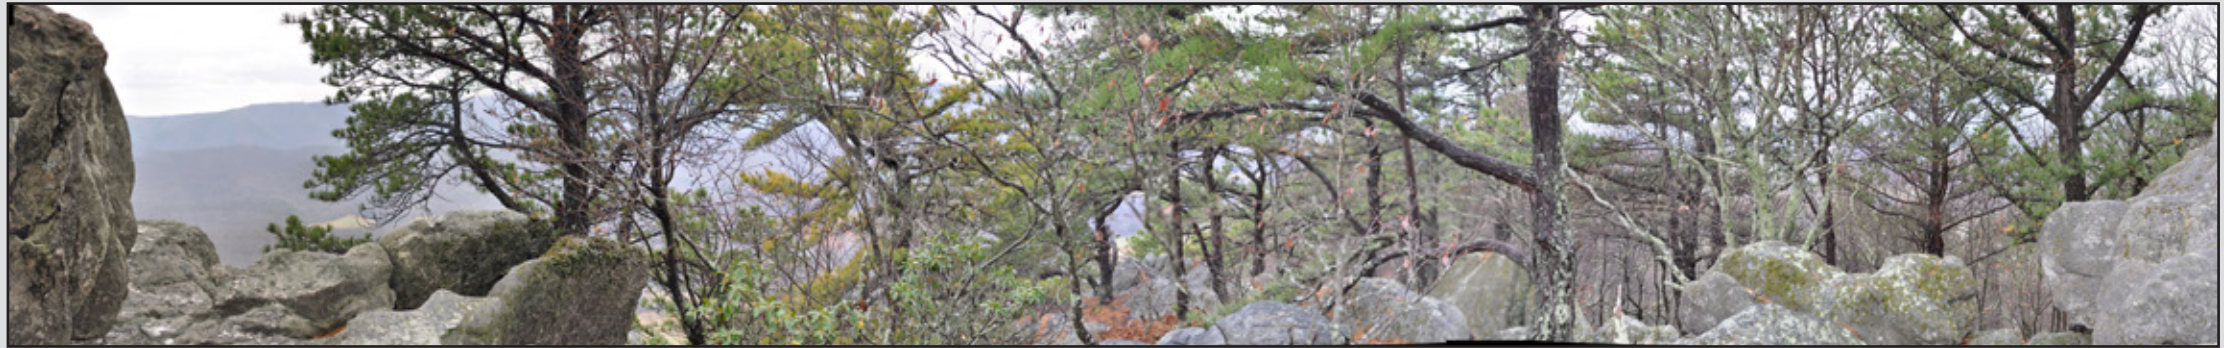
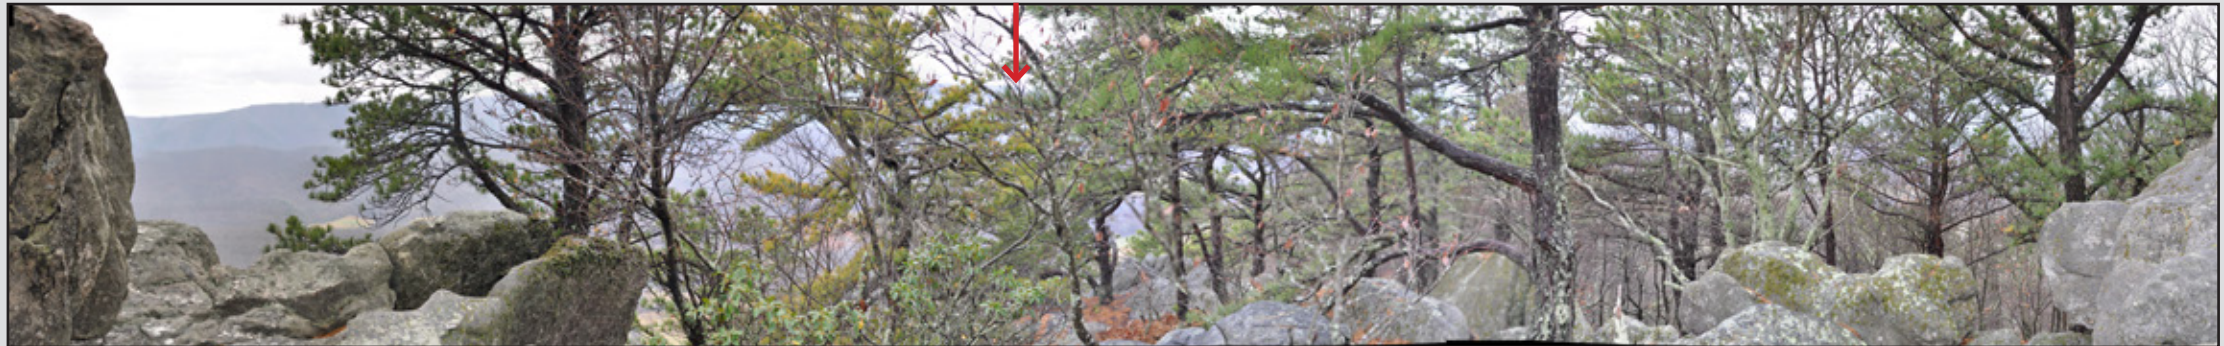
Figure 10

Post Construction - The proposed pipeline would cross over Fort Lewis Mountain approximately 7.8 miles from the Dragon’s Tooth Vista. From KOP 23, views toward the project would be screened by vegetation. The red arrow indicates approximately where the proposed pipeline would cross Fort Lewis Mountain in the distance. The proposed pipeline would be completely screened by vegetation and terrain.
