4. SUMMARY OF VISUAL IMPACTS

APPENDIX B

SIMULATIONS AND PHOTOGRAPHY

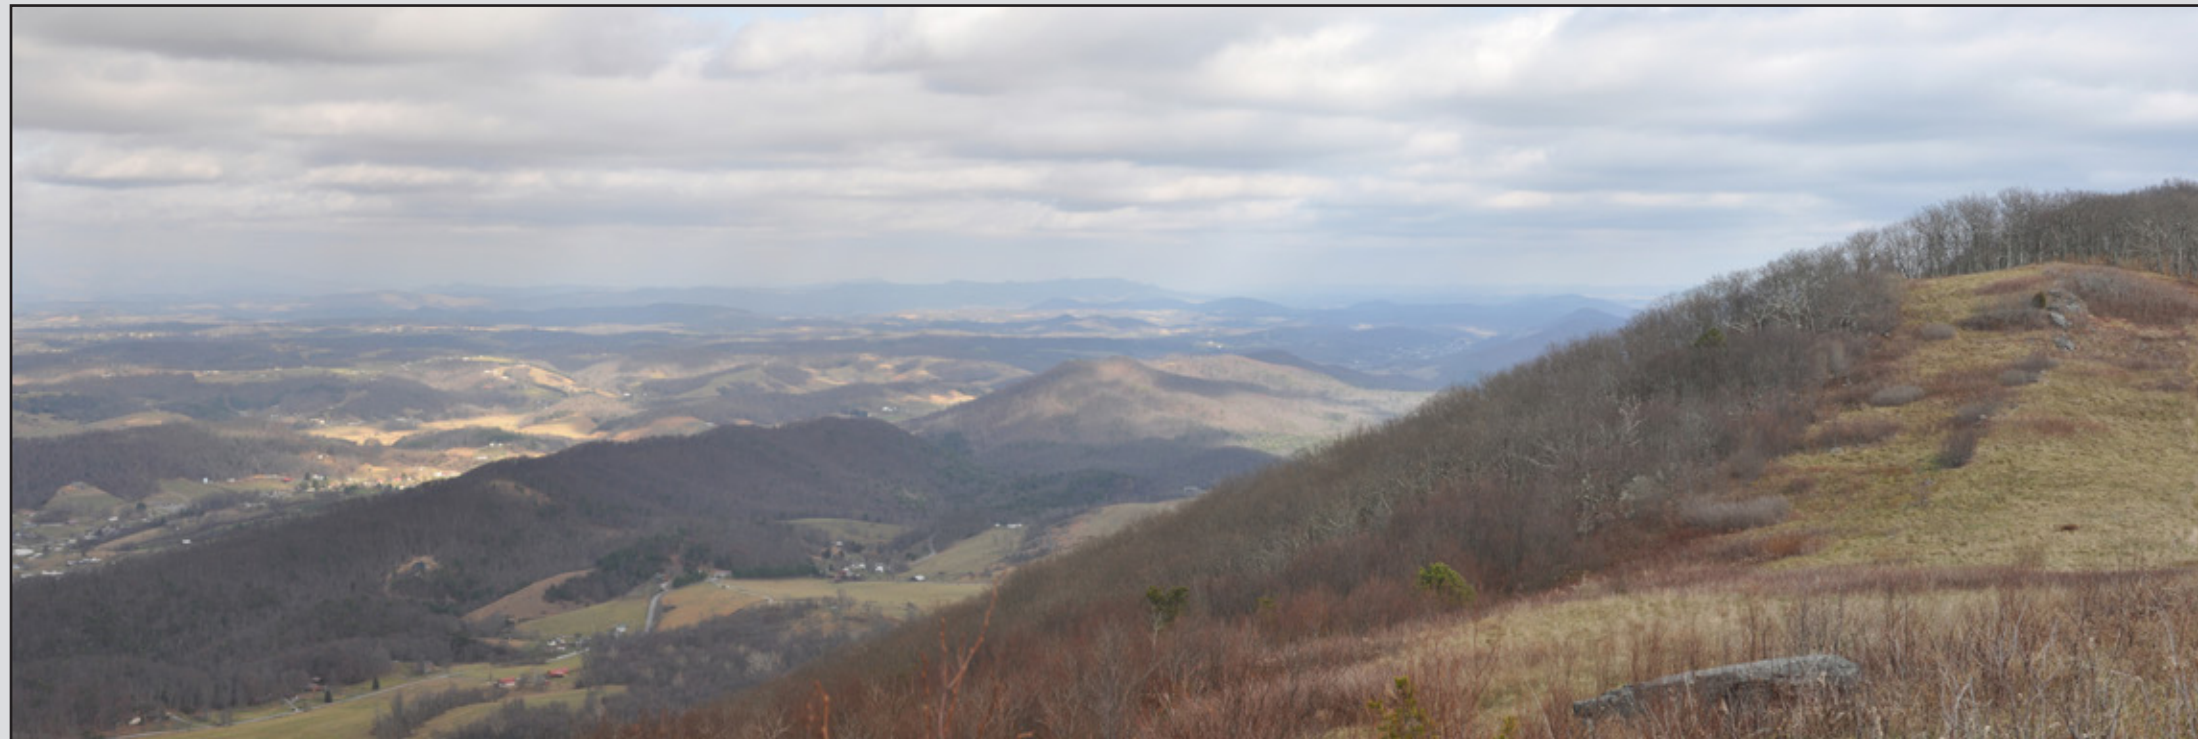
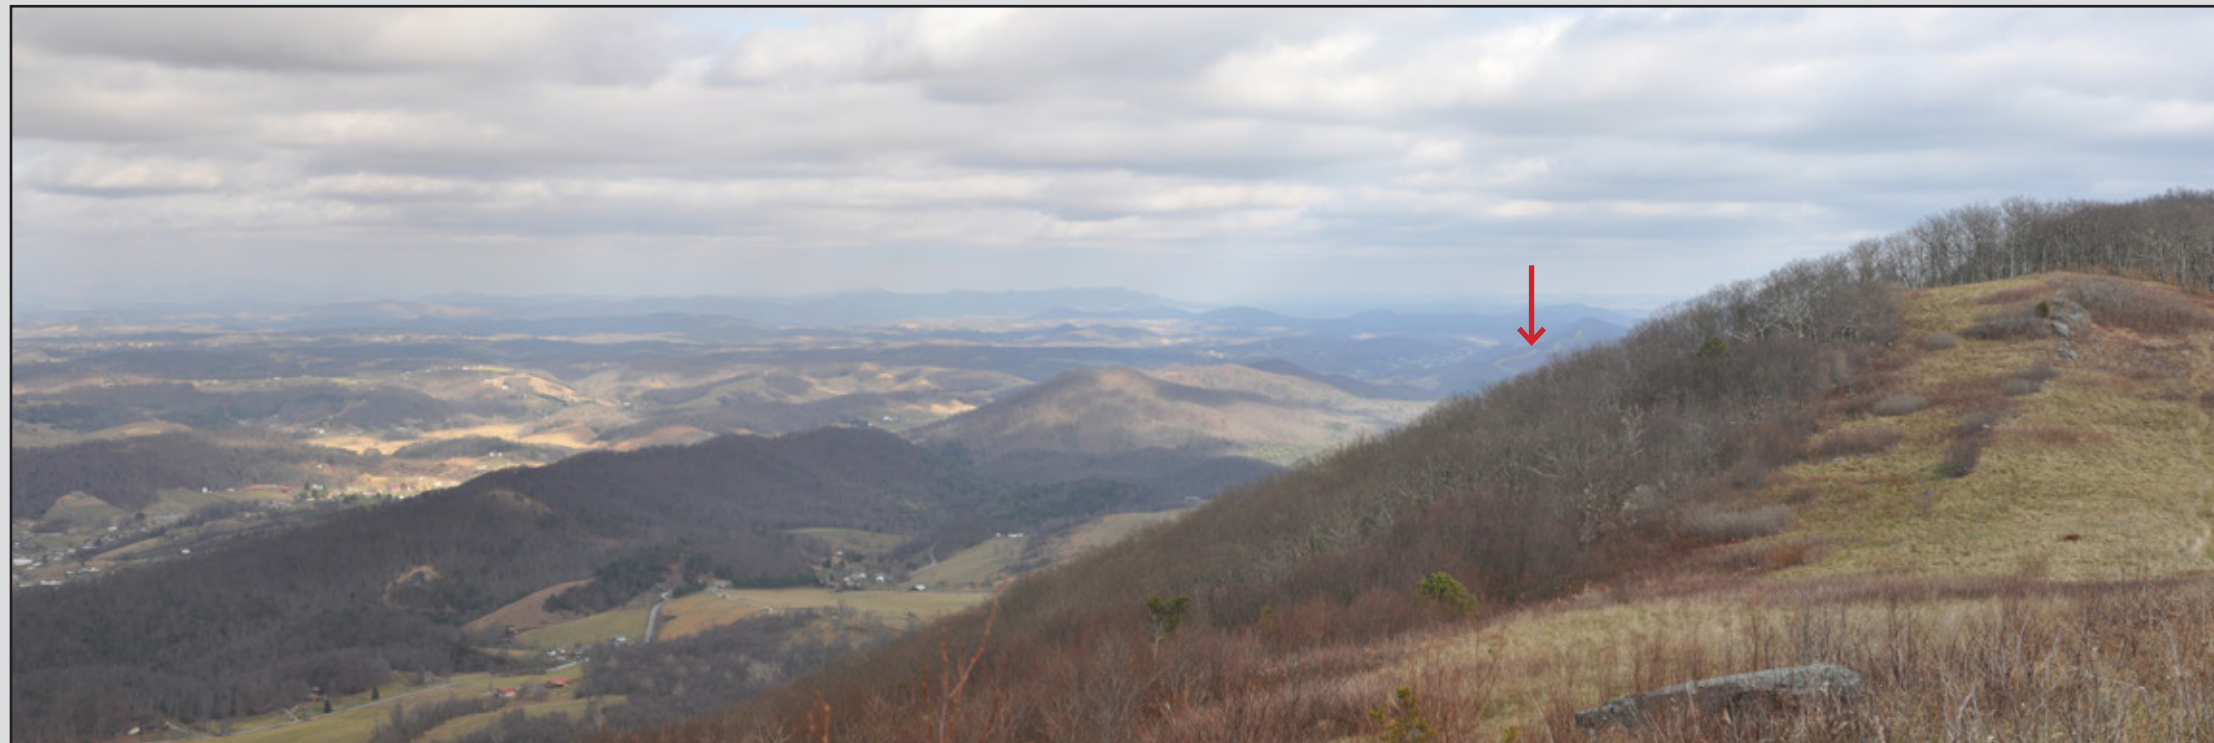
Figure 11

Post Construction - The proposed pipeline would cross over Peters Mountain approximately 4.2 miles from the Rice Field Vista. The red arrow indicates where the proposed pipeline would be visible crossing over Little Mountain. Views of the pipeline crossing Peters Mountain would be screened.

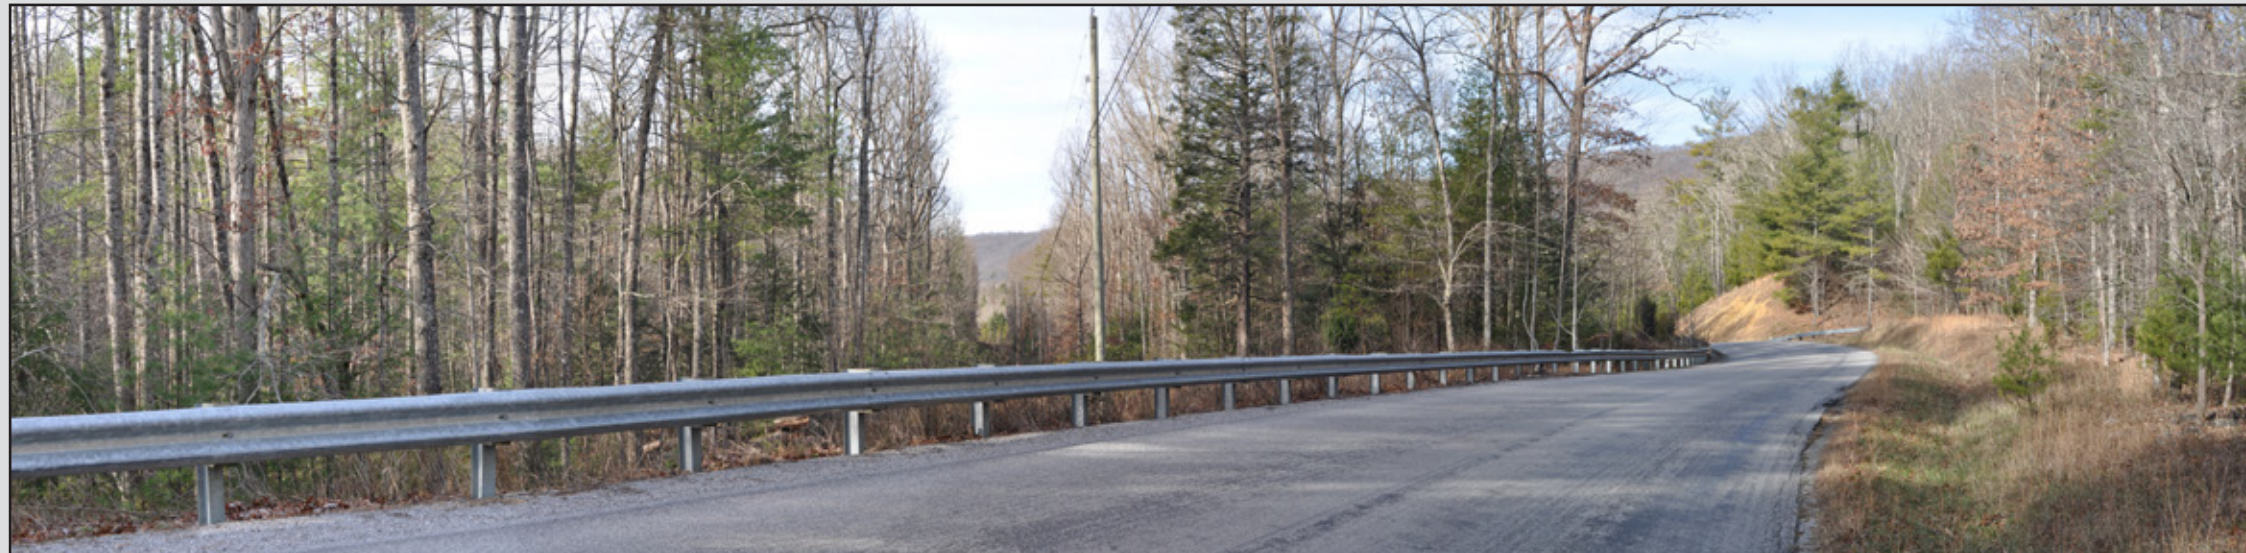
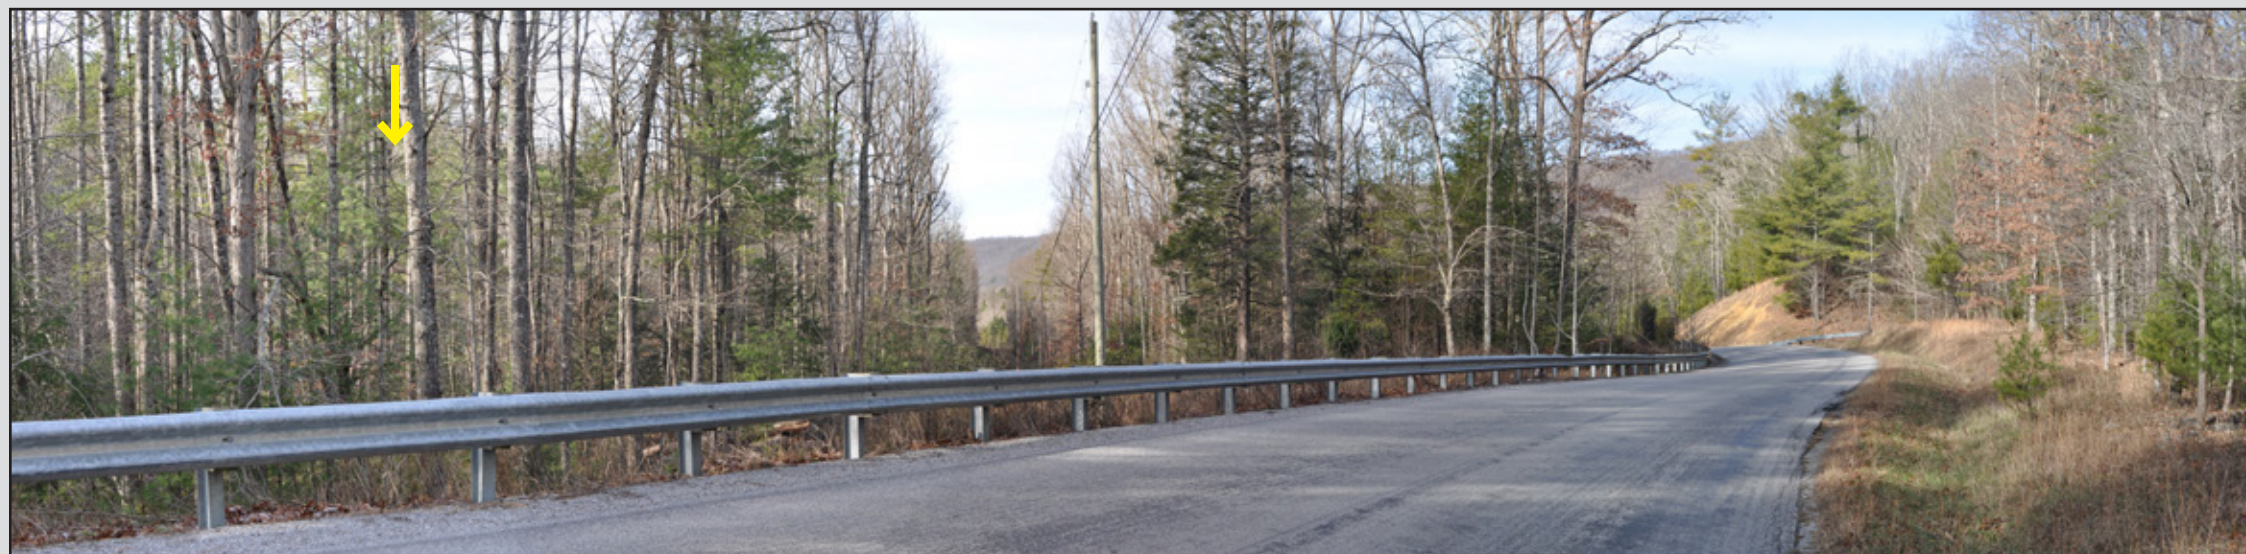
Post Construction - The proposed pipeline crossing Sinking Creek Mountain and the adjacent valley would be screened by vegetation. The yellow arrow indicates approximately where the proposed pipeline would be located crossing over Brush Mountain. Views would be completely screened by terrain and vegetation.

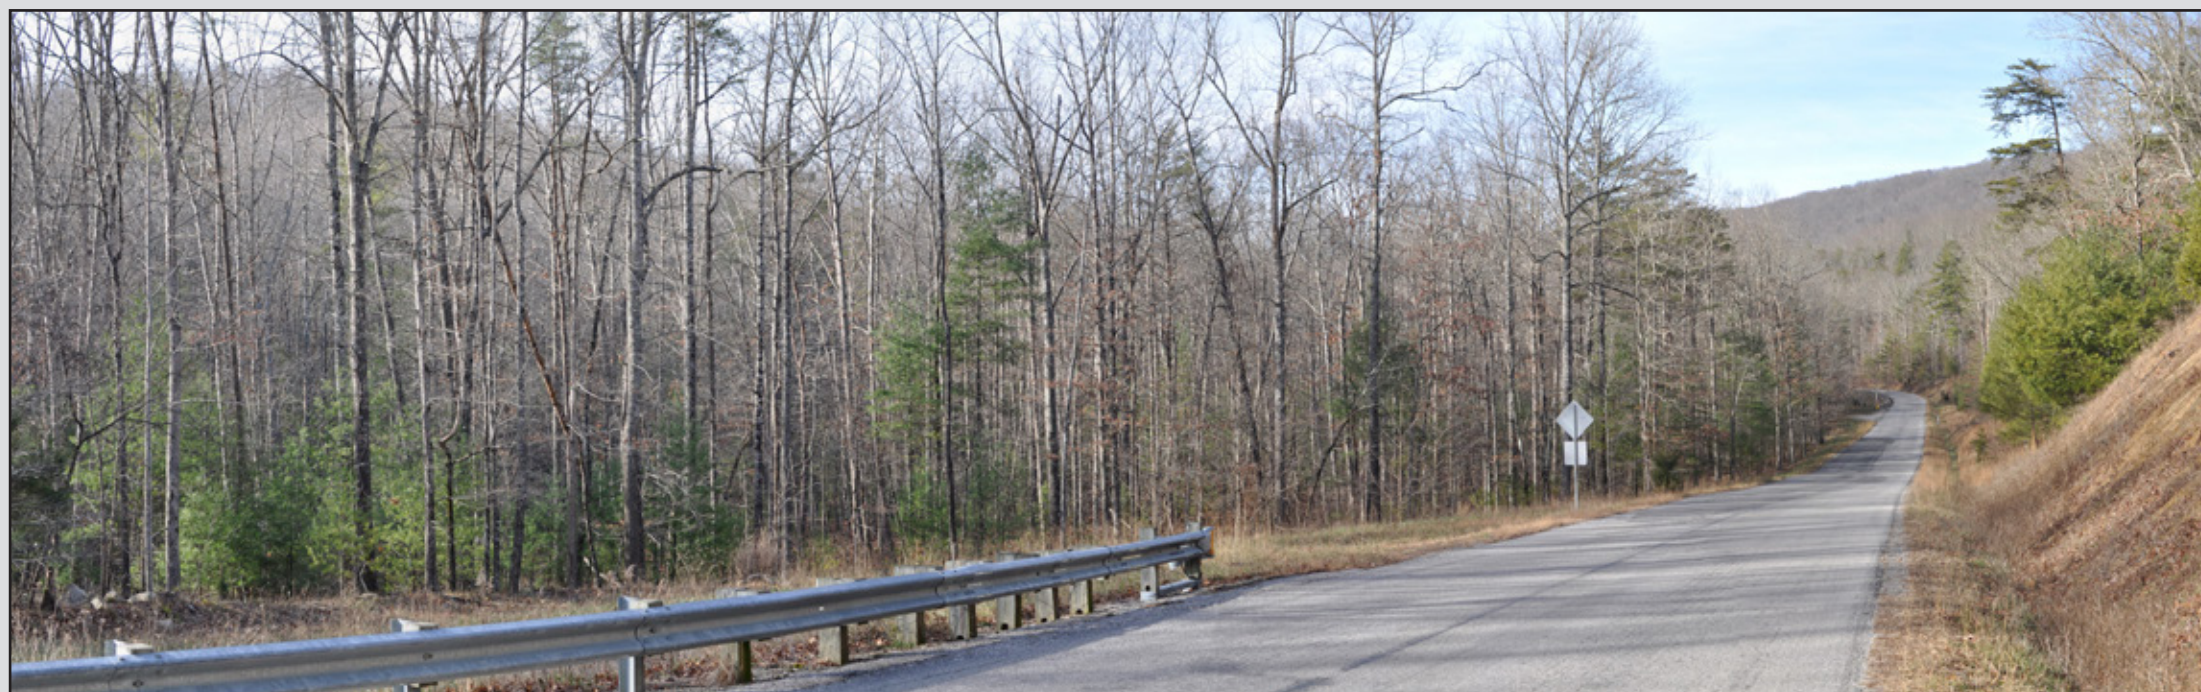
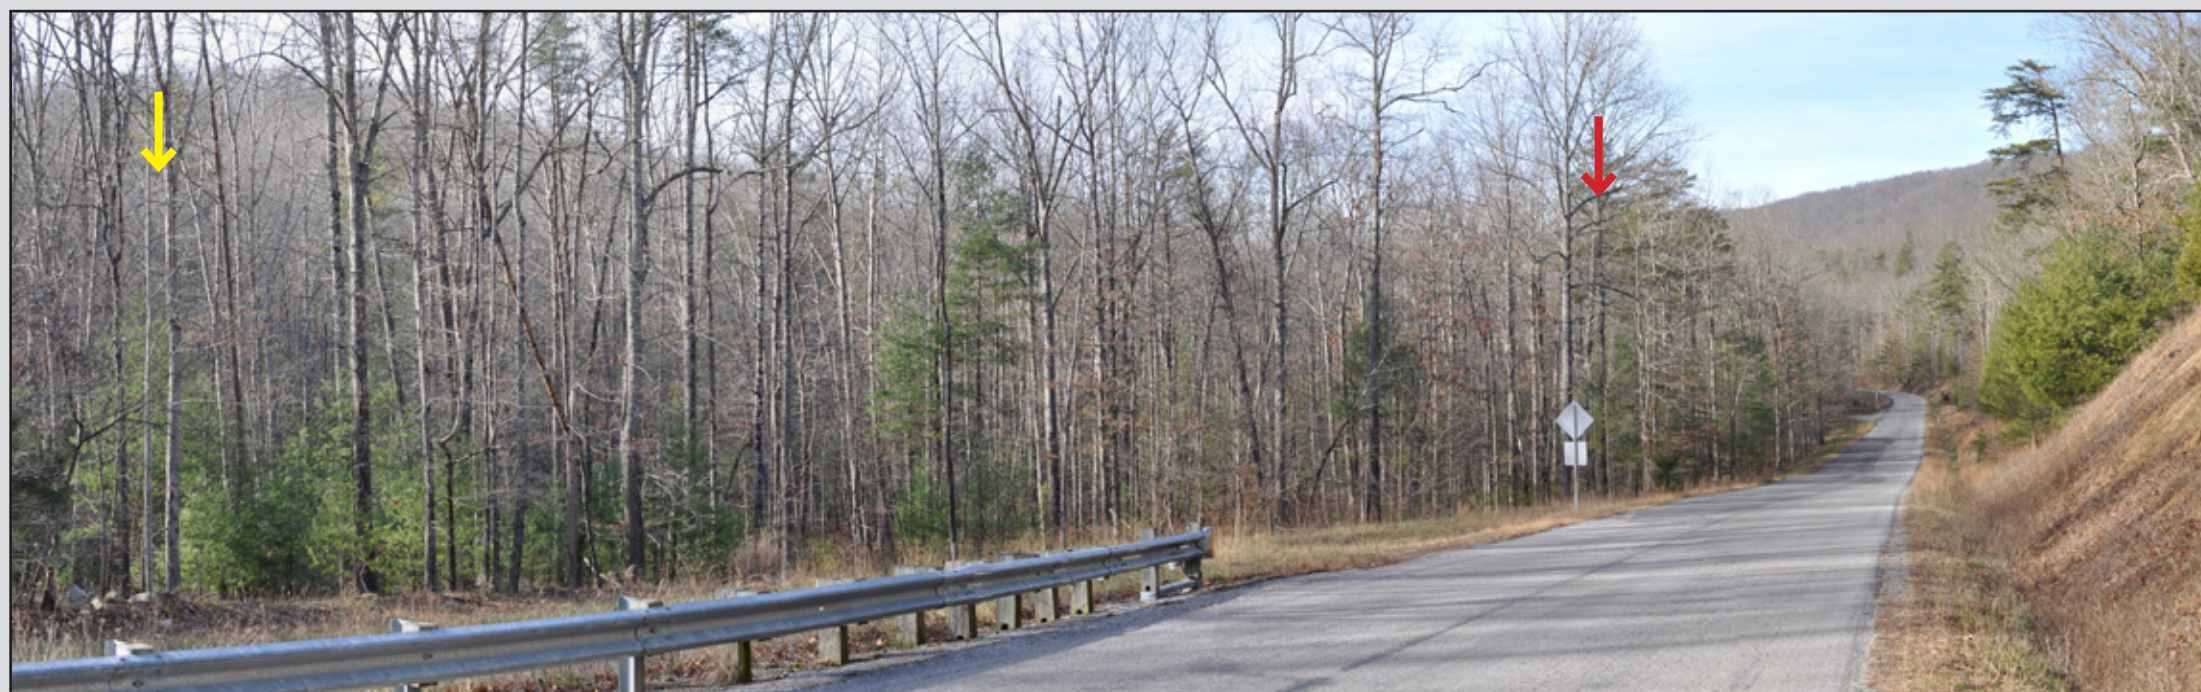
Figure 13

Post Construction - The proposed pipeline crossing Sinking Creek Mountain and the adjacent valley would be screened by vegetation. The yellow arrow indicates approximately where the proposed pipeline would be located crossing Brush Mountain. The red arrow indicates where the pipeline would cross Gap Mountain. Both crossings would be completely screened by terrain and vegetation.

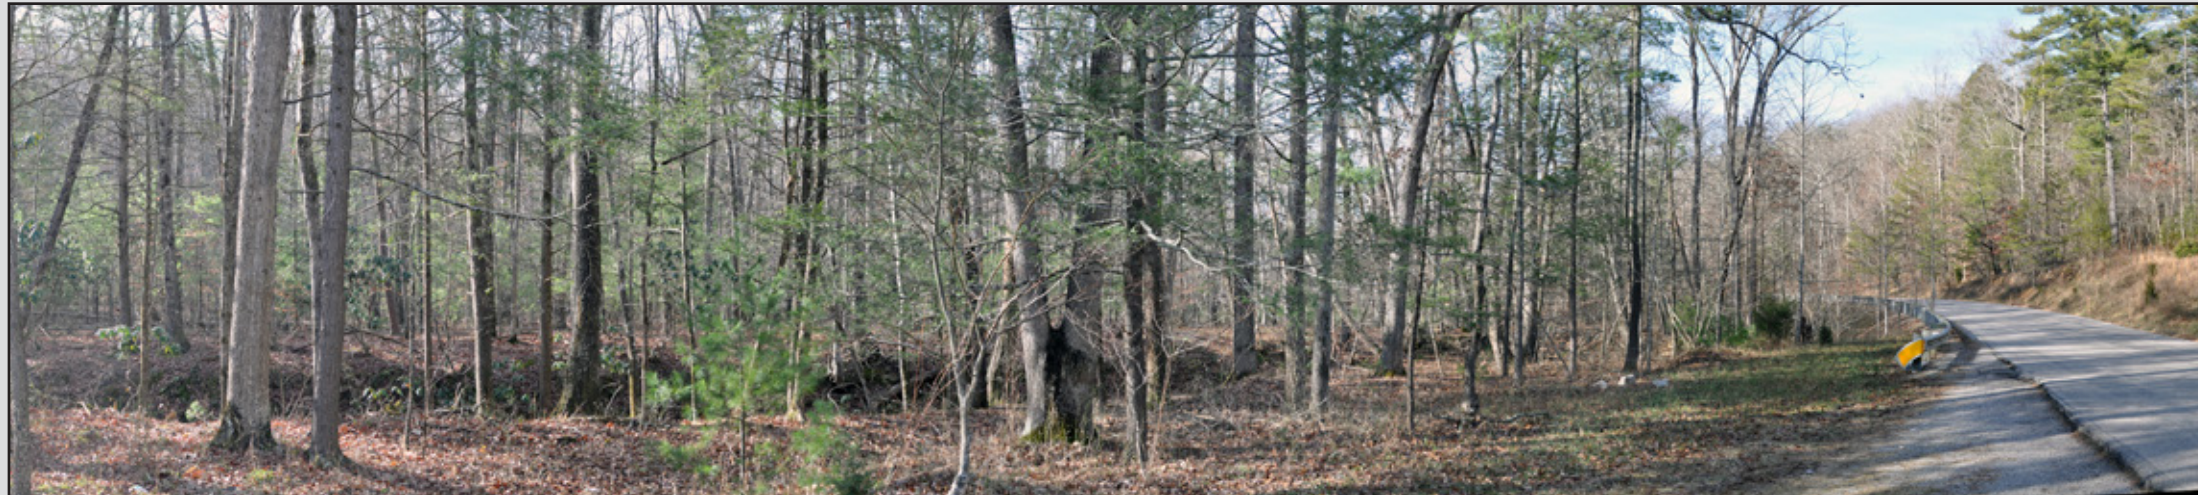
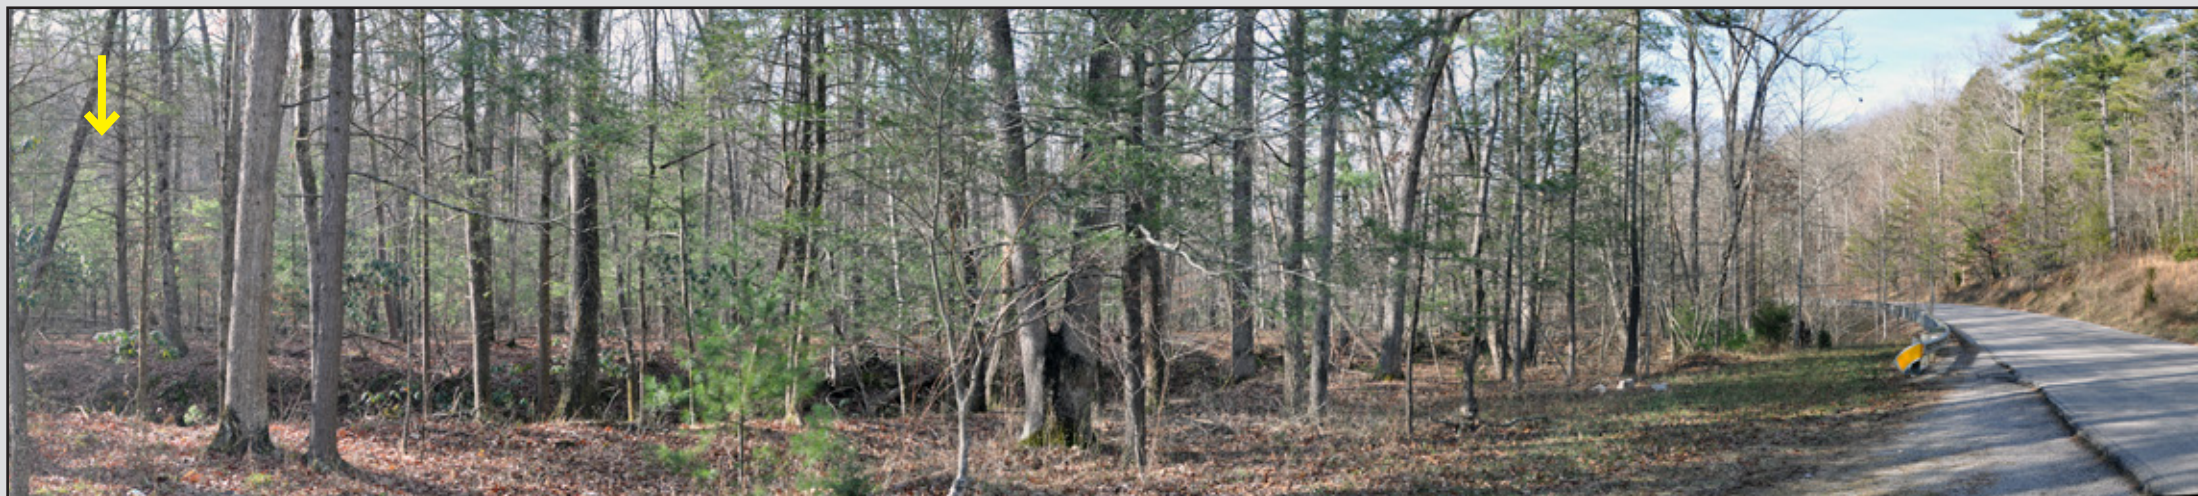
Figure 14

Post Construction - The proposed pipeline crossing Sinking Creek Mountain and the adjacent valley would be screened by vegetation. The yellow arrow indicates approximately where the proposed pipeline would be located crossing the lower slopes of Brush Mountain. Views would be completely screened by terrain and vegetation.

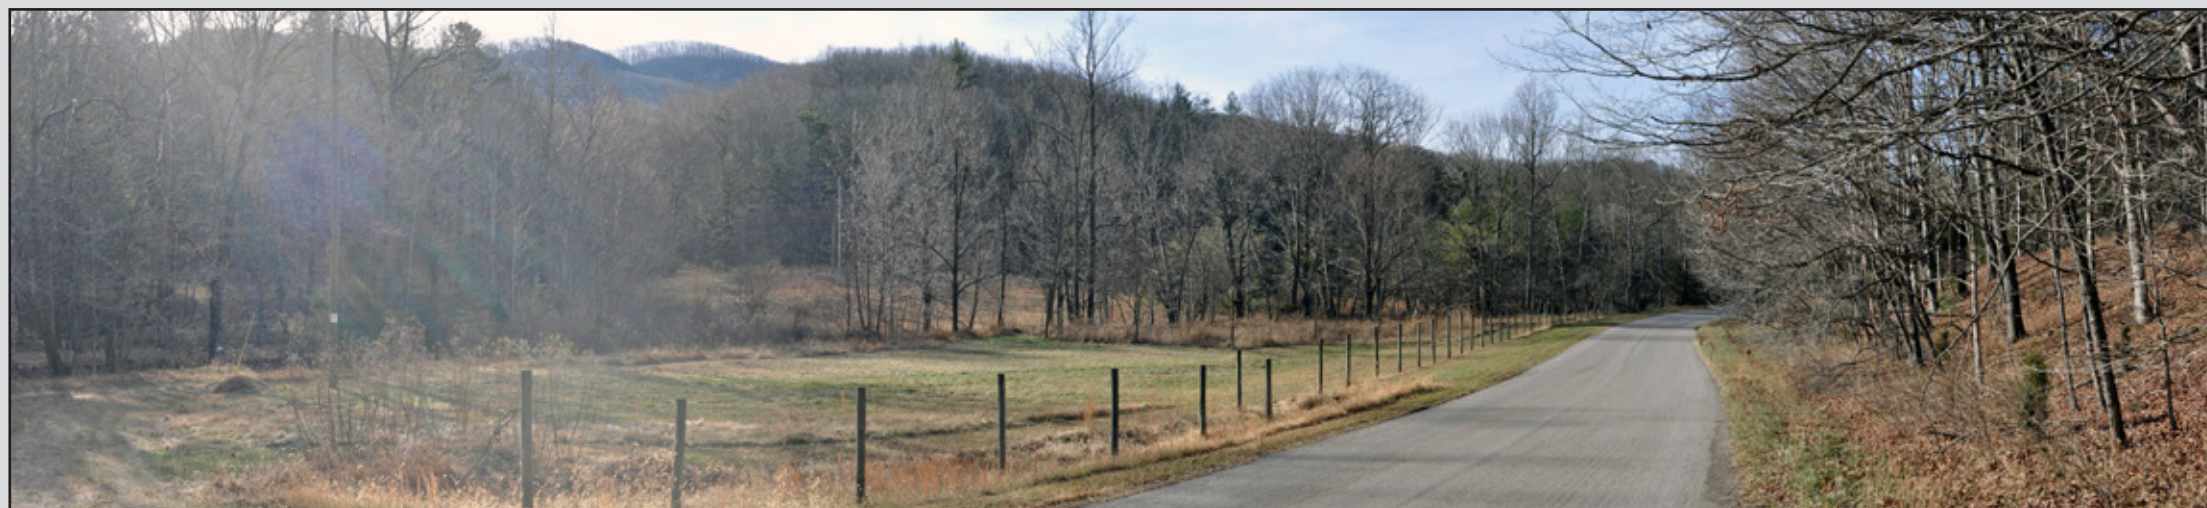
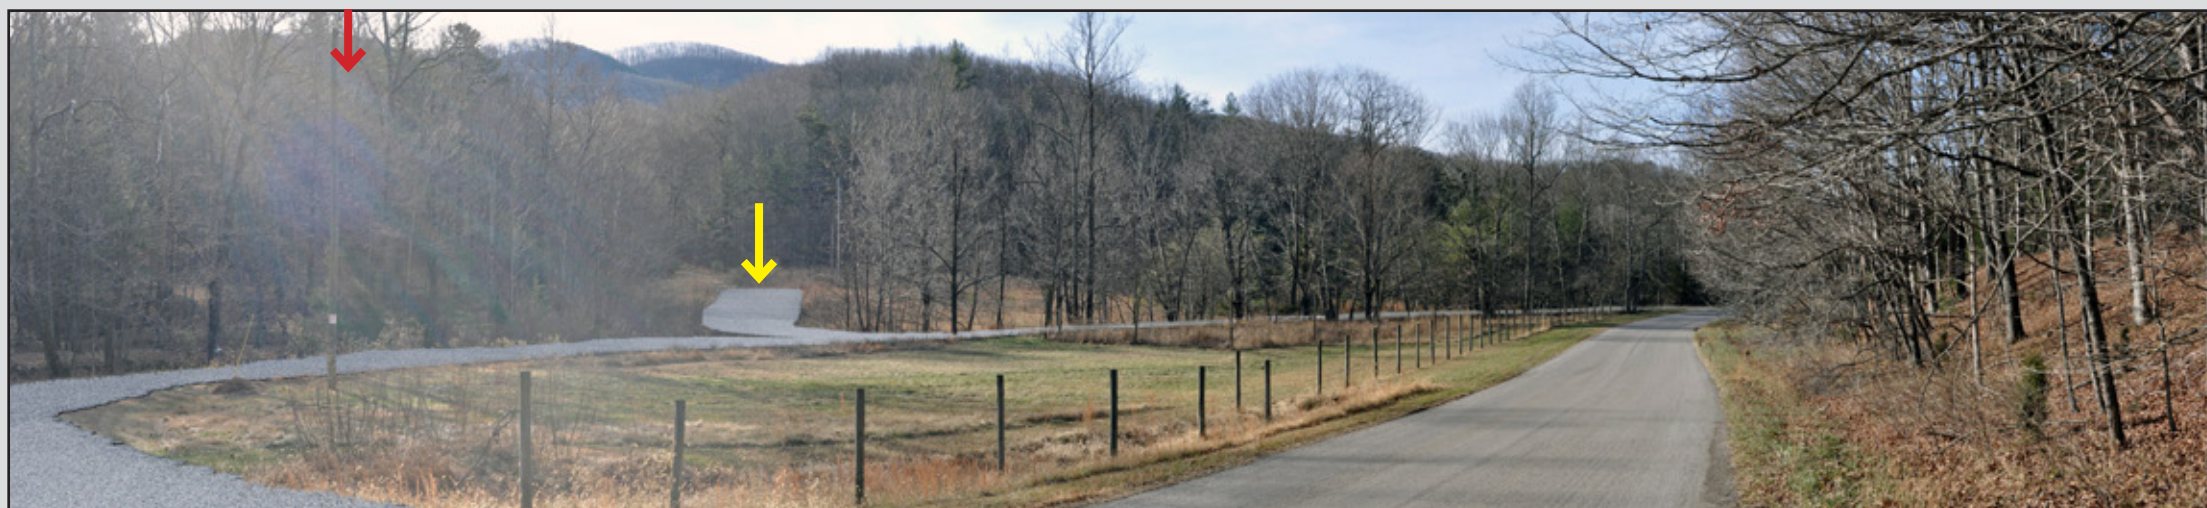
Post Construction - The proposed pipeline access road would be visible leading from Craig Creek Road towards the pipeline right-of-way. However, the proposed pipeline crossing and where it crosses the valley adjacent to Craig Creek Road would be screened by vegetation and terrain. The yellow arrow indicates the road upgrades that would be visible from KOP PT-25. The red arrow indicates approximately where the pipeline would cross over Brush Mountain, and would be screened by vegetation from this location.

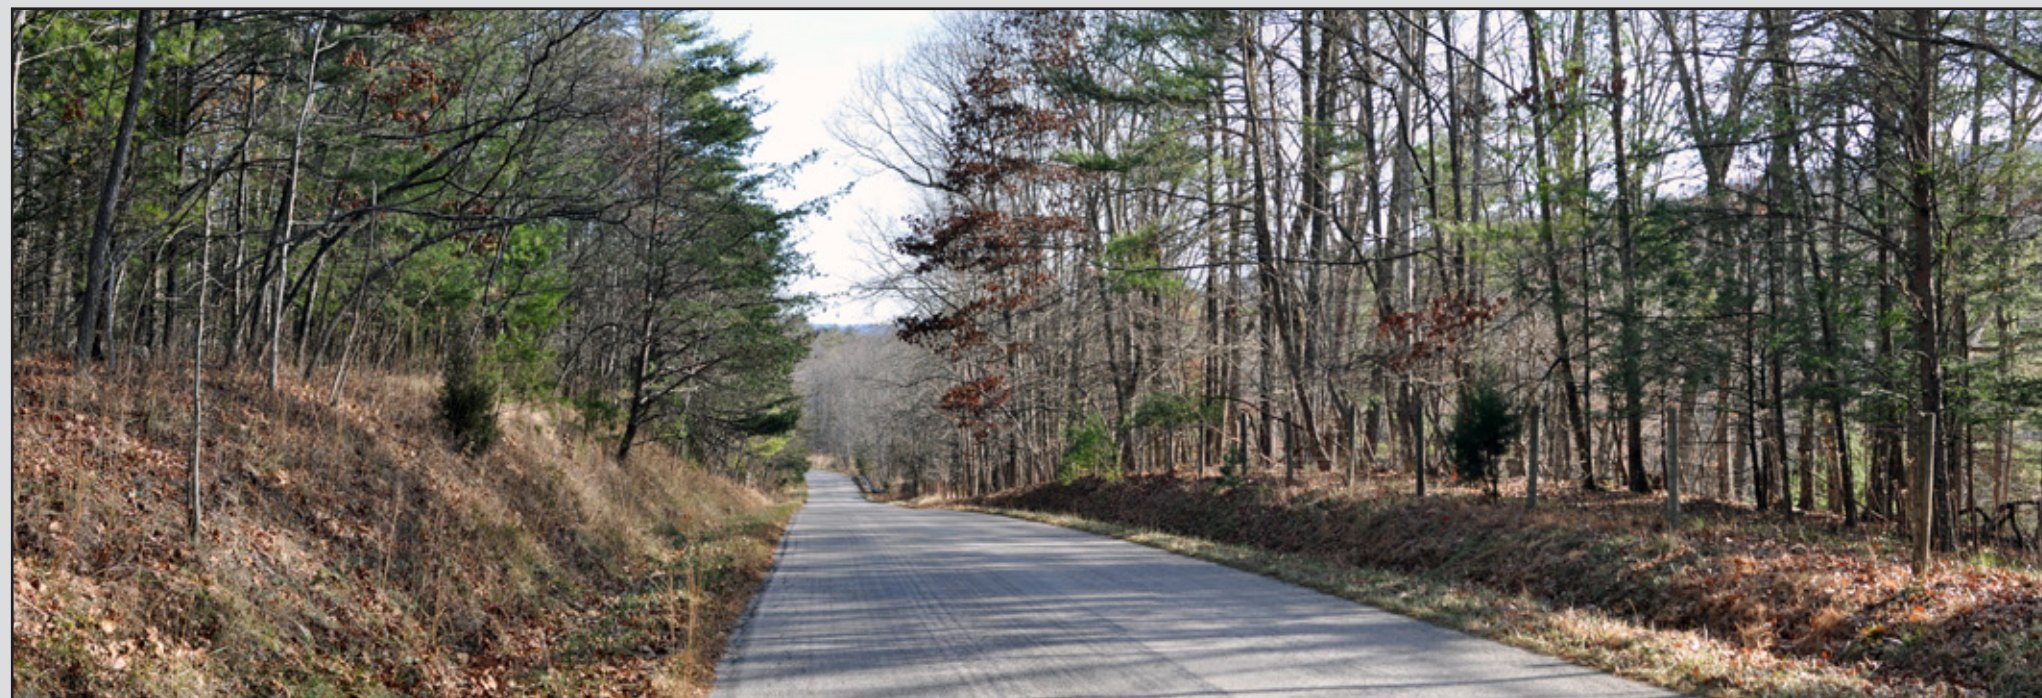
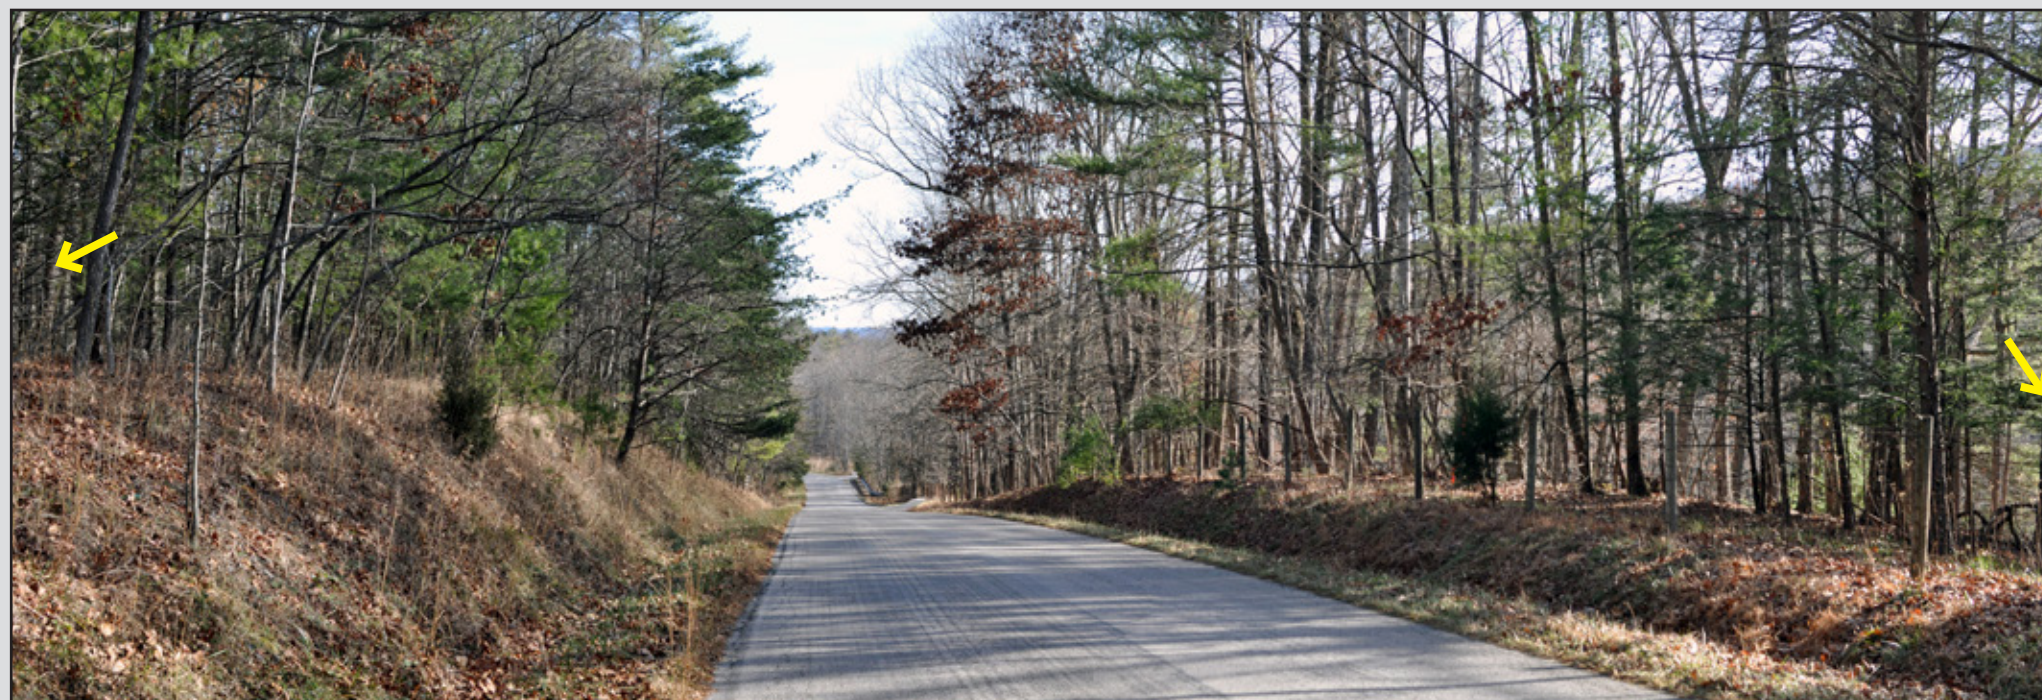
Post Construction - The proposed pipeline would cross Craig Creek Road immediately adjacent to KOP PT-26. However, the pipeline would be bored under the road and the bore pits would be located approximately 60-100 feet from the road and would be screened by vegetation and terrain. The yellow arrows indicate that the bore pits would be located to the north and south of the road and would be completely screened.

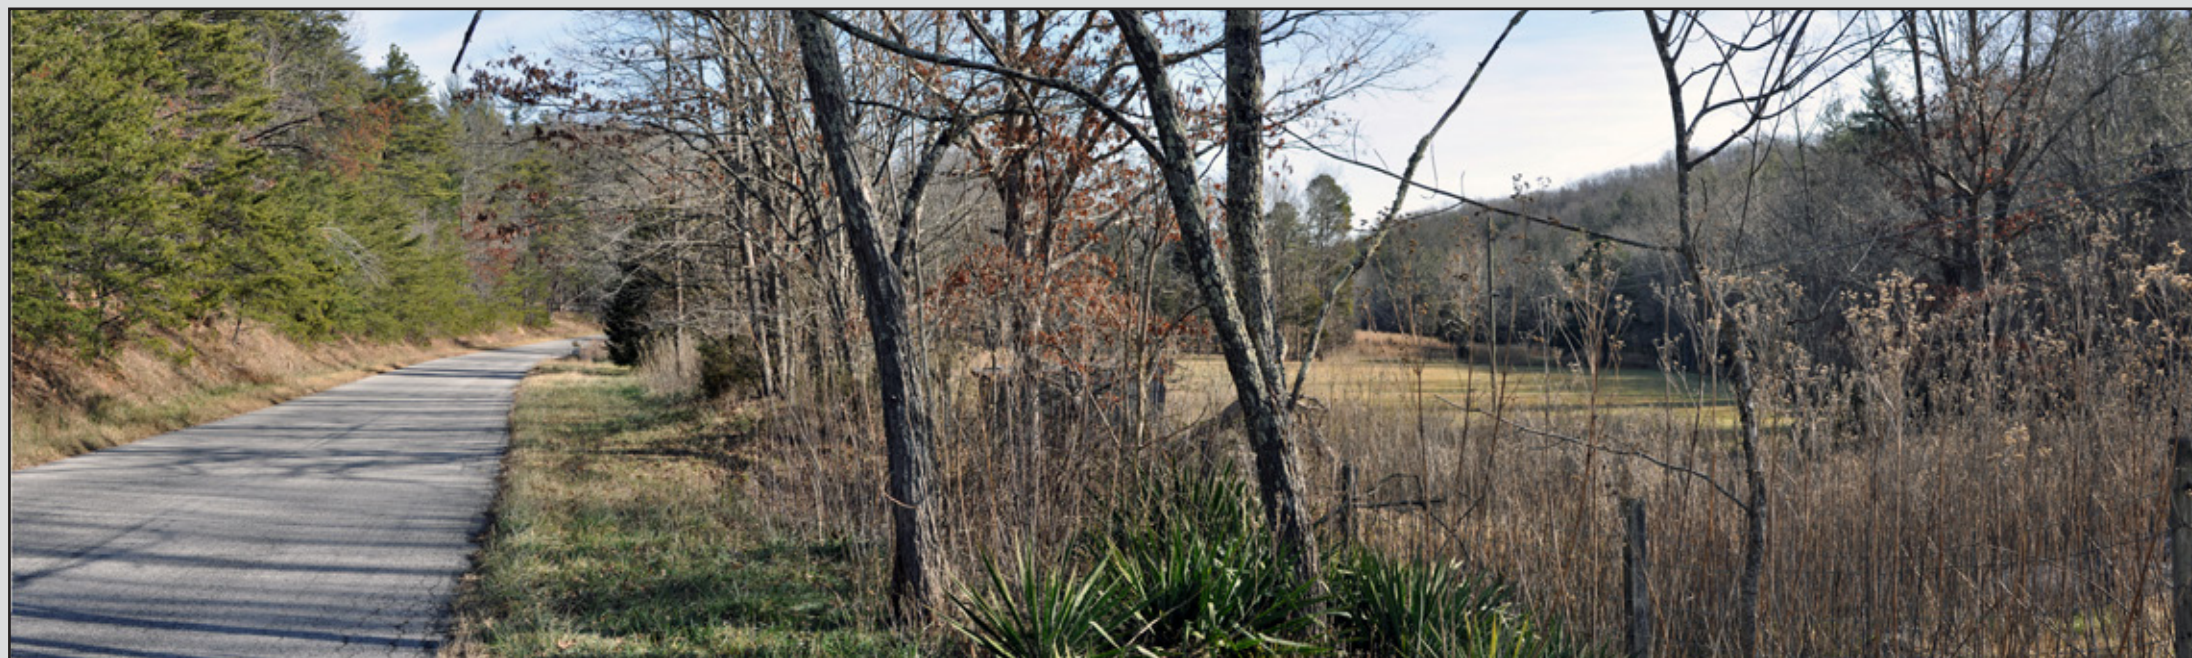
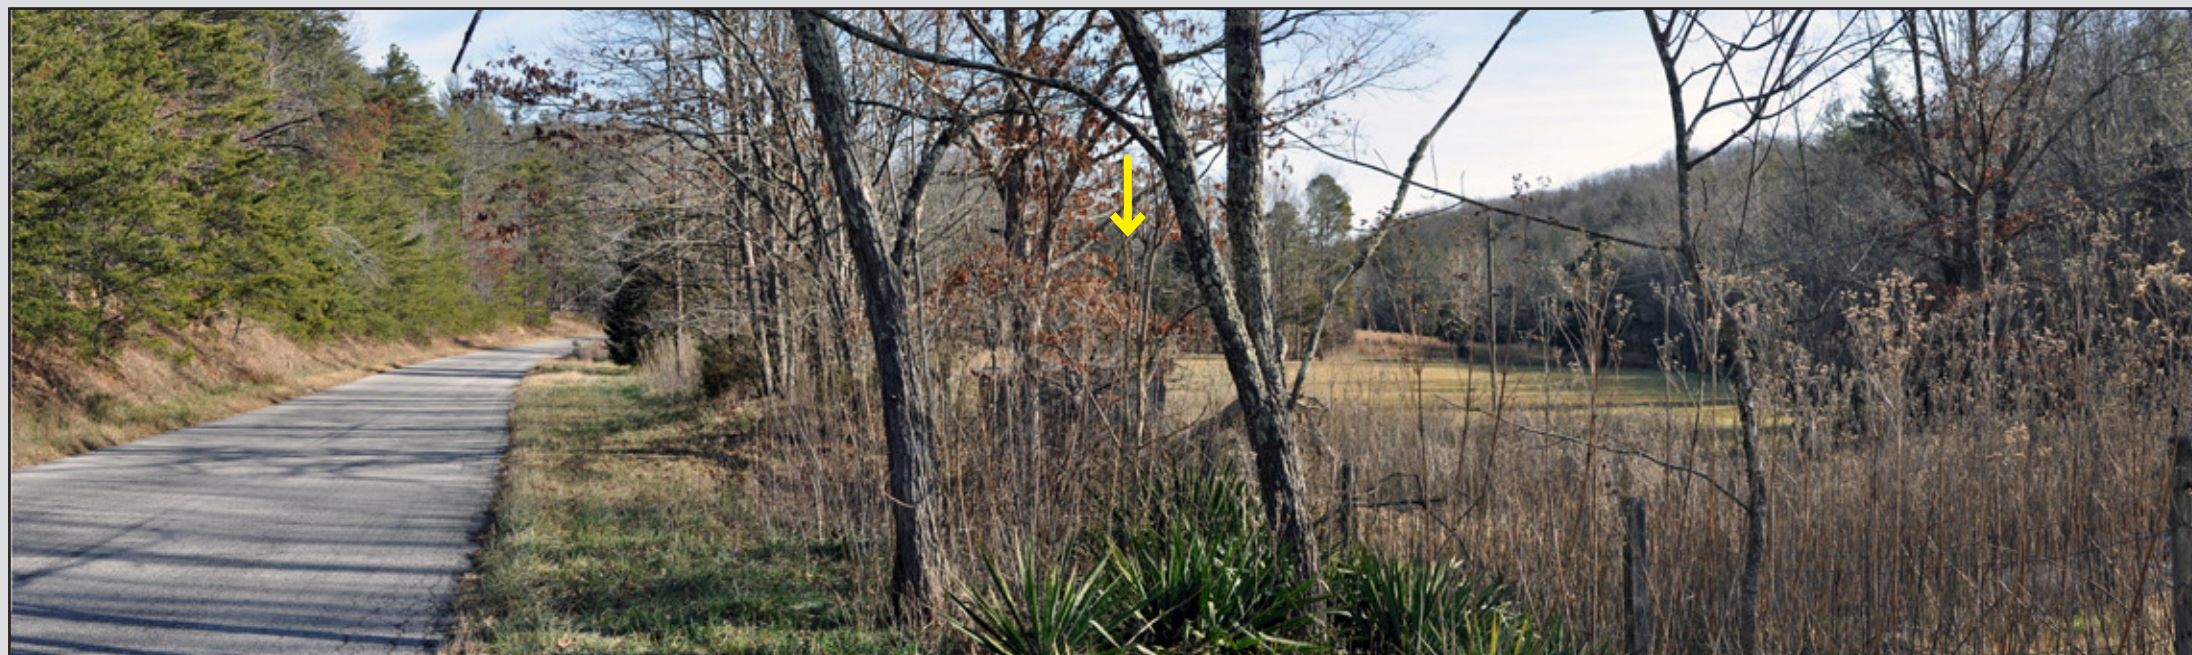
Post Construction - The proposed pipeline would cross Craig Creek Road approximately 0.23 mile east of KOP PT-28. The pipeline would be screened by vegetation and terrain. The yellow arrow indicates where the proposed pipeline would be located crossing the open field and over Brush Mountain. Views of the pipeline from this location would be screened by vegetation.

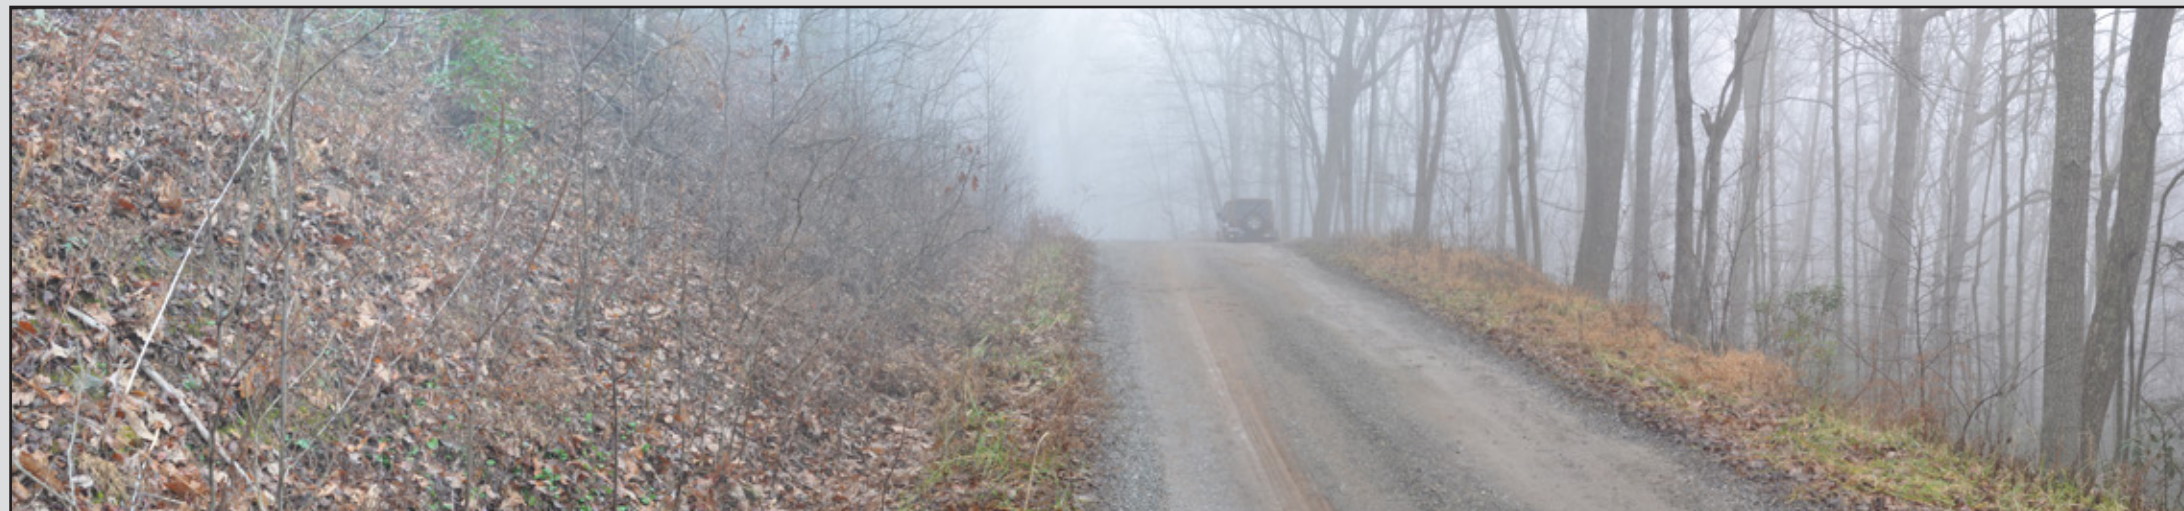
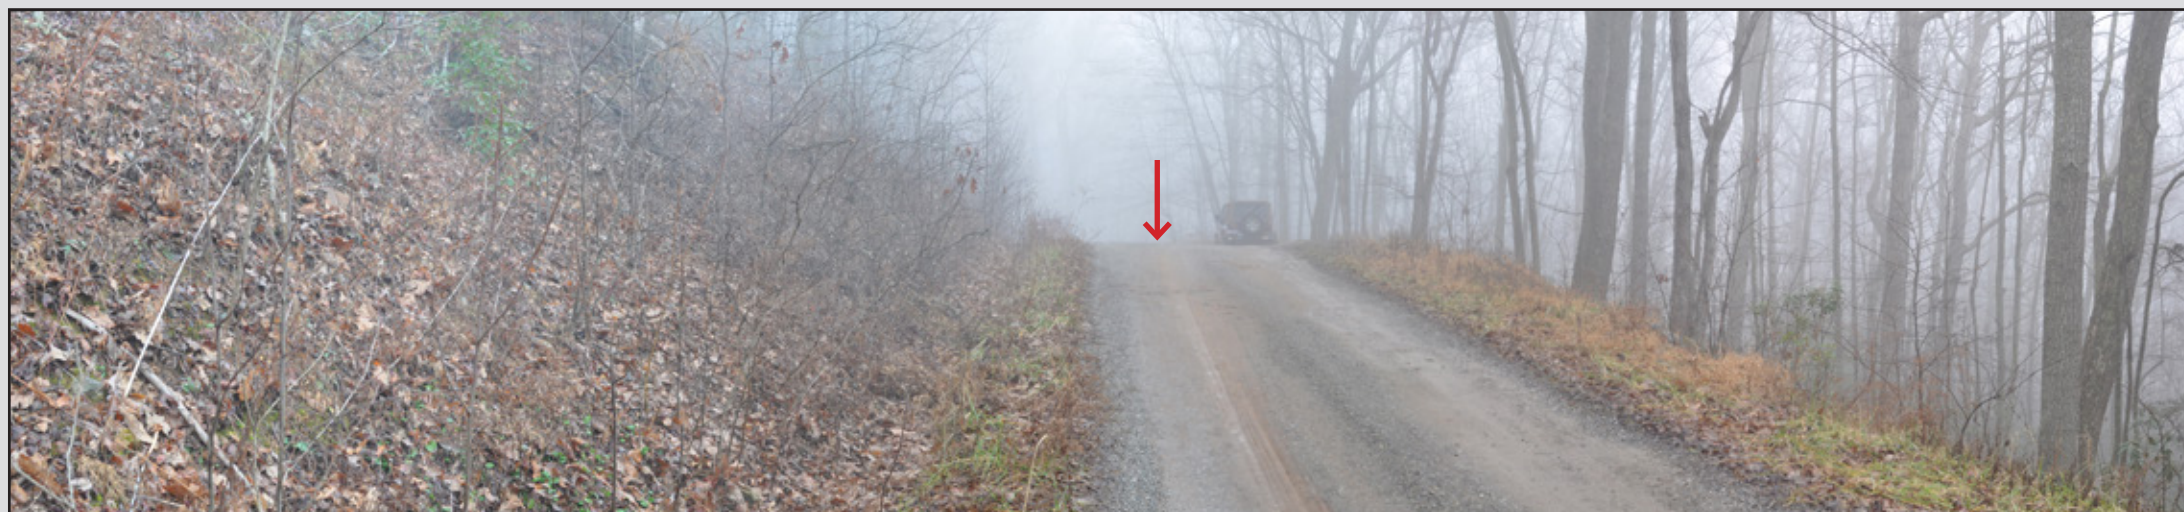
Post Construction - No modifications would be visible from KOP PR-1. Modifications would be located over the hill and completely screened from this viewpoint.
