4. SUMMARY OF VISUAL IMPACTS

APPENDIX B

SIMULATIONS AND PHOTOGRAPHY

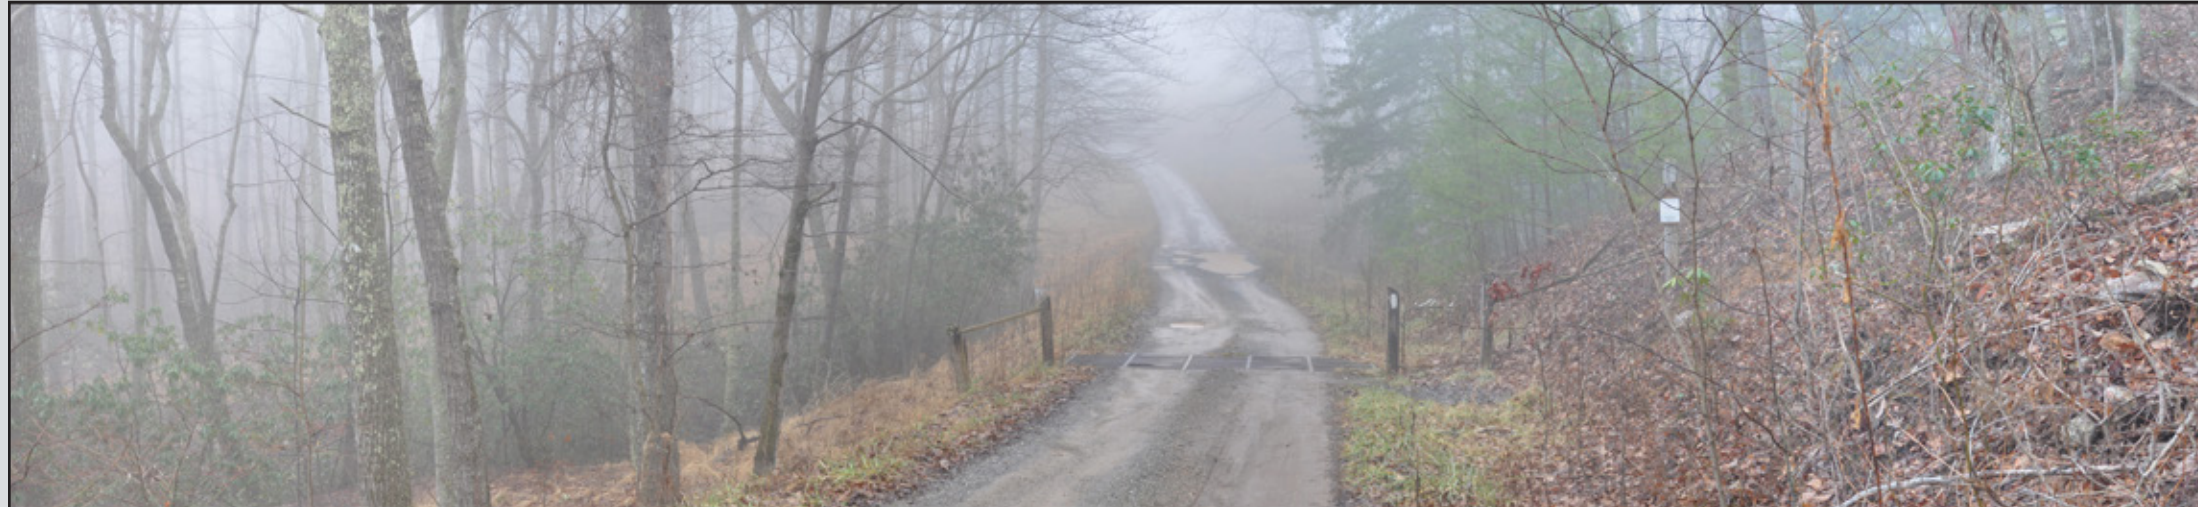
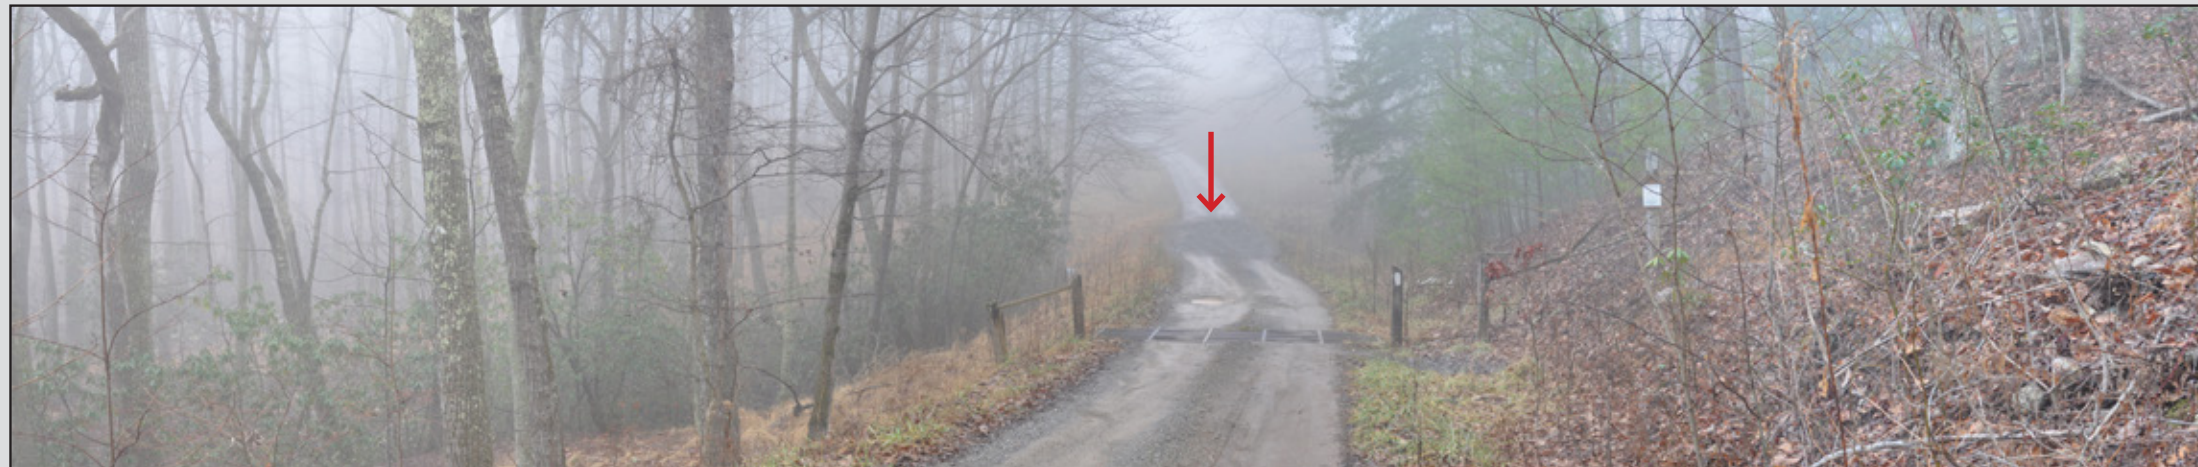
Post Construction - From this location modifications to the gravel in the roadway would be apparent where culvert upgrades would occur.

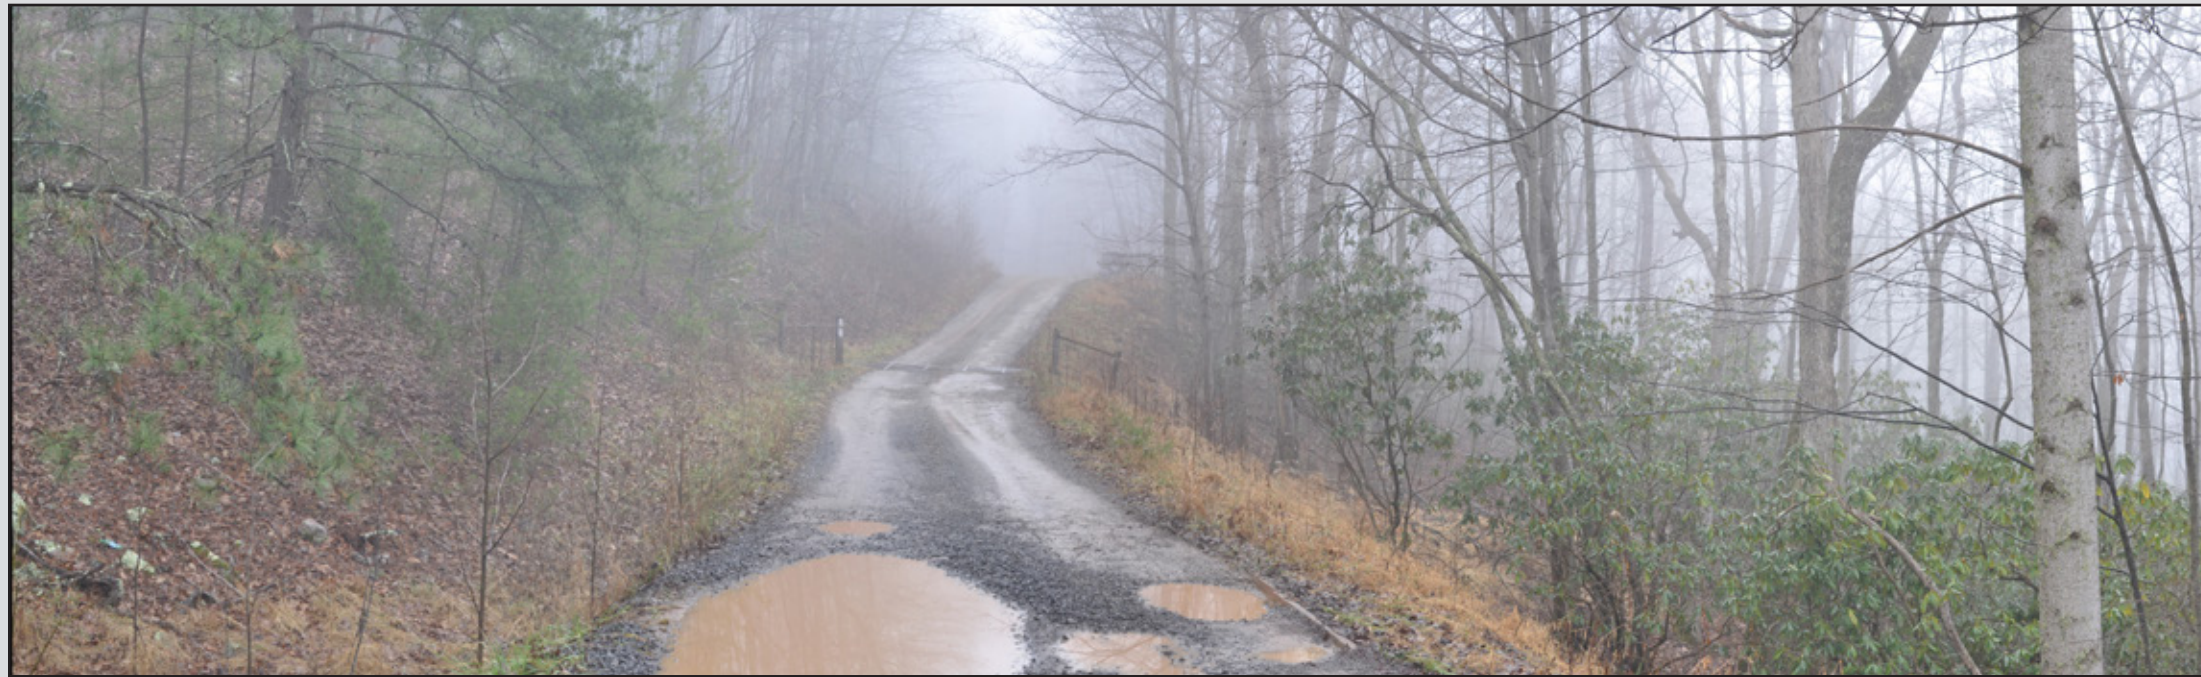
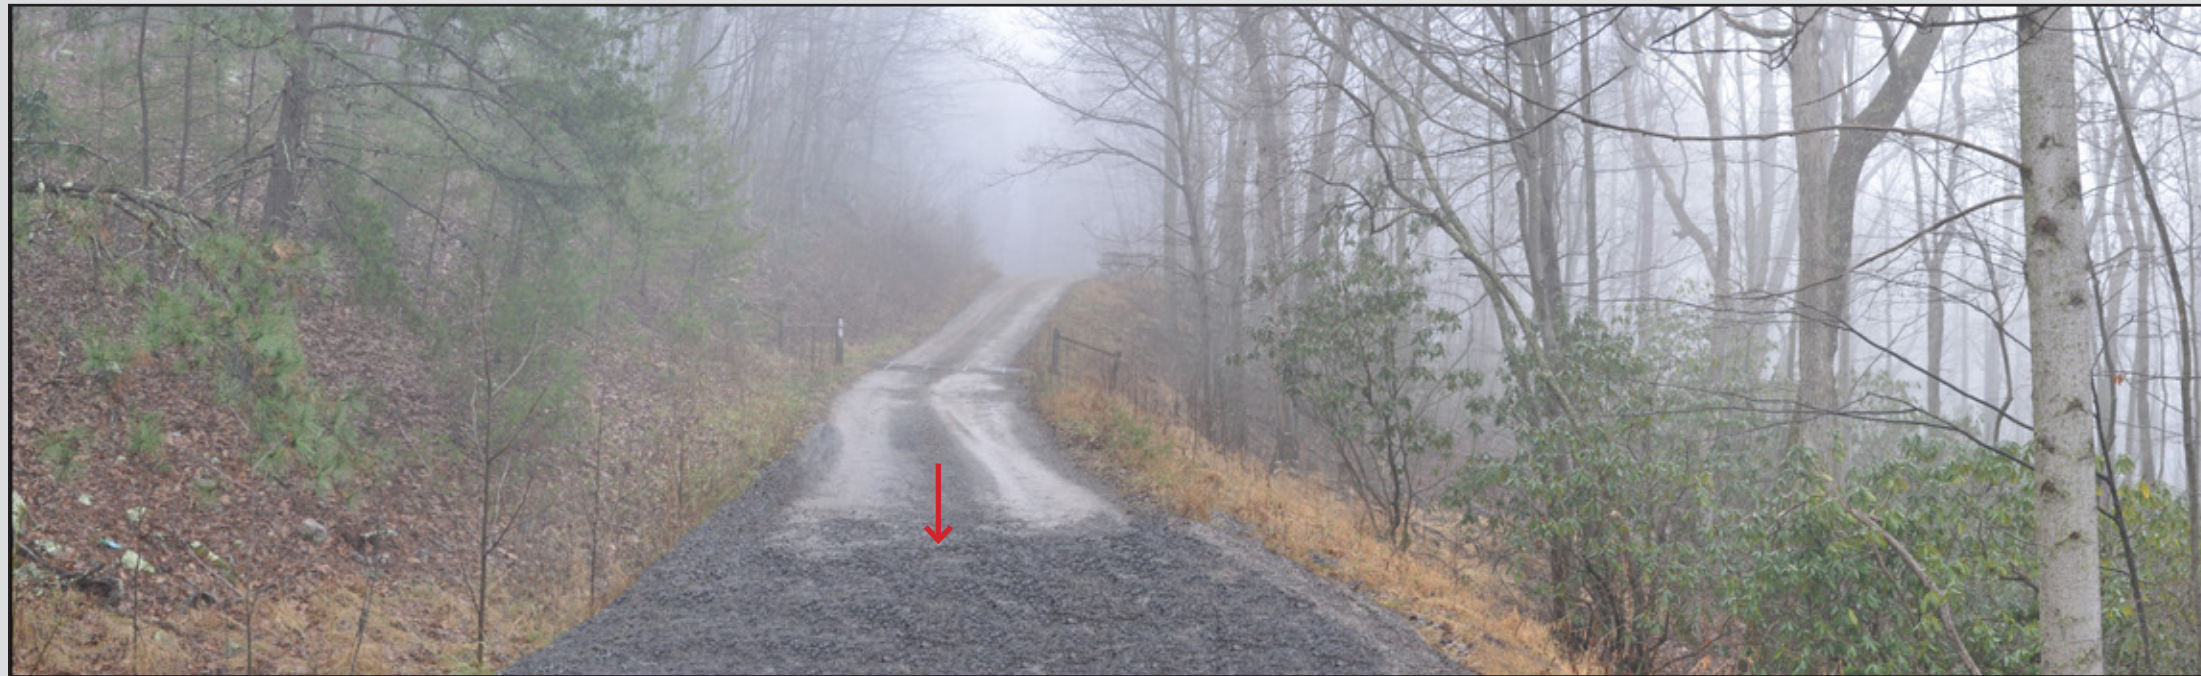
Pocahontas Road KOP PR-3

Post Construction - From this location modifications to the gravel in the roadway would be apparent in the immediate foreground where culvert upgrades would occur.

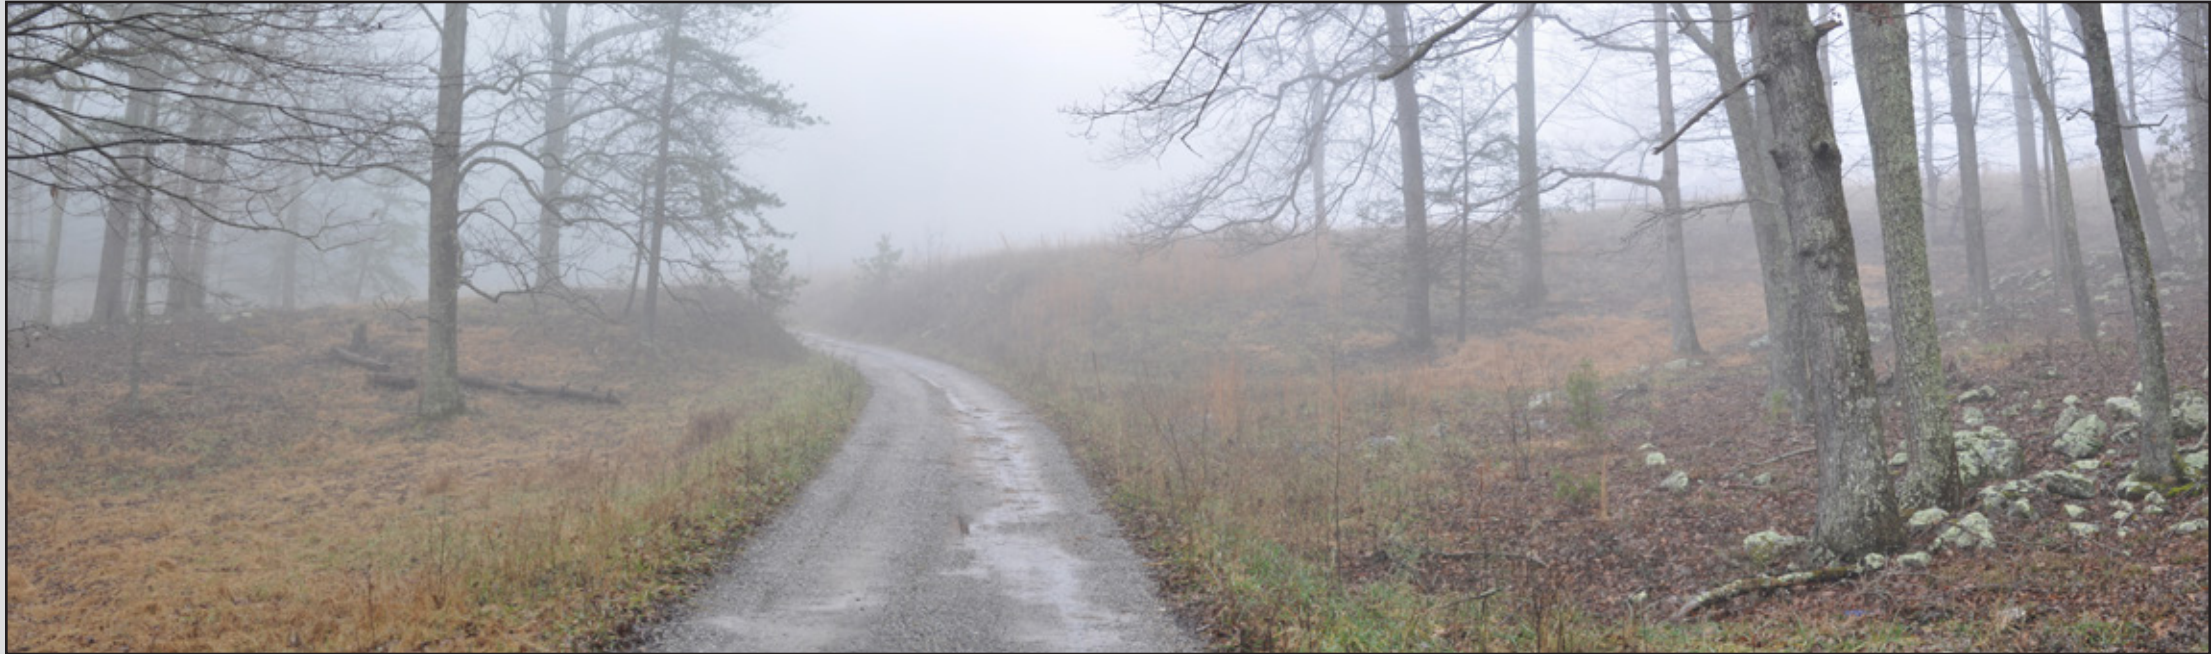
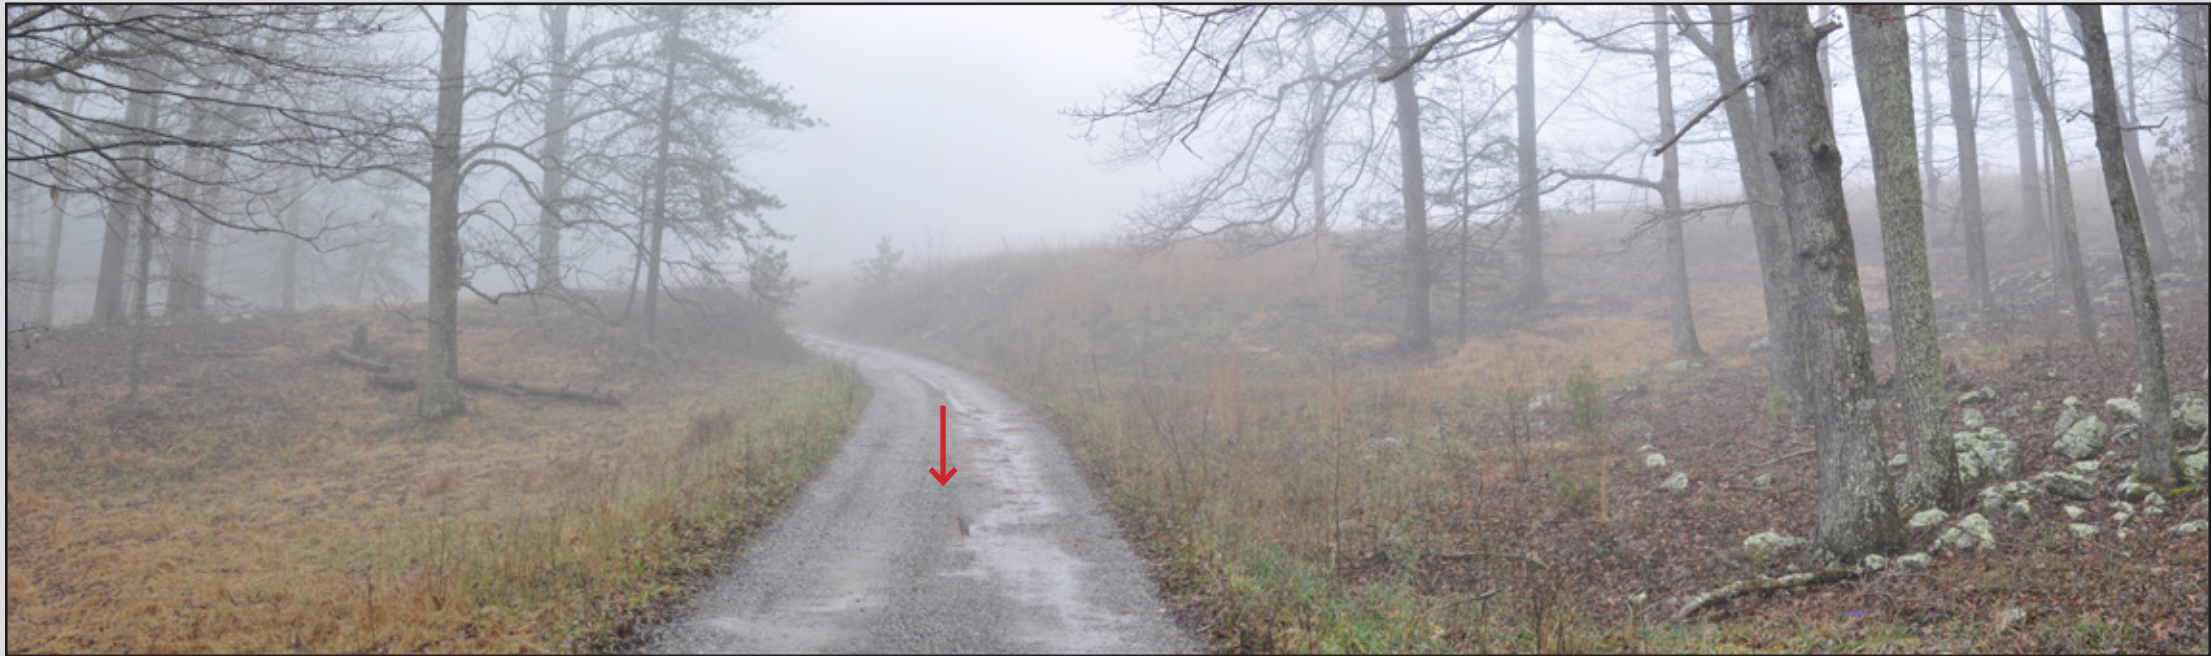
Figure 21

Post Construction - No modifications would be visible from KOP PR-5.

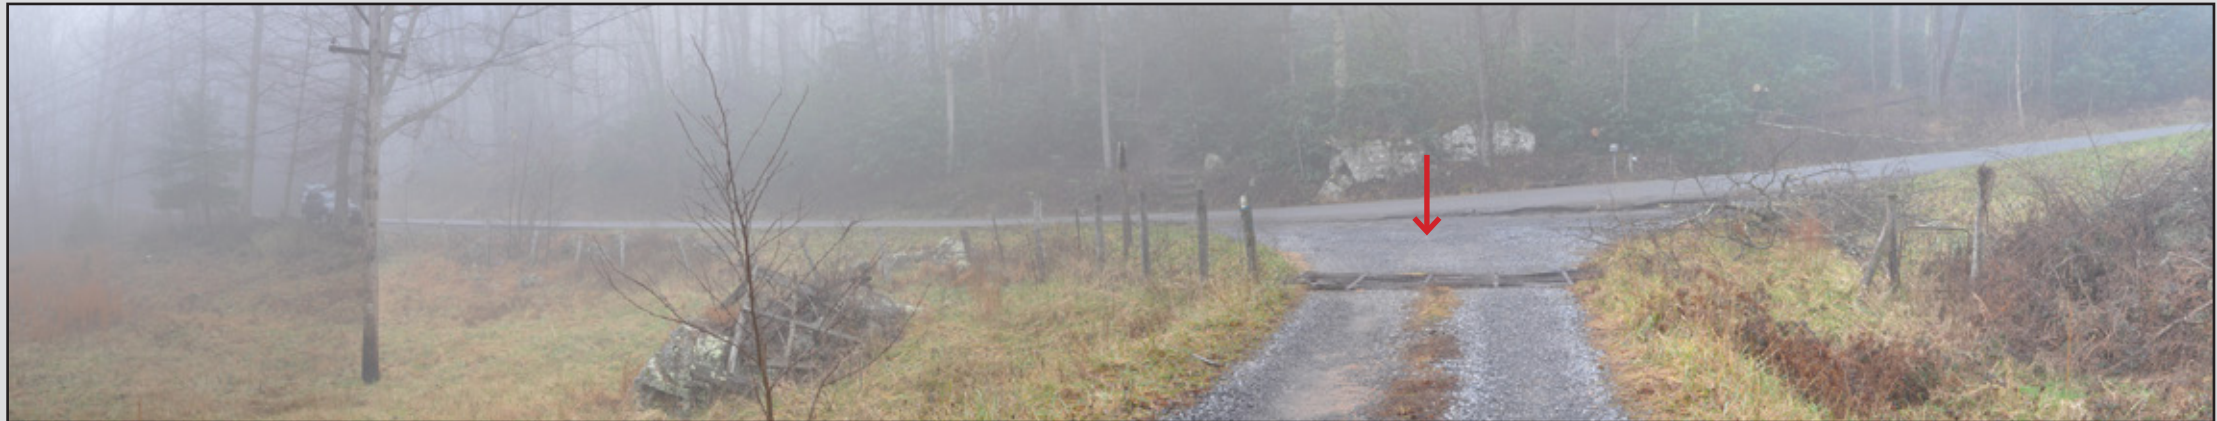
Post Construction - No modifications would be visible from KOP PR-6.
