Re: Mountain Valley Pipeline, LLC
Docket No. CP16-10-000
Weekly Status Report No. 104

**Re: Mountain Valley Pipeline Project (Permit No. WVR310667)
Response to Notice of Violation No. W19-17-030-JTL**

Attachment A
Corrective Action Photos

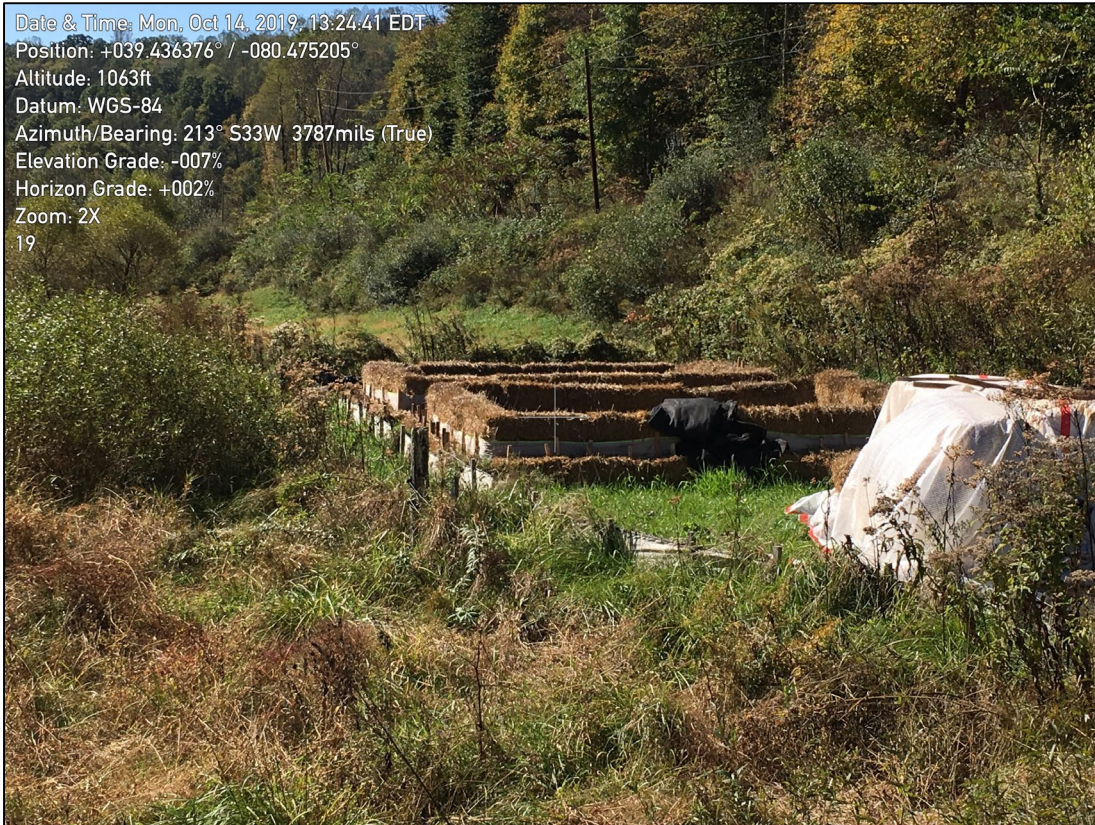
Photo 1: Photo illustrates the two additional dewatering structures that replaced the structure identified in the DEP investigation.

- Two additional dewatering devices were installed;
- The original dewatering device was removed, and the area is stabilized; and
- The hillside near Station 645+00 has been stabilized with erosion control blanketing and super silt fence.

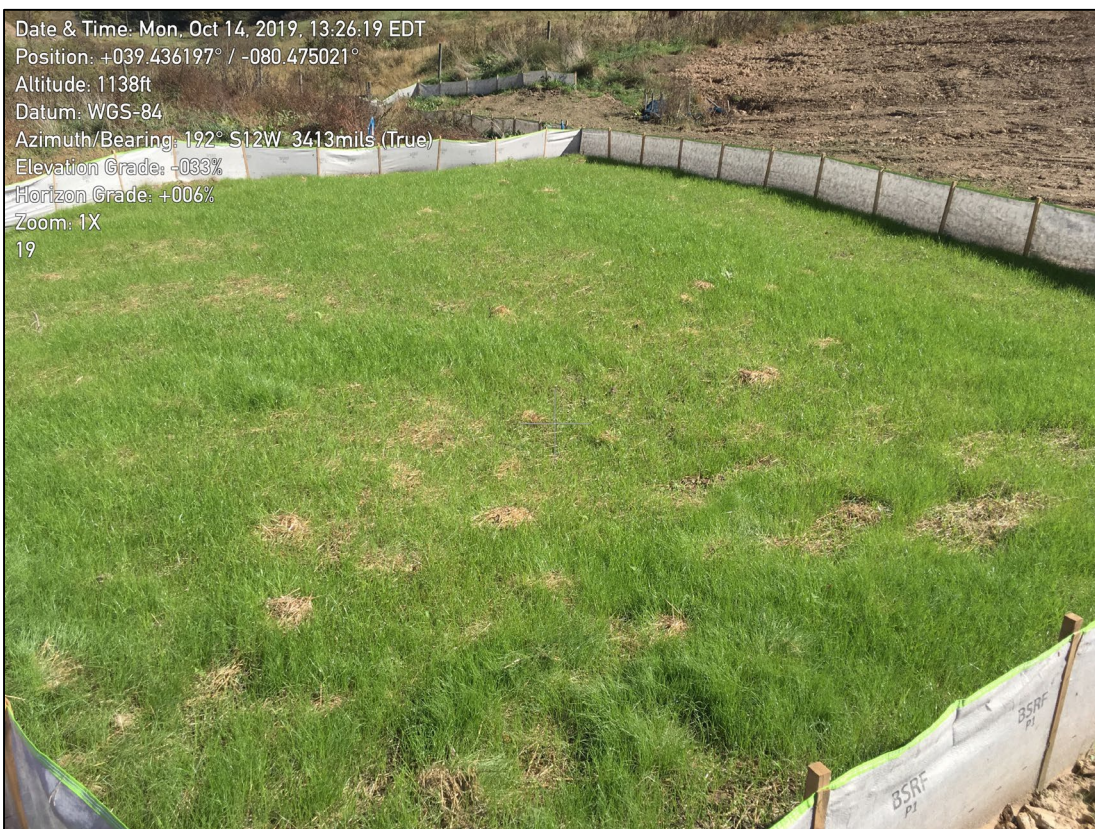
Photo 2: Photo illustrates the location of the original dewatering structure. The area is stabilized and vegetated.

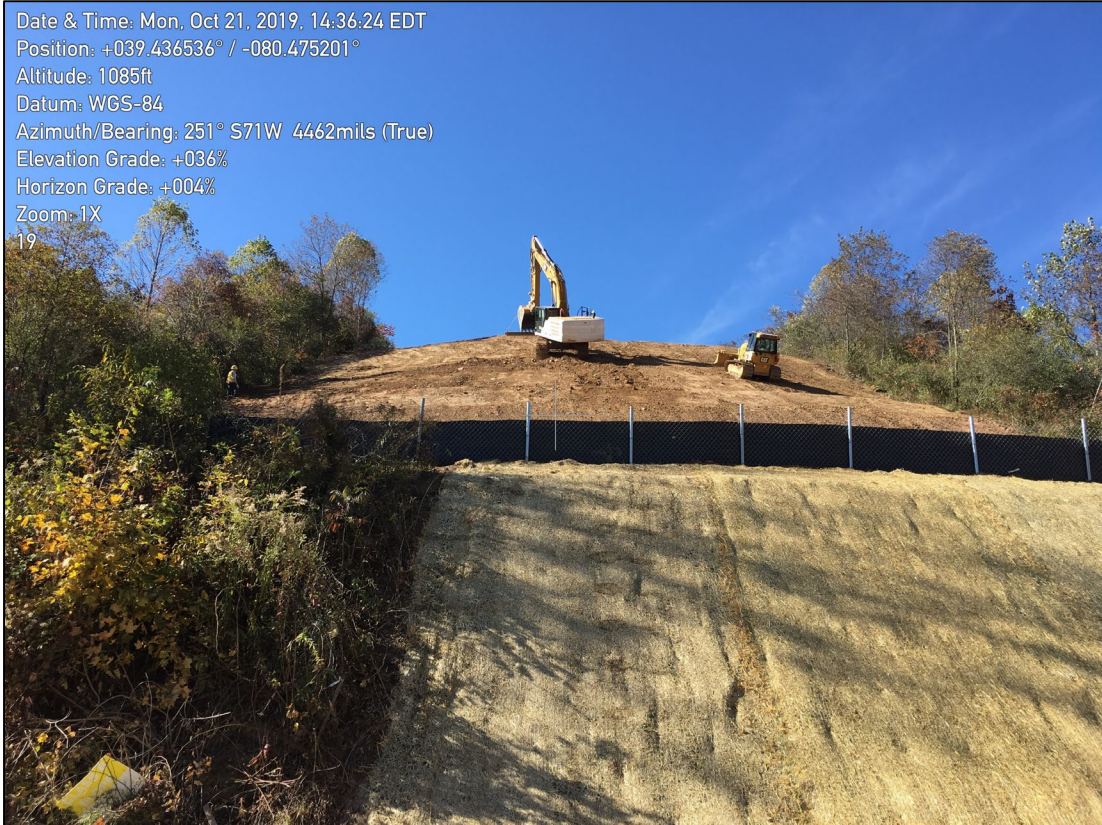
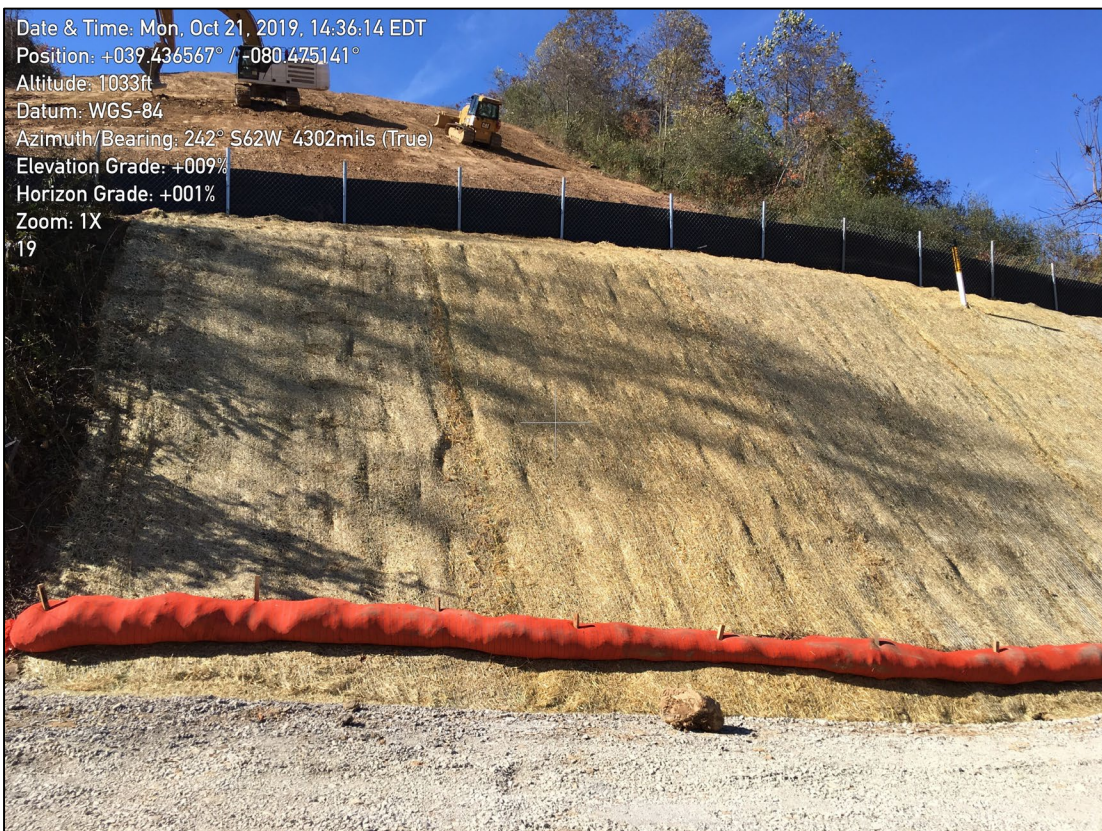
Photos 3 & 4: Photos illustrates the restoration near station 645+00. Erosion control blanketing and supersilt fence has been installed. The area upslope of the super silt fence is being prepared for restoration and stabilization.
